### LANDSLIDES AND RELATED FEATURES

OF THE BURGESS FALLS, TENN. QUADRANGLE

by  
Roger E. Thomas and Alfred R. Taylor

U.S. Geological Survey  
OPEN FILE MAP 82-653 (A-4)

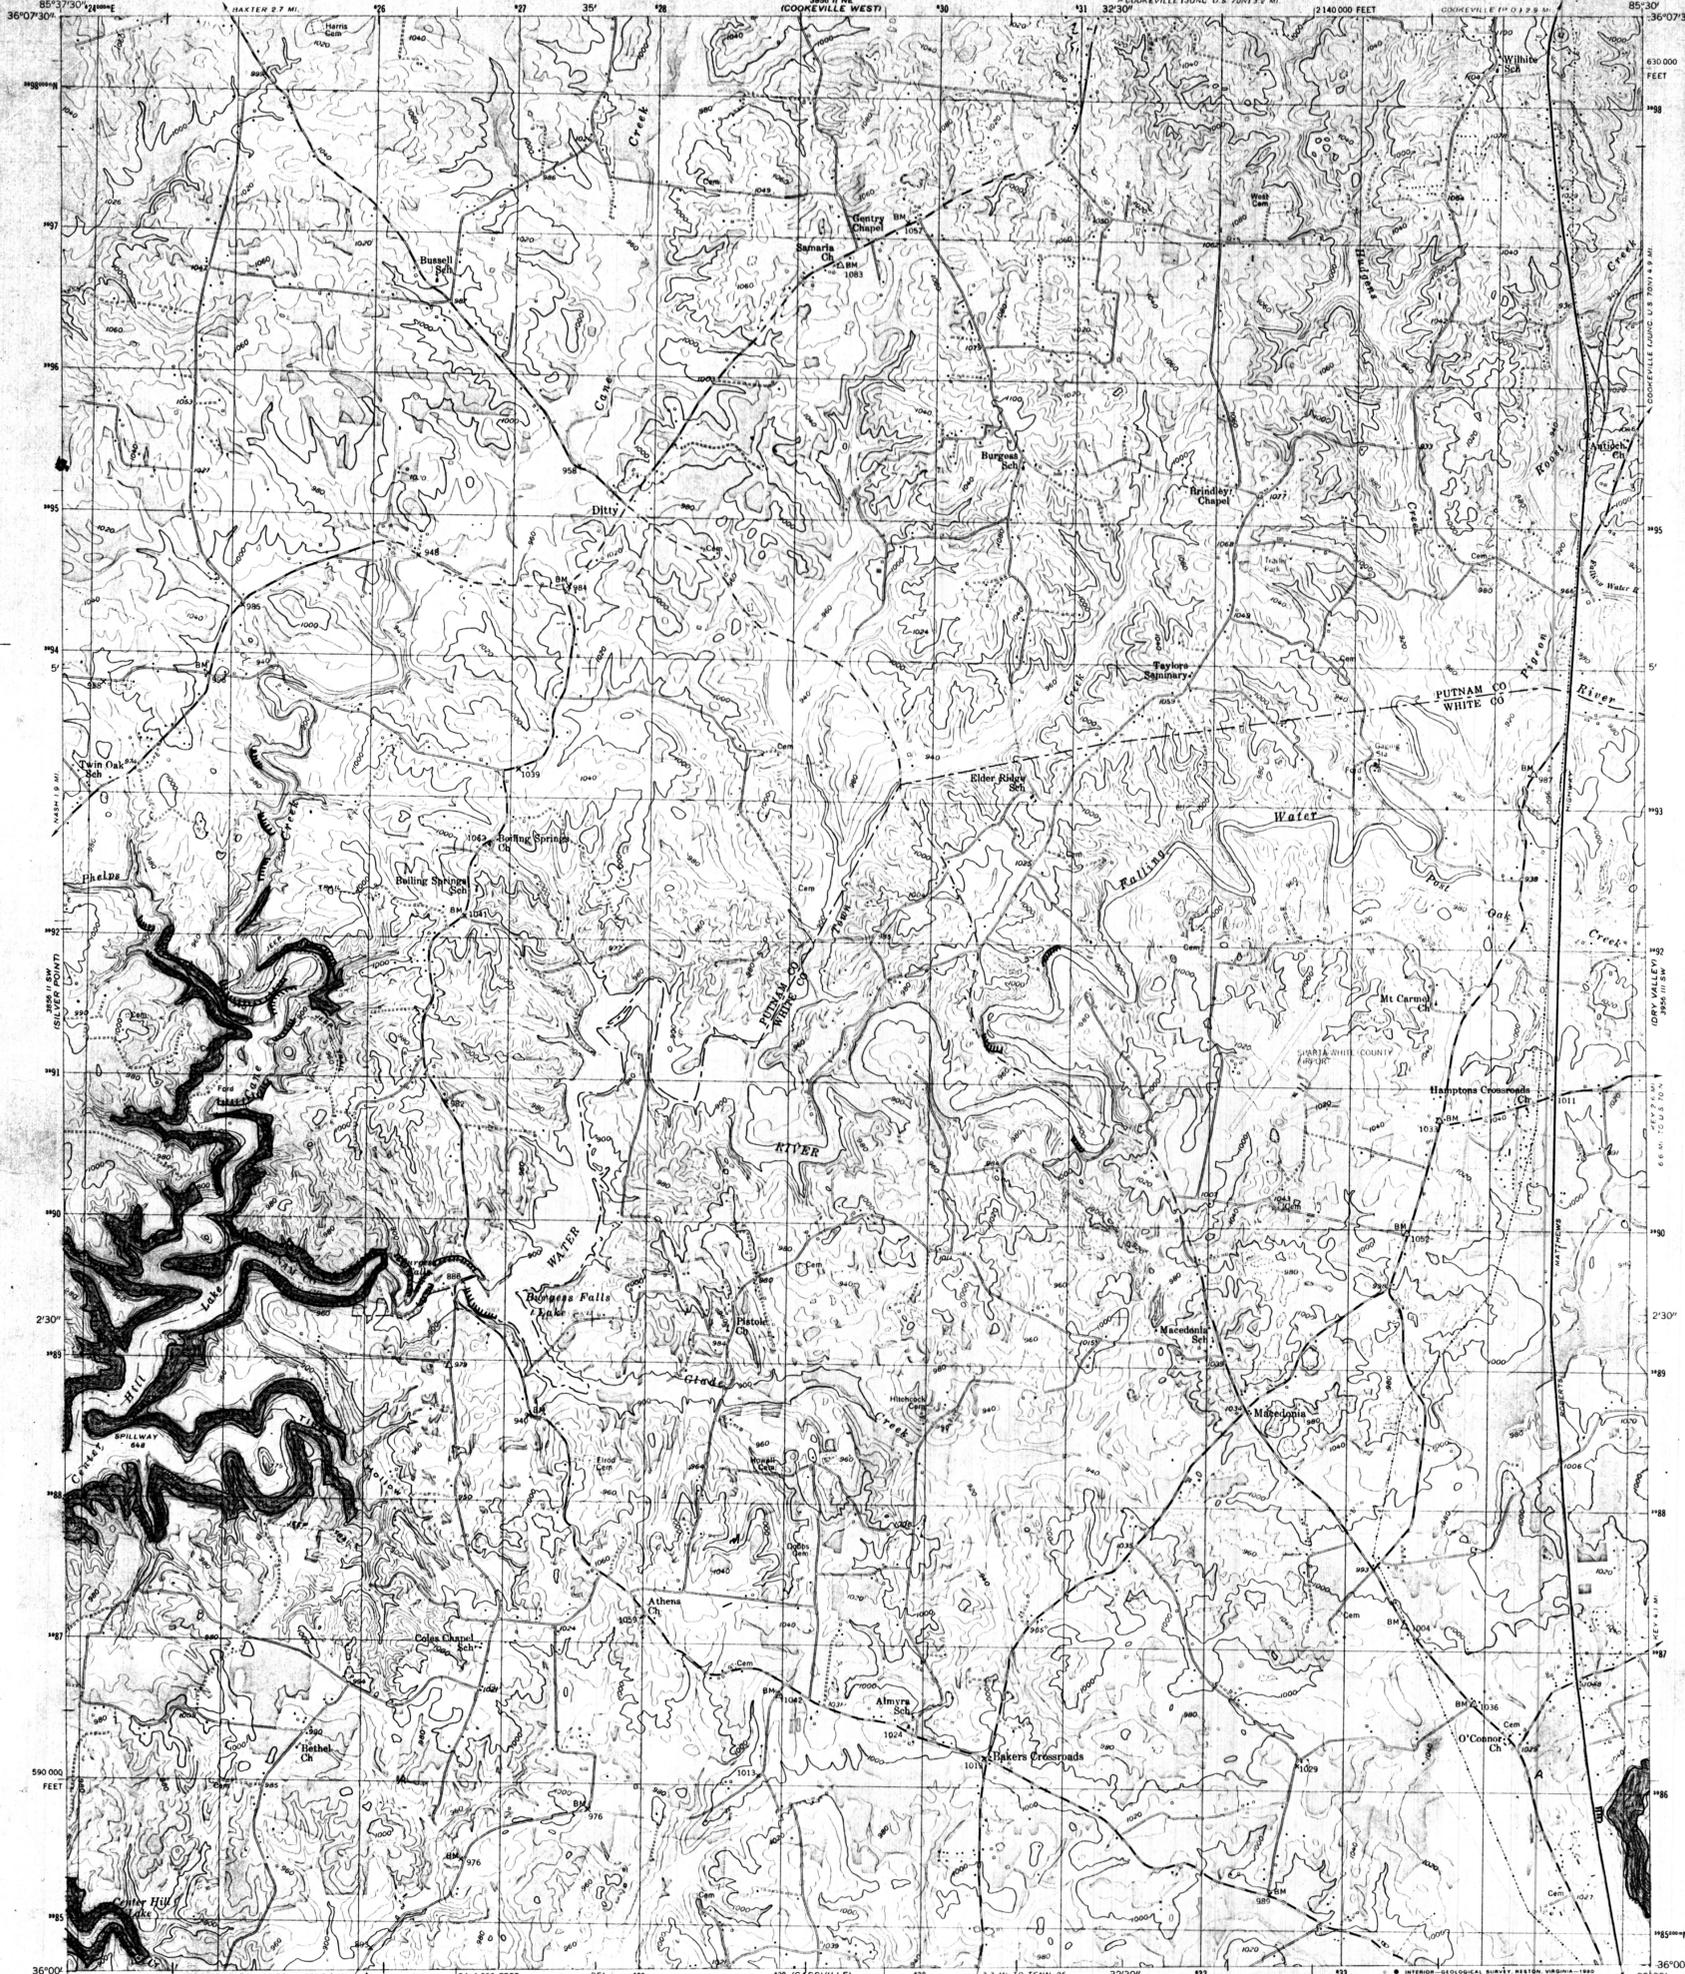
BURGESS FALLS, TENN.  
N 3600-W 8530/7.5  
1956

Landslides and related features interpreted  
from aerial photographs:

**ACTIVE OR RECENTLY ACTIVE LANDSLIDE**  
Complex landslide composed of earthflow, debris  
slide, earth and rock slump. Identified from  
historical records, and from scars, debris and  
other field evidence. Ground extremely unstable;  
sliding accelerated by excavation, loading and  
changes in drainage conditions. May include  
areas with several active slides too small to  
be shown separately. Questioned where doubtful.

**OLD LANDSLIDE**  
Area of extensive hummocky ground caused by  
earthflow and earth and rock slump. Lacks  
clear evidence of active sliding. Relatively  
stable in natural, undisturbed state,  
generally not affected by small structures properly  
sited in areas away from the edge of the toe;  
can be reactivated by extensive, rapid excava-  
tion, loading, and changes in ground water and  
surface water conditions. Area of old landslide  
probably includes recent ones not identified  
from field evidence or otherwise documented.  
Upslope boundary of landslide generally defined  
by modified scarp, but downslope (toe) may be  
gradational and not well defined. Questioned  
where doubtful.

**COMBINATION LANDSLIDE**  
Area of recent and old slides in which  
individual slides are not identified.

**COLLUVIAL SLOPE**  
Valley wall along major streams with slope as  
steep as 40° (85%); stony, clayey silt soil up  
to 50 ft. (15 m) thick; commonly buttressed by  
a terrace or bench at the toe of the slope; very  
susceptible to sliding by cutting of toe area,  
removal of terrace or bench, and overloading;  
slide commonly activated without apparent cause.

**COLLUVIAL SLOPES WITH LANDSLIDES**  
Landslides too small or obscure to map  
individually.

**AREAS SUSCEPTIBLE TO DEBRIS FLOWS AND DEBRIS  
AVALANCHES**  
Primarily shallow, narrow ravines and chutes with  
accumulation of stony colluvium generally 10 ft.  
(3 m) or less in thickness; susceptible to rapid  
movement during intense rainfall. Most ravines  
and chutes designated show evidence of former  
debris flows and avalanches.

**AREAS SUSCEPTIBLE TO ROCKFALL**  
Steep, locally vertical, natural and man-made  
slopes and cliffs, 15 ft. (4.5 m) or more high;  
formed dominantly of sandstone, limestone, sandy  
shale, mudstone and claystone. Interbedded mud-  
stone, claystone and shale weather rapidly leaving  
sandstone and limestone rock faces unsupported.

**SOIL AND ROCK SUSCEPTIBLE TO LANDSLIDING**  
Soil and rock similar to that involved in land-  
slides elsewhere in map area; primarily areas  
underlain by claystone, mudstone and shale  
associated with other rock types. Rock weathers  
rapidly on exposure forming clayey soil highly  
susceptible to sliding. Includes coves (U-shaped,  
shallow valleys) containing thick layers of clayey  
soil that are very susceptible to sliding where  
excavation breaks continuity of slope and where  
overloaded by artificial fill.

**AREAS LEAST PRONE TO LANDSLIDES**  
Map areas in which no patterns or symbols are shown;  
primarily valley floors, ridge tops and broad  
benches; modification by excavation and fill may  
lead to local landslides.
