U.S. GEOLOGICAL SURVEY

**Ground Failure Associated with the Puget Sound Region
Earthquakes of April 13, 1949, and April 29, 1965**

Open-File Report 90-687

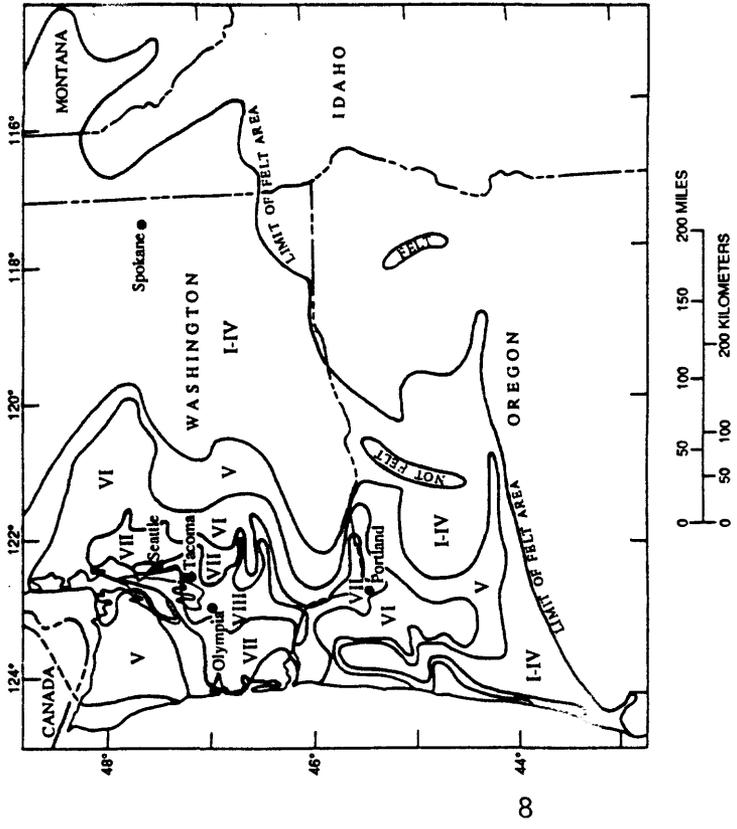
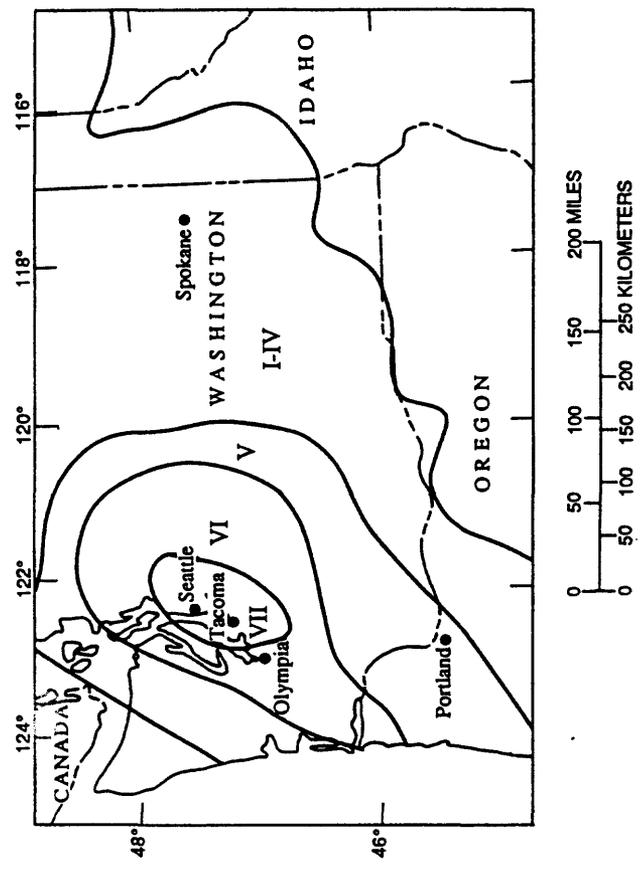
Figure 1.--Intensity maps for the Puget Sound earthquakes of, A, April 13, 1949 (modified from Ulrich, 1949), and B, April 29, 1965 (modified from Algermissen and Harding, 1965).

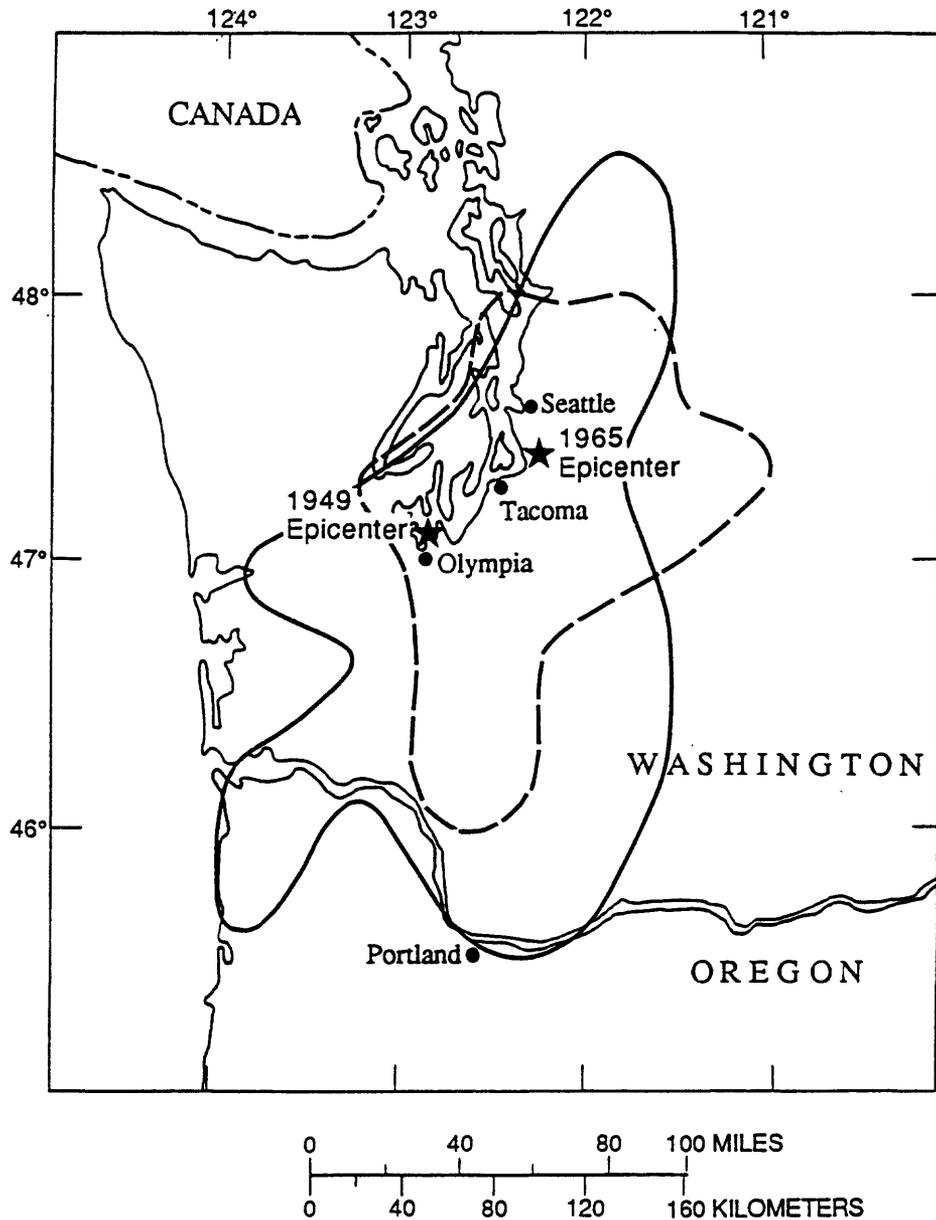
Figure 2.--Approximate areas of reported ground failures related to the Puget Sound earthquakes of April 13, 1949 (solid line) and April 29, 1965 (dashed line) (modified from Keefer, 1983).

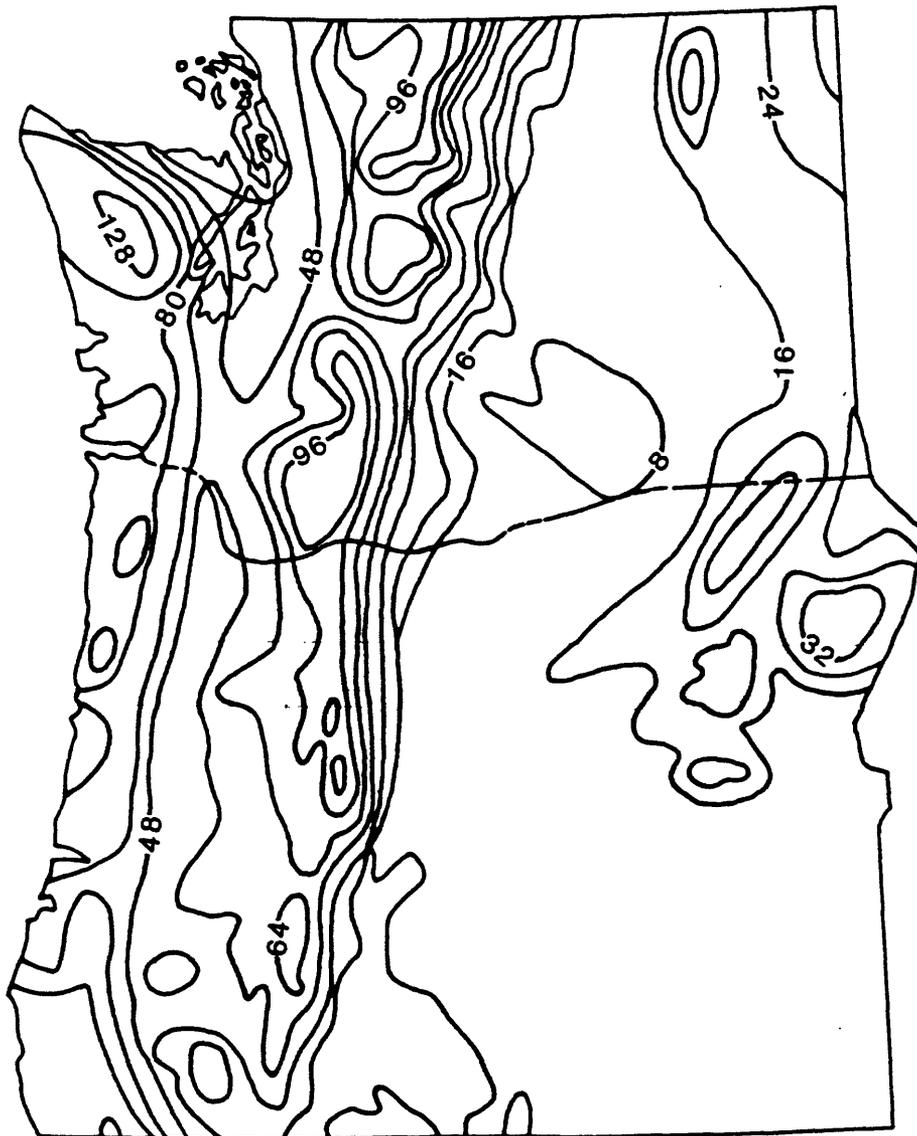
Figure 3.--Contour map showing mean annual precipitation (in inches) in Washington and Oregon for the period 1931-1960 (modified from U.S. Geological Survey, 1970).

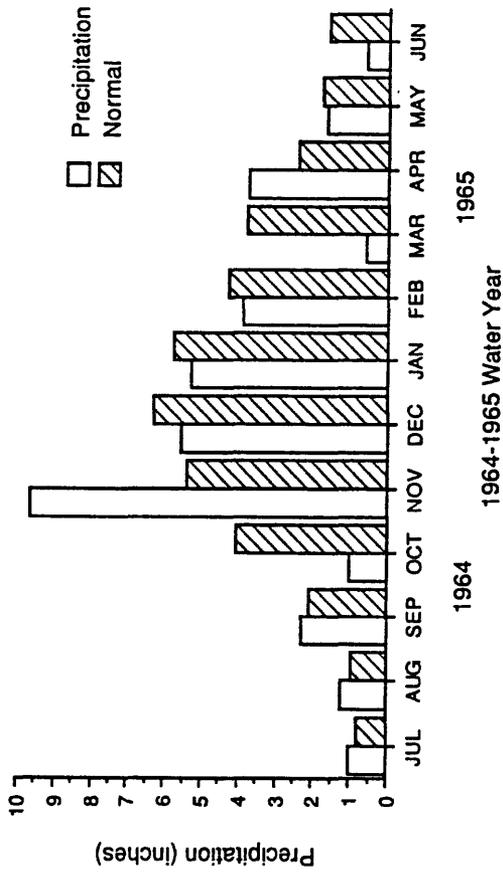
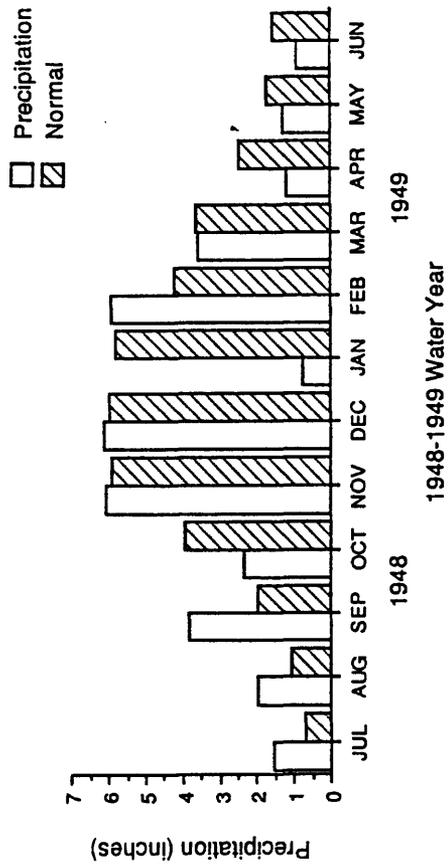
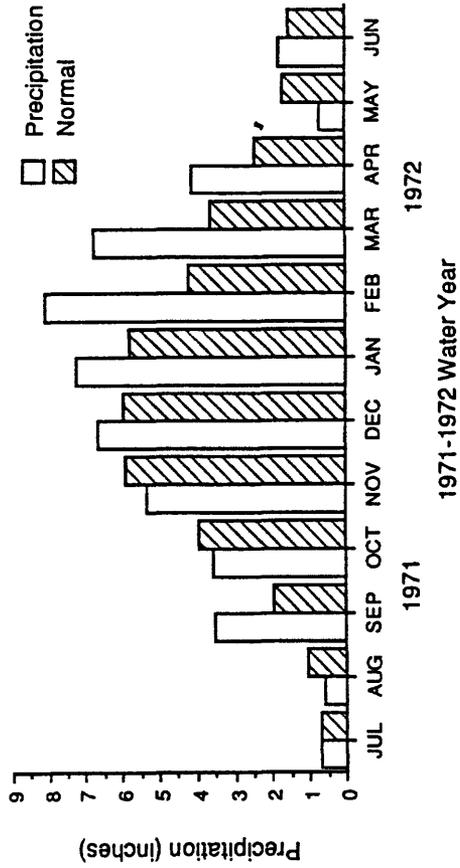
Figure 4.--Graphs showing precipitation in the Seattle-Tacoma area for the water years 1948-1949, 1964-1965, and 1971-1972 (U.S. Department of Commerce).

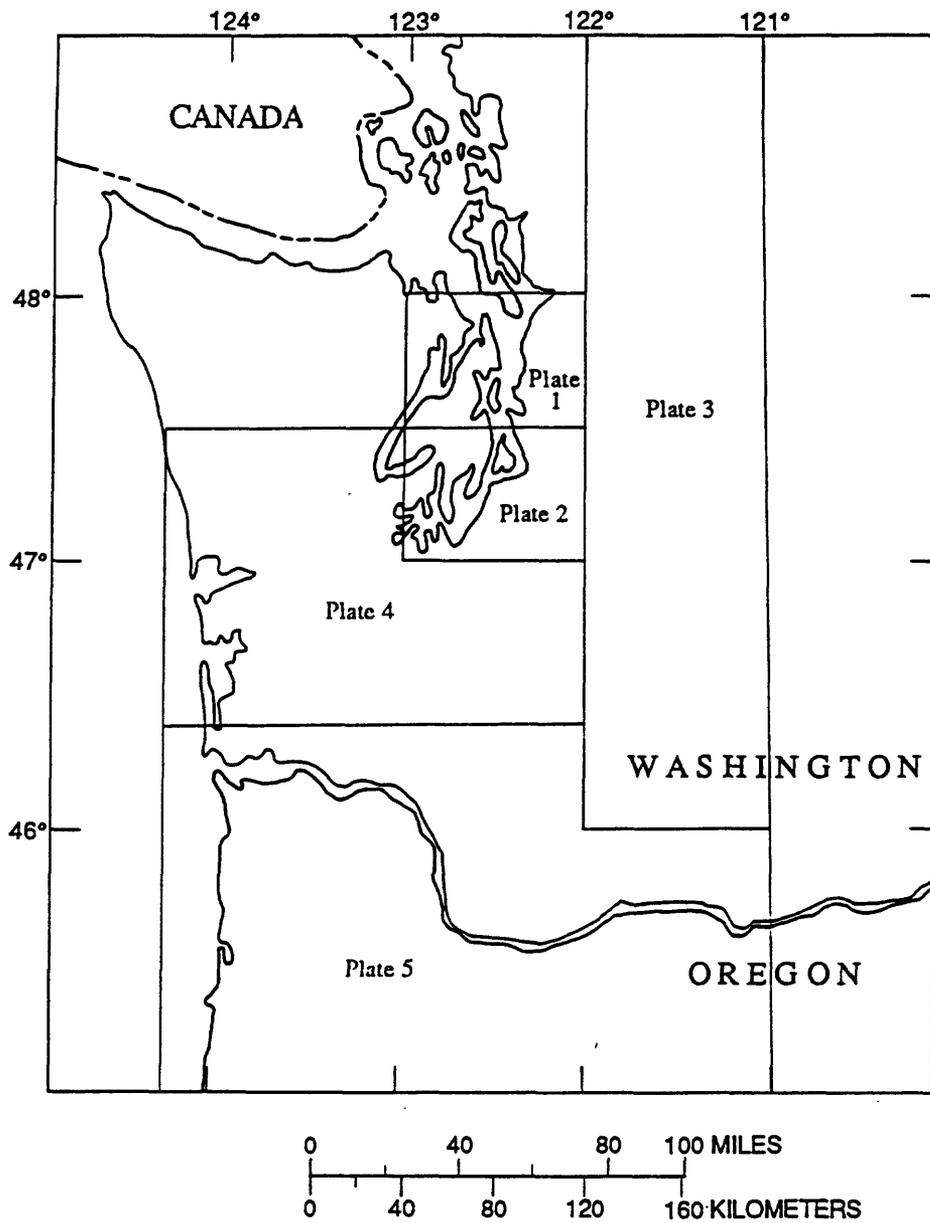
Figure 5.--Map of the western Washington-northwestern Oregon region showing areas covered by ground-failure location maps (plates 1-5).

The Central and Southern Puget Lowland region (pls. 1 and 2, fig. 5) includes much of the Puget Sound lowland. Approximately 85 percent of the reported ground failures in the 1965 earthquake and 50 percent in the 1949 quake occurred in this region. Some areas of the region experienced Modified Mercalli intensities (MMI) as high as VIII during the 1949 and 1965 earthquakes (Ulrich, 1949; Algermissen and Harding, 1965, von Hake and Cloud, 1967) (figs. 1 and 5). Ground cracks and settlement were the most numerous and widespread of the reported ground failures. Most were isolated occurrences of limited extent that caused only minor damage to roads, buildings, foundations, driveways, utilities, etc. Some, however, contributed to the considerable structural damage that occurred in areas of relatively intense ground shaking. Landslides in the region were most common on hillsides and coastal bluffs and along the banks of rivers, lakes, and other bodies of water. Many caused damage to structures, including roads, railroads, buildings, waterfront facilities, utility lines, and recreational facilities. One large debris avalanche, with an estimated volume of approximately $650 \times 10^3 \text{ yds}^3$ ($500 \times 10^3 \text{ m}^3$), occurred along the eastern bluff of the Tacoma Narrows 3 days after the April 13, 1949, earthquake. A few flow failures, related to the 1965 event, also occurred in the region. A significant number of ground failures developed in an environment thought to be conducive to liquefaction failures, as suggested by the presence of sediment types susceptible to liquefaction, high water tables, and in some cases the occurrence of sand boils in the immediate vicinity. These and other of the region's ground failures are considered in greater detail in the following discussion.

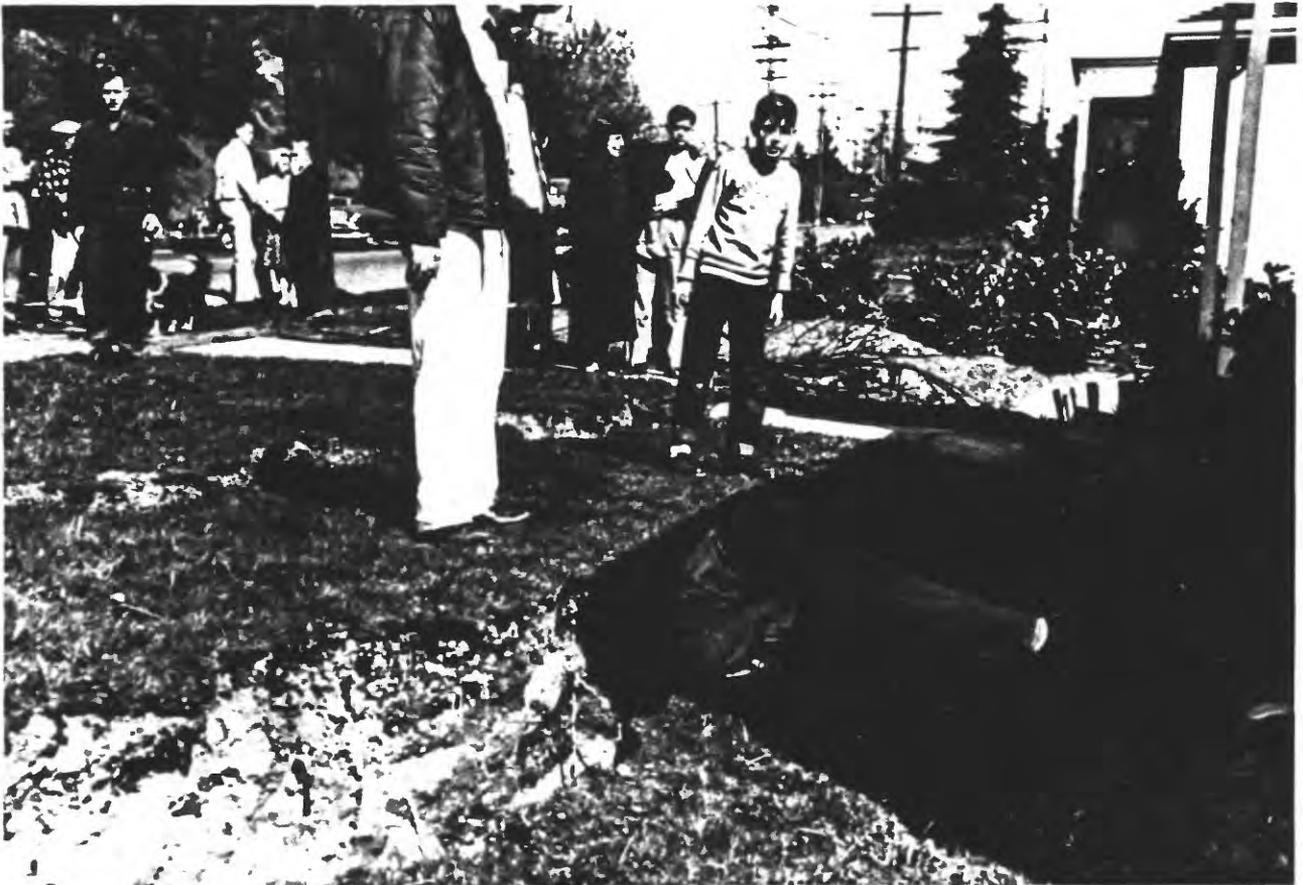
Figure 6.--Slumping and settlement induced by the April 13, 1949 earthquake, damaged several houses in West Seattle. Photo shows slump scarp exposing artificial fill near Admiral Way (pl. 1, loc. 10). (Photograph from Seattle Post-Intelligencer Collection, courtesy of the Museum of History and Industry Seattle.)

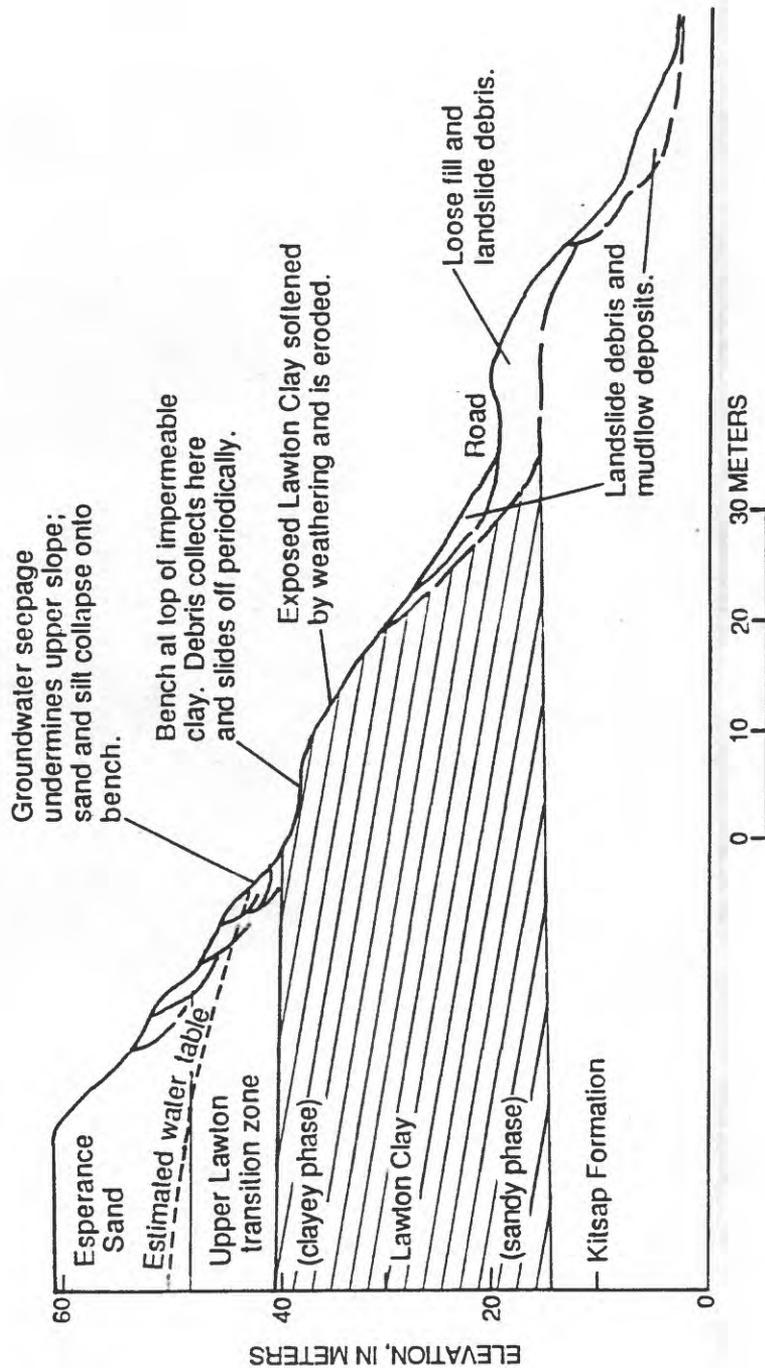
Figure 7.--Cross-section of a West Seattle bluff showing stratigraphy and locations of slope failure (figure taken from Tubbs and Dunne, 1977).

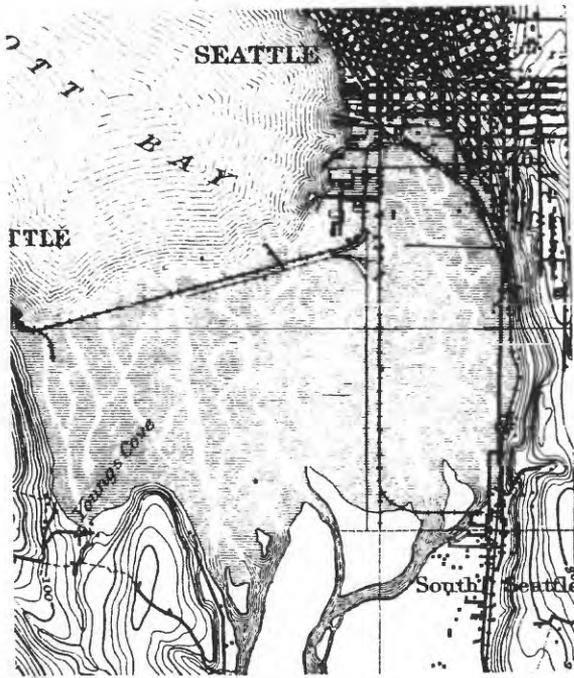
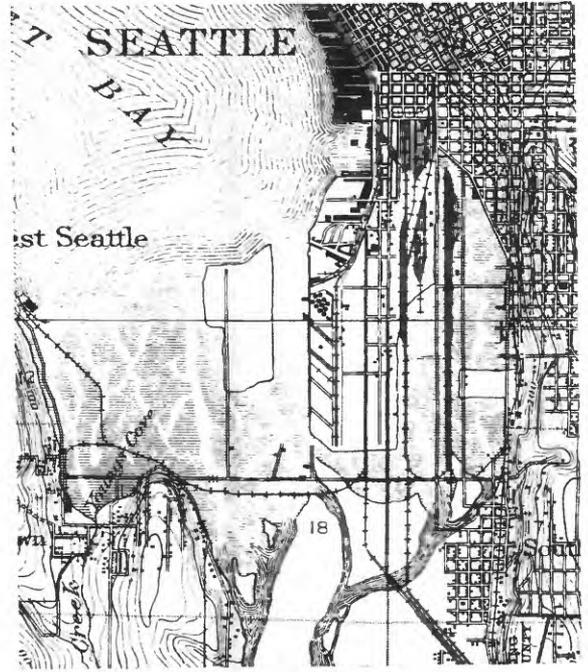
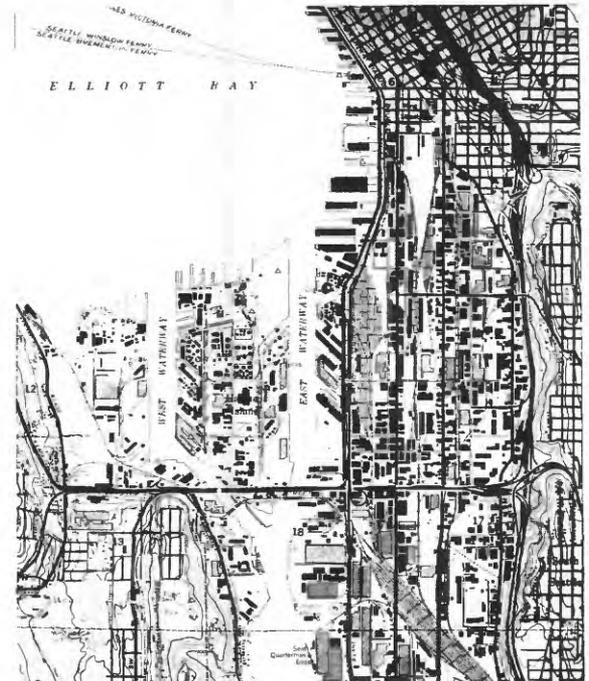
Figure 8.--Maps showing a sequence of development of the former tidal flats area, at and near the mouth of the Duwamish River, Seattle, between the years 1893 and 1973. A, shows the area as it existed in 1893, B, in 1908, and C, in 1973. Since 1893, the tidal flats have been extensively covered by artificial fill to allow development. The area was the site of many earthquake-induced ground failures and considerable property damage in both 1949 and 1965. Map scales are approximately 1:62,500 (from U.S. Geological Survey 1:62,500 Seattle, 1894; 1:62,500 Seattle, 1909 (reprinted in 1942); 1:24,000 Seattle South, 1949 (photorevised 1968 and 1973)).

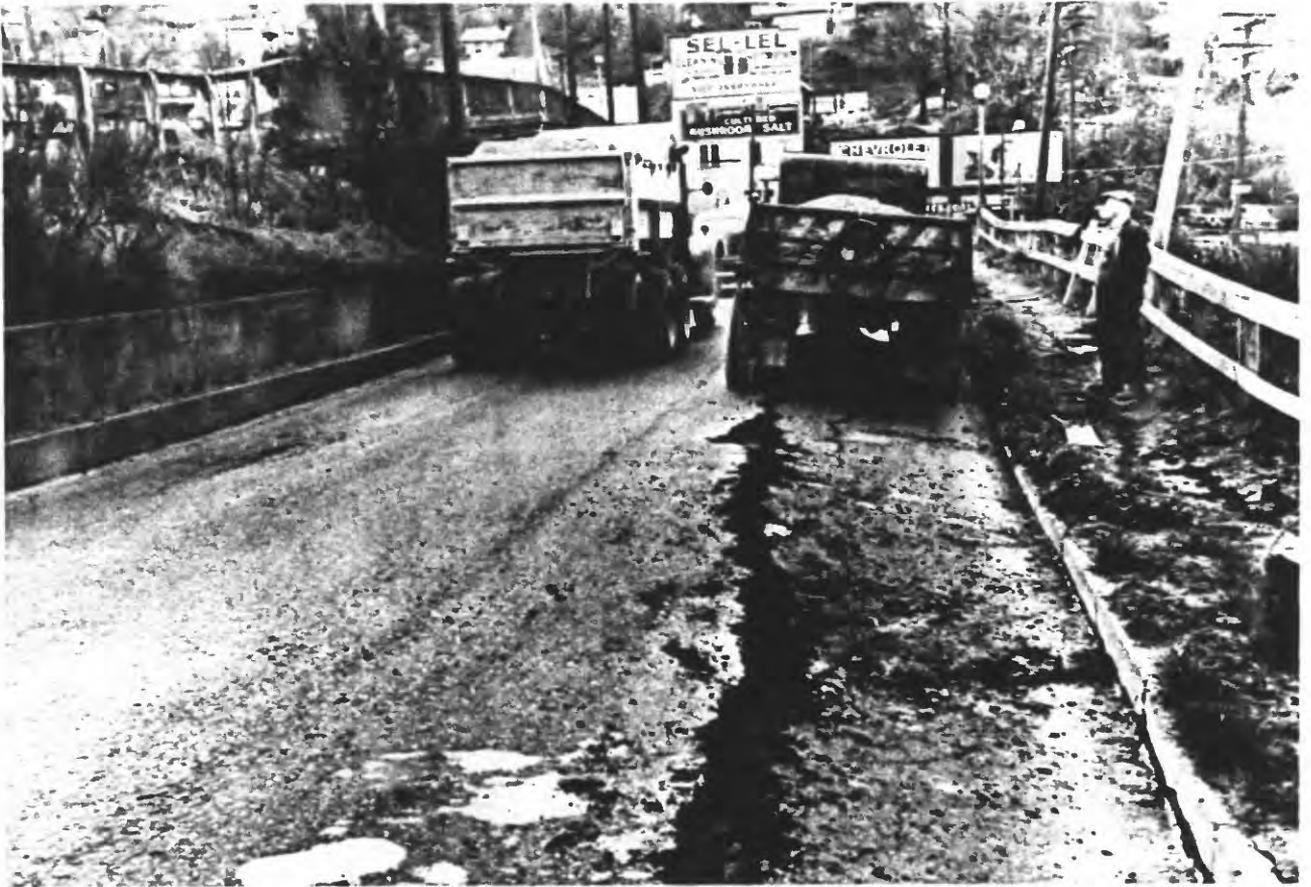
Figure 9.--View along Spokane Street approach to West Seattle (pl. 1, loc. 16). Photo shows pavement cracks and slight slump in road embankment composed of artificial fill. Note arcuate scarp and tilted light pole (right side of photo). The ground failure was triggered by the April 13, 1949, earthquake. (Seattle Post-Intelligencer Photo Collection, Museum of History and Industry, Seattle.)

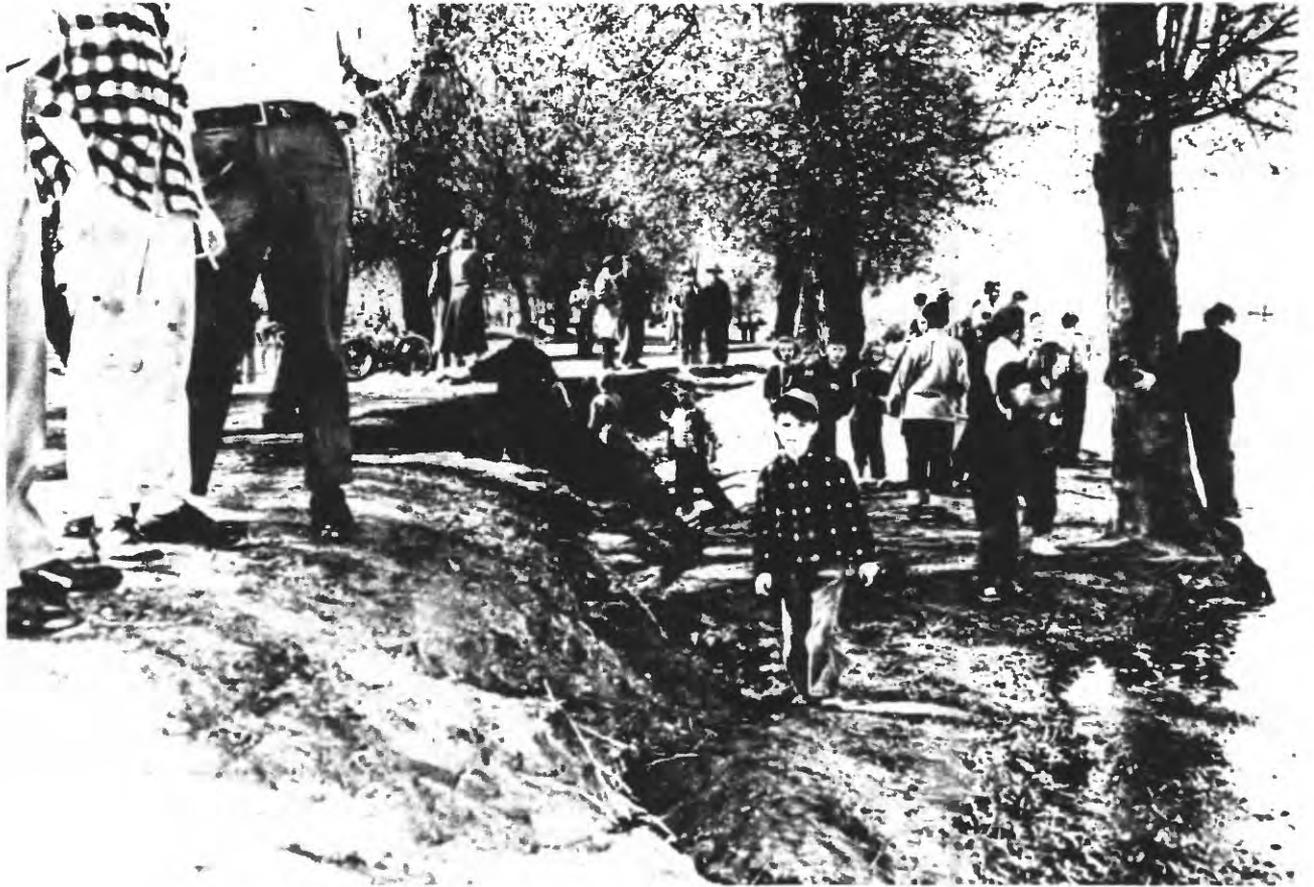
Figure 10.--Slump along the shore of Green Lake north of downtown Seattle. This 1949 earthquake-induced ground failure occurred near the south end of the lake (pl. 1, loc. 33) in an area that subsequently experienced ground failure during the April 29, 1965 earthquake. (Photograph from Seattle Post-Intelligencer Collection, courtesy of the Museum of History and Industry, Seattle.)

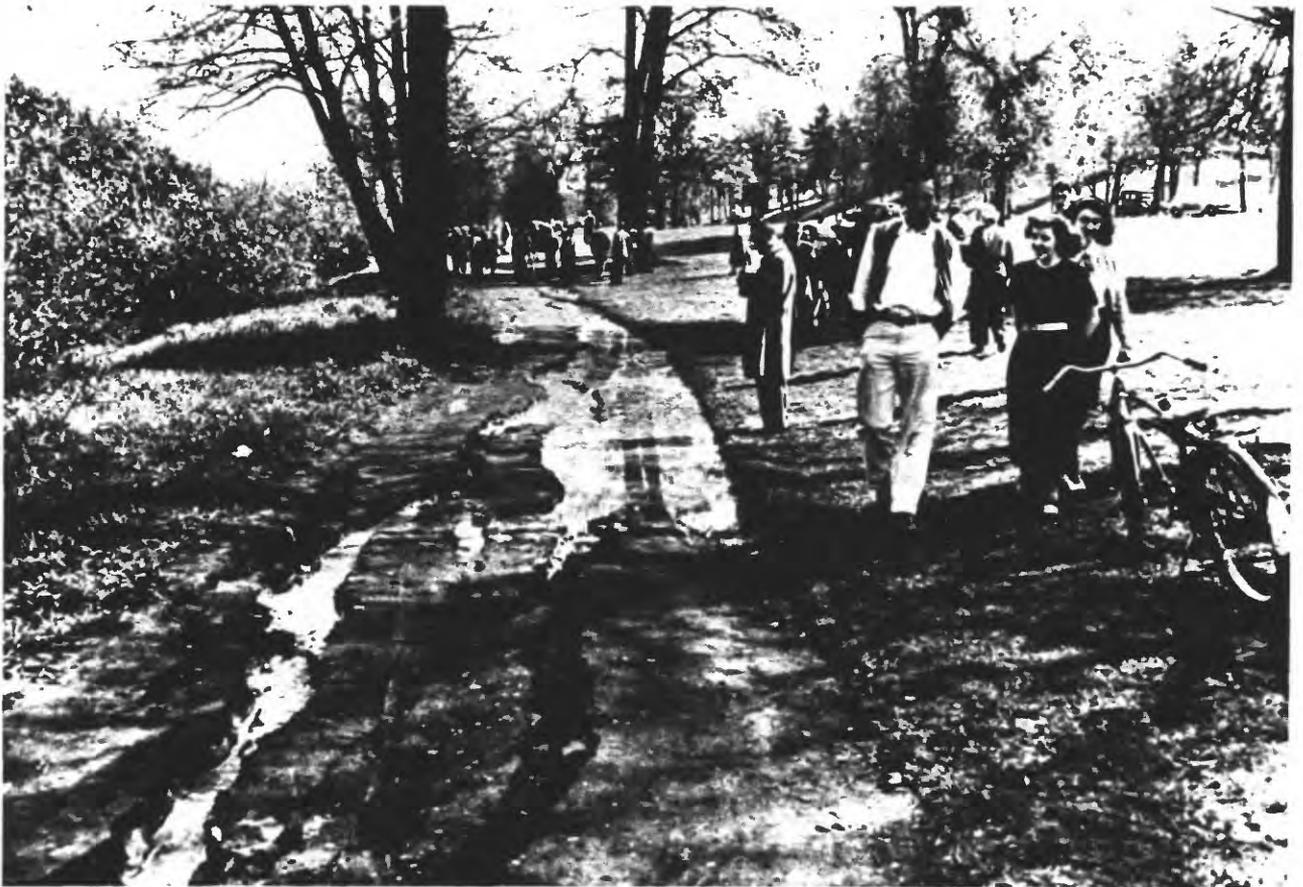
Figure 11.--Ground cracks on the southeast side of Green Lake in north Seattle (pl. 1, loc. 33). The cracks opened during or shortly after the April 13, 1949, earthquake and probably resulted from subsidence and lateral movement of the ground downslope toward the lake (out of sight to the left of view in photo). (Photograph from Seattle Post-Intelligencer Collection, courtesy of the Museum of History and Industry, Seattle.)

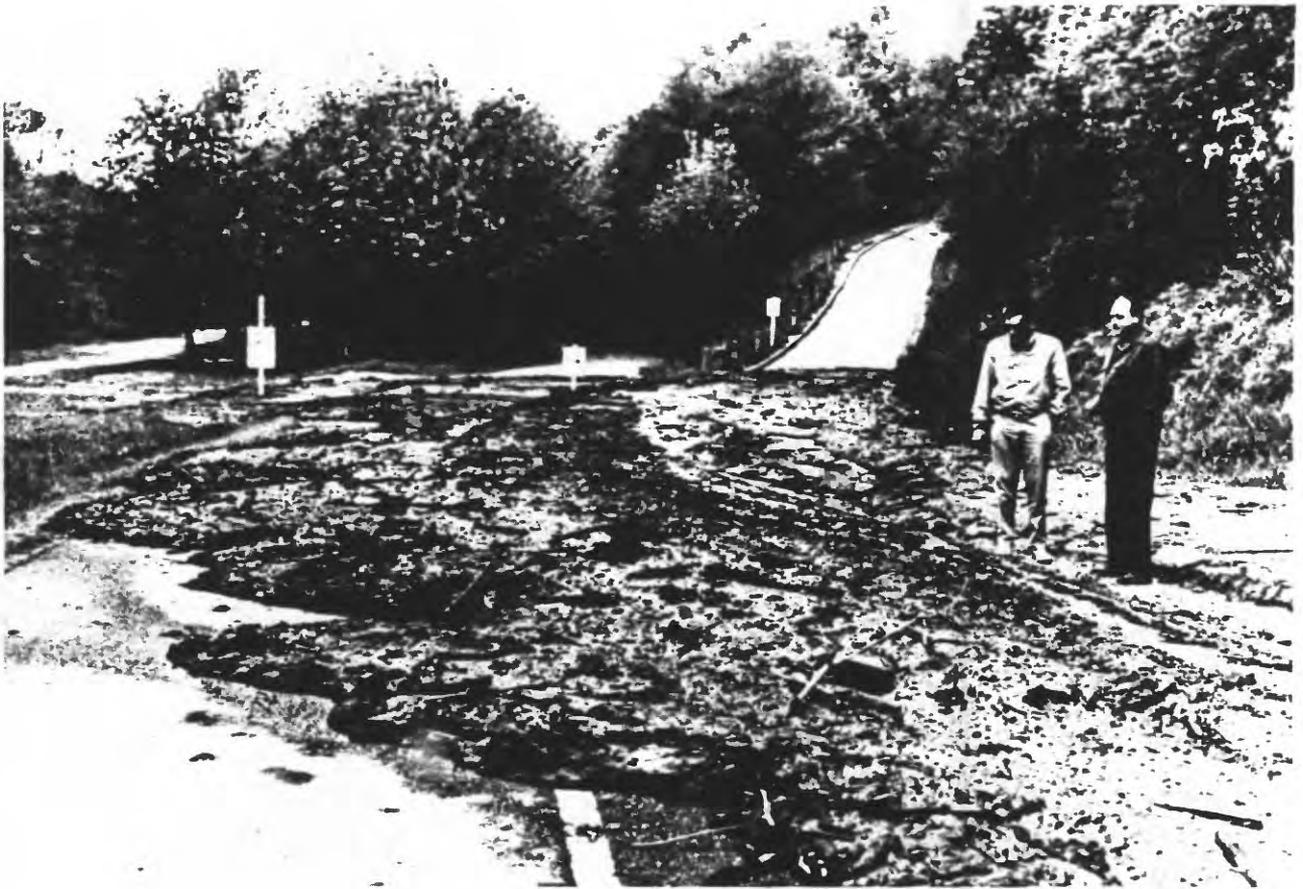
Figure 12.--Mud flow covering Carkeek Park Road in Carkeek Park, northwest Seattle (pl. 1, loc. 36). This mud flow developed as material from an earth slide, triggered by the April 29, 1965, earthquake, mixed with water and flowed down a Piper Creek tributary ravine. (Photograph by permission of the Seattle Times Co.)

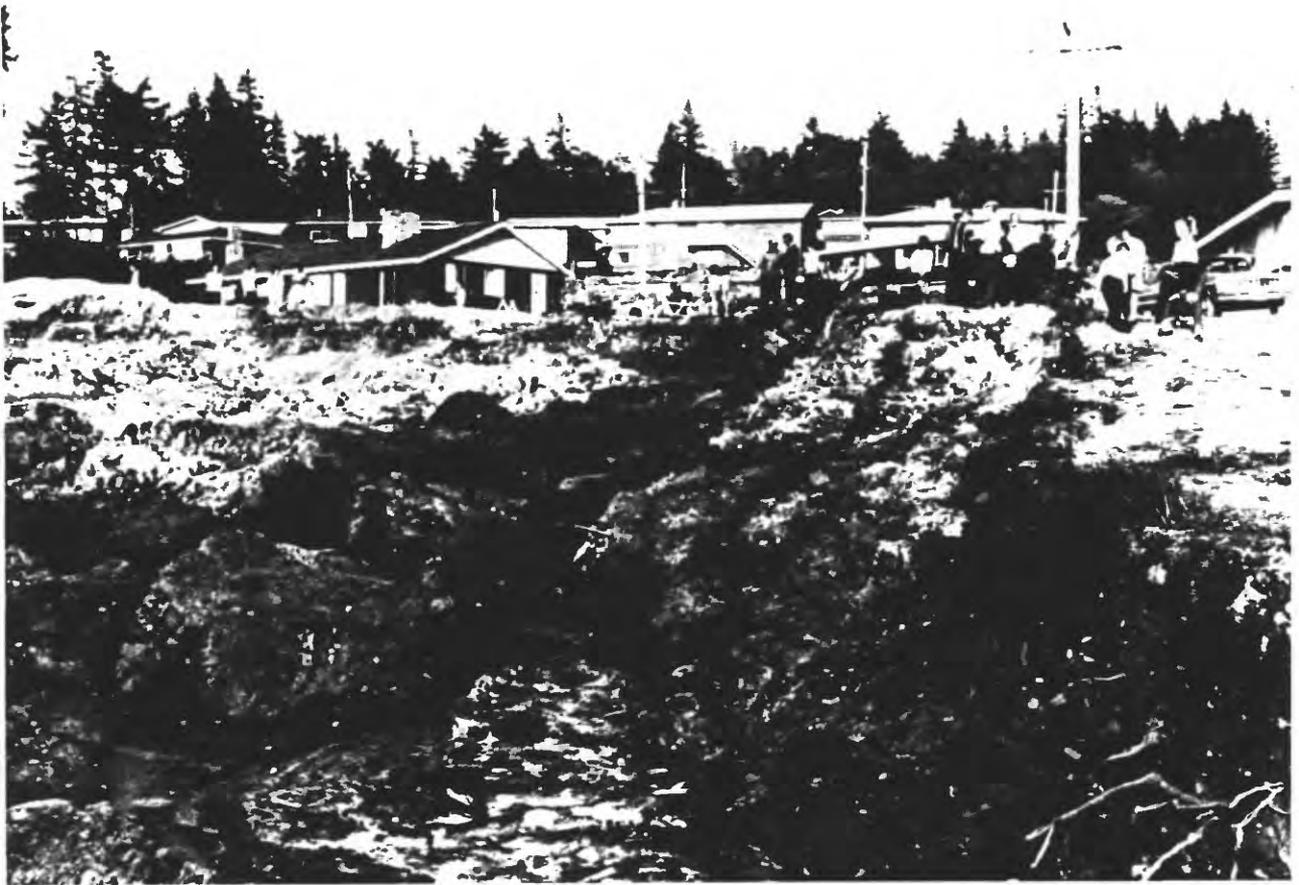
Figure 13.--Earthflow in Edmonds, Wash. (pl. 1, loc. 40) induced by the April 29, 1965, Seattle-Tacoma earthquake. The landslide mobilized at the head of a small ravine and flowed downslope approximately 200 yds (180 m), destroying an abandoned city water-well shed in its path. (Photograph from the Seattle Post-Intelligencer Collection, courtesy of the Museum of History and Industry, Seattle.)

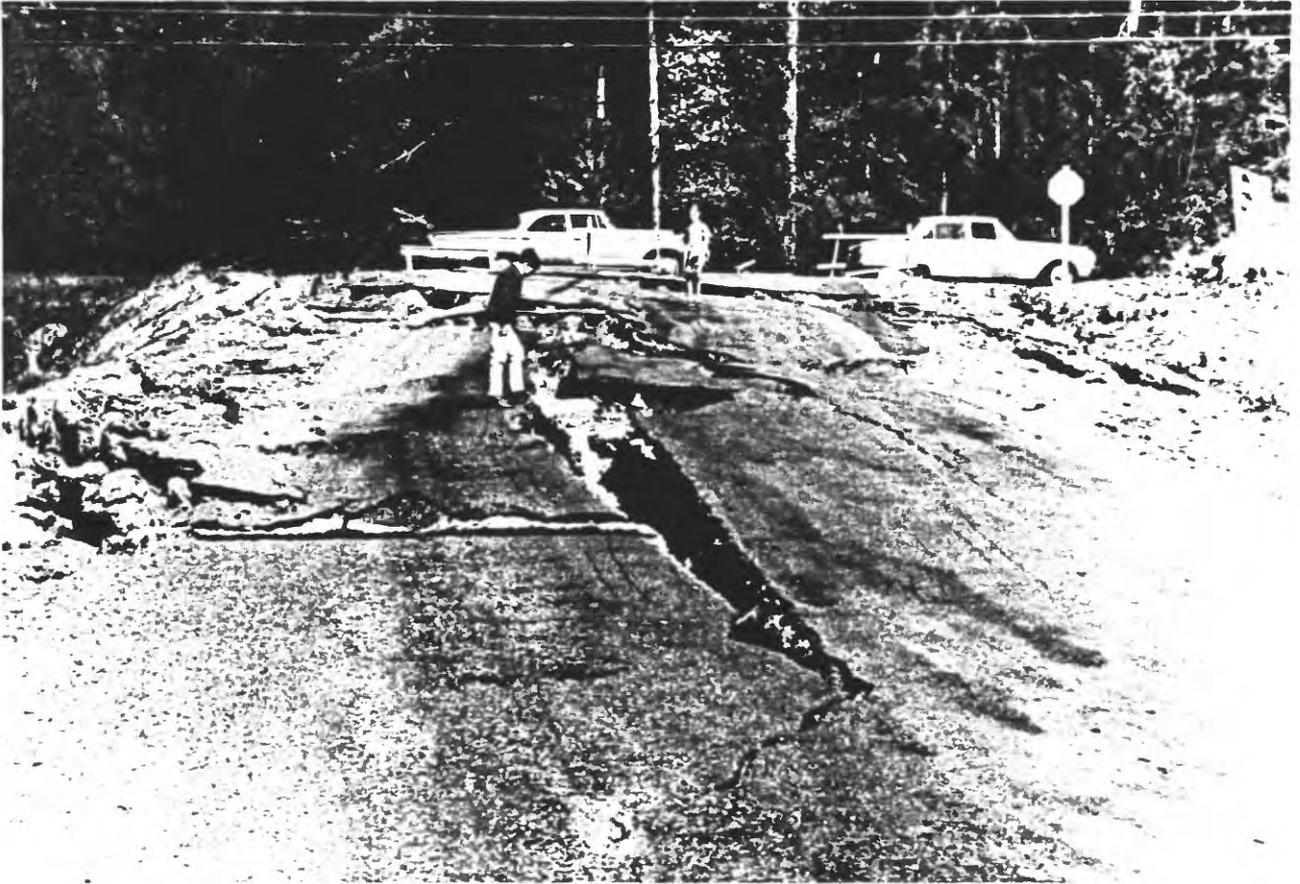
Figure 14.--Damage to Country Club Road southwest of Port Orchard, Wash., (pl. 1, loc. 2) due to slumping induced by the April 29, 1965 Seattle-Tacoma earthquake. This slump occurred in granular fill underlain by Vashon glacial drift. (Photograph by permission of the Bremerton Sun.)

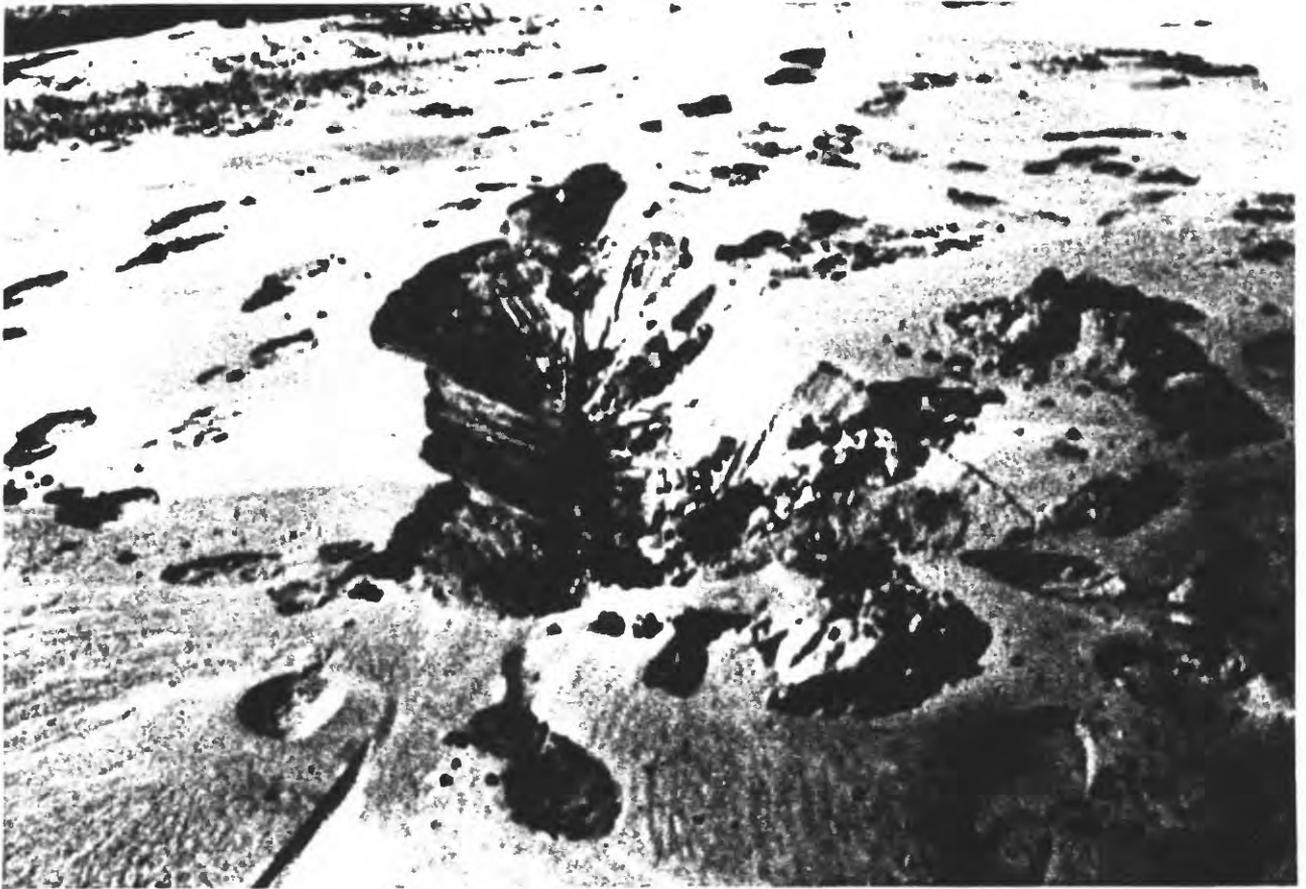
Figure 15.--Sand boil in Puyallup Wash., (pl. 2, loc. 68) produced by the April 13, 1949, earthquake. The 1949 earthquake generated many sand boils in the area of northwest Puyallup. Some, such as this one, deposited considerable volumes of sediment on the surface; others were associated with damage to homes in the area. (Photograph by Richard Six, Puyallup, Wash.)

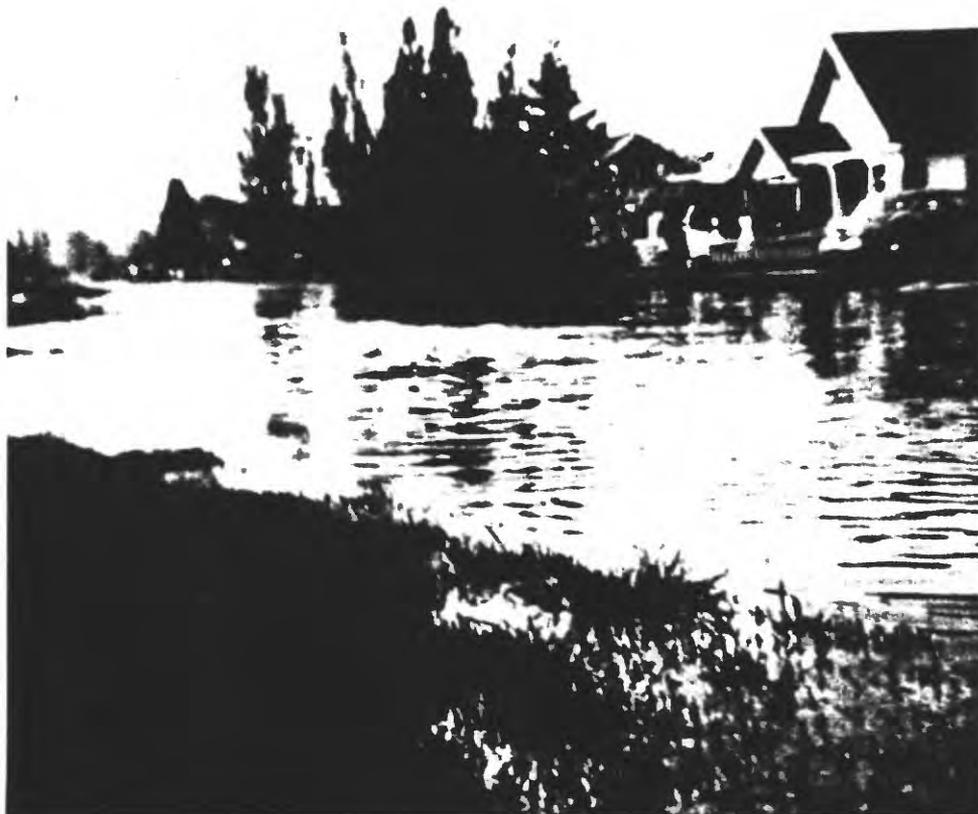
Figure 17.--Flooding in northwest Puyallup (pl. 1, loc. 68) at the time of the April 13, 1949, earthquake. According to local residents the flooding could not be attributed to broken water mains and may have resulted from the ejection of ground water from the many sand boils that occurred in the area. (Photograph by Richard Six, Puyallup, Wash.)

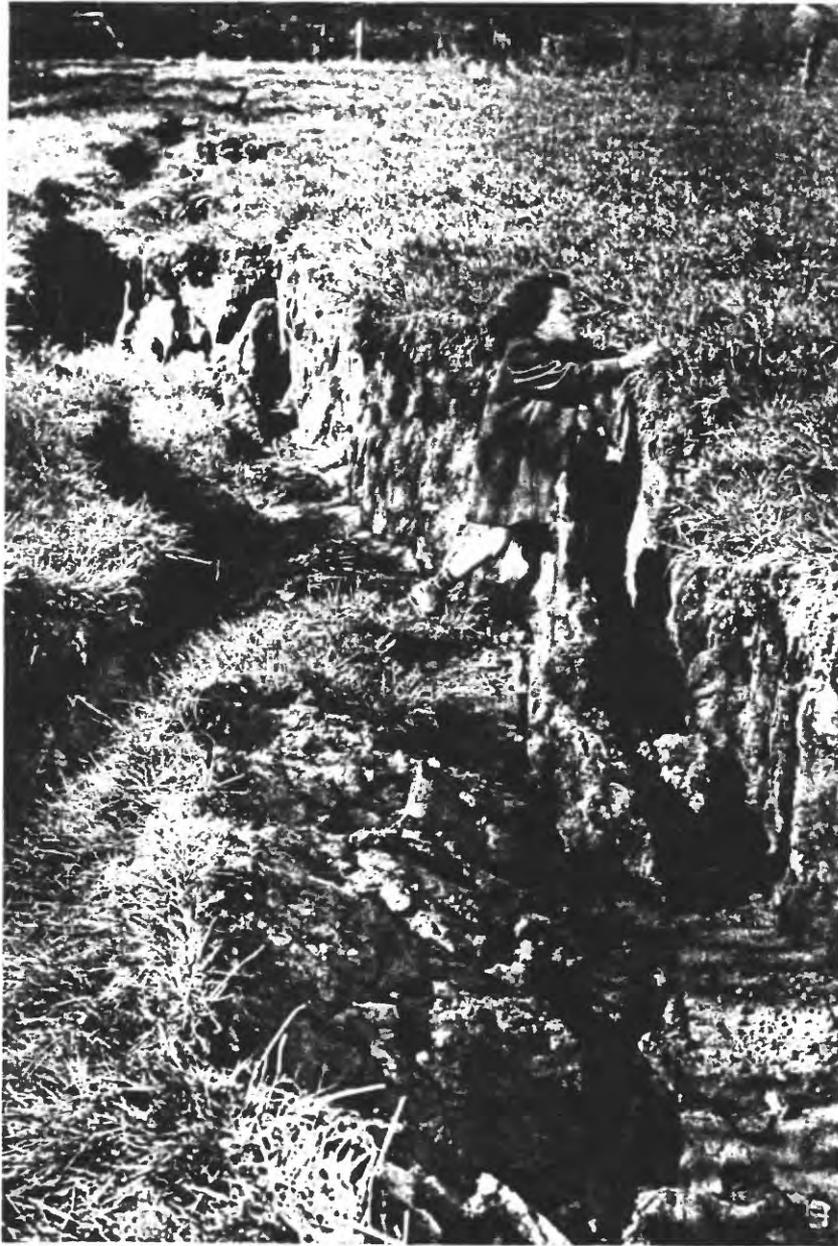
Figure 18.--Ground crack along Clarks Creek northwest of Puyallup associated with slumping or lateral spreading of alluvial sediments (pl. 2, loc. 71). This 1949 earthquake-induced ground failure extended along 200-300 ft (60-90 m) of the west bank of Clarks Creek; lateral movement was in the direction of the creek (out of sight to left of view in photo). (Richards Photographic Studio Photo Collection, Tacoma Public Library, Tacoma, Wash.)

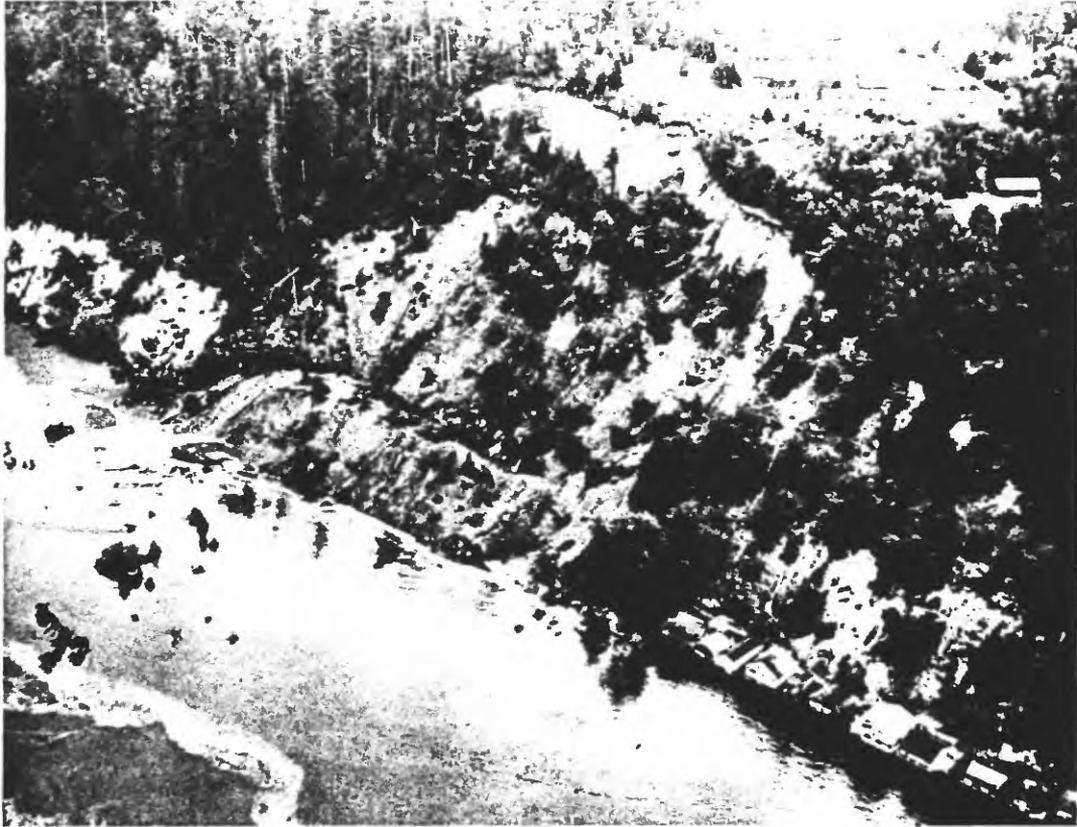
Figure 19.--Tacoma Narrows landslide, April 16, 1949 (pl. 2, loc. 81). This landslide was probably triggered by the 1949 Olympia earthquake which occurred 3 days before the slide. The large mass narrowly missed homes to the south on Salmon Beach as it plunged into the waters of the Tacoma Narrows. The resulting 8-ft (2.5-m) tidal wave damaged small boats and nearby dock facilities. (Photograph by permission of Associated Press).
