U.S. GEOLOGICAL SURVEY

**Ground Failure Associated with the Puget Sound Region
Earthquakes of April 13, 1949, and April 29, 1965**

Open-File Report 90-687

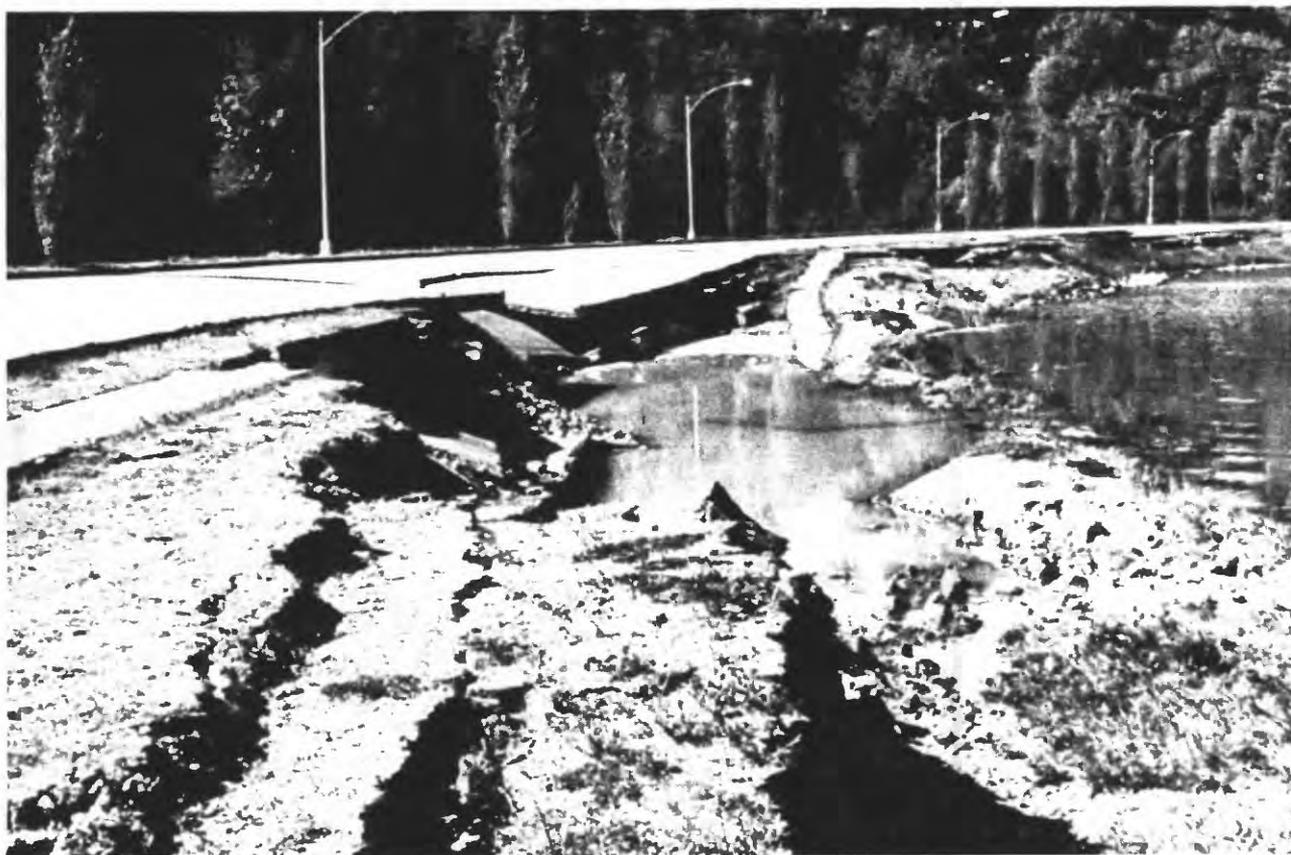
Figure 20.--Damage to Deschutes Parkway, Olympia, Wash., resulting from 1965 earthquake-induced ground failure (pl. 2, loc. 48). The Parkway was constructed on granular fill placed on tidal-flat muds which are now within the limits of Capitol Lake; failure was probably due to liquefaction. (Photograph by G.W. Thorsen, Division of Geology, Washington Department of Natural Resources, Olympia.)

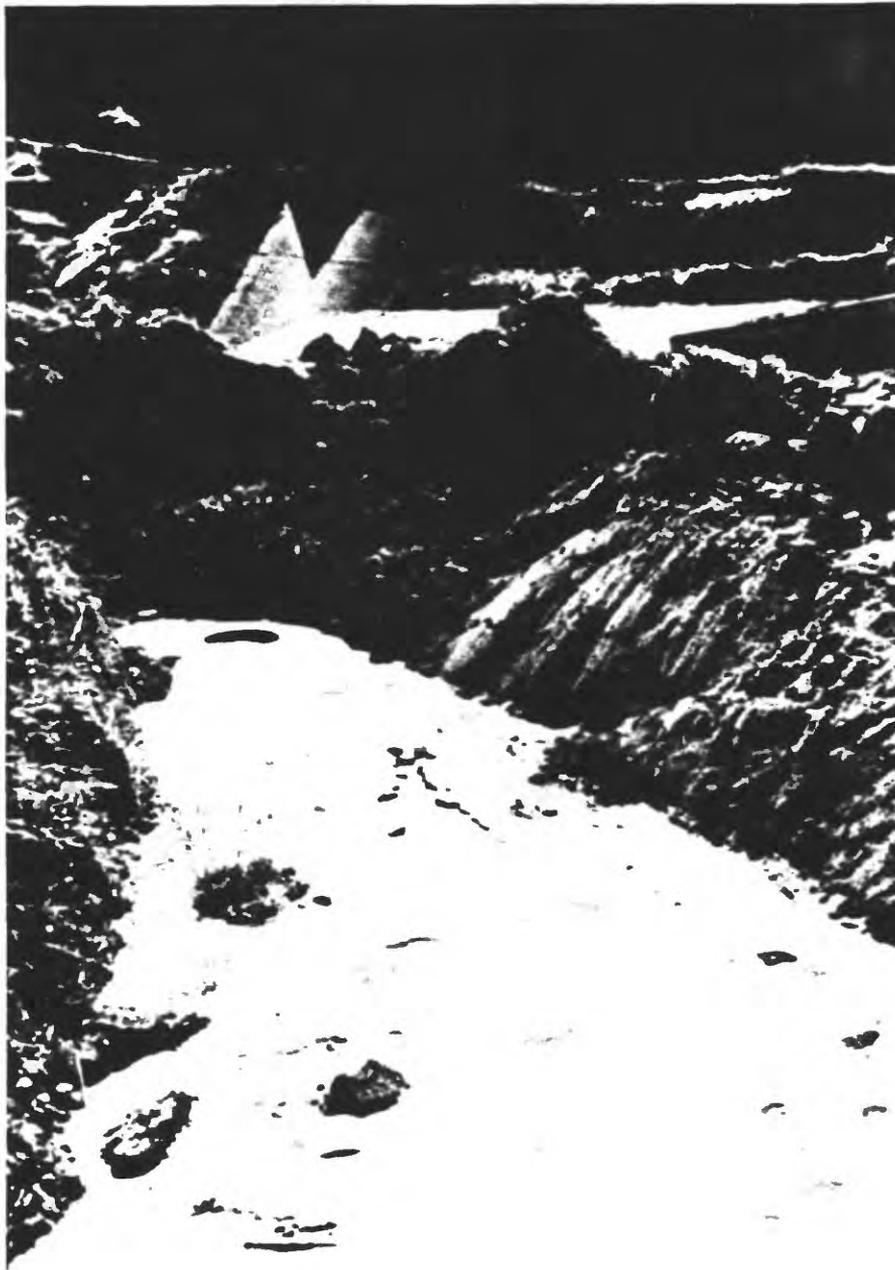
Figure 21.--Sand boils (near Capitol Lake in Olympia, Wash.) related to the earthquake of April 29, 1965 (pl. 2, loc. 48). The sand boils are evidence of soil liquefaction at this ground failure location. Sidewalk slab in background shows scale. (Photograph by G.W. Thorsen, Division of Geology, Washington Department of Natural Resources, Olympia.)

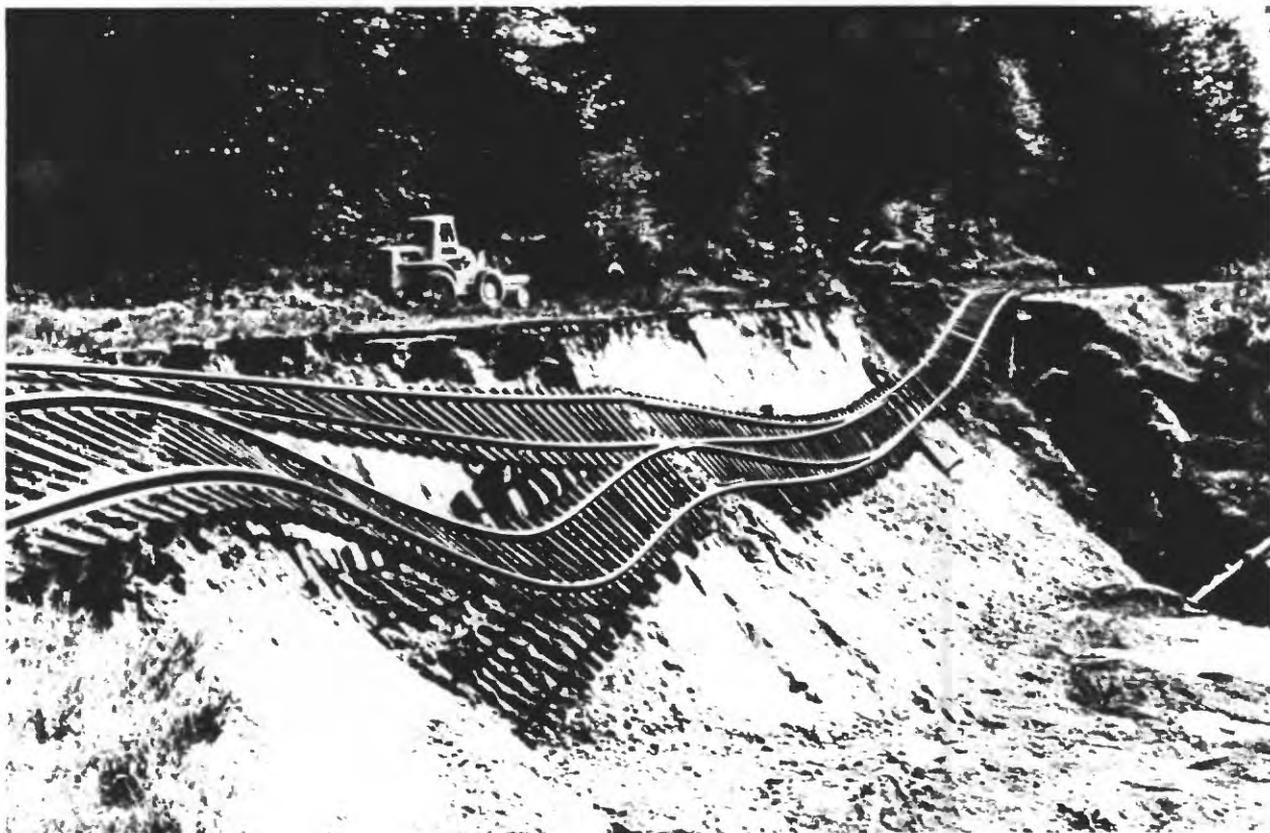
Figure 22.--Damage to Union Pacific Railroad tracks near Olympia, Wash. (pl. 2, loc. 45) due to a 1965 earthquake-induced slope failure in artificial fill. It was reported by the press that the slide severed the city of Tumwater's main sewage line causing sewage to flow into Capitol Lake. (Photograph by G.W. Thorsen, Division of Geology, Washington Department of Natural Resources, Olympia.)

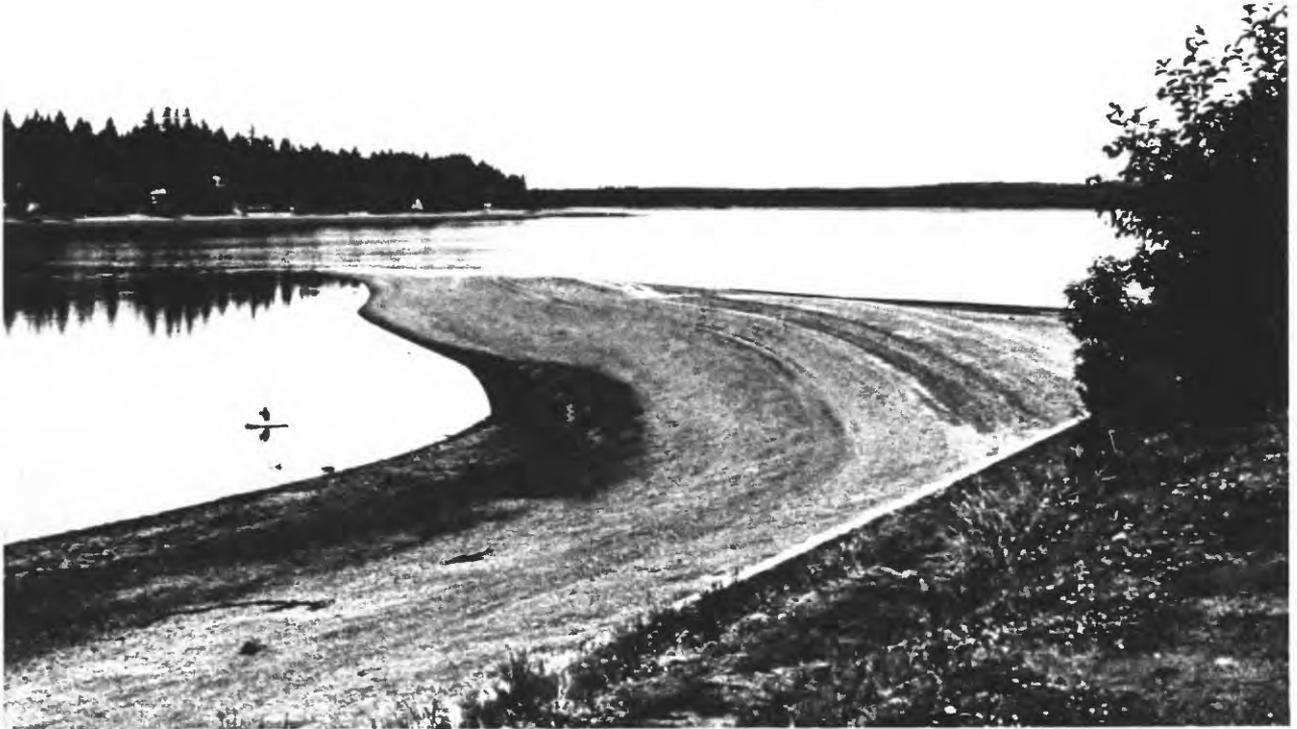
Figure 23.--View of Cooper's Point located 7 mi (11 km) north of Olympia (pl. 2, loc. 51). Approximately 150 ft (45 m) of the end of the sand spit failed and disappeared into Puget Sound during the April 13, 1949 earthquake. (Photograph was taken in 1988).

Approximately 150 ft (45 m) of the sandspit at Cooper's Point north of Olympia (loc. 51, fig. 23) slid into Puget Sound during the 1949 earthquake. An eyewitness reported seeing the mass of land sinking beneath the waves. Soundings taken afterward, at high tide, indicated water depths of approximately 50 ft (15 m) in an area where formerly the spit was 5 ft (1.5 m) above water at high tide. The sandspit is a Holocene age beach deposit (Washington Department of Ecology, 1980a) that includes medium to coarse sand and minor gravel.

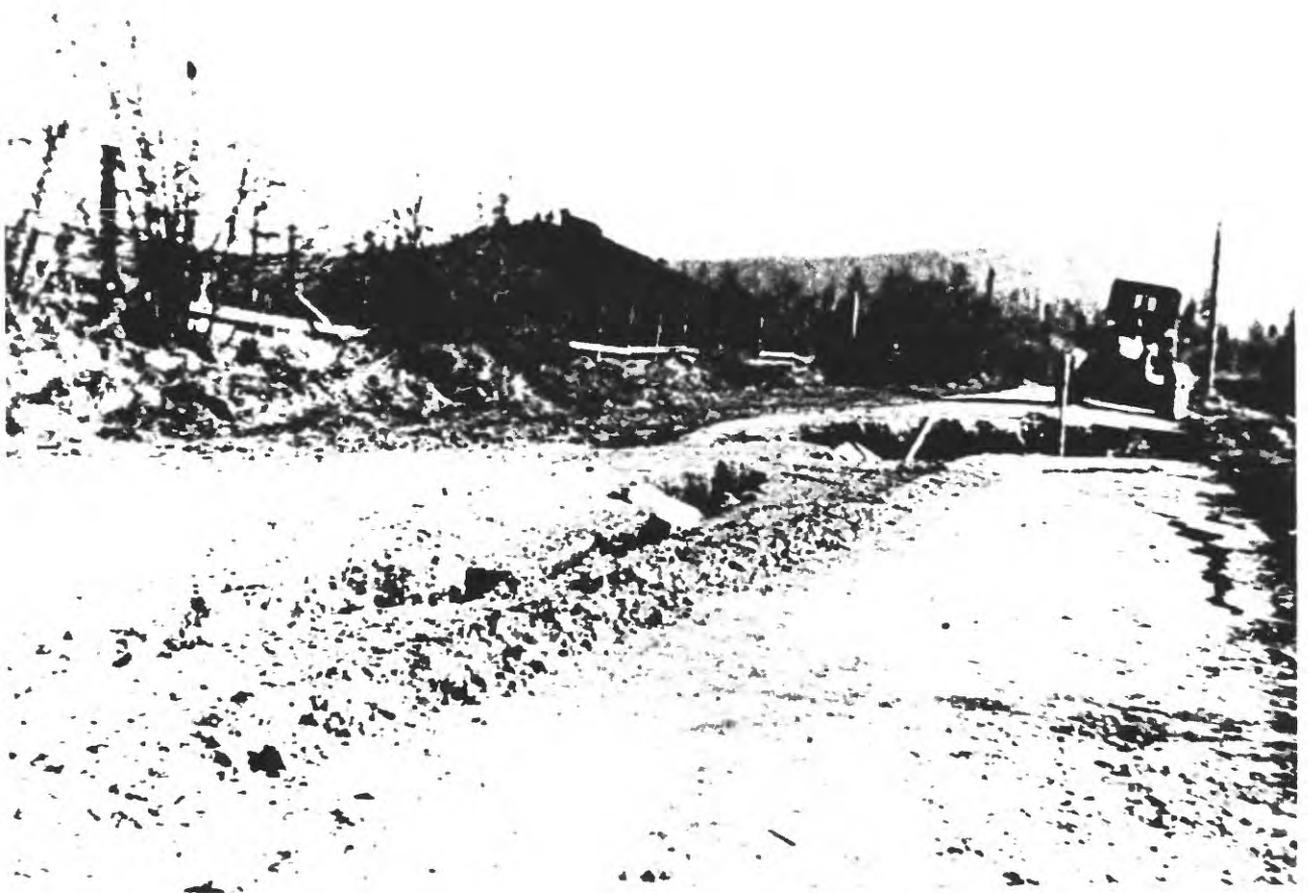
Figure 24.--Slump of 3-4 ft (1-1.2 m)-high road embankment in the Cowlitz River Valley, approximately 1 mi (1.6 km) southwest of Randle, Wash. (pl. 3, loc. 118). This April 13, 1949, earthquake-induced ground failure occurred in artificial fill underlain by loose liquefiable sand. The earthquake also produced sand boils in an adjacent field. (Photograph by Alice Peters, Randle, Wash.)

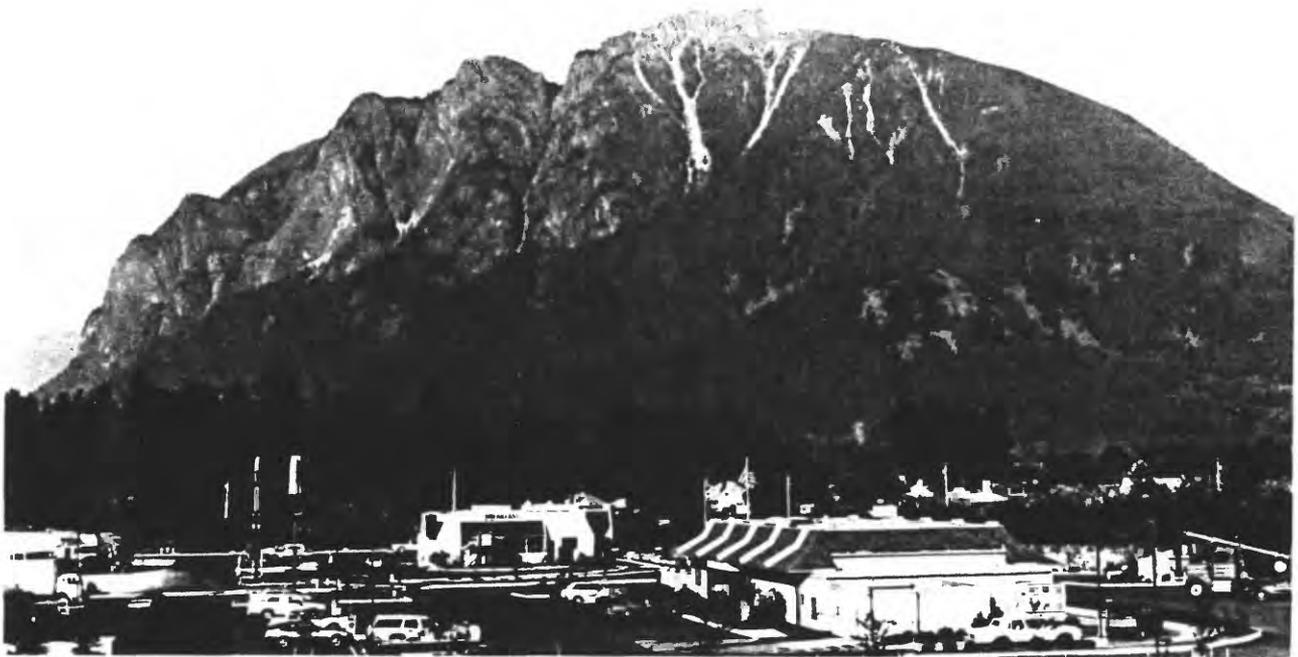
Figure 25.--Mount Si near North Bend, Wash. (pl. 3, loc. 130).
"Rockslides" on Mount Si were reported for the Puget Sound area earthquakes of April 29, 1945, April 13, 1949, and April 29, 1965. (Photograph was taken in 1988).

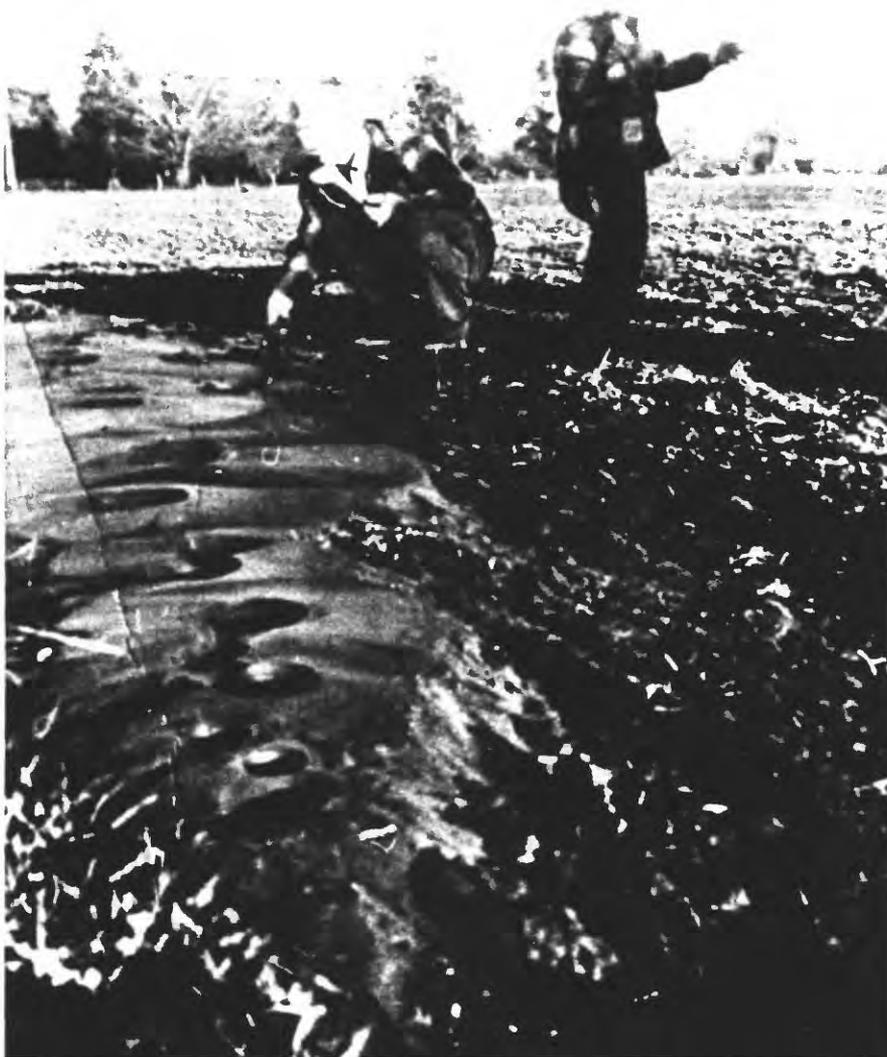
Figure 26.--Alignment of sand boils in field 1 mi (1.6 km) southwest of Centralia (pl. 4, loc. 146) is related to linear ground crack from which the water and sand were emitted. Geysers of water and sand spouted as much as 18 in (45 cm) above the ground surface and water continued to flow slowly for about a week according to an eyewitness account of this April 13, 1949, liquefaction phenomenon. (Photograph by Ted Dorn, Centralia, Wash.)

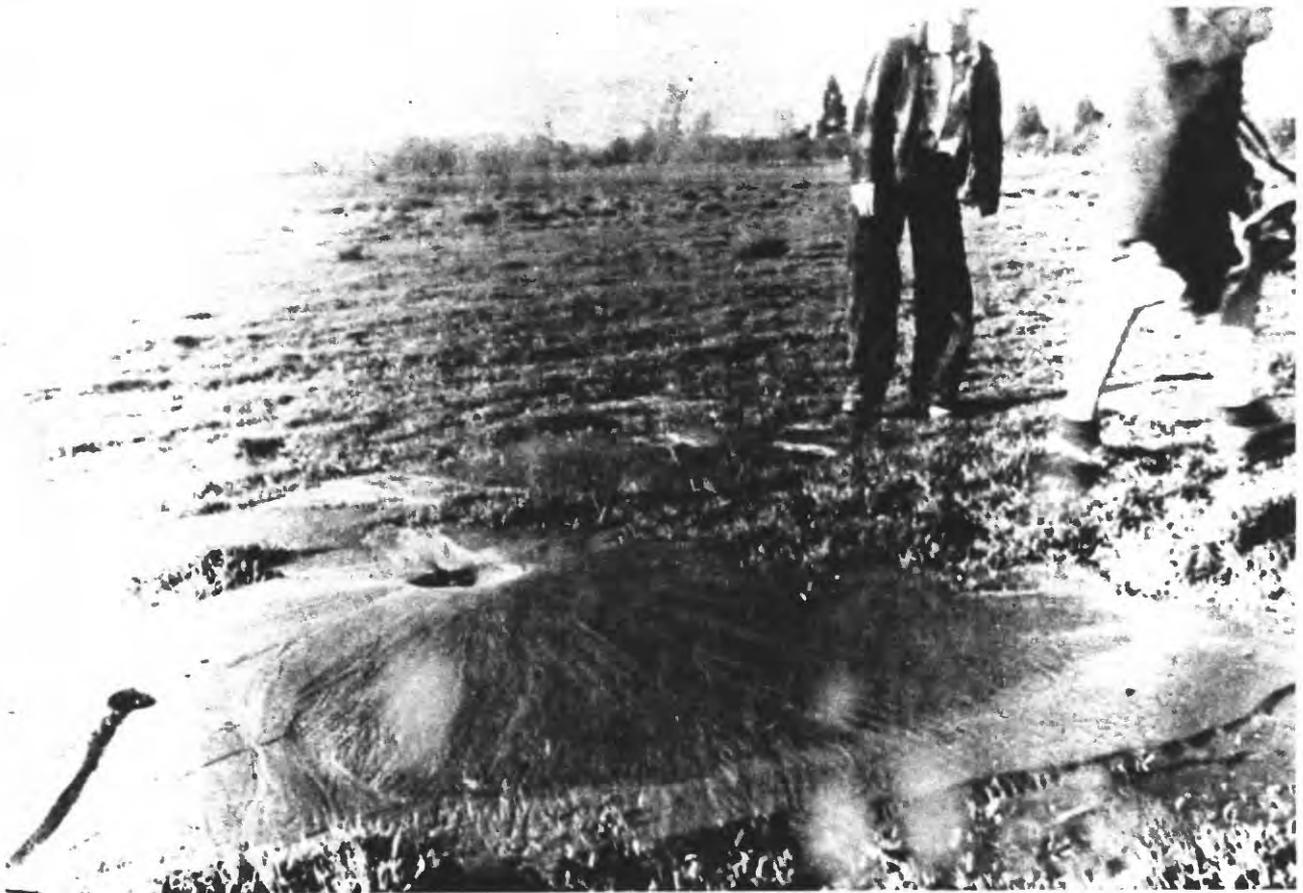
Figure 27.--Sand boils on floodplain of the Chehalis River approximately 1 mi (1.6 km) southwest of Centralia (pl. 4, loc. 146). Water and sand spouted from several ground cracks at this location at the time of the 1949 Olympia earthquake. (Photograph by Ted Dorn, Centralia, Wash.)

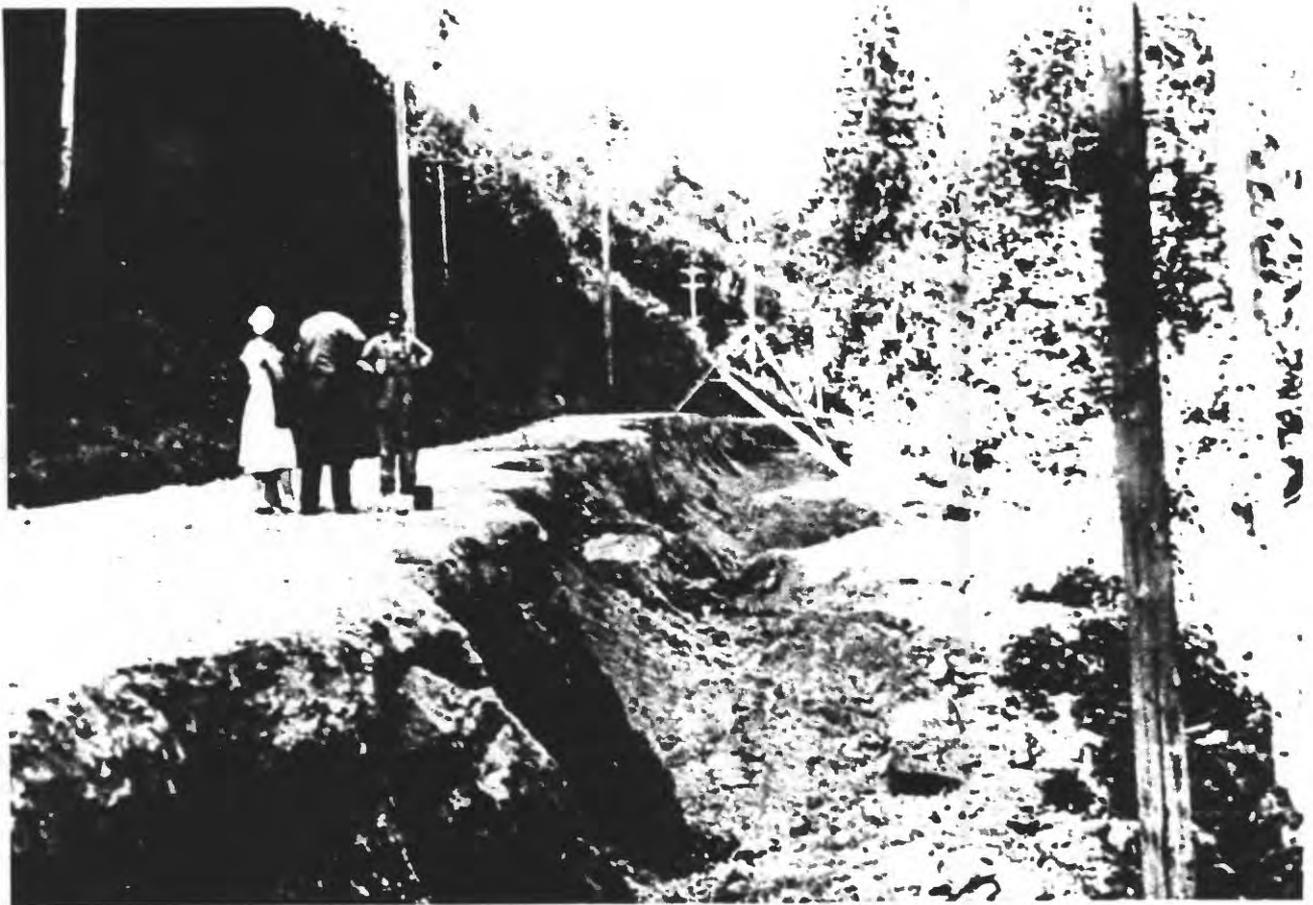
Figure 28.--Photo of scarp created by May 13, 1949, landslide on the west side of Ohop Lake, Pierce County (pl. 3, loc. 138). Incipient failure, induced by the April 13, 1949, earthquake one month before, resulted in the development of a 700-ft (210 m)-long and 8-in. (20 cm)-wide ground crack. On May 13th, complete failure occurred as the unstable mass suddenly slumped and(or) flowed approximately 100 ft (30 m) into the lake, damaging the roadway, utility lines, and cottages near the shore. (Photograph by permission of Tacoma News Tribune.)

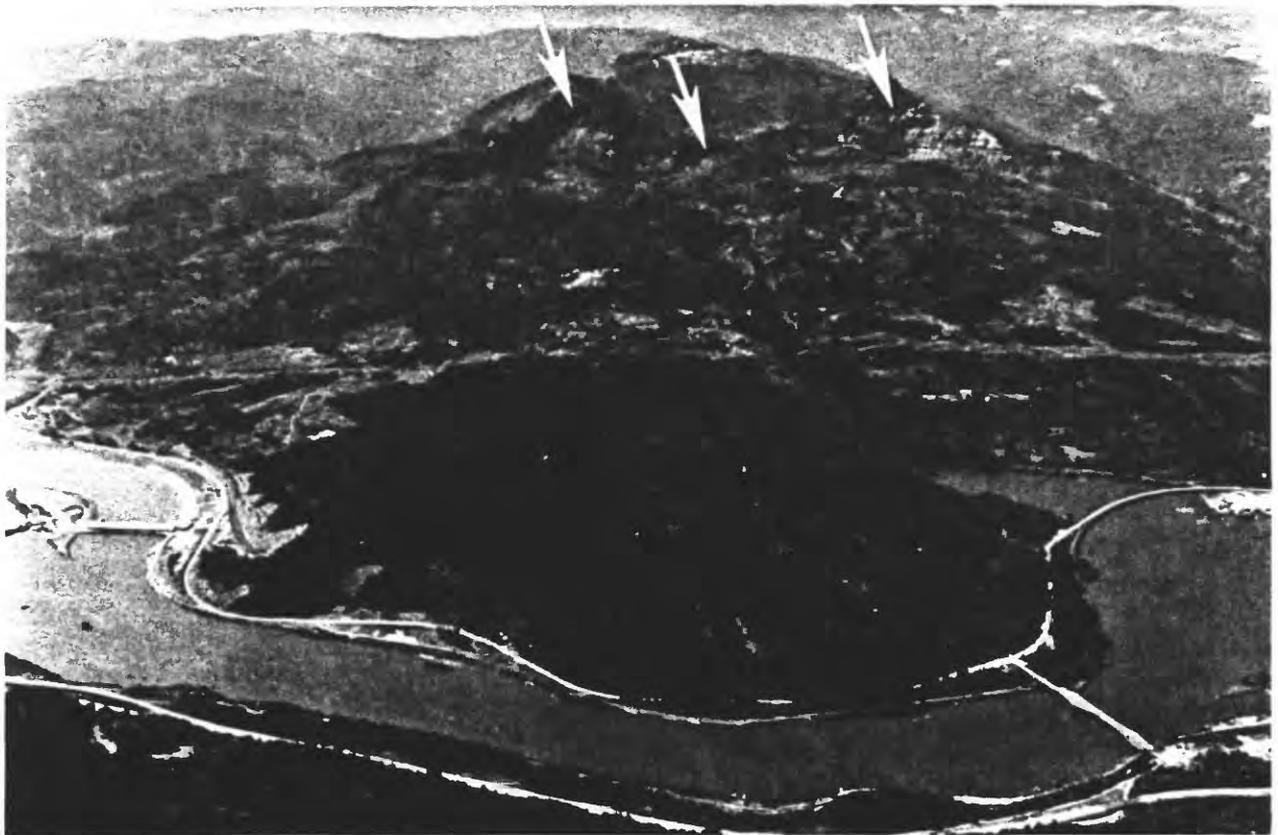
Figure 29.--Bonneville slide area along the Columbia River west of Stevenson, Wash. (pl. 5, loc. 160). Rockfall/rock avalanche activity, triggered by the April 13, 1949 earthquake, occurred along the steep headscarp (arrows), creating a dust cloud visible for miles along the Columbia River Gorge. (Photograph by Derek Cornforth, Landslide Technology, Portland, Oreg.)
