Hurricane Isaac: Observations and Analysis of Coastal Change

Open-File Report 2013-1270

U.S. Department of the Interior
U.S. Geological Survey

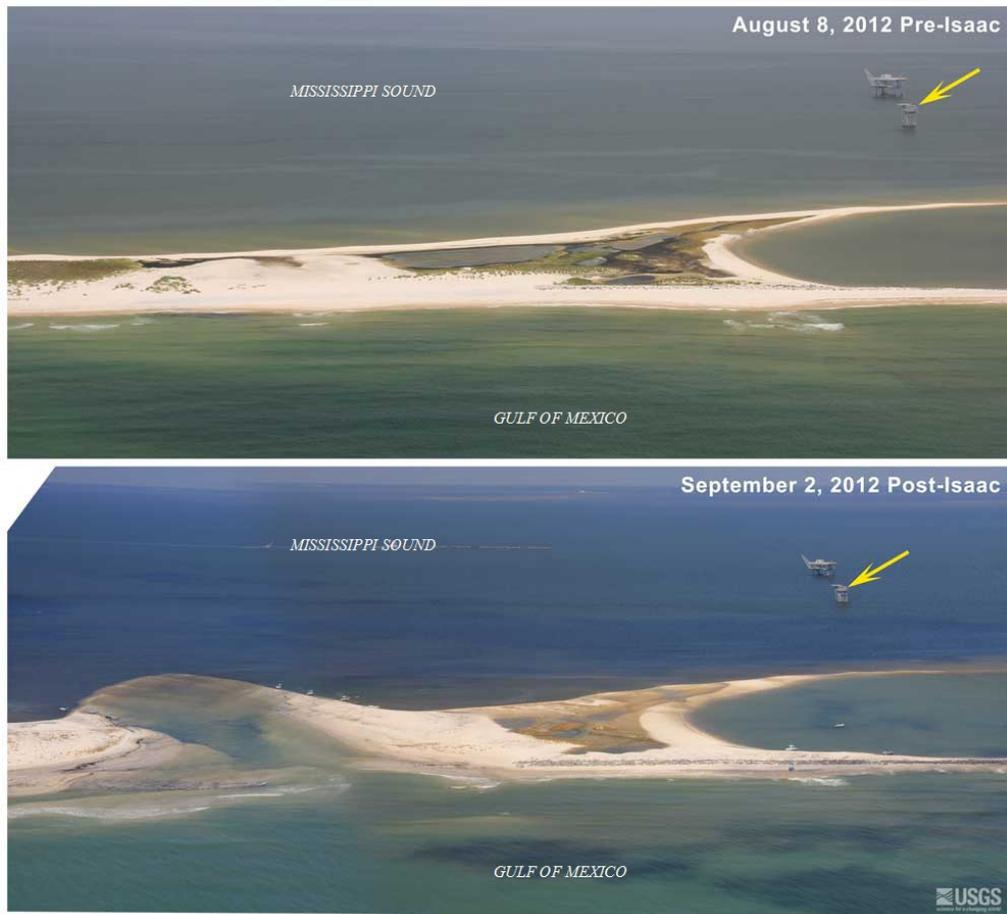
Cover photograph: Oblique aerial photographs of Dauphin Island, Alabama, from August 8, 2012 (top) and September 2, 2012 (bottom), 5 days after Hurricane Isaac made landfall (Photo credit: USGS).

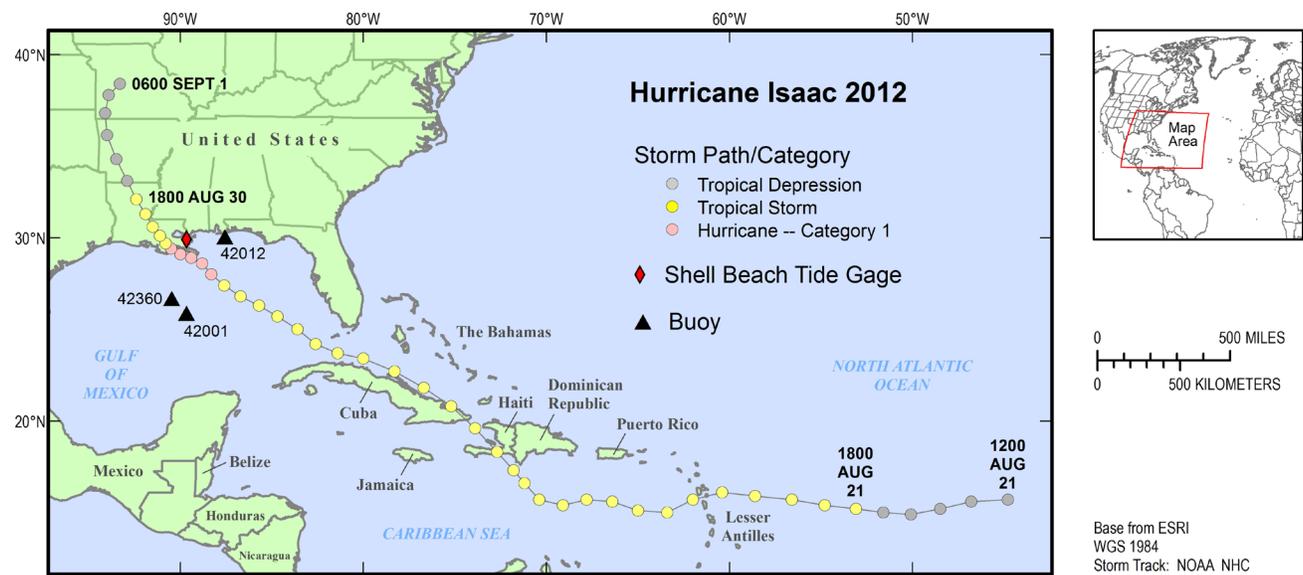
Figure 1. Track of Hurricane Isaac, locations of operating buoys 42001, 42012, and 42360, and Shell Beach tide gage, August 21-September 1, 2012.

Isaac was an active tropical weather system in the central tropical Atlantic Ocean, Caribbean Sea and Gulf of Mexico from August 21 to September 1, 2012 UTC (fig. 1). It became the ninth named storm of the 2012 hurricane season on August 21 at 1800 UTC about 835 kilometers (km) east of the Lesser Antilles. Isaac crossed the eastern Caribbean Sea, Haiti, Cuba, and the Gulf of Mexico as a tropical storm before strengthening to a Category 1 hurricane on the Saffir-Simpson Hurricane Wind Scale (Schott and others, 2012) on August 28 at 1200 UTC, about 140 km southeast of the mouth of the Mississippi River. It made landfall in Louisiana as a Category 1 hurricane at Southwest Pass, on the mouth of the Mississippi River, around 0000 UTC, August 29, with maximum sustained winds of 120–130 kilometers per hour (km/h) (Berg, 2013).

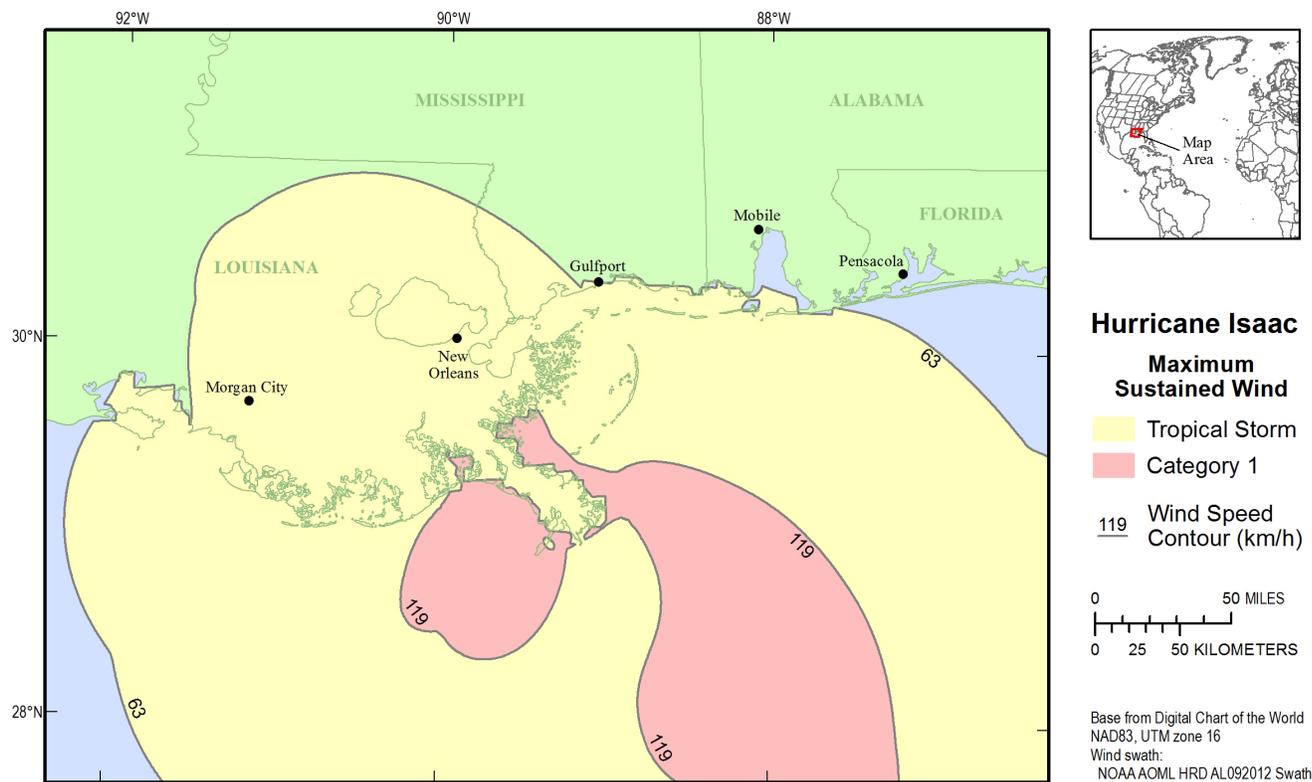
Figure 2. Extent of Hurricane Isaac's maximum sustained winds categorized by tropical storm (yellow) and Category 1 hurricane (pink) strengths. The data were derived from estimates made by NOAA AOML.

Isaac's maximum sustained winds were measured at 120–130 km/h at the Mississippi River with wind gusts of 139–152 km/h (Berg, 2013). Using methods described by Powell and others (1998), the National Oceanic and Atmospheric Administration's (NOAA) Atlantic Oceanographic and Meteorological Laboratory (AOML) Hurricane Research Division estimated sustained hurricane-force winds (119 km/h or greater) along approximately 215 km of the Mississippi River delta shoreline but did not extend inland (fig. 2). Tropical storm-force winds impacted the coastline from Marsh Island, on the central Louisiana coast, eastward to the Alabama/Florida border, extending inland into much of southeast Louisiana and parts of Mississippi.

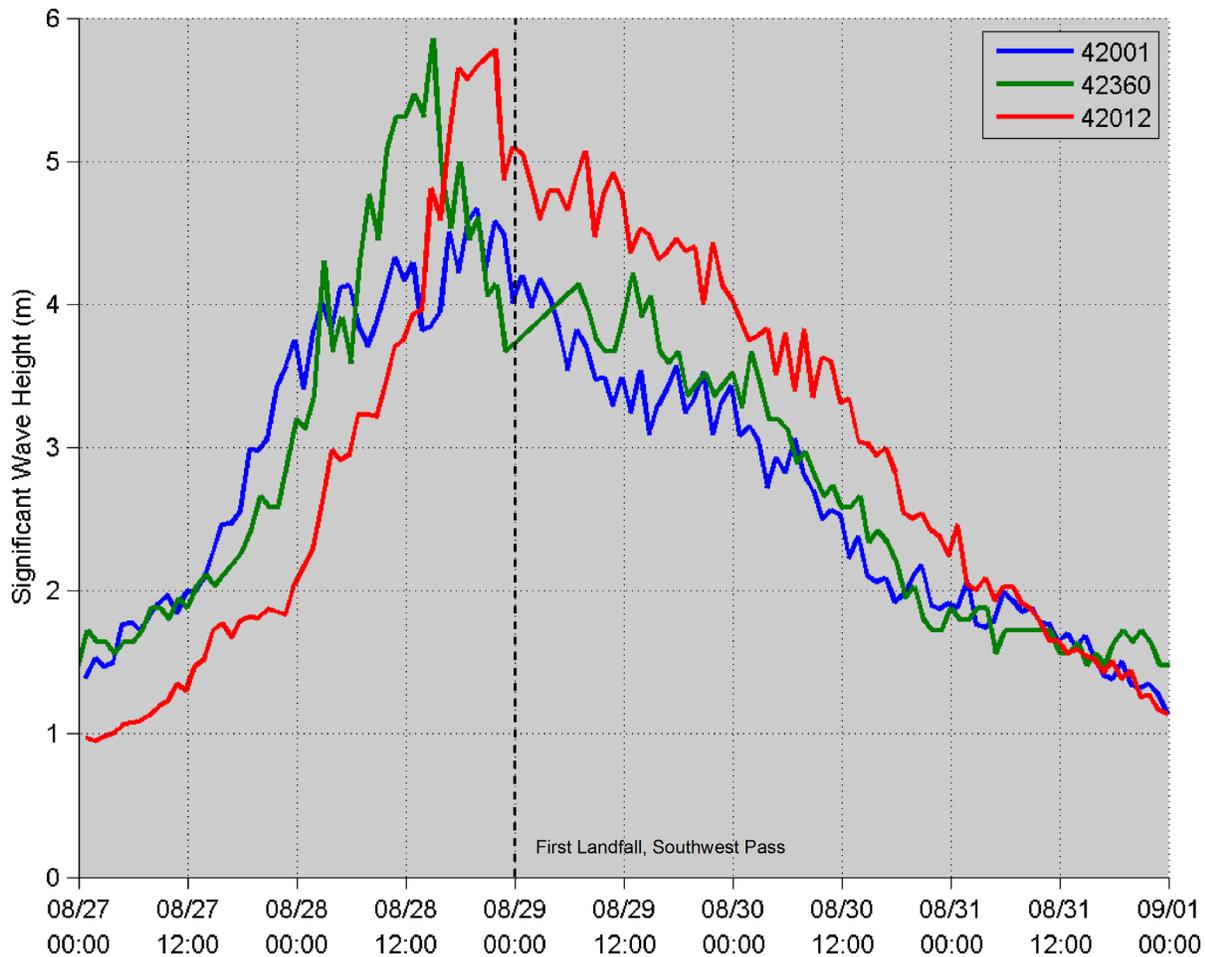
Figure 3. Significant wave heights during the passage of Hurricane Isaac at buoys 42001, 42012, and 42360.

Several moored buoys measured heights and periods of waves generated by Hurricane Isaac. Hurricane Isaac passed near three buoys in the Gulf of Mexico as it approached landfall in Louisiana (fig. 1). NOAA National Data Buoy Center (NDBC) buoy 42012 is located approximately 80 km southeast of Mobile, Alabama, in 27.7 meters (m) of water. NOAA NDBC buoy 42001 is located approximately 335 km south of Southwest Pass (Mississippi River) in deep water (>2,500 m). Petrobras-U.S.A. operated buoy 42360, which is located approximately 260 km south of Timbalier Island, Louisiana, in deep water (>2,500 m). The maximum significant wave heights recorded by these buoys was 5.9 m at buoy 42360 approximately 9 hours before first landfall, 4.7 m at buoy 42001 approximately 5 hours before first landfall, and 5.8 m at buoy 42012 approximately 3 hours before first landfall (National Data Buoy Center, undated) (fig. 3). All three buoys were outside the extent of hurricane force winds.

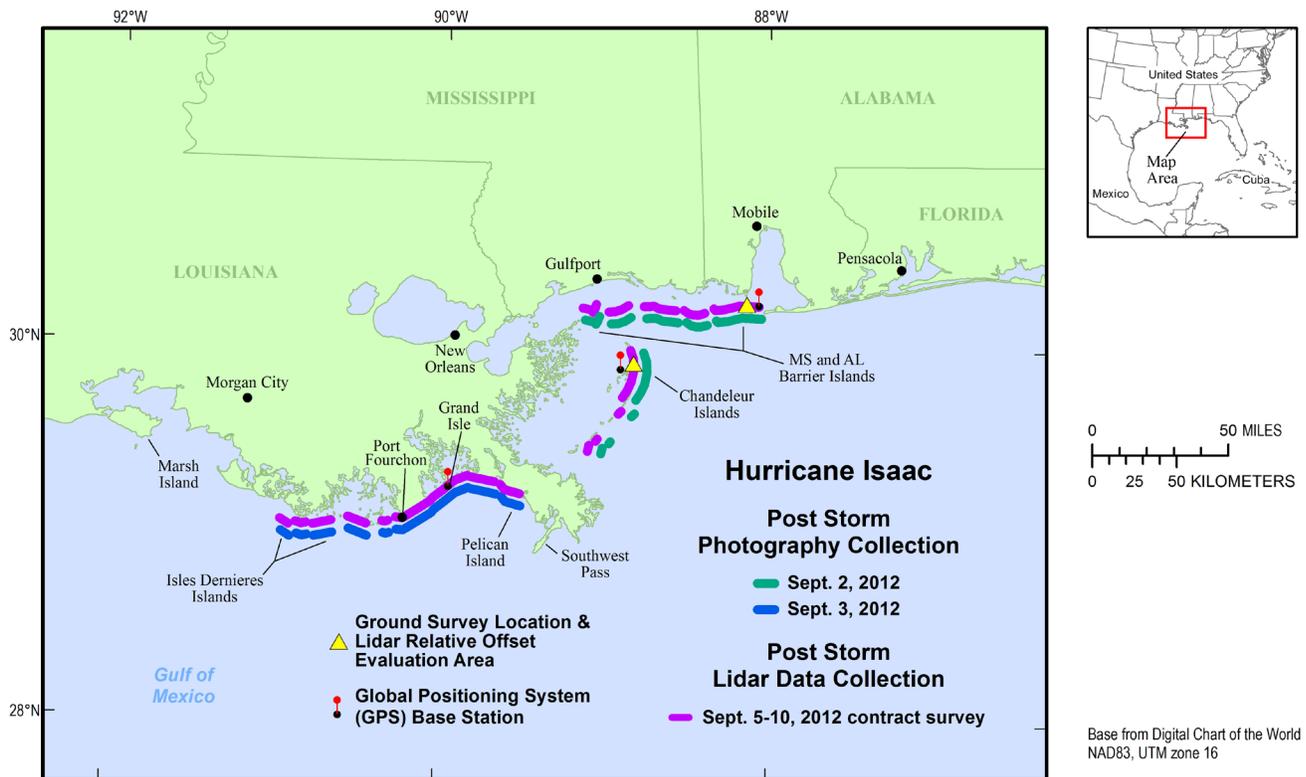
Figure 4. Locations of post-Hurricane Isaac oblique aerial photography and lidar topography missions, ground-based control surveys, and GPS base stations.

The USGS NACCH project responded to Hurricane Isaac with the following data-collection missions (fig. 4):

- Post-storm oblique aerial photography (September 2–3, 2012)
- Post-storm airborne lidar topographic survey (September 5–10, 2012)
- Ground-based control surveys (September 3 and September 6, 2012)

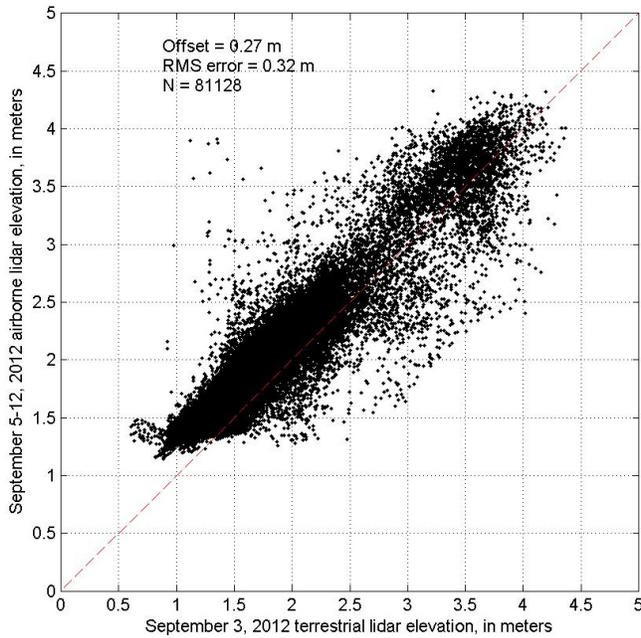
Figure 5. Relation between Dauphin Island, Alabama, terrestrial lidar survey and September 2012 last-return airborne lidar survey.

The Dauphin Island ground survey used a terrestrial lidar instrument mounted to a truck. The survey points were interpolated to a 2x2-m grid to match the airborne lidar grid resolution. The offset between the gridded ground survey and the September 5–10, 2012, last-return gridded lidar data is 0.27 m (\pm 0.32 m) (fig. 5). The lidar data for Mississippi and Alabama were adjusted by subtracting 0.27 m before extracting morphologic features.

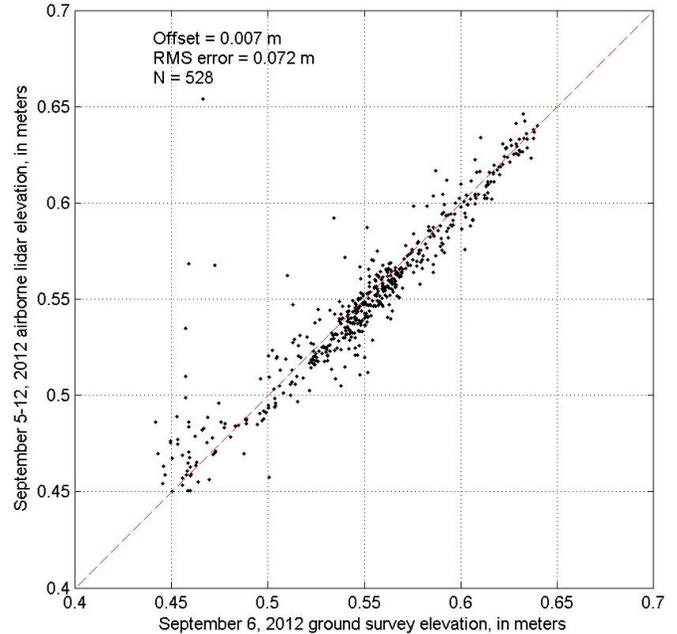
Figure 6. Relation between Chandeleur Islands, Louisiana, ground survey and September 2012 last-return airborne lidar survey.

The Chandeleur Islands ground survey was conducted simultaneously with the lidar flight. A kinematic GPS mounted on a buggy was used to survey 90,000 square meters (m²) of the low-lying beach and marsh. The survey points were interpolated to a 2x2-m grid to match the lidar grid resolution. The offset between the gridded ground survey and the last-return gridded lidar data is 0.007 m (\pm 0.072 m), well within the expected vertical error of the lidar data (fig. 6).

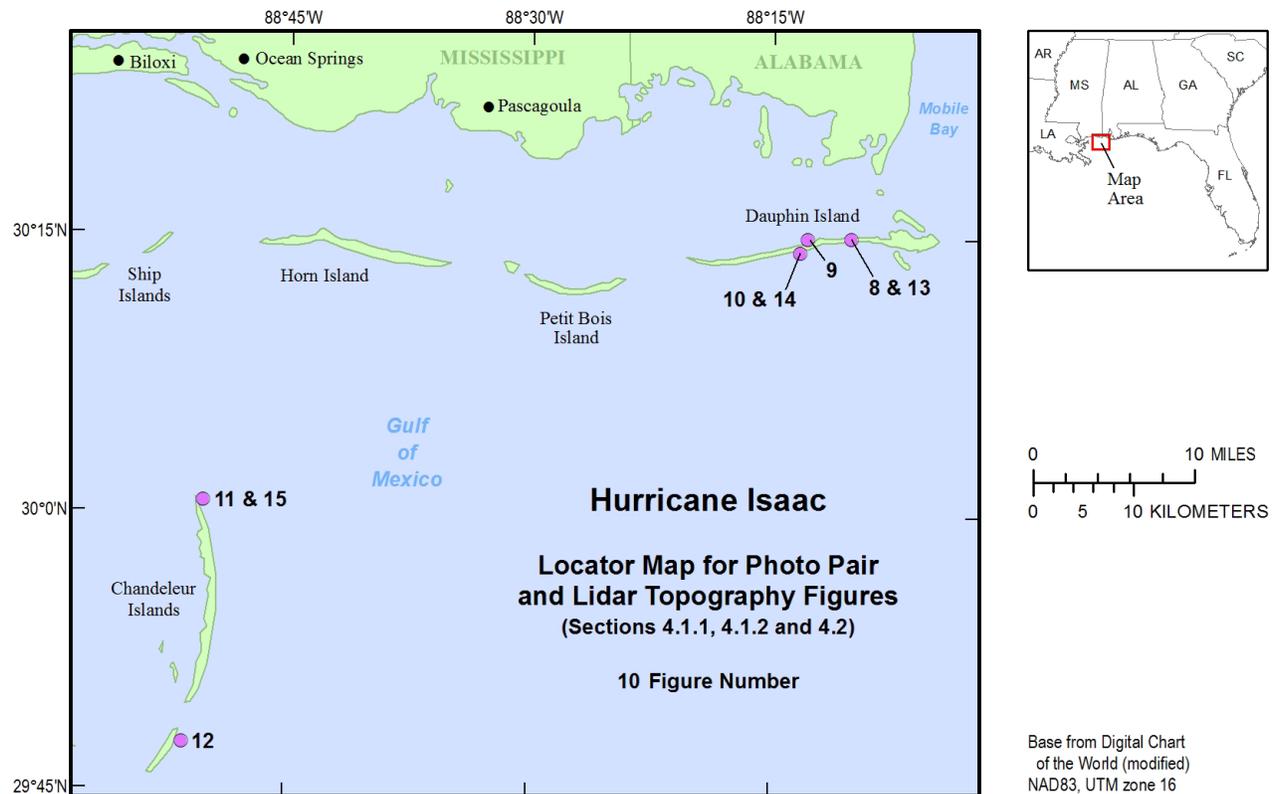
Figure 7. Map showing locations of photo-pair and lidar topography figures found in sections 4.1.1, 4.1.2, and 4.2.

Figure 7 shows the camera location of pre-storm and post-storm photo-pairs (figs. 8-10) that show some of Isaac’s impact on Dauphin Island. The photographs were taken August 8, 2012, 20 days prior to the storm, and September 2, 2012, 5 days after the storm. Additional photo-pairs can be found online at <http://coastal.er.usgs.gov/hurricanes/isaac/photo-comparisons/>.

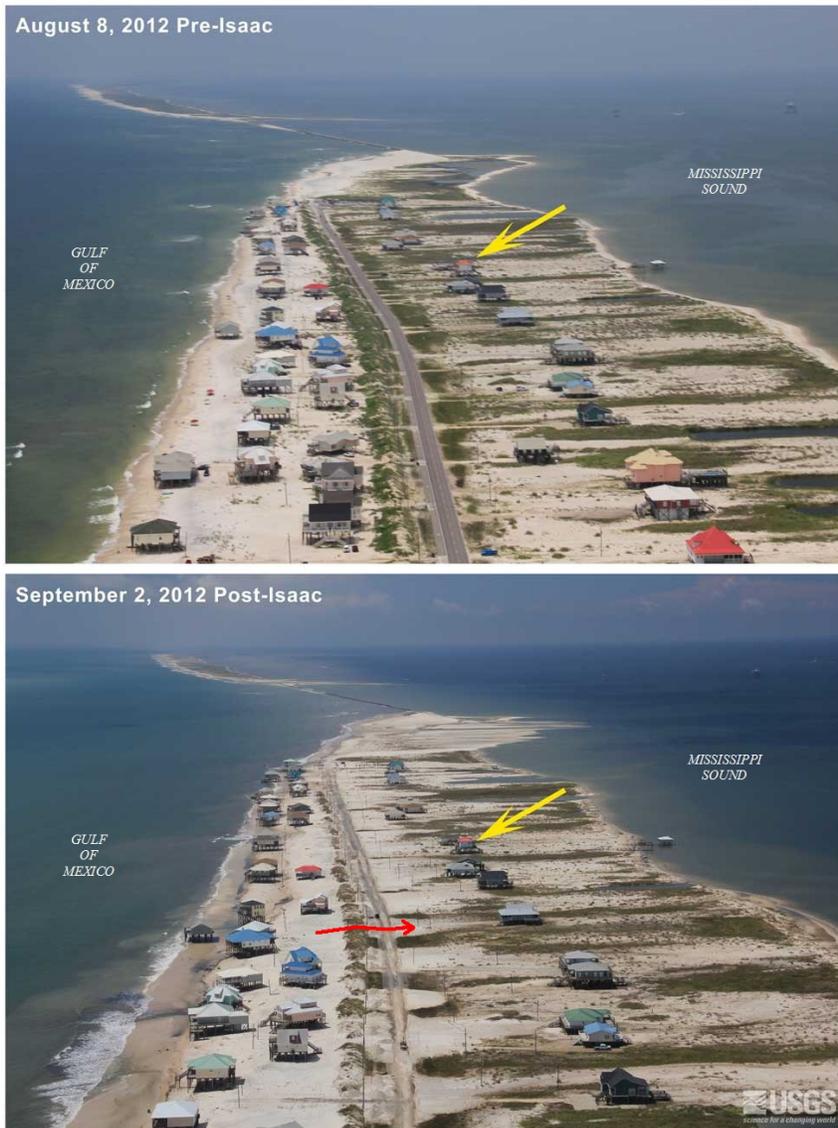
Figure 8. Oblique aerial photographs of Dauphin Island, Alabama, from August 8, 2012 (top) and September 2, 2012 (bottom), 5 days after Hurricane Isaac made landfall. The view is looking west along the island with the Gulf of Mexico on the left and the Mississippi Sound on the right. The yellow arrows in each photograph point to the same feature. Overwash from the Gulf (left) deposited sand onto the road and beyond. It appears that the overwash funneled through breaks in dunes that were constructed in 2010 in response to the Deepwater Horizon oil spill as illustrated by the red arrow. The inlet seen in the distance (Katrina Cut) started as an island breach made by Hurricane Ivan in 2004. Hurricane Katrina widened the breach into an inlet in 2005. The linear rock structure spanning the inlet was built in 2010 in response to the Deepwater Horizon oil spill.

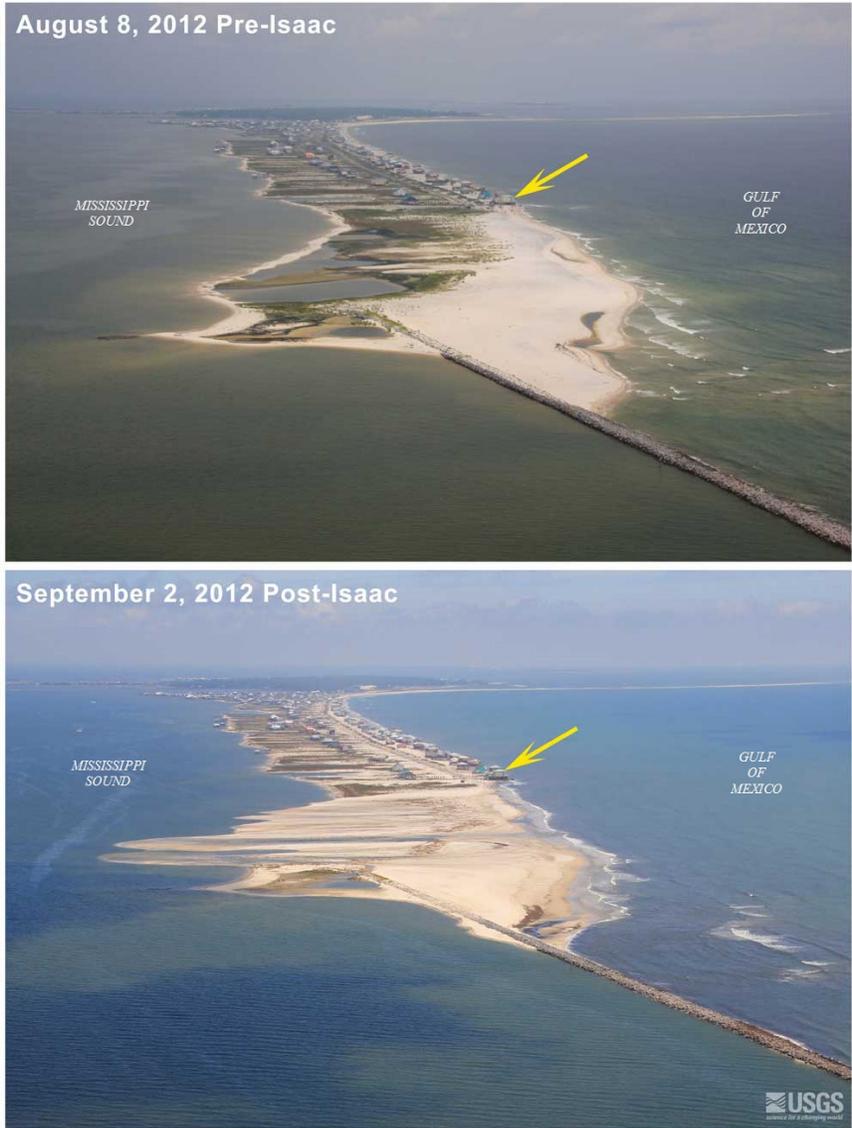
Figure 9. Oblique aerial photographs of Dauphin Island, Alabama, from August 8, 2012 (top) and September 2, 2012 (bottom), 5 days after Hurricane Isaac made landfall. The view is looking from Katrina Cut east along the island with the Gulf of Mexico on the right and the Mississippi Sound on the left. The yellow arrows in each photograph point to the same feature. Overwash crossed the width of the island, filling water bodies with sand and depositing more sand into the sound.

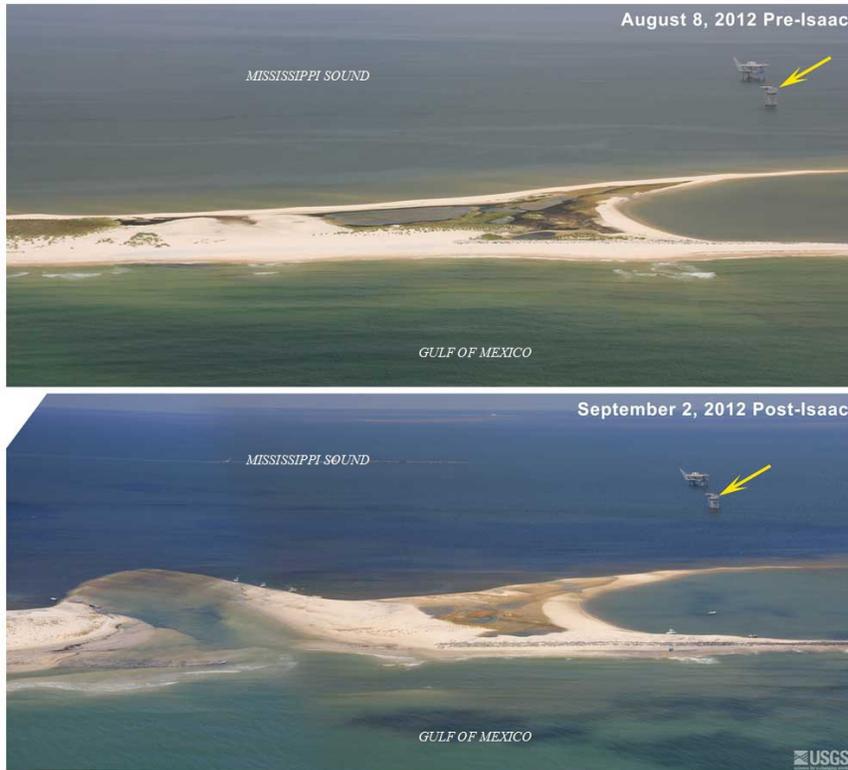
Figure 10. Oblique aerial photographs of Dauphin Island, Alabama, from August 8, 2012 (top) and September 2, 2012 (bottom), 5 days after Hurricane Isaac made landfall. The view is looking northward from the Gulf of Mexico to the island immediately west of Katrina Cut and beyond to the Mississippi Sound. The yellow arrows in each photograph point to the same feature. Storm surge and wave setup and runup cut through the island, creating a new breach and depositing sand into the sound in the form of an overwash fan.

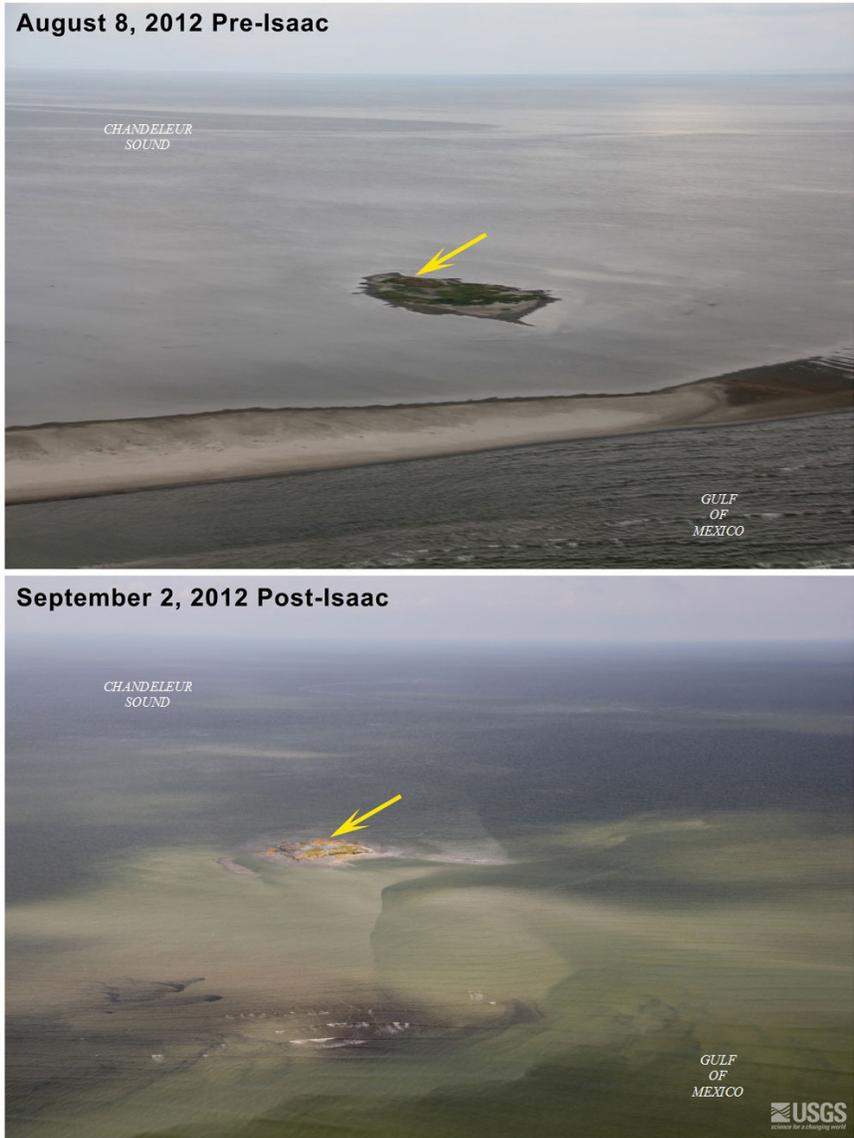
Figure 11. Oblique aerial photographs of a remnant of Chandeleur Islands, Louisiana, from August 8, 2012 (top) and September 2, 2012 (bottom), 5 days after Hurricane Isaac made landfall. The view is looking west from the Gulf of Mexico to Chandeleur Sound. The yellow arrows in each photograph point to the same feature. The sand in the pre-storm photograph is part of an oil-protection berm that was constructed in response to the 2010 Deepwater Horizon oil spill. The berm was completely eroded away by Isaac and the sand was distributed into the surrounding waters.

Figures 11–12 are pre-storm and post-storm photo-pairs that show some of the effects of Isaac on the islands. The photographs were taken August 8, 2012, 20 days prior to the storm, and September 2, 2012, 5 days after the storm. The point-of-view locations of the photo-pairs are shown in figure 7. Additional photo-pairs can be found online at <http://coastal.er.usgs.gov/hurricanes/isaac/photo-comparisons/>.

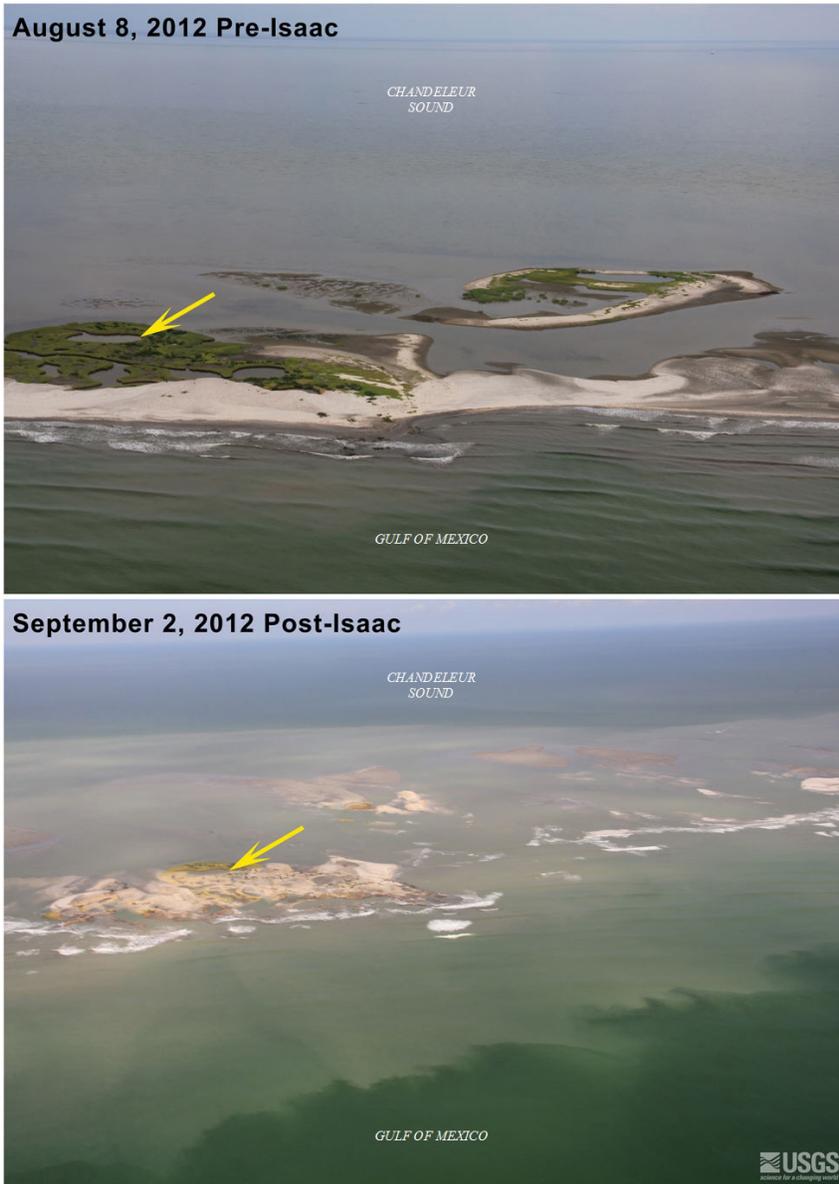
Figure 12. Oblique aerial photographs of Chandeleur Islands, Louisiana, from August 8, 2012 (top) and September 2, 2012 (bottom), 5 days after Hurricane Isaac made landfall. The view is looking west from the Gulf of Mexico, across the island and beyond to Chandeleur Sound. The yellow arrows in each photograph point to the same feature. The island was severely eroded by waves and storm surge. Sand was deposited on the island remnants and into the sound.

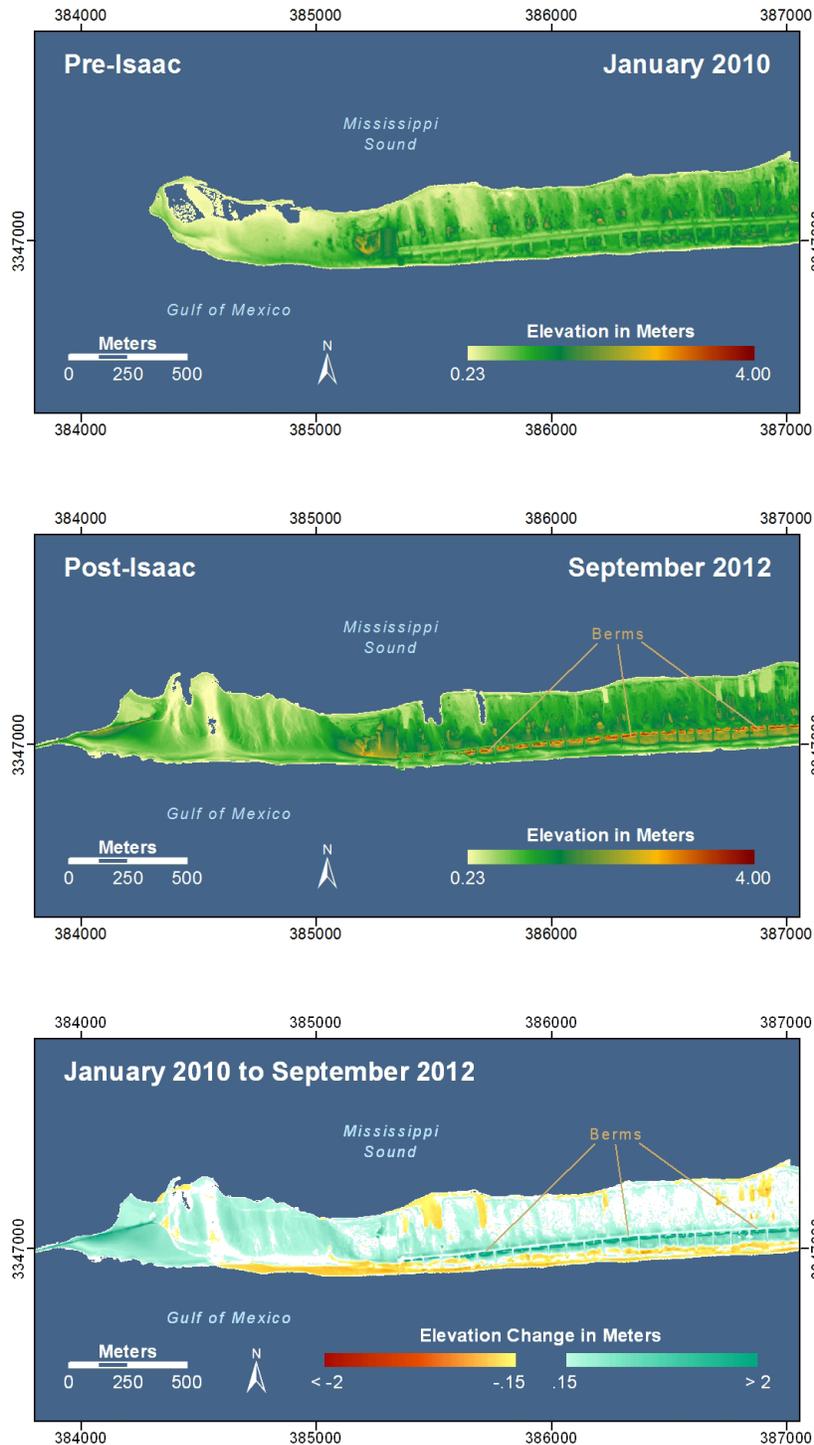
Figure 13. Elevation of Dauphin Island, Alabama, before (top) and after (middle) Hurricane Isaac and elevation change (bottom). The western extent of the inhabited portion of Dauphin Island (east of Katrina Cut) experienced shoreline erosion and overwash. In the post-storm elevation map, a line of berms running west-east along the road form higher elevation features that were not present in the pre-storm elevation map and appear as regions of deposition in the elevation difference map. These berms were constructed in response to the 2010 Deepwater Horizon oil spill after the pre-storm lidar data were collected and prior to Isaac's landfall. Overwash deposition appears north of the main access road. The deposition at the western end of the map documents the construction of the rock structure placed across Katrina Cut. Houses were removed from the lidar data and are not represented in these maps.

Figures 13–15 show some of the coastal changes that occurred on Dauphin Island, Alabama, and Chandeleur Islands, Louisiana, during Hurricane Isaac. Each figure includes pre-storm and post-storm elevation maps and an elevation change map. In the elevation maps, yellow and green colors indicate lower elevations, and orange and red colors indicate higher elevations. In the elevation change maps, the yellow to red colors indicate erosion (such as shoreline retreat), and blue to green colors indicate accretion (such as overwash deposits where waves and surge have moved sand landward). The locations of the figures are shown in figure 7.

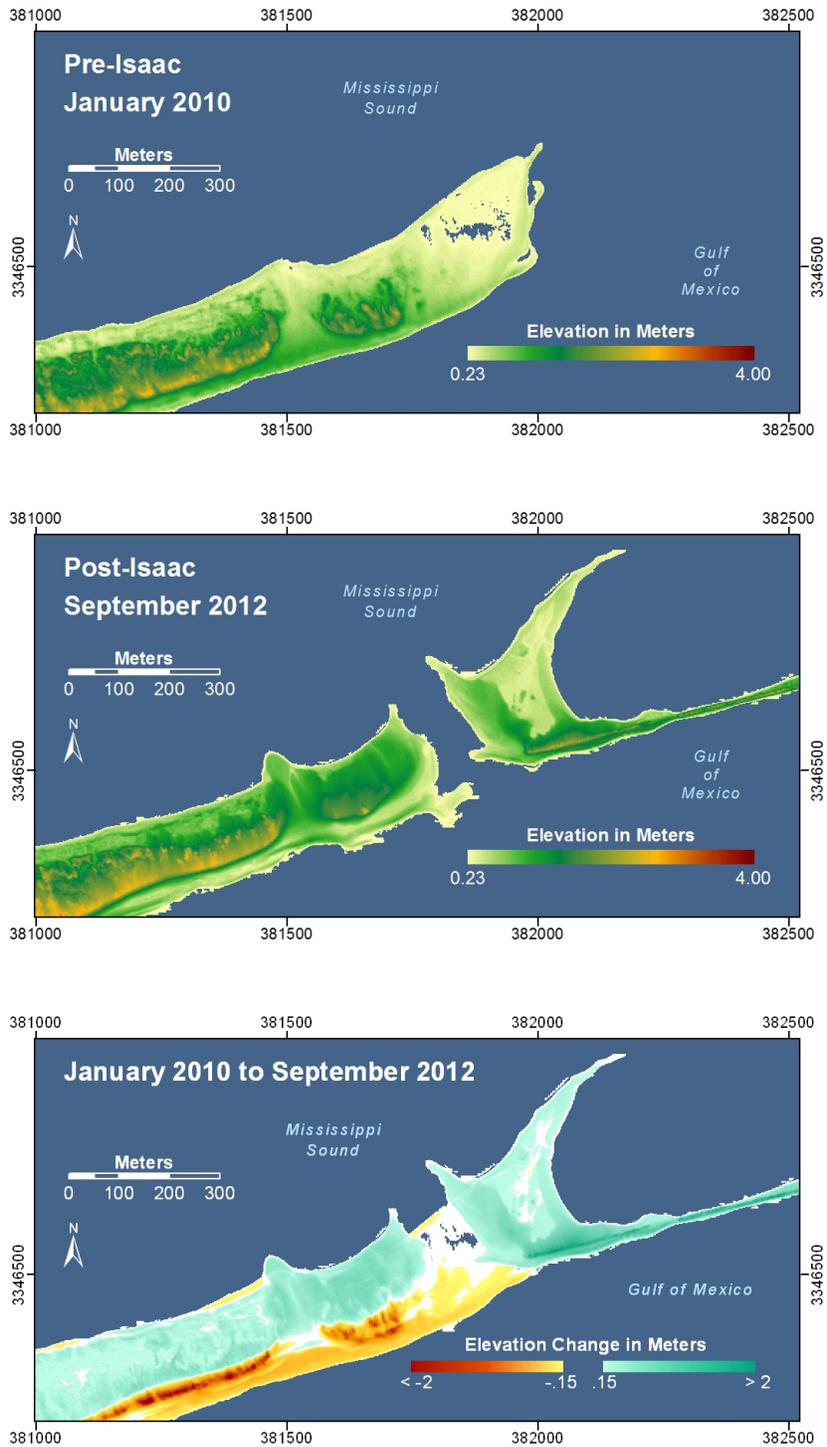
Figure 14. Elevation of Dauphin Island, Alabama, west of Katrina Cut, before (top) and after (middle) Hurricane Isaac and elevation change (bottom). The inlet that formed during Hurricane Katrina was closed with a rock structure (figs. 8–10) after collection of the pre-storm lidar data and prior to Isaac's landfall and appears as a depositional feature in the bottom map. During Isaac, the island to the west of the rock structure was breached and experienced shoreline erosion and overwash. The spit feature behind the rock structure formed prior to Hurricane Isaac.

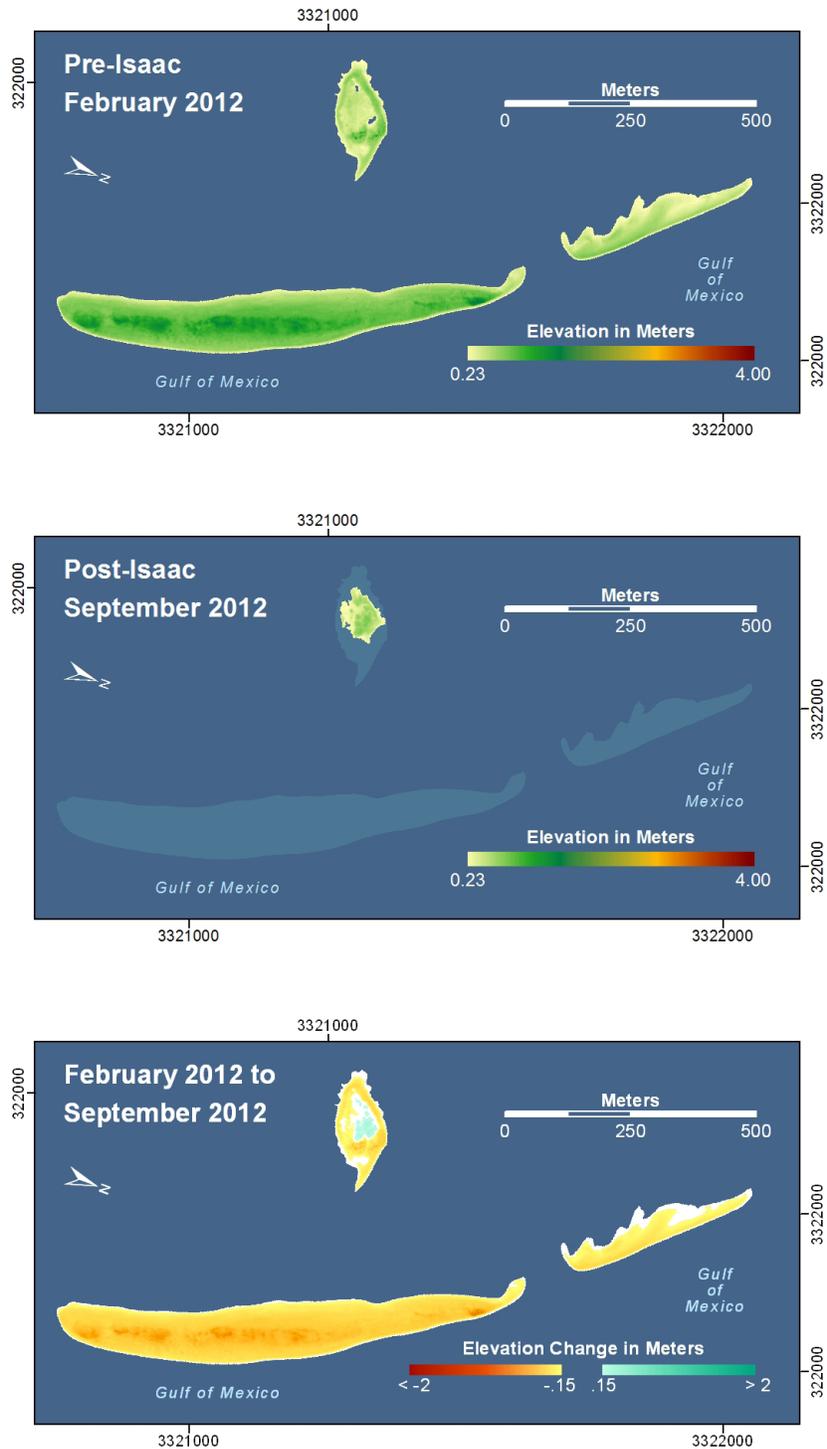
Figure 15. Elevation of Chandeleur Islands, Louisiana, before (top) and after (middle) Hurricane Isaac and elevation change (bottom). In 2010, a sand berm was constructed seaward of a small, remnant island at the north end of the islands. Prior to Hurricane Isaac, the berm had been eroded, but some sections still remained. Storm surge and waves from Isaac eroded away what remained of the berm. The remnant island experienced erosion along its outer edge and some deposition occurred in the island center. In the post-Isaac (middle) map, the pre-storm berm and island footprints are indicated in light blue.

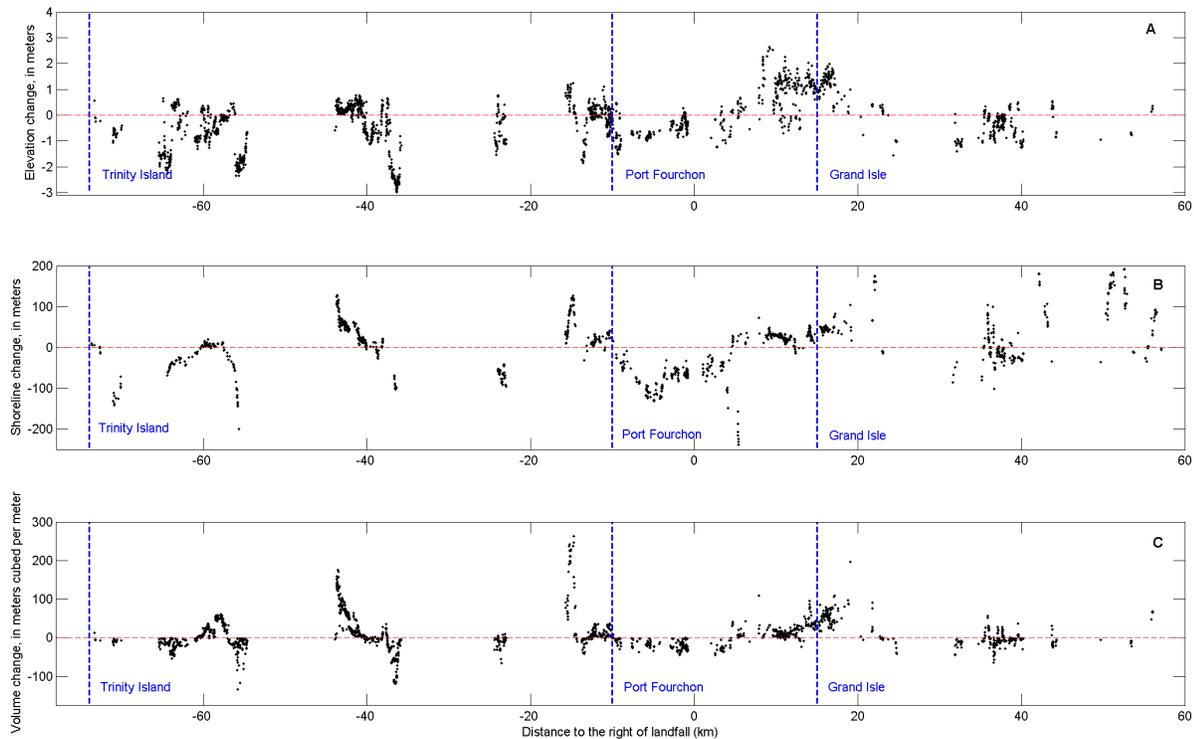
Figure 16. Hurricane Isaac (A) dune elevation change, (B) shoreline change, and (C) beach volume change between September 2008 and September 2012 for the central Louisiana barrier island coast. Vertical dashed lines indicate the center of Trinity Island (the eastern-most of the three islands composing the Isles Dernieres), and the towns of Port Fourchon and Grand Isle, Louisiana. In the x-axis label, “right” refers to the right side of the forward path of the hurricane, or “east” here.

The cross-shore peak elevations of the most seaward sand dune (or berm if there was no dune) were found and their locations extracted from the grids at 10 m intervals in the alongshore direction. The pre-storm to post-storm difference in elevation at those locations was defined as hurricane-induced change (figs. 16A–18A) (Stockdon and others, 2009).

The shoreline position was extracted from the grids at 10 m intervals in the alongshore direction by locating the cross-shore position of the mean high water (MHW) elevation. The MHW elevation was based on regional tidal records (Weber and others, 2005). A MHW elevation of 0.37 m NAVD 88 was used for the region from Isles Dernieres to Pelican Island, Louisiana, and 0.23 m was used for the Chandeleur Islands, Louisiana, and the Mississippi and Alabama barrier islands region. Shoreline change was calculated by measuring the cross-shore distance between the pre-storm and post-storm shoreline position (figs. 16B–18B). Shoreline position errors are typically on the order of 1 to 2 m (Stockdon and others, 2002) with varying uncertainty due to data noise and beach slope.

Beach volume changes were calculated at 10 m intervals in the alongshore direction by differencing the pre-storm and post-storm elevation grids and integrating the differenced values in the cross-shore direction that fell between the pre-storm shoreline and pre-storm dune base, yielding the volume change per meter length of coastline (figs. 16C–18C).

A reduction in dune height ranging from 0 to 3 m was observed in the Isles Dernieres, Louisiana, and near Port Fourchon, Louisiana, where Hurricane Isaac made landfall. Dune-height changes were positive at Grand Isle, Louisiana, about 20 km to the east of landfall, due to construction of a manmade line of dunes in 2009 (Cardno, 2009) (U. S. Army Corps of Engineers, 2012) (fig. 16A). Shoreline change was variable on the central Louisiana coast from Trinity Island (part of the Isles Dernieres) to Grand Isle, Louisiana. Shoreline accretion eastward of the Grand Isle line is likely due to beach nourishment projects (Coastal Protection and Restoration Authority, 2013) evident in aerial photography (GoogleEarth, 2013) (fig. 16B). On the eastern and western ends of the Isles Dernieres, where currents flowing through inlets rapidly move sand, more extreme shoreline erosion and accretion of 100 to 200 m was observed. Volume changes largely follow the same pattern as the shoreline changes for the central Louisiana barrier islands (fig. 16C). The large volume gain to the west of Port Fourchon was the result of a restoration project in July 2012 (Scofield, 2012).

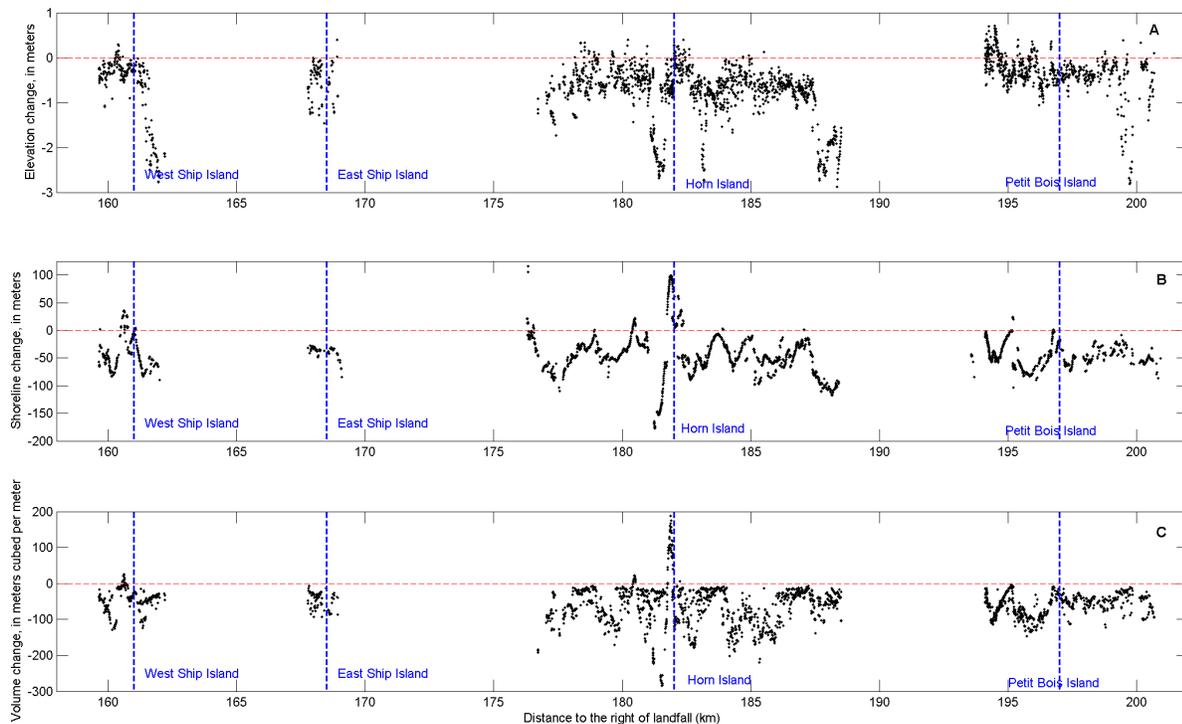
Figure 17. Hurricane Isaac (A) dune elevation change, (B) shoreline change, and (C) beach volume change between September 2008 and September 2012 for the state of Mississippi barrier island coast. Vertical dashed lines indicate the centers of West and East Ship Islands, Horn Island, and Petit Bois Island. In the x-axis label, “right” refers to the right side of the forward path of the hurricane, or “east” here.

Along the Mississippi barrier island coast, 150 to 200 km to the east of where Hurricane Isaac made landfall, dune-height erosion ranged from 0 to 3 m (fig. 17A). The eastern ends of West Ship, Horn, and Petit Bois Islands all experienced dune erosion of 2 to 3 m, while the western ends of the islands had little change, possibly due to the long-term westward migration of the islands. Shoreline erosion of 40 to 50 m was observed across the region, with the exception of an accretion of about 100 m near the center of Horn Island where there is an inflection point in the shoreline orientation (fig. 17B). Similar to the Louisiana sandy barriers, volume losses here follow the same pattern as shoreline changes (fig. 17C). Because the pre-storm survey is from September 2008, changes in shoreline position and beach volume presented here may be a combination of long-term and storm-induced change.

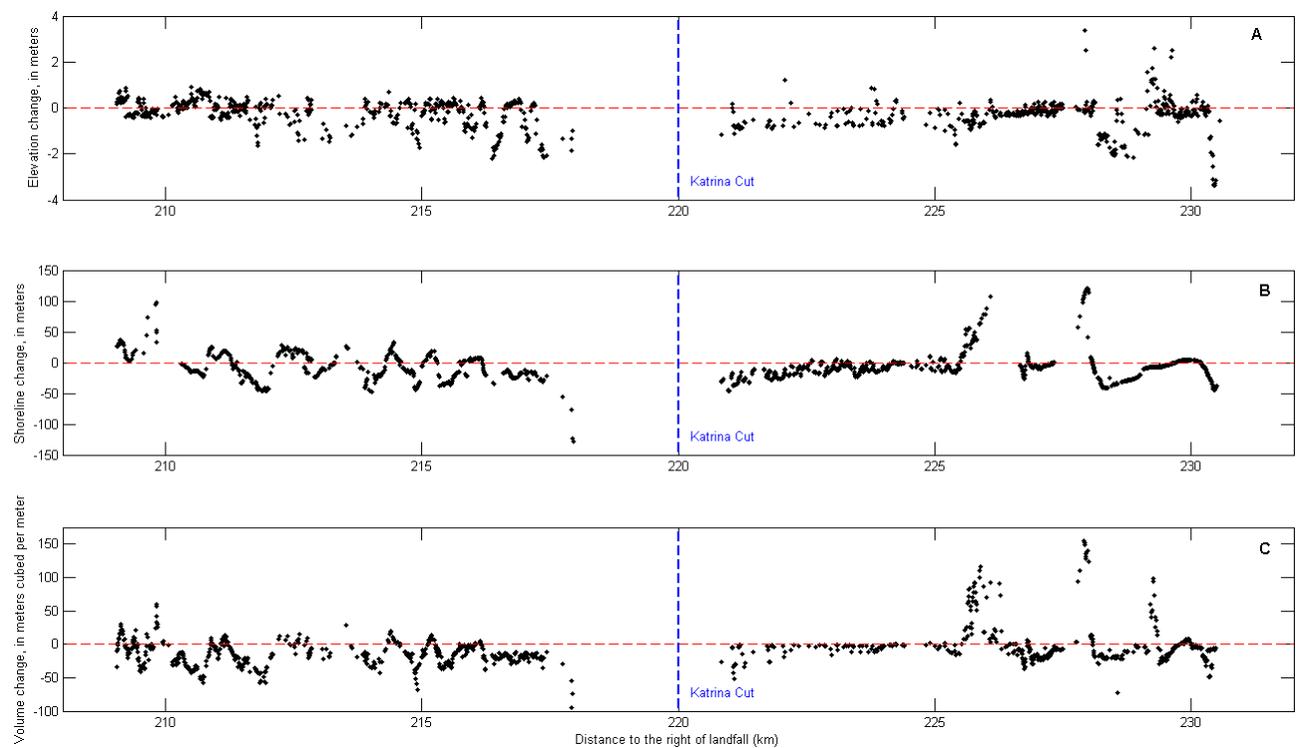
Figure 18. Hurricane Isaac (A) dune elevation change, (B) shoreline change, and (C) beach volume change between September 2008 and September 2012 for Dauphin Island. In the x-axis label, “right” refers to the right side of the forward path of the hurricane, or “east” here.

Dauphin Island, Alabama, 220 km to the east of where Hurricane Isaac made landfall, experienced very little change from the pre-storm dune height (fig. 18A). Some dunes to the west of the Katrina Cut were overwashed during Hurricane Isaac, resulting in 2 to 3 m of dune erosion. Shoreline change was variable, particularly on the west side of the island where 1 km-long oscillations were apparent (fig. 18B). The beach on the western edge of Katrina Cut experienced 100–150 m of shoreline loss and corresponding volume loss. The area of shoreline accretion on the eastern side of the island corresponds to the continued northeast migration of Pelican Island shoal. Volume changes mirror the same pattern as the shoreline changes for the Dauphin Island coast, with losses greatest to the west of Katrina Cut and the largest gain near the pier (approximately 225 km to the east of where Isaac made landfall) (fig. 18C).
