LANDSLIDE IN MOUTIER-COURT GORGES  
(A translation)

Peter, A. (Chief Engineer at Delemont), Glissement de terrain dans les gorges de Moutier-Court; La Route et la Circulation Routiere, no. 10, pp. 165-172, 206-208, 23 fig., Solothurn, Switzerland, 1938.

Translated by Mrs. Severine Britt, U. S. Geological Survey, 1947.

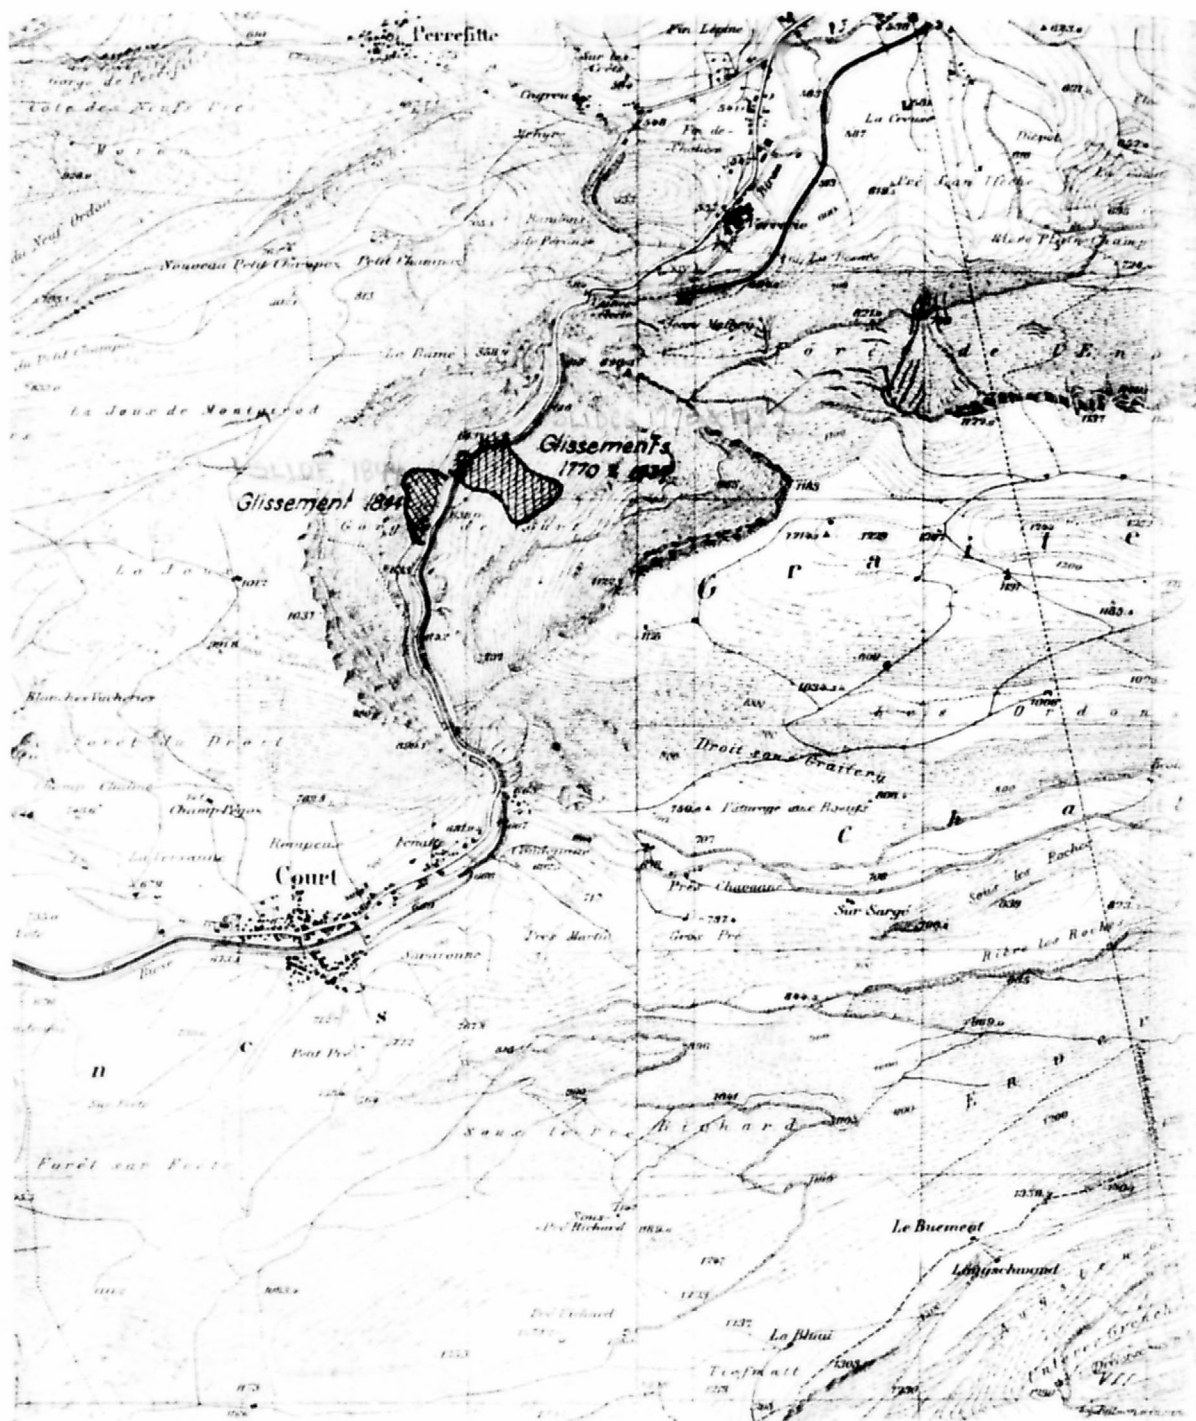
Fig. 1.

In these gorges the Birse cuts the anticline which constitutes the Graiterey range at right angles, according to the geologist, Dr. Buxdorf; the axis of the anticline trends west and the eastern side of the valley exposes the oldest formations. The central part of the Moutier-Court Gorges is occupied by the following Jurassic formations (figs. 1, 2, and 3):

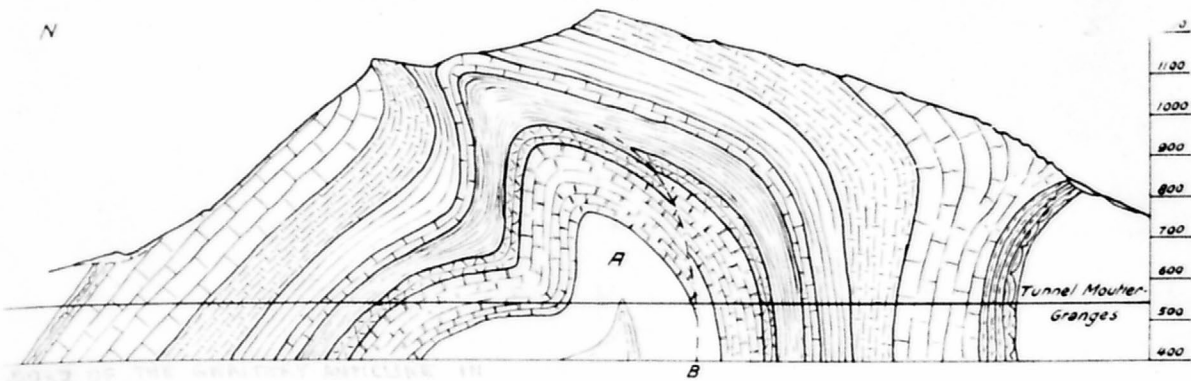
**Fig. 2**  
Graitery

Le noyau de l'anticlinal du  
Graitery dans le tunnel  
Moutier-Granges (Fig 2)  
et au versant oriental des  
Gorges de Court (Fig 29).

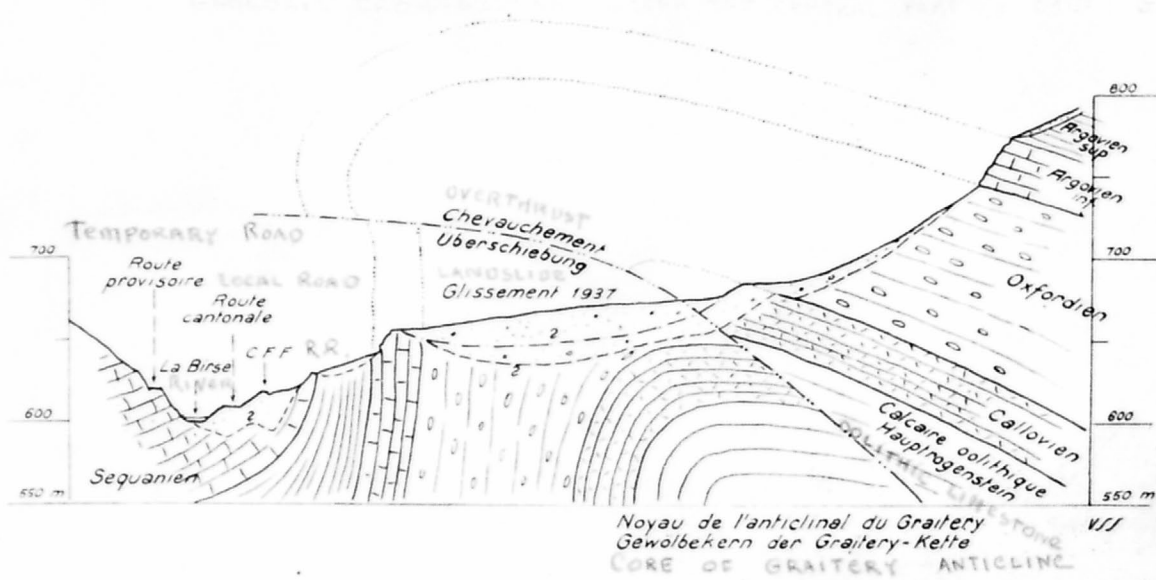
Fig. 3.

**Coupe géologique à travers la partie centrale des gorges de Court**  
par Dr A. Buxtorf et Dr L. Vonderschmitt, géologues à Bâle.

The strata just enumerated form an arch in the central section of the gorges. This arch, however, is not symmetrical: its south side is slightly inclined whereas its north side is vertical. In addition, an overthrust occurred in the layers of the north side; this overthrust is perfectly visible in the Argovian layers. The geologists' opinion varies as to

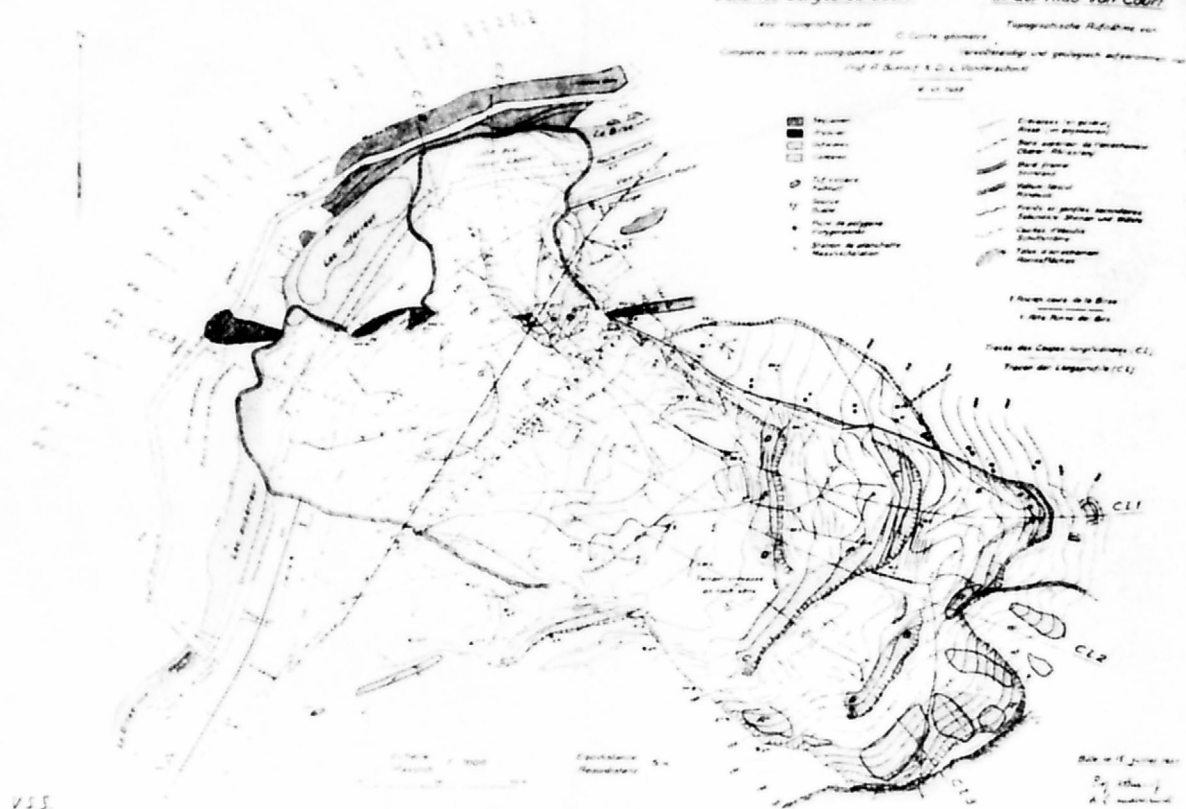
Fig. 4.

GLISSEMENT DANS LES GORGES DE COURT.

*Coupes longitudinales*

Partie mise en mouvement par le glissement de 1937  
Durch die Rutschung von 1937 bewegter Teil  
Partie restée stable - Stabil gebliebener Teil SBC 2

----- Surface antérieur au glissement à un pas environ 1' 10'' 000  
Oberfläche von der Rutschung entsprechend dem Plan 1' 10'' 000  
SURFACE BEFORE THE SLIDE

#### Landslide in Court Gorges (fig. 4)

- 1) The middle and low portion of the mass underwent a movement of translation varying between 30 and 50 meters.
- 2) In the upper portion of the slide, the movement was slower.
- 3) The scarps which were formed in the upper part of the slide, (separation zone CC<sup>1</sup>, DD<sup>1</sup>, fig. 4) are the result of a fracture caused by the fact that the lower portion of the mass flowed more rapidly on account of its great capacity of absorbing water rather than because of the inclination of its slide plane.

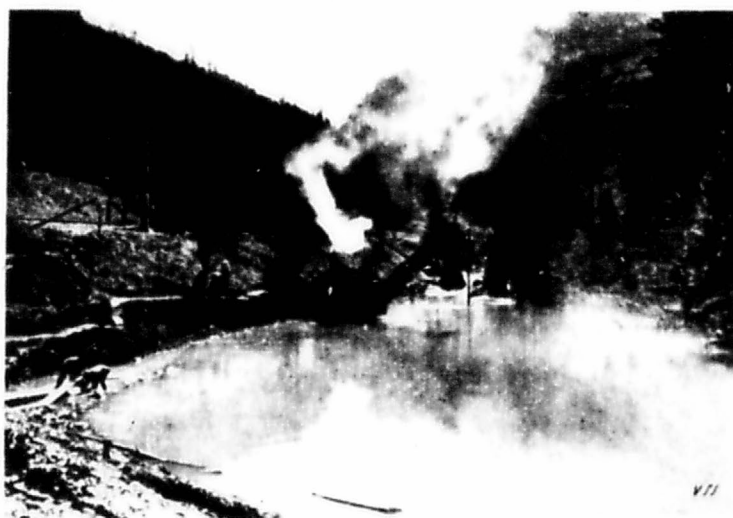
Fig. 16.

It was first attempted to keep open the bed of the Birse by means of strong wooden frames of 4 by 2.5 m., 30-40 cm. in diameter, but it was in vain; the pressures exerted by the face of the slide very quickly broke these frames. An excavator was then used but without success; the best measure, although expensive, was blasting. This prevented the water from rising in the two lakes formed by the masses of the slide face (figs. 16 and 17).
