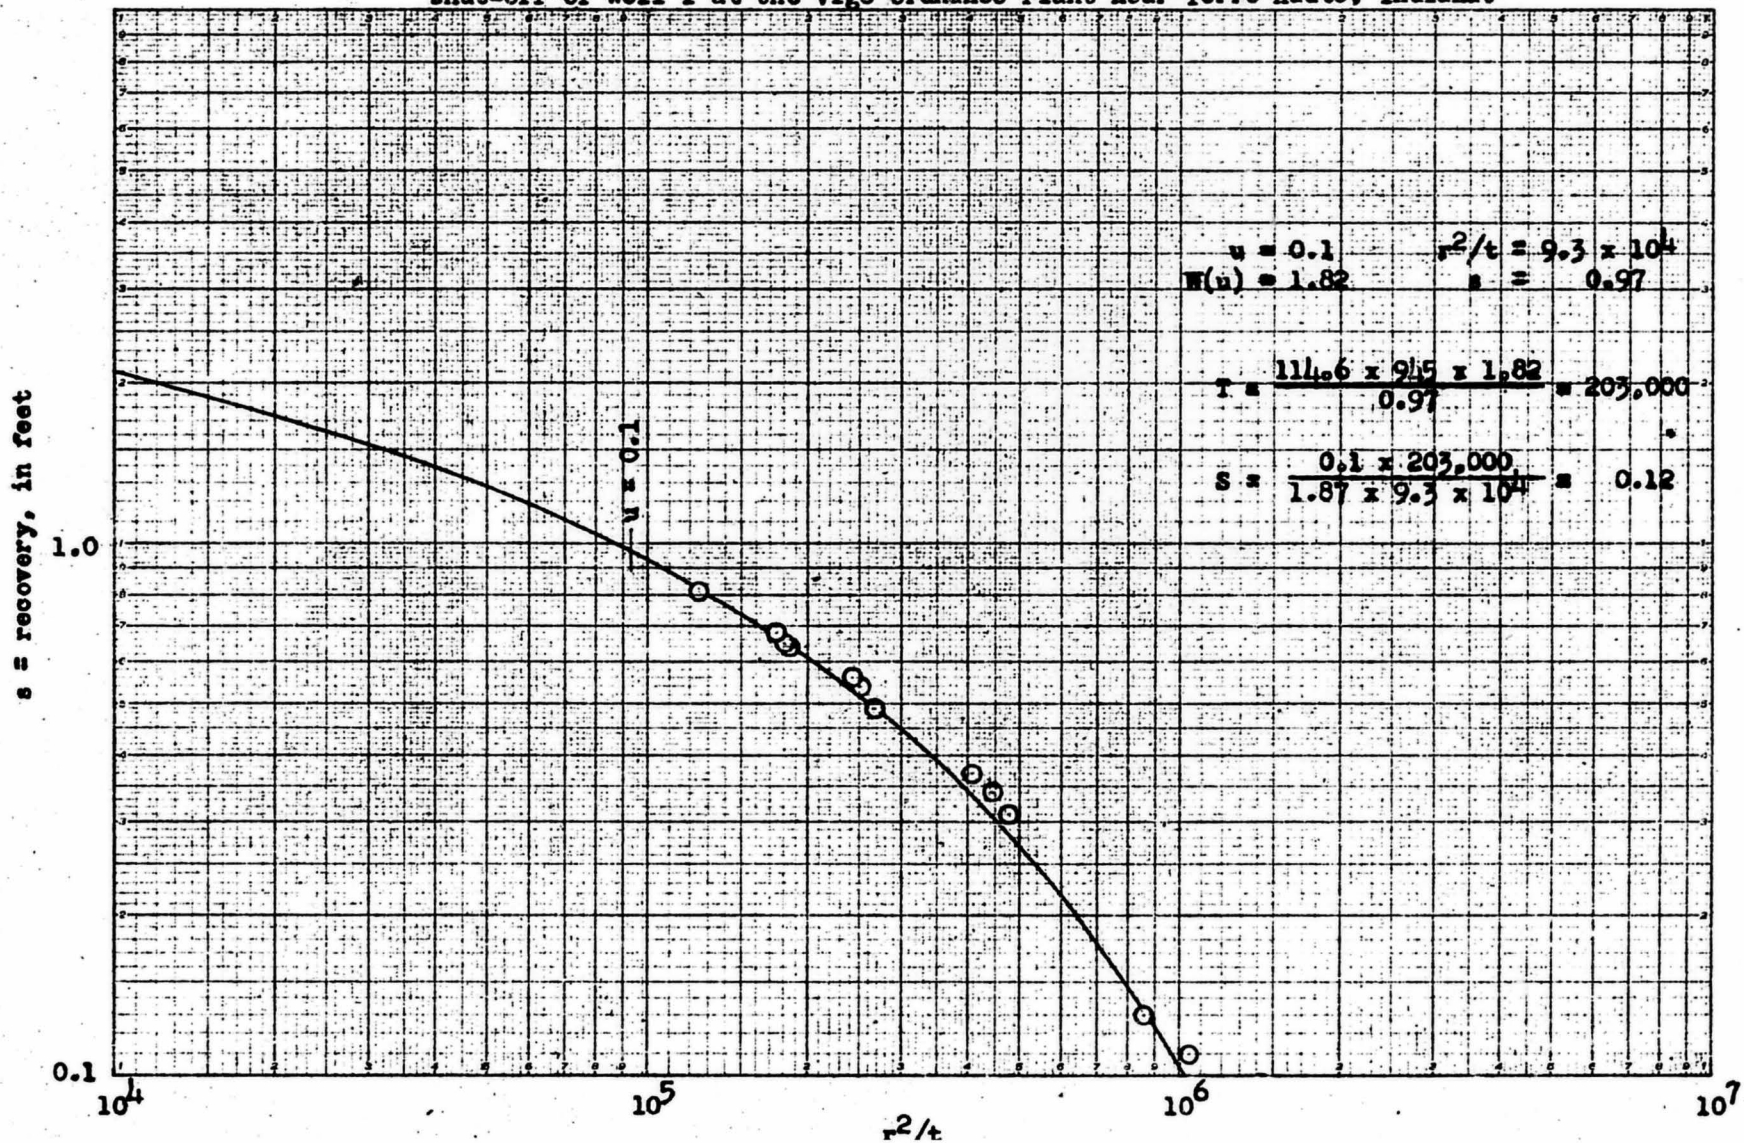
Fig. 13 -- Logarithmic graph of the recovery of water level in observation well P 2 after the shut-off of well 1 at the Vigo Ordnance Plant near Terre Haute, Indiana.
