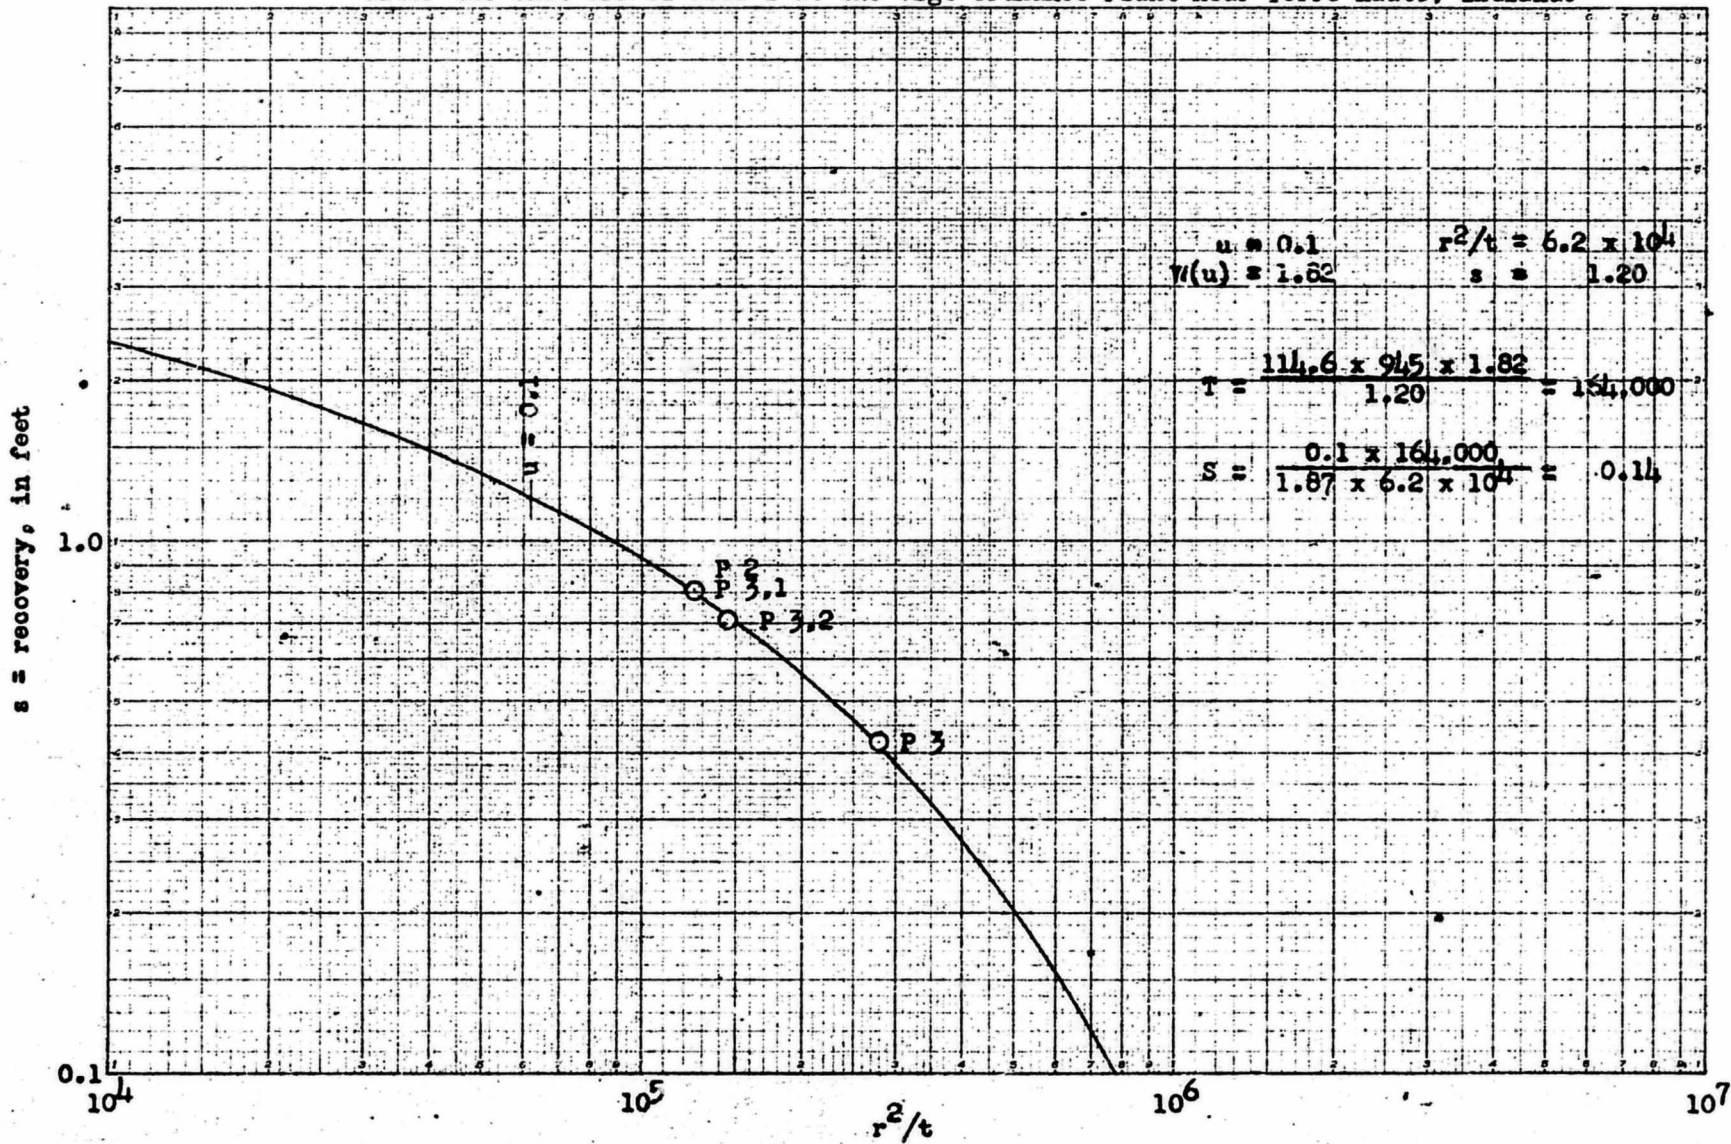
Fig. 18 -- Logarithmic graph of the recovery of water level in a profile line of observation wells after the shut-off of well 1 at the Vigo Ordnance Plant near Terre Haute, Indiana.
