LANDSLIDE CONDITIONS ALONG THE FERRY COUNTY HIGHWAY
PARALLELING LAKE ROOSEVELT FROM KETTLE FALLS
TO THE MOUTH OF THE SPOKANE RIVER
WASHINGTON

Fred O. Jones

March 1954

54-136

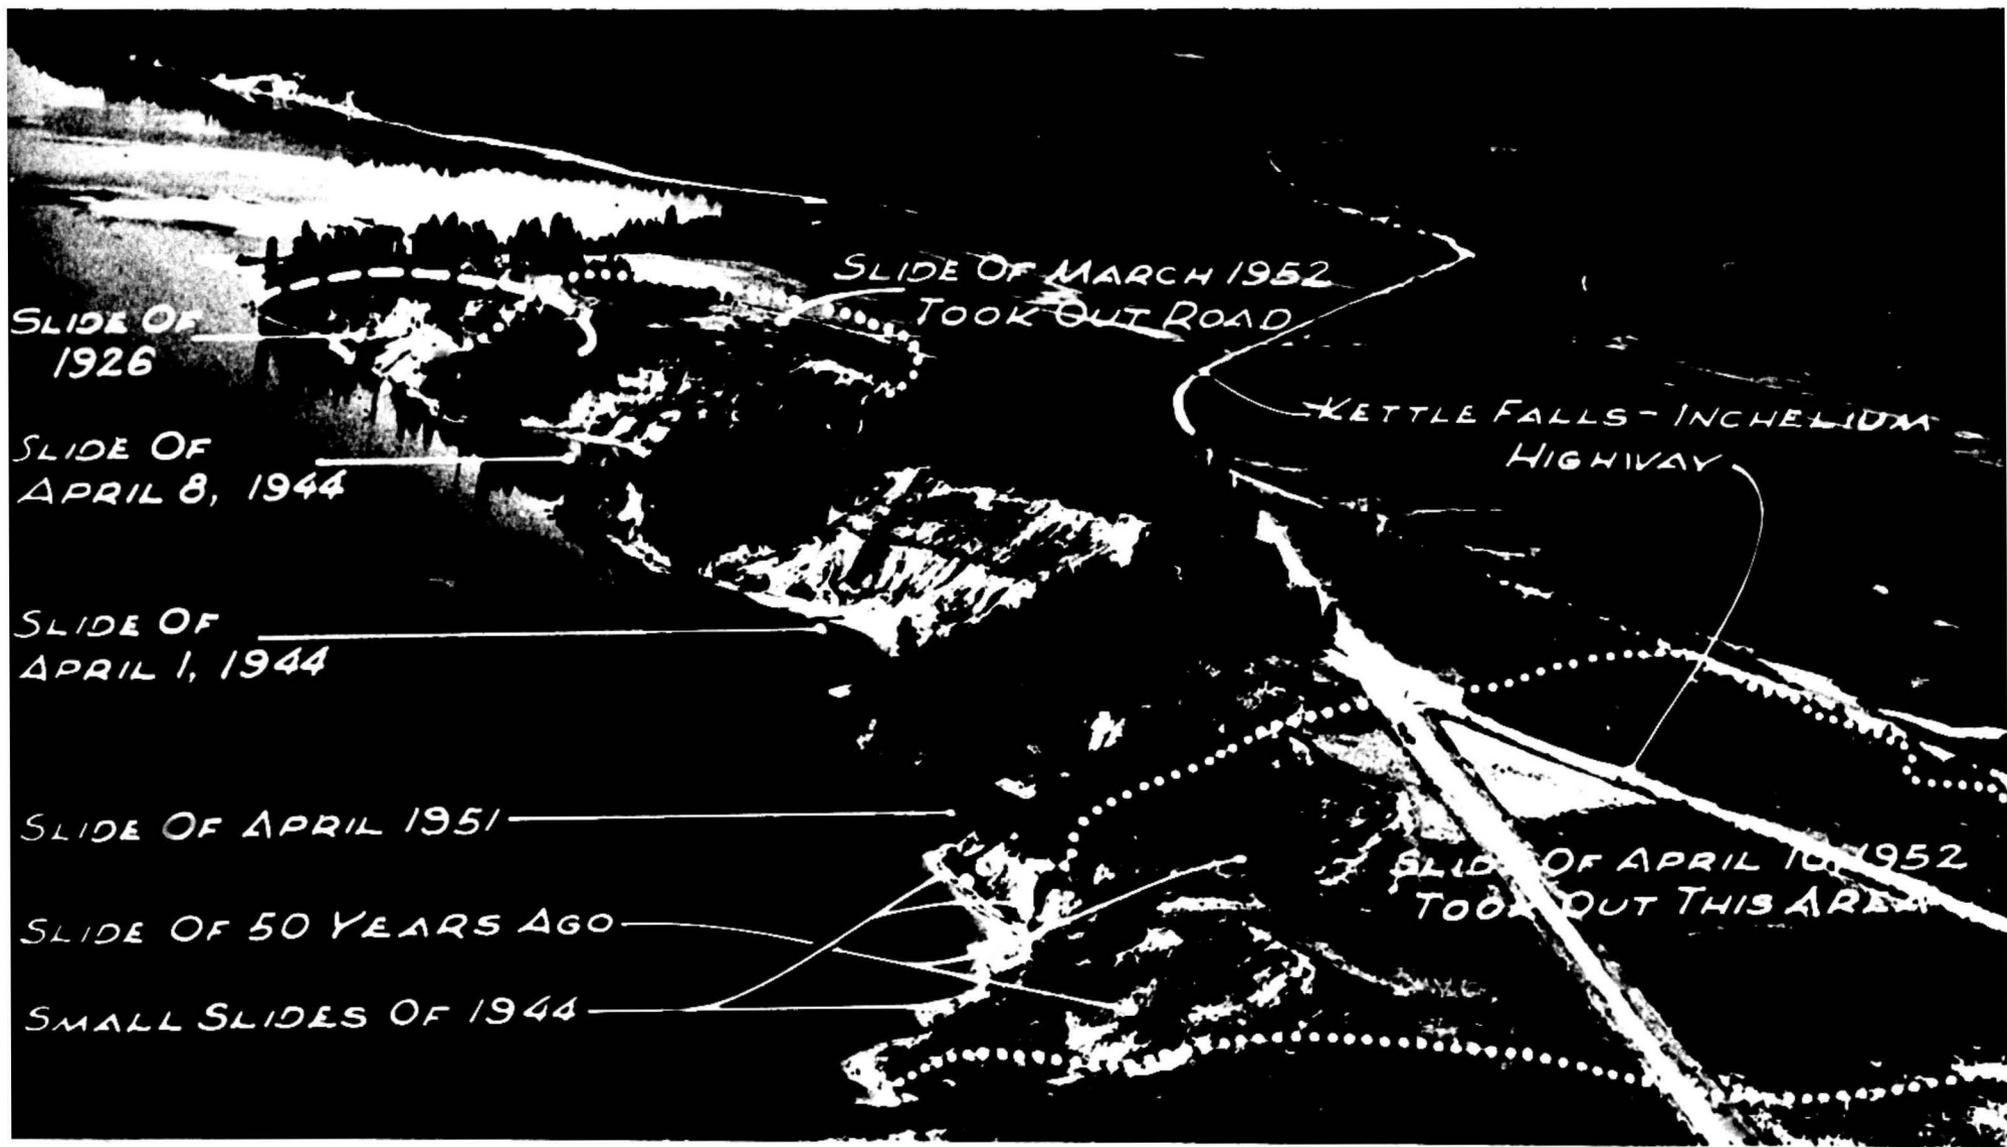
PLATE 1

Reed Terrace Landslide Area, May 15, 1951. Between Sherman Creek and Monument 1
Kettle Falls quadrangle

Reed Terrace Landslide Area, May 15, 1951, between Sherman Creek and Monument No. 1,
Kettle Falls Quadrangle

In this section the highway crosses one of the most active landslide areas in the upper Columbia River Valley. This area is known as the Reed terrace, and is composed chiefly of lacustrine silt and clay. A large section of the highway was taken out completely on this terrace in the spring of 1952 (see Plates 1 and 2). The slide necessitated a temporary relocation of the highway. Detailed site studies would be necessary to relocate this section permanently.

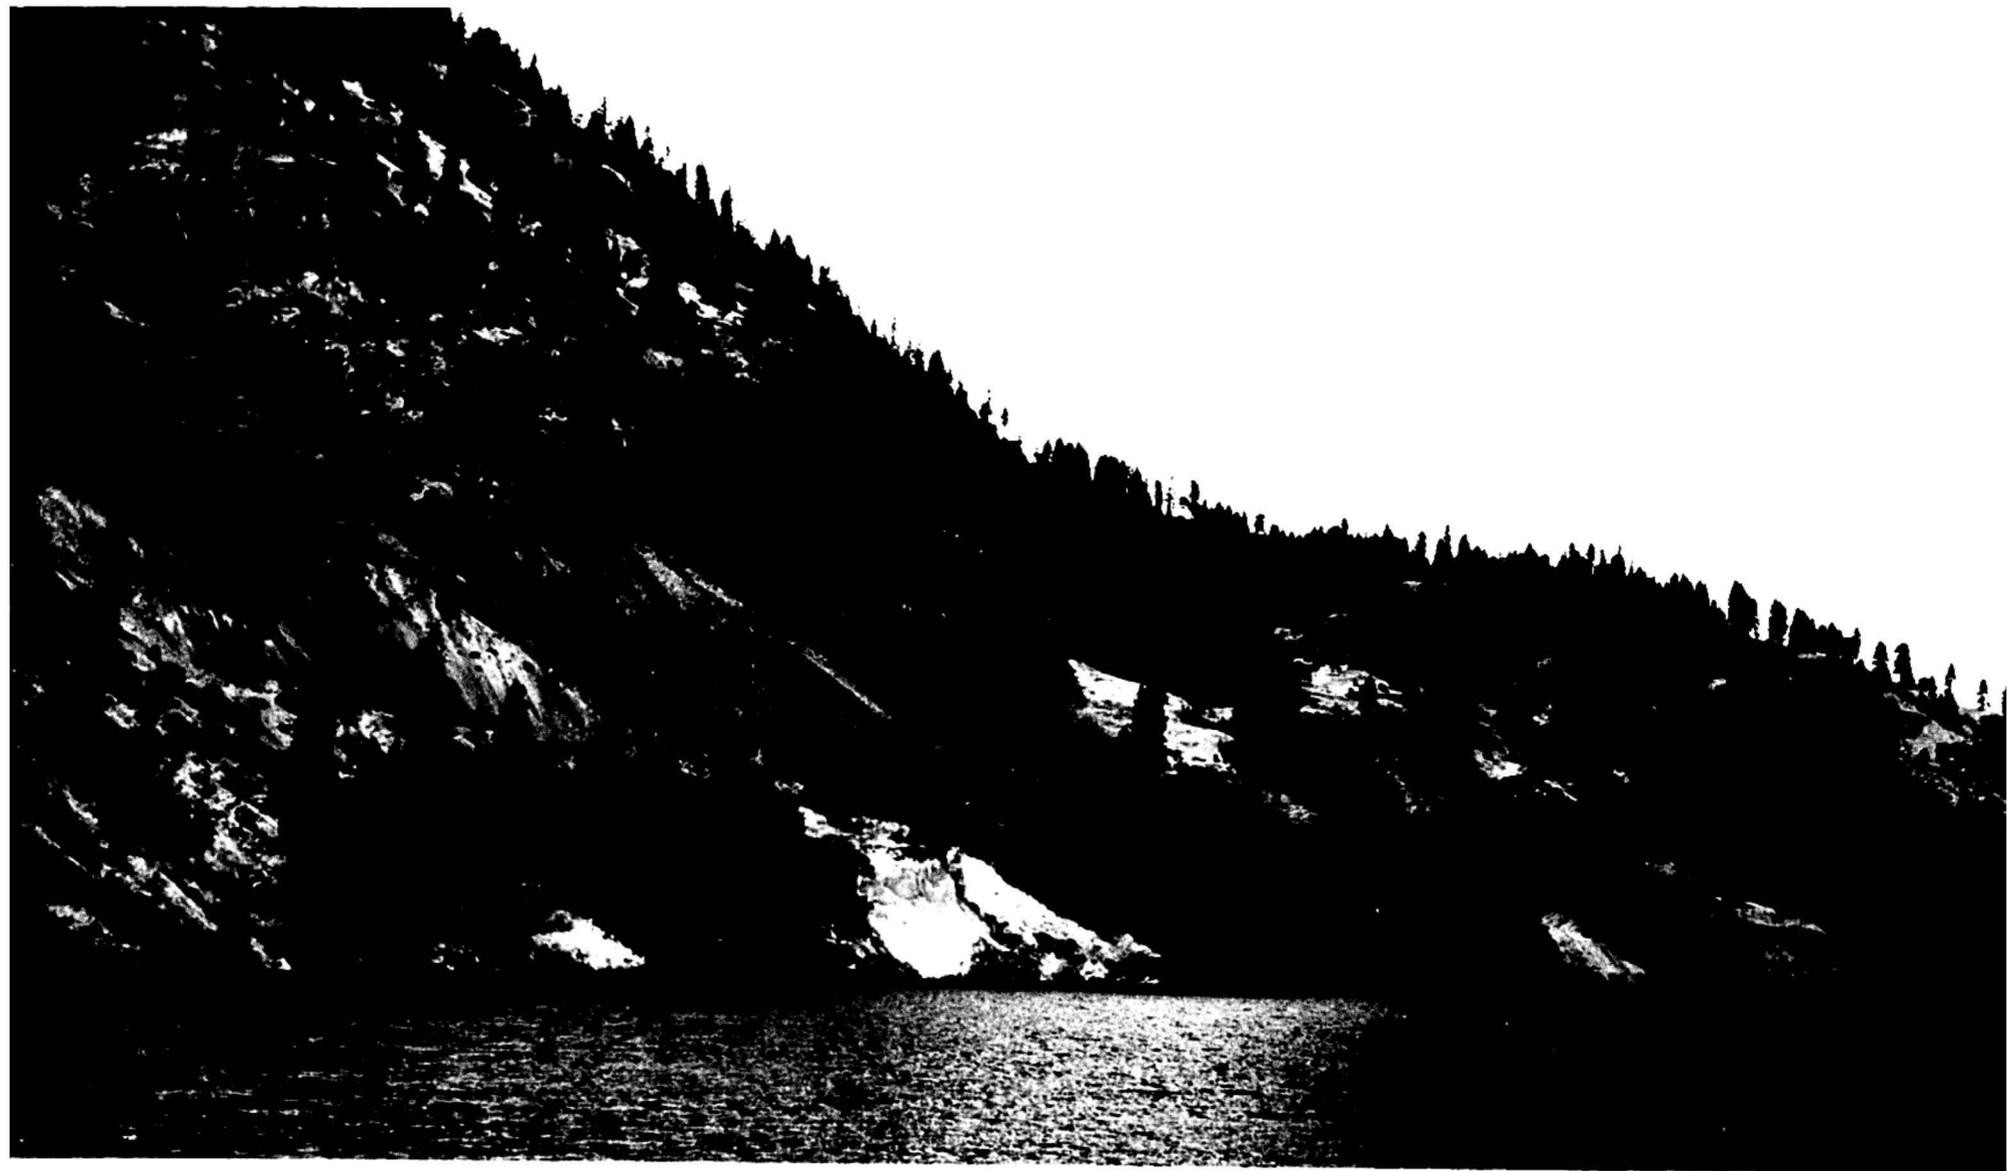
PLATE 3

Lakeshore between Monument 9 and Monument 10 - Etchellium quadrangle - August 11, 1952

Lakeshore between Monument 9 and Monument 10, Inghelium Quadrangle, August 11, 1952

The highway parallels the edge of the lake quite closely in this section. It has been constructed in glacial fill materials such as silt, clay, sand, gravel, and till in most places, but locally is cut into bedrock. Thick slope wash and huge talus deposits extend over the laminated silt and clay in many places, but the only place they can be observed is in the slides and wave banks below the highway. There are three landslides in this section, one of them cutting back to the outer edge of the road surface. Because continued landslide activity may be expected, detailed site studies would be needed as a basis for relocating around the area or of placing the highway grade on bedrock. Plate No. 3 illustrates the conditions along the most unstable part of this section.

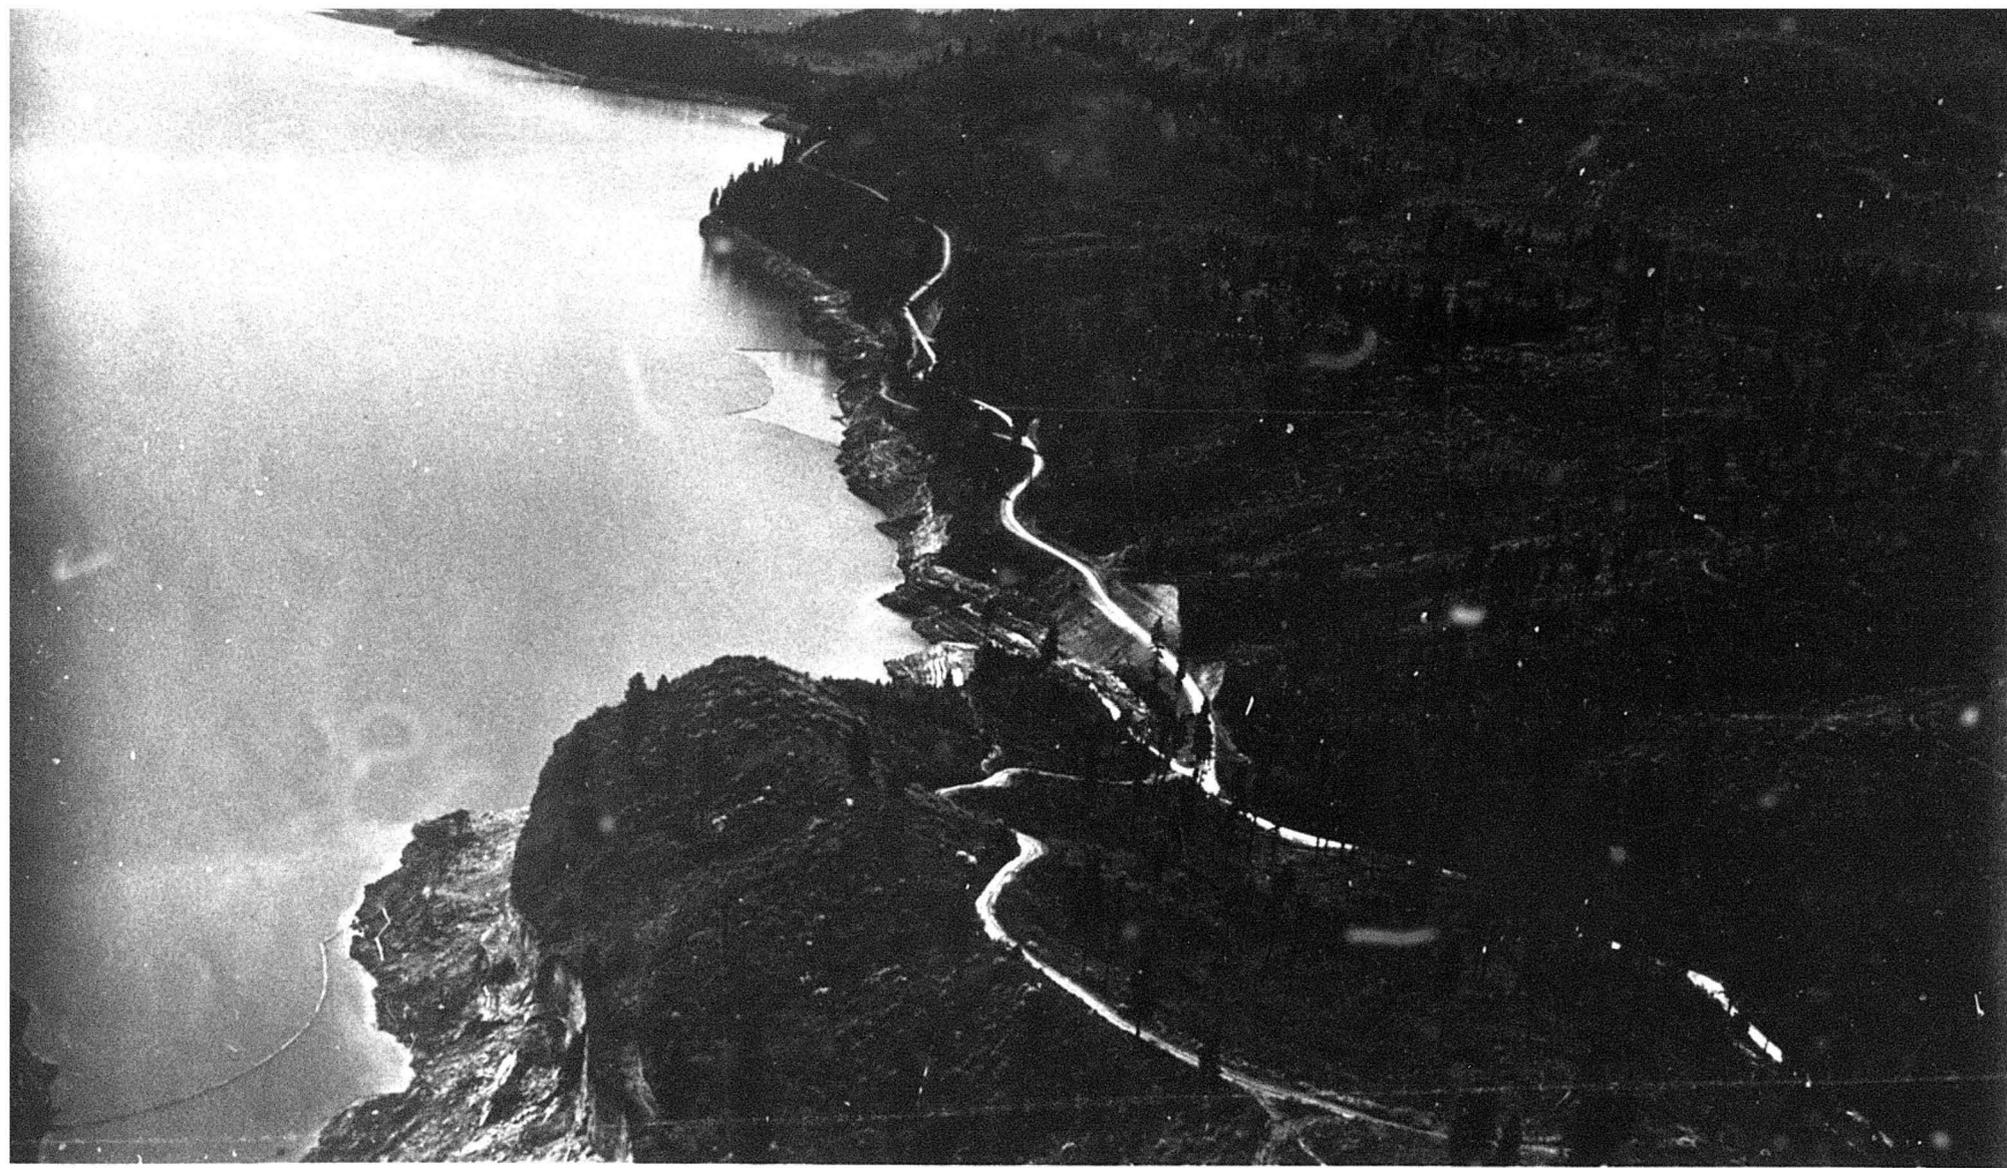
PLATE 4

Aerial oblique looking down lake showing the highway in the Falls Creek
area between Monument 19 and Monument 20 - Wilmont Creek quadrangle

Aerial oblique looking down lake showing the highway in the Falls Creek area between
Monument 19 and Monument 20, Wilmont Creek Quadrangle, April 21, 1953

One landslide in this section (Falls Creek area) has completely severed the road and another has cut into the shoulder. The highway in this area rests entirely on beds of silt, clay, and fine sand. Steeply dipping bedrock underlies the deposits at varying shallow depths. The water table is very shallow. It is doubtful if measures to drain the ground water from the surficial deposits would be successful. Detailed studies at the site would be needed to relocate this section of the road. Plates Nos. 4 and 5 illustrate the Falls Creek area. Plate No. 6 shows the landslide which cut the highway in the spring of 1951.

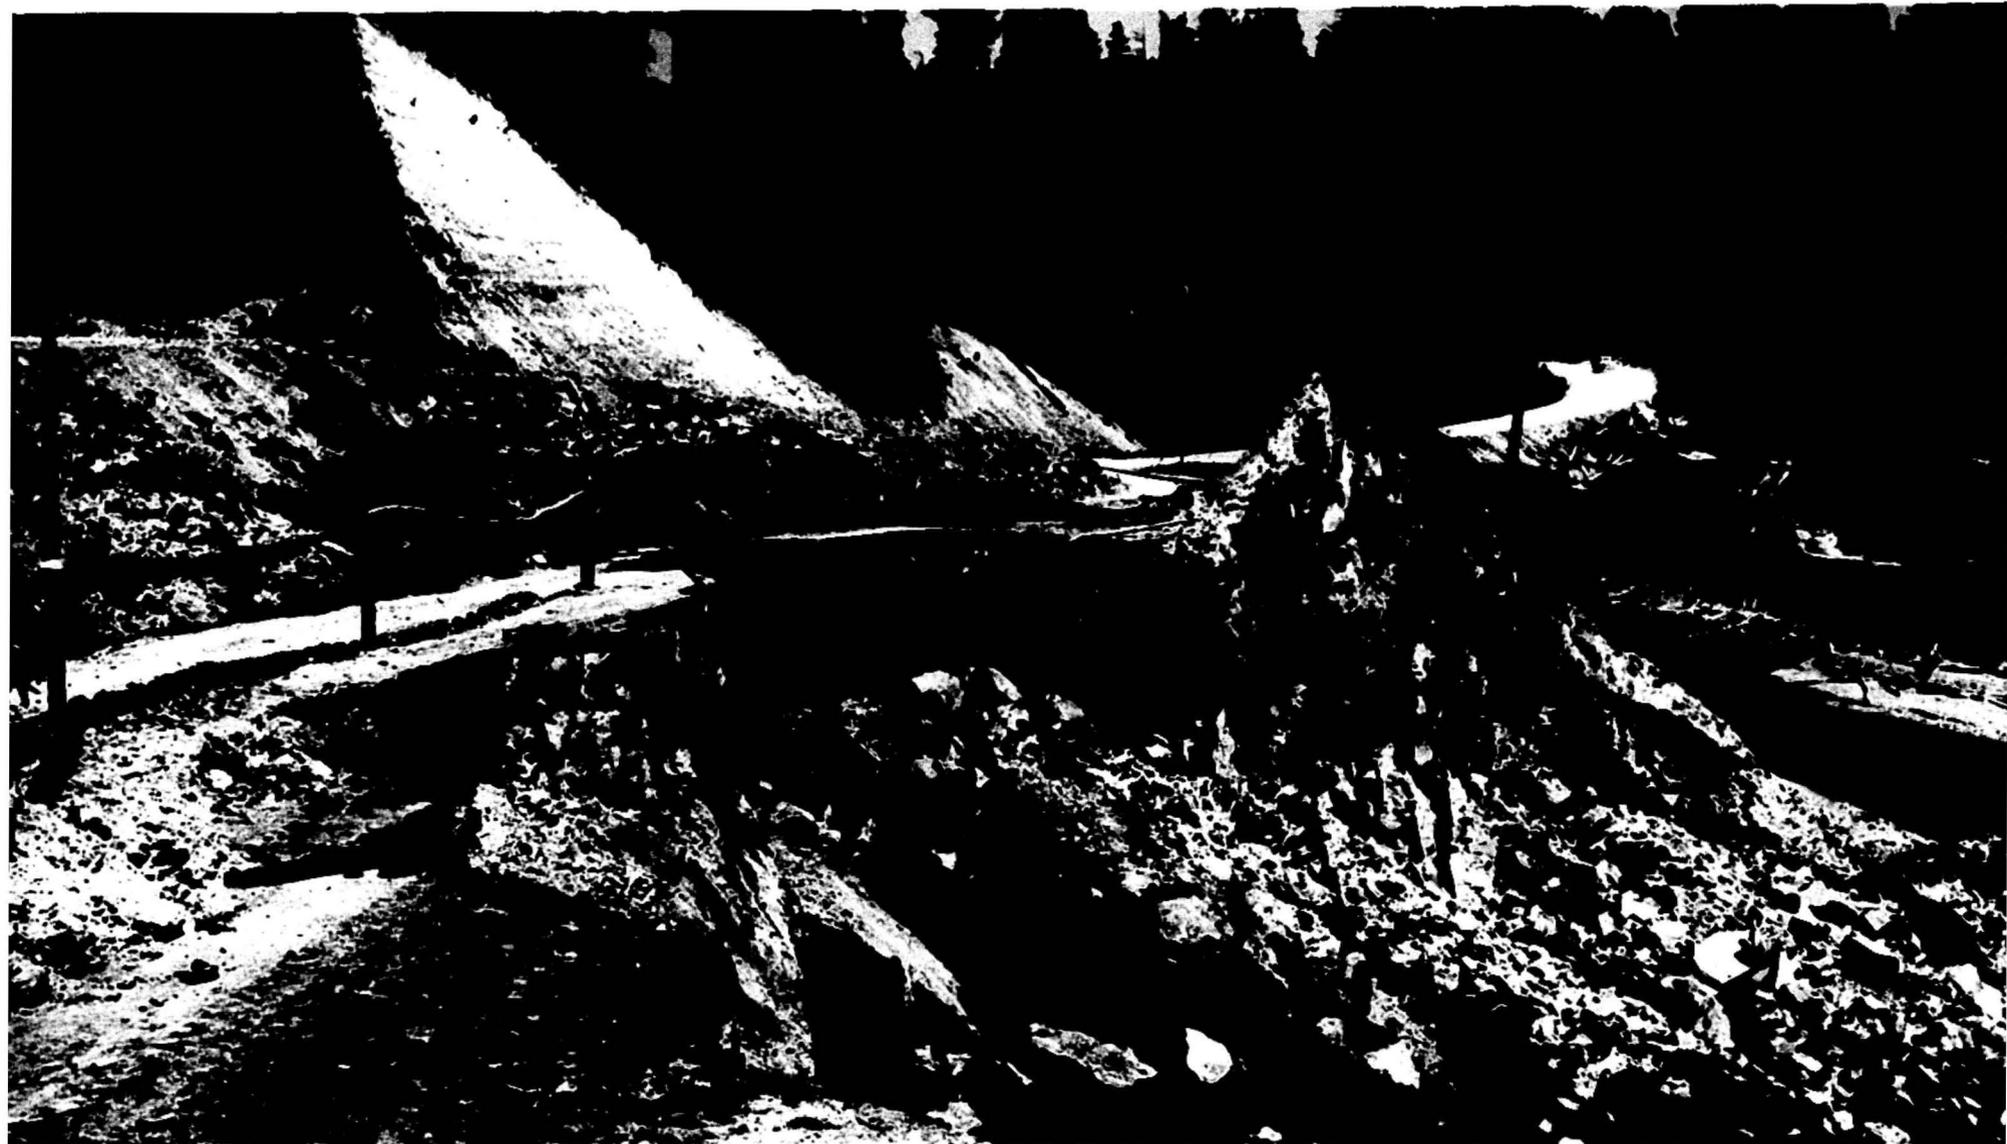
PLAT 6

Landslide which cut highway in spring of 1951 in the Falls Creek area
between Monument 19 and Monument 20 - Siltmore Creek quadrangle
May 16, 1951 photograph 293

Landslide which cut highway in spring of 1951 in the Falls Creek area between Monument 19 and Monument 20, Wilmont Creek Quadrangle, May 16, 1951

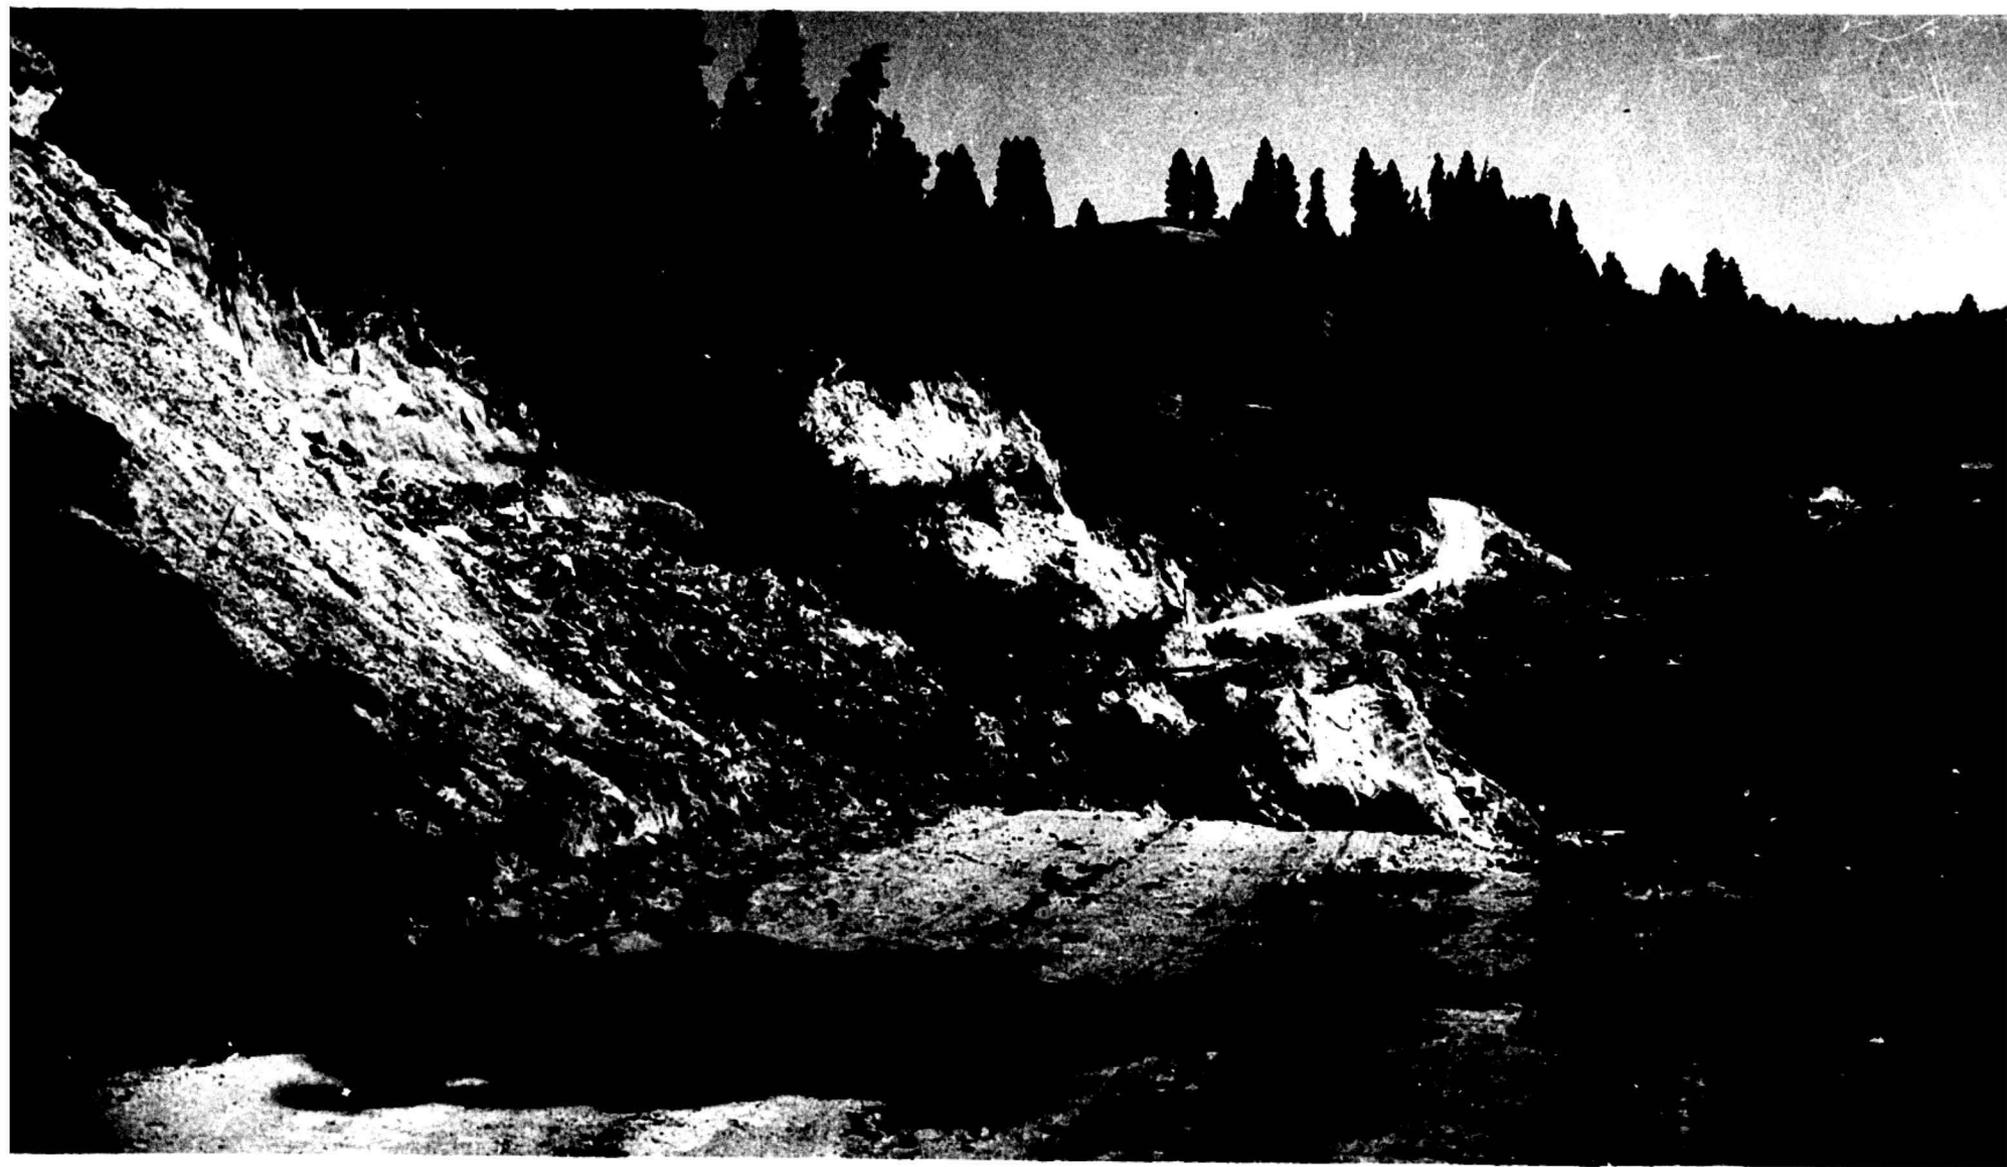
PLATE 7

Landslide at Minemile Creek which completely cut highway on
July 3, 1949 - Milmont Creek quadrangle between Monument 25
and Monument 26

Landslide at Ninemile Creek which completely cut highway on July 3, 1949 - Wilmont Creek
Quadrangle between Monument 25 and Monument 26

In this area the highway skirts Minemile Bay. Large landslides have completely cut the road in two places, and a small one has partly cut it. Throughout this section the road rests on alternate sections of granite bedrock, beds of unconsolidated silt and clay, and silty slope wash. The places which are entirely on bedrock are safe, but they account for less than 30 percent of the section. Additional sliding can be expected, and detailed site studies would be needed for relocation. The highway has been closed most of the time since a landslide on July 3, 1944 (see Pl. No. 7). Plate No. 8 shows the same slide in May 1951. Plate No. 9 shows a slide which cut the highway in the winter of 1952.

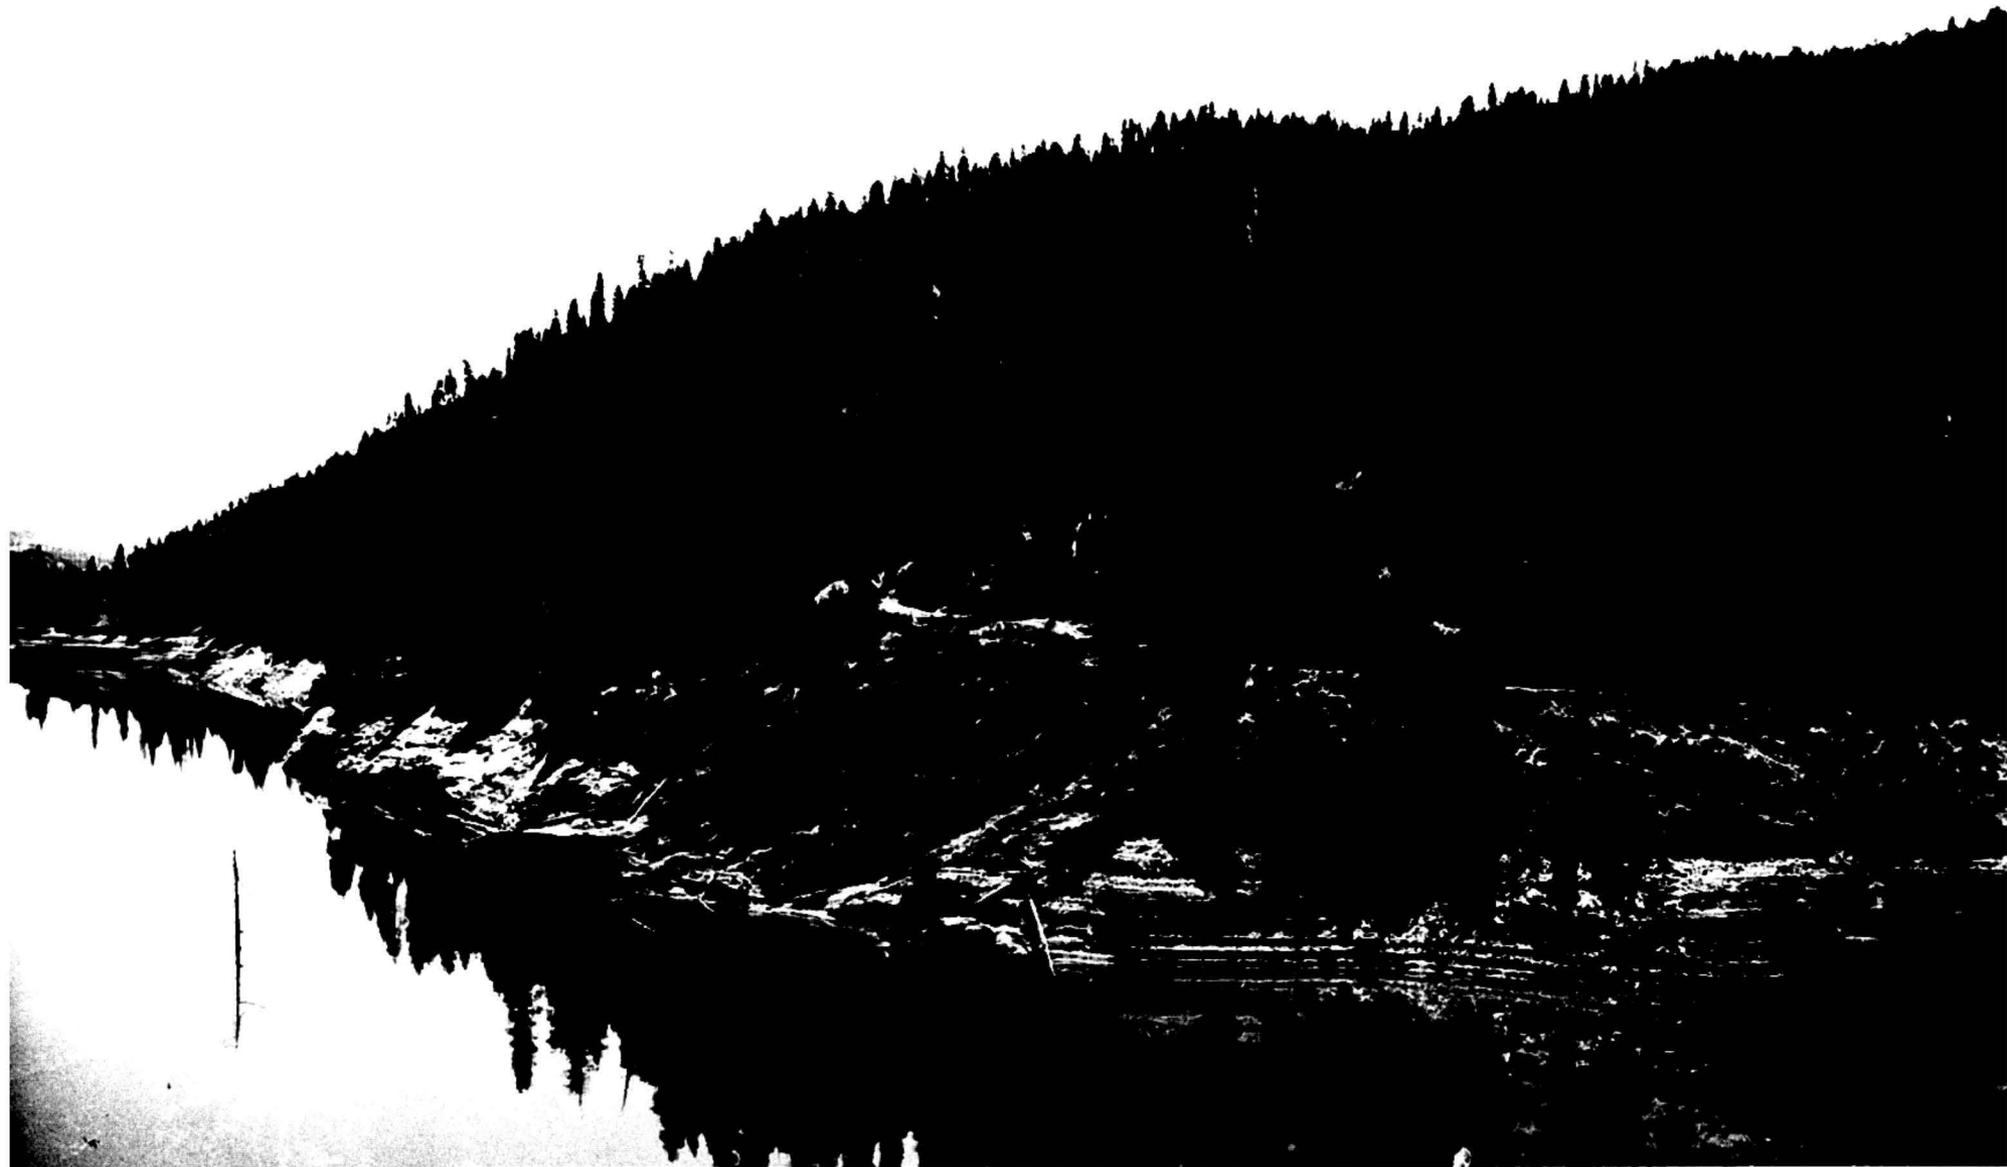
PLATE 9

Landslide just south of Minemile Bay which severed highway in the
winter of 1952 - Willmont Creek quadrangle between Monument 25
and Monument 26

Landslide just south of Ninemile Bay which severed highway in the winter of 1952 -
Wilmont Creek Quadrangle between Monument 25 and Monument 26
