U. S. DEPARTMENT OF THE INTERIOR  
GEOLOGICAL SURVEY  
Water Resources Division  
Philadelphia, Pennsylvania

HYDROLOGY and SEDIMENTATION in BIXIER RUN, COREY CREEK  
and ELK RUN WATERSHEDS, PENNSYLVANIA

Open File Report  
Prepared by Quality of Water Branch - November 1957

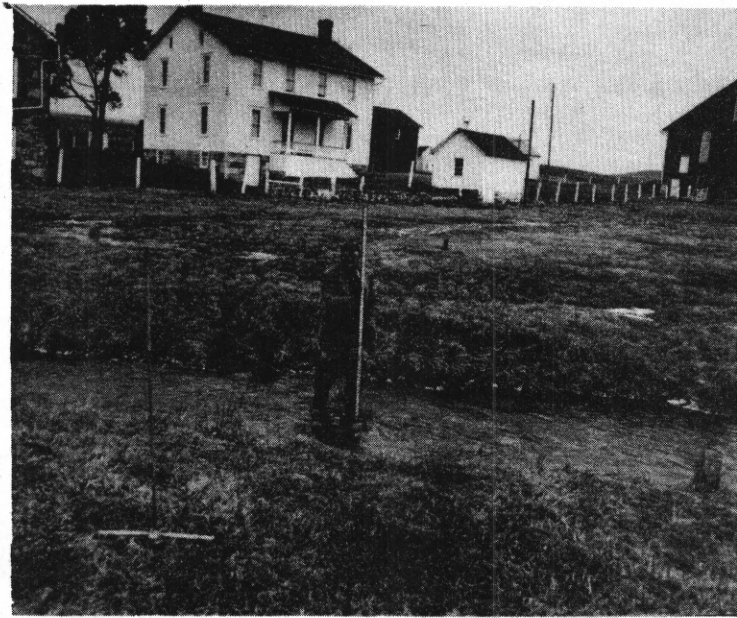
Figure 5. - Sediment aggradation-degradation range.

The amount of aggradation or degradation occurring in the channel system in each watershed is measured by means of aggradation-degradation ranges. These ranges are marked by steel pipes on either side of the stream at right angles to the stream flow. The pipes are spaced far enough from the edge of the stream so that they will include most if not all of the flood plain. A steel tape is stretched between the two pipes and level readings of the stream bed are taken at one-half foot intervals between the pipes (Fig. 5). An engineer's level is used and elevations are obtained to the nearest one-hundredth of a foot and related to permanent bench marks. This method gives an accurate cross-section at the same spot each time the levels are run (approximately once a year).

Sediment aggradation-degradation range - A site on a stream channel at which once yearly or more often levels are run to determine the actual cross-section at that point. A pipe is driven into the ground on either side of the stream and a wire stretched between them. An engineer's level and level rod are used to obtain elevations at each one-half foot interval across the stream and adjacent flood plain, once yearly on the average.

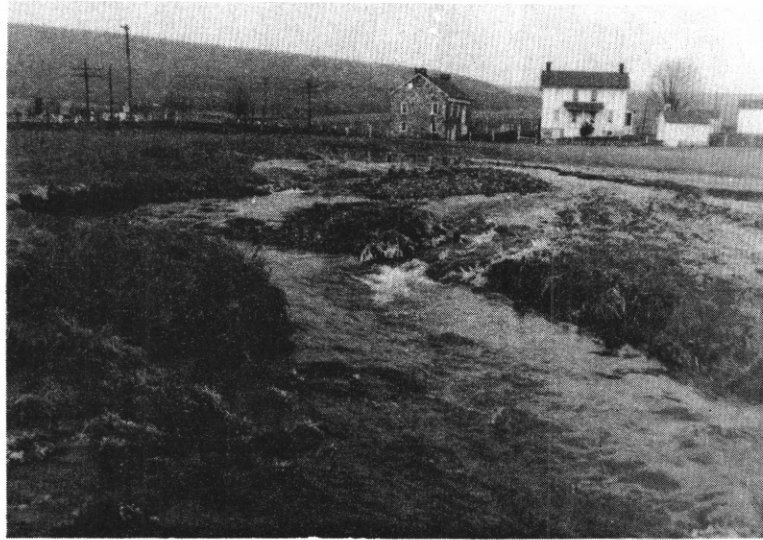
Figure 6. - Bixler Run at Kistler showing rock and gravel fill causing widening and eventual splitting of the channel.

During the period of investigation the upstream tributaries to Bixler Run, Corey Creek, and Elk Run have been aggrading or filling. Figure 6 is a photograph taken on the Bixler Run main stem at Kistler. Rock and gravel fill has caused widening here, and may cause eventual braiding or dividing of the channel. Figure 7 is a photograph taken on the East Branch of Bixler Run and illustrates rock and gravel building up a natural dam which may eventually change the course of the stream at this point. The deposits pictured in Figures 8 and 9 were left by a recent flood. The sharp angularity of the rocks suggests recent introduction into the stream channel. The size of the material in the deposits in Figure 9 illustrates the great carrying power of a small stream during high flood flows.

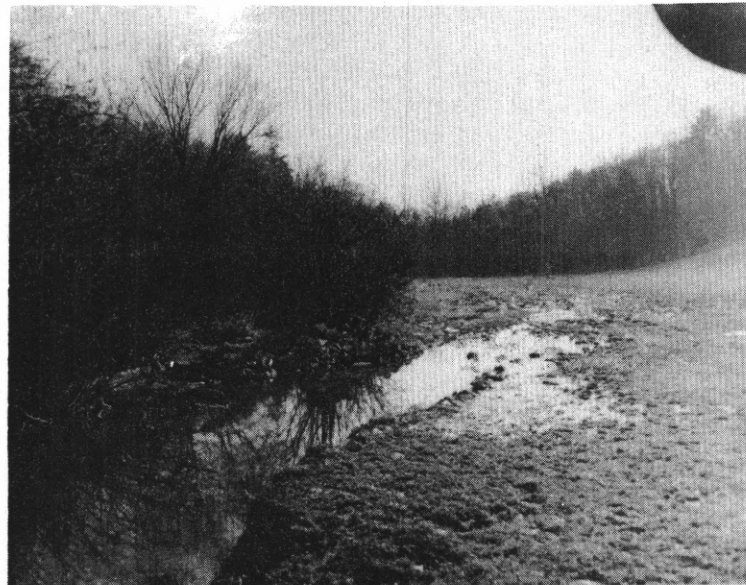
Figure 7. - East Branch Bixler Run showing buildup of a natural dam to possibly change the course of the stream.

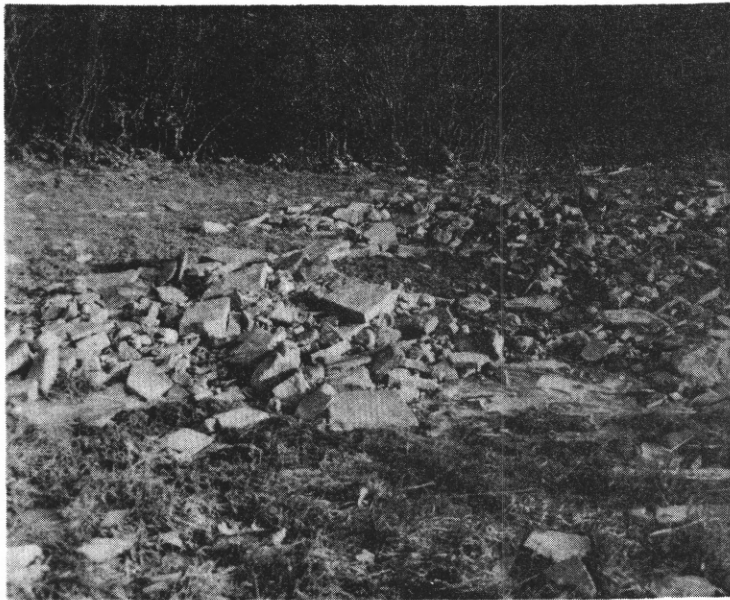
Figure 8. - Close-up of material shown in Figure 7.

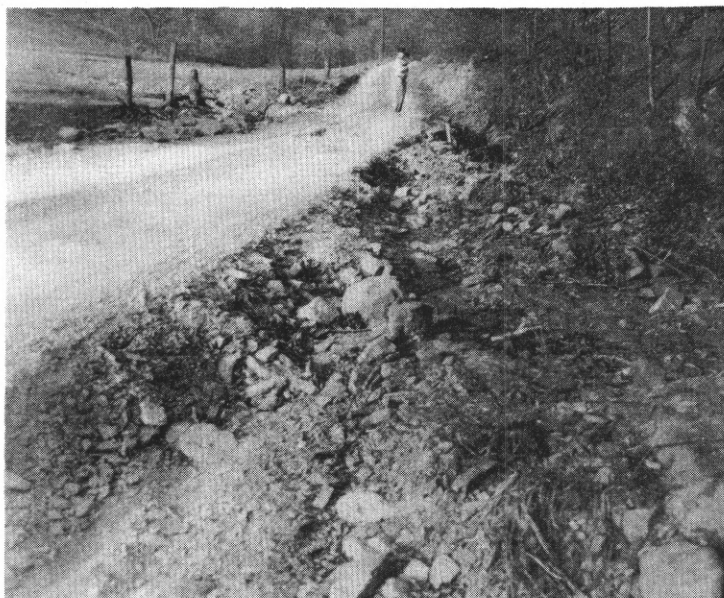
Figure 9. - Recent flood deposits in Bixler Run headwaters.

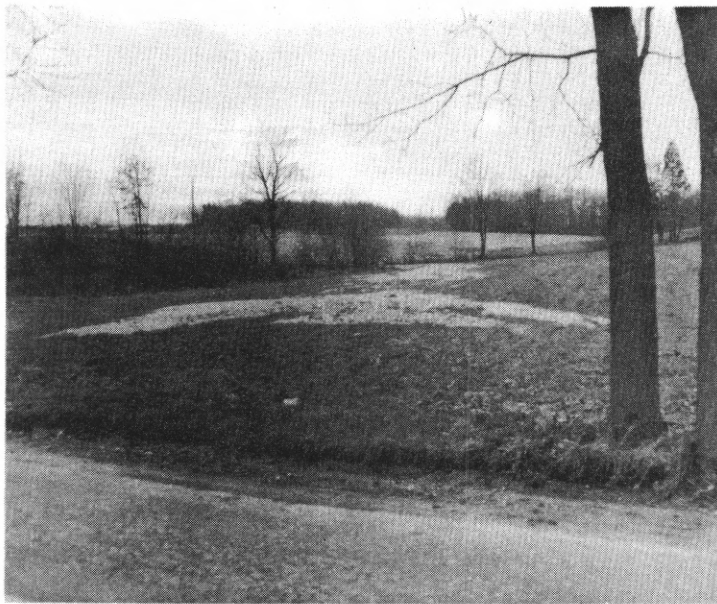
Figure 16. - New outwash material enroute to the stream channel.

deposits of rock and gravel. Apparently these rocks are loosened by the rains which wash away the surrounding soil particles. Assisted by each succeeding rain storm and continued cultivation these rocks and gravel move slowly down-slope until they reach the stream bed. Figure 16 is a photograph showing new outwash material (rock and gravel) which has been deposited temporarily in a pasture on the way down-slope to the stream bed. This material came from a small area as a result of a heavy rainfall which cut deeply into a fractured limestone outcrop. This type of movement is probably an unusual occurrence. After reaching the stream this material may remain in the stream channel for some time until a flood moves it downstream. With the stream bed raised by the addition to this rock and gravel, the next high or even moderately high water will probably widen the channel and overflow the flood plain.

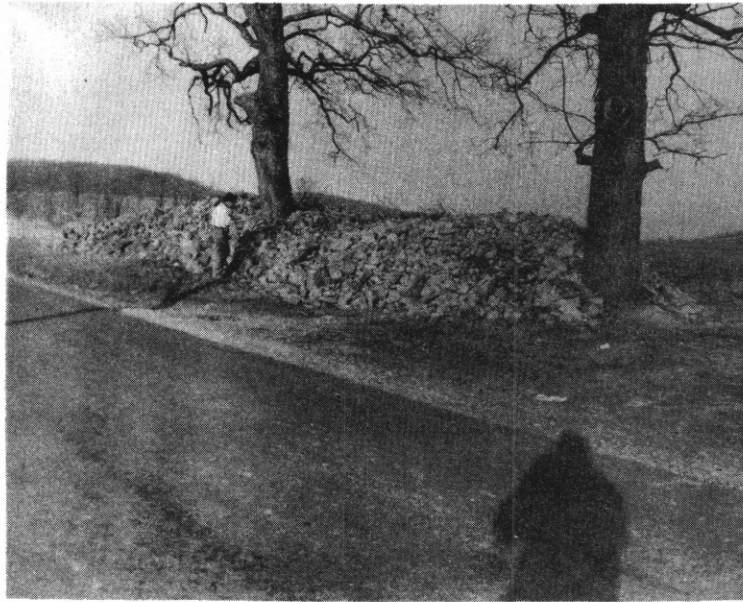
Figure 17. - This pile of rock lies in the Bixler Run watershed on one of the main upstream tributaries. It is about a mile below range No. 27 and at the spot which the photographs in figures 18 and 19 were taken. These rocks were apparently dredged from the channel and carried from the adjacent fields during the past few years.

To prevent the loss of valuable farm land, many land owners remove these larger sediments from stream beds. Figure 17 shows a pile of rock which lies along one of the main upstream tributaries of Bixler Run. The majority of the rocks in this picture were dredged from the stream channel, the remainder being hauled from the nearby fields. Figure 18 is a picture taken shortly after the channel at this location had been straightened in May 1956. Figure 19 is a photograph of the same location taken 7 months later following the flood of November 1, 1956. Notice the disposition of rock and gravel sediments in the center of the stream bed causing the beginning of the meander.

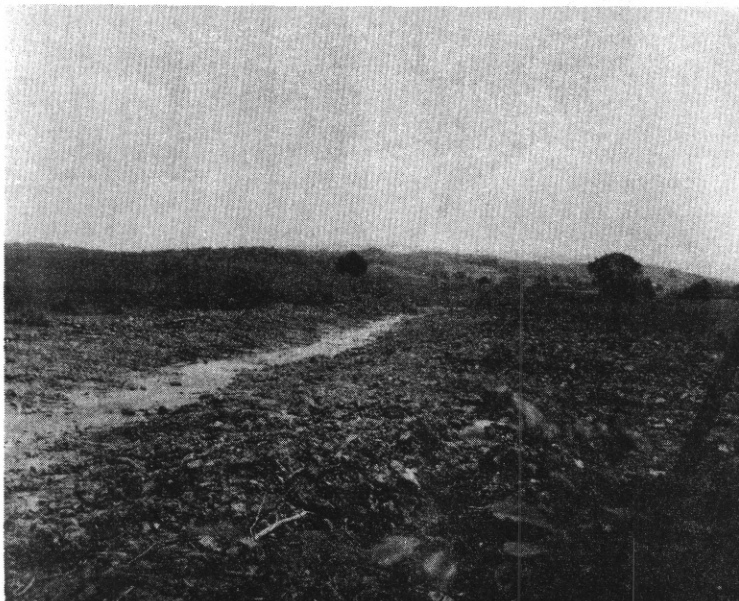
Figure 18. - Channel straightening job immediately after completion in May 1956.

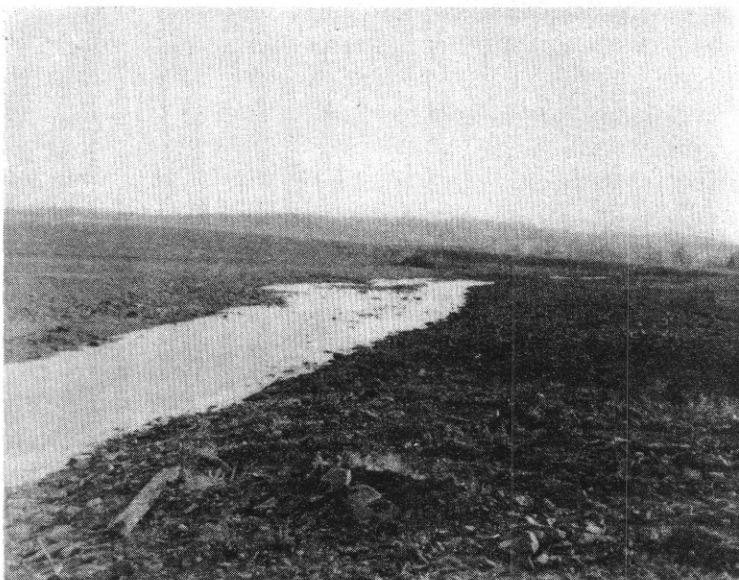
Figure 19. - Same view taken seven months later in December 1956 after the flood of November 1, 1956. Shows deposition in center of channel and beginning of a meander.
