(200)
R290
no. 506

Fig. 17.--Geologic cross sections at bridge at Mile Post 456.7 in Goldstream Valley near

Fairbanks, Alaska. The Alaska Railroad.

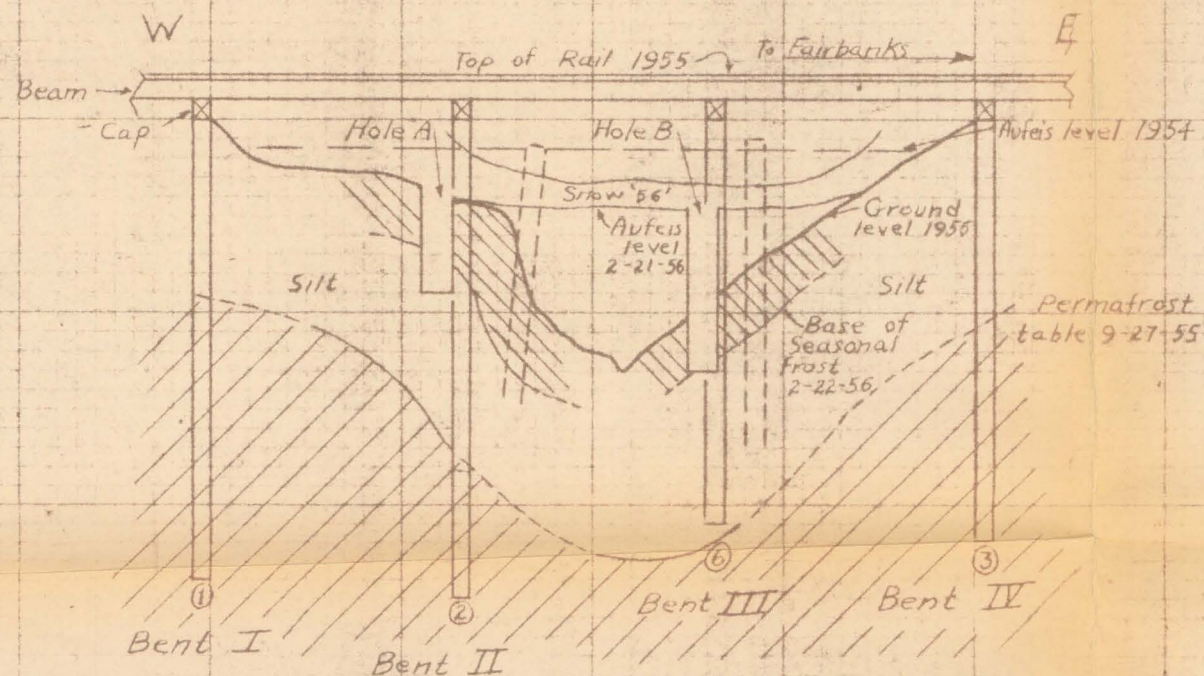
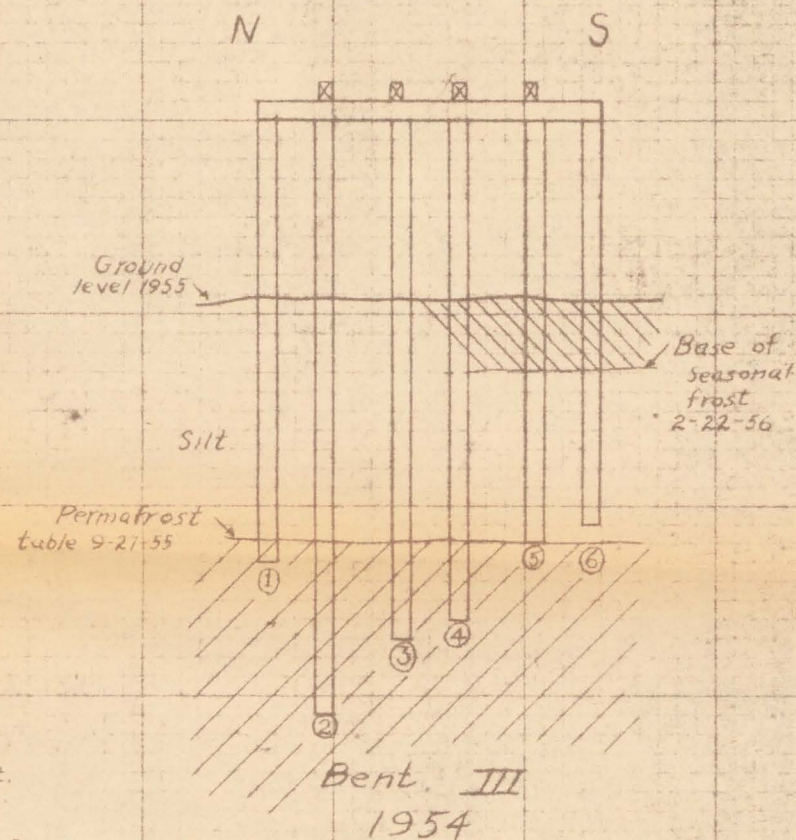
0 5 10 20 Ft.
Horizontal and Vertical Scale
Dashed piling 1947
Solid piling 1954
② Pile number
(Shortest pile in each bent plotted)
