Preliminary Report on the Geologic and  
Geophysical Investigations of the  
Loveland Basin Landslide, Clear  
Creek County, Colorado  
by  
Robinson, C.S.; Carroll, R.A. & Lee, F.T.

Preliminary report on the geologic and geophysical investigations  
of the Loveland Basin landslide, Clear Creek County, Colorado  
by C. S. Robinson, R. A. Carroll, and F. T. Lee

September 1963

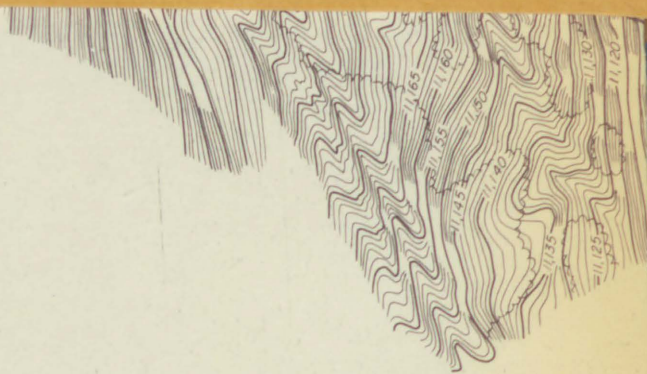
FIGURE 3: STRUCTURE CONTOUR MAP OF THE TOP OF T  
Contour inte

Figure 3 is a structure contour map of the top of the slip zone, showing the topography of the upper surface of the slip zone. From this map the dip of the top of the slip zone may be calculated for any area of the slide. Also, from this map it is possible to calculate for any position on the ground the angle and length of any drill hole that might be drilled to intercept the top of the slip zone.

**3.--Structure contour map of the top of the slip zone of the Loveland Basin landslide.**
