Joints in Clay and Their Relation to
the Slope Failure at Greenbelt,
Maryland, December 28, 1962.

JOINTS IN CLAY AND THEIR RELATION TO THE SLOPE FAILURE
AT GREENBELT, MARYLAND, DECEMBER 28, 1962

Joints in clay and their relation to the slope failure
at Greenbelt, Maryland, December 28, 1962

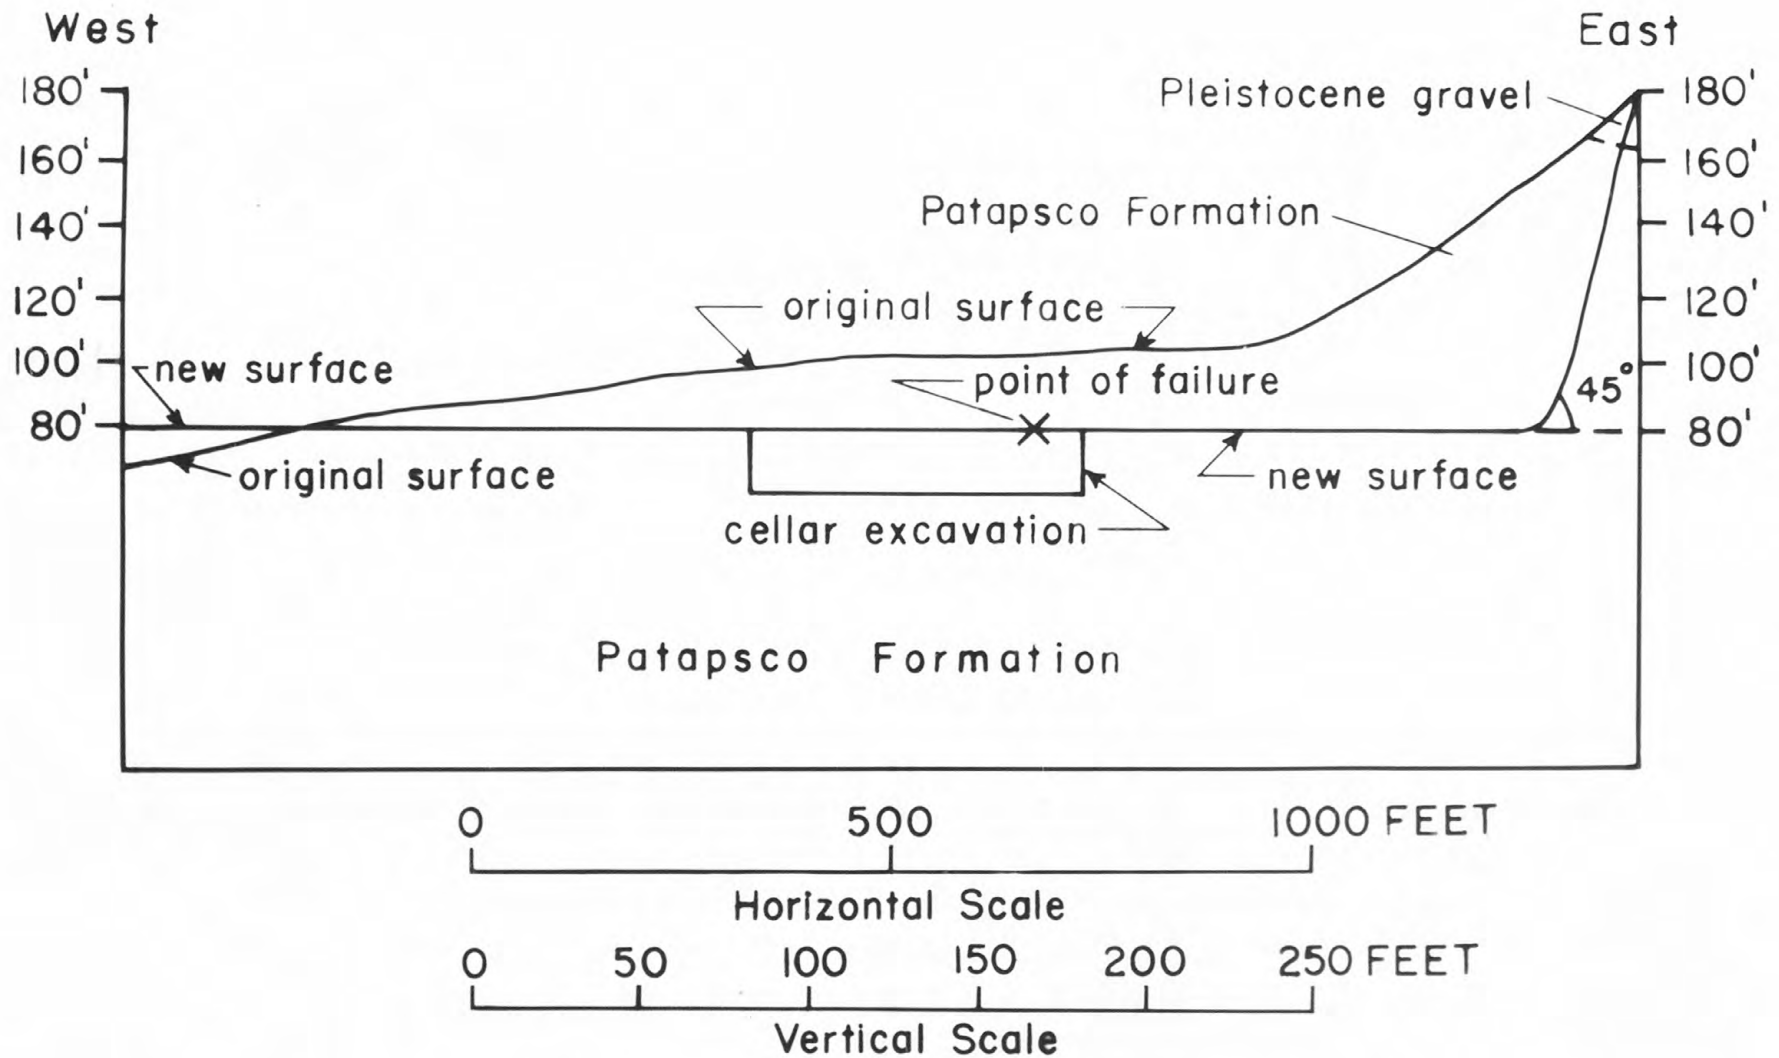
Figure 2: Sketch of East-West cross-section through the excavation at Greenbelt, Maryland, showing the original and new surfaces, and the amount of the Patapsco Formation that was moved

store, which consisted of leveling the side of a hill as much as 80 feet and digging an 18-foot-deep cellar approximately 400-feet square. With the exception of the gravel in the upper 10 feet, all the excavation is in the Patapsco Formation (fig. 2).

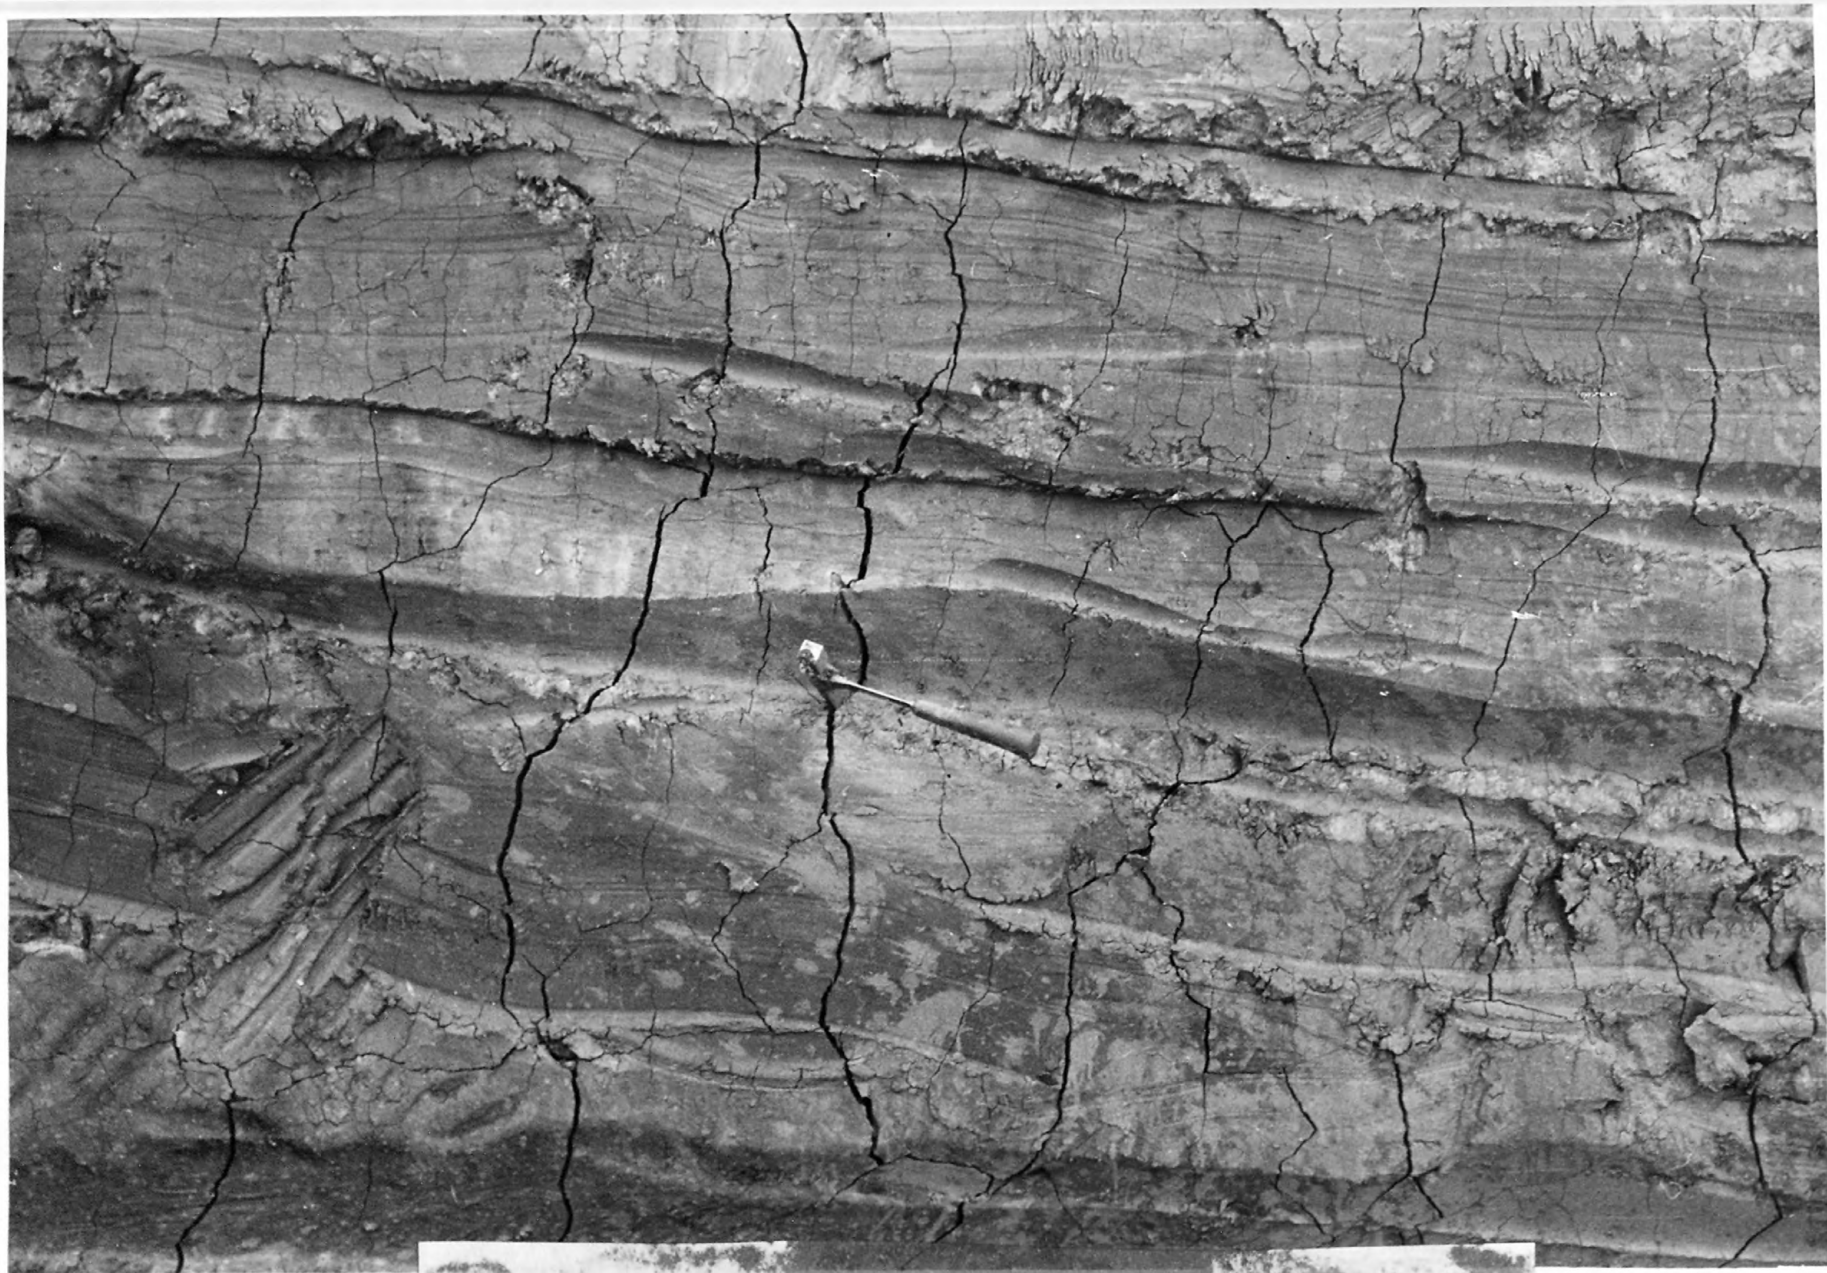
Figure 3. East wall of the excavation of Greenbelt, Maryland, showing the joint set in the clays of the Patapsco Formation of Cretaceous age. (Photo by author)

The east-trending joints, which penetrate the east and west walls of the cellar excavation at least a foot are, for the most part, less than one-half inch wide, although some measure as much as an inch in width. Figure 3 shows a portion of the clay exposed on the east wall of the cellar excavation. The nearly vertical cracks, which are as much as a foot and a half apart, are the principal joint set, and the less extensive cracks are probably the result of desiccation. The joint set was observed only on the east and west walls; none were observed on the floor of the excavation because the traffic of construction equipment obscured the details. Since the east-trending joint set is parallel with the north and south walls, they do not intersect these faces.

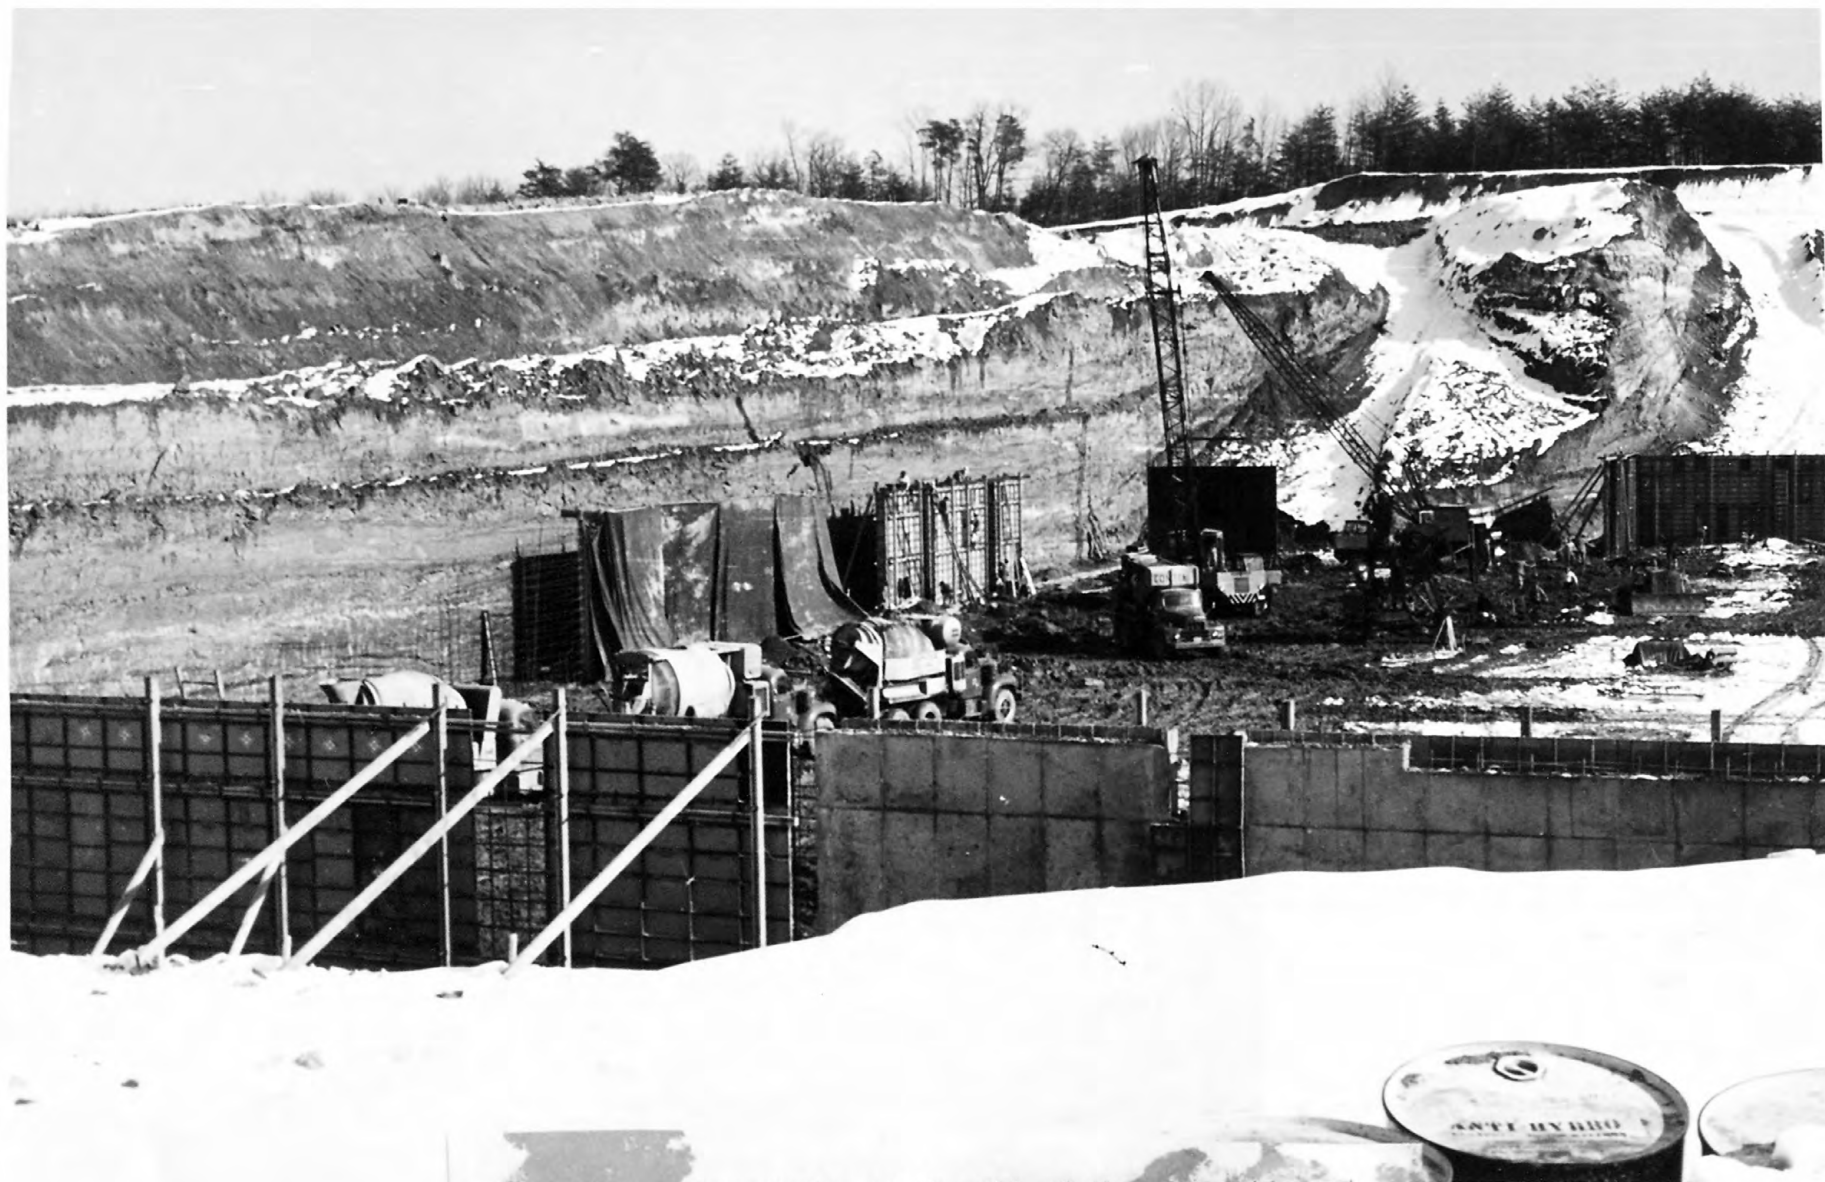
Figure 4. View of the north wall of the excavation at Greenbelt, Maryland, taken about 1:00 p.m. on December 28, 1962. (Photo by author)

The cellar excavation was completed by the early part of December and concrete for the cellar walls was being poured on the north side by December 28th. A picture (fig. 4) taken about 1:00 p. m. on the 28th shows the overall view of the north wall of the excavation. At about 1:15 p. m. on the same day, a section of the north wall, 42 feet wide, 15 feet high, and about a foot thick, toppled, carrying with it a section of the forms that were being filled with concrete. Five men were

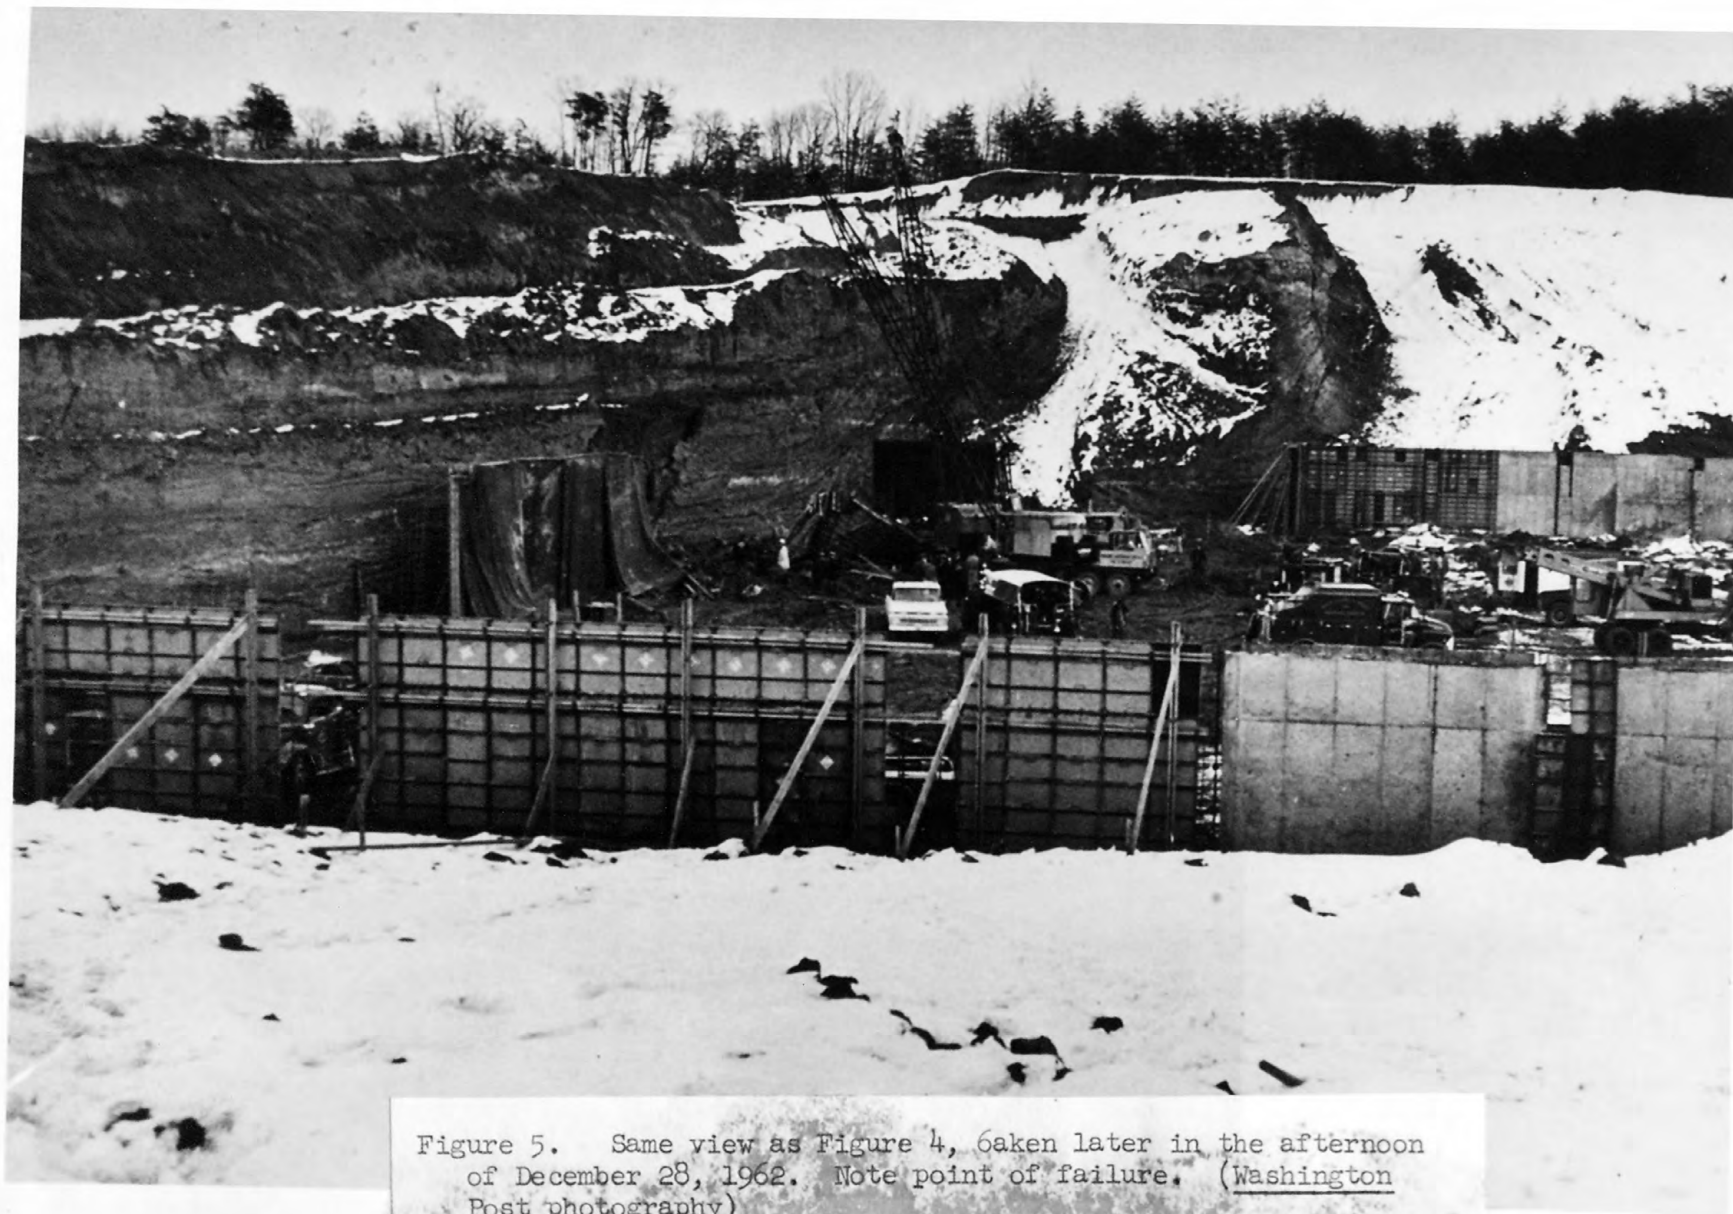
Figure 5. Same view as Figure 4, taken later in the afternoon of December 28, 1962. Note point of failure. (Washington Post photography)

killed and 11 injured. A picture (fig. 5) taken later in the afternoon of the 28th shows the same view as figure 4. Figure 6, taken 4 days later, shows a closer view of the part of the wall of the cellar excavation after the fall. Note the absence of any major cracks on this face except those connected with the failure.

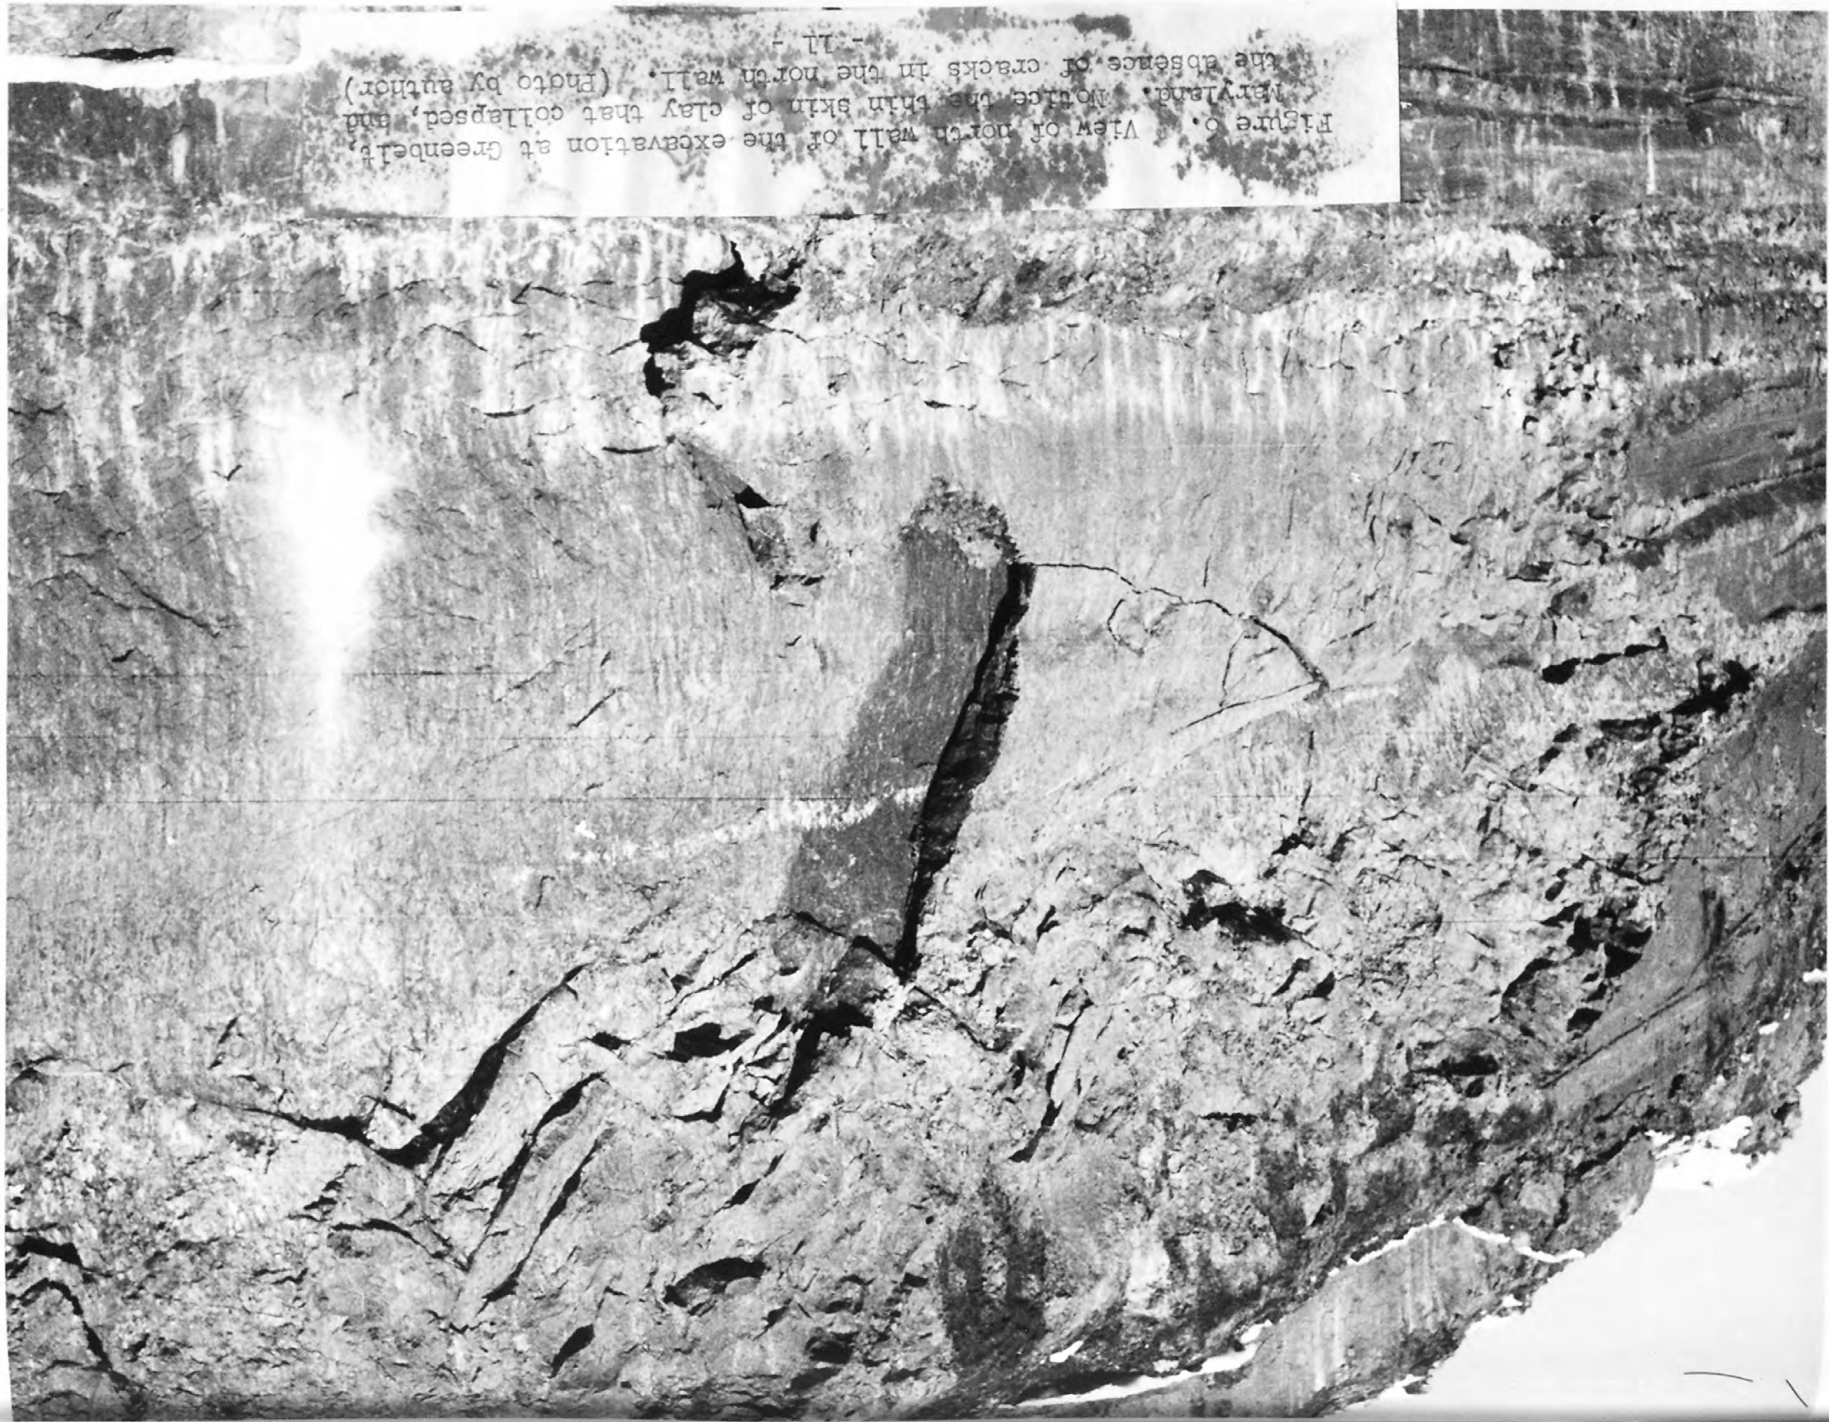
Figure 6. View of north wall of the excavation at Greenbelt, Maryland. Notice the thin skin of clay that collapsed, and the absence of cracks in the north wall. (Photo by author)

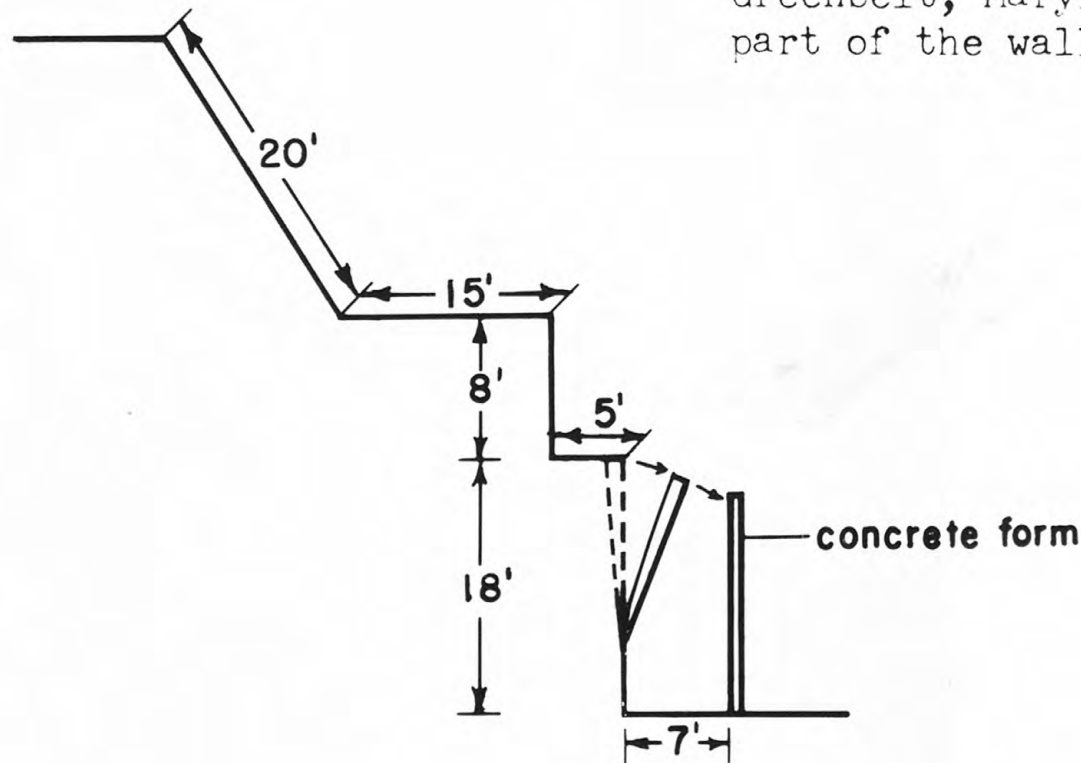
Figure 5: Schematic cross-section of the north wall of the excavation at Greenbelt, Maryland, showing the part of the wall that failed

clay wall that collapsed

December was dry and cold, and the ground was estimated to have been frozen to a depth of about 3 feet. This estimate is based on observations of other excavations in the area. On the 25th of the month about 3 inches of snow fell, and although the temperature rose briefly above freezing point on the 26th and 27th, the snow did not begin to melt until the 28th. The official maximum temperature in Washington, D. C., that day was 39°, and on the north wall of the excavation, which received full sun most of the morning, the temperature was probably above 40° for several hours. Figure 7 is a schematic cross section of the north wall, drawn from a photograph (fig. 8), and shows the part of the wall that failed. The following sequence of events could account for this failure. The snow melted and water flowed into a joint that was parallel to and about a foot from the edge of the north wall. The joint filled with melt water, and as the water could not escape because of the frozen clay, a hydrostatic pressure was built up. The pressure forced the joint surfaces apart, and in so doing, the upper part of the wall was pushed outward until it became unbalanced and fell, toppling forward instead of slumping or sliding.

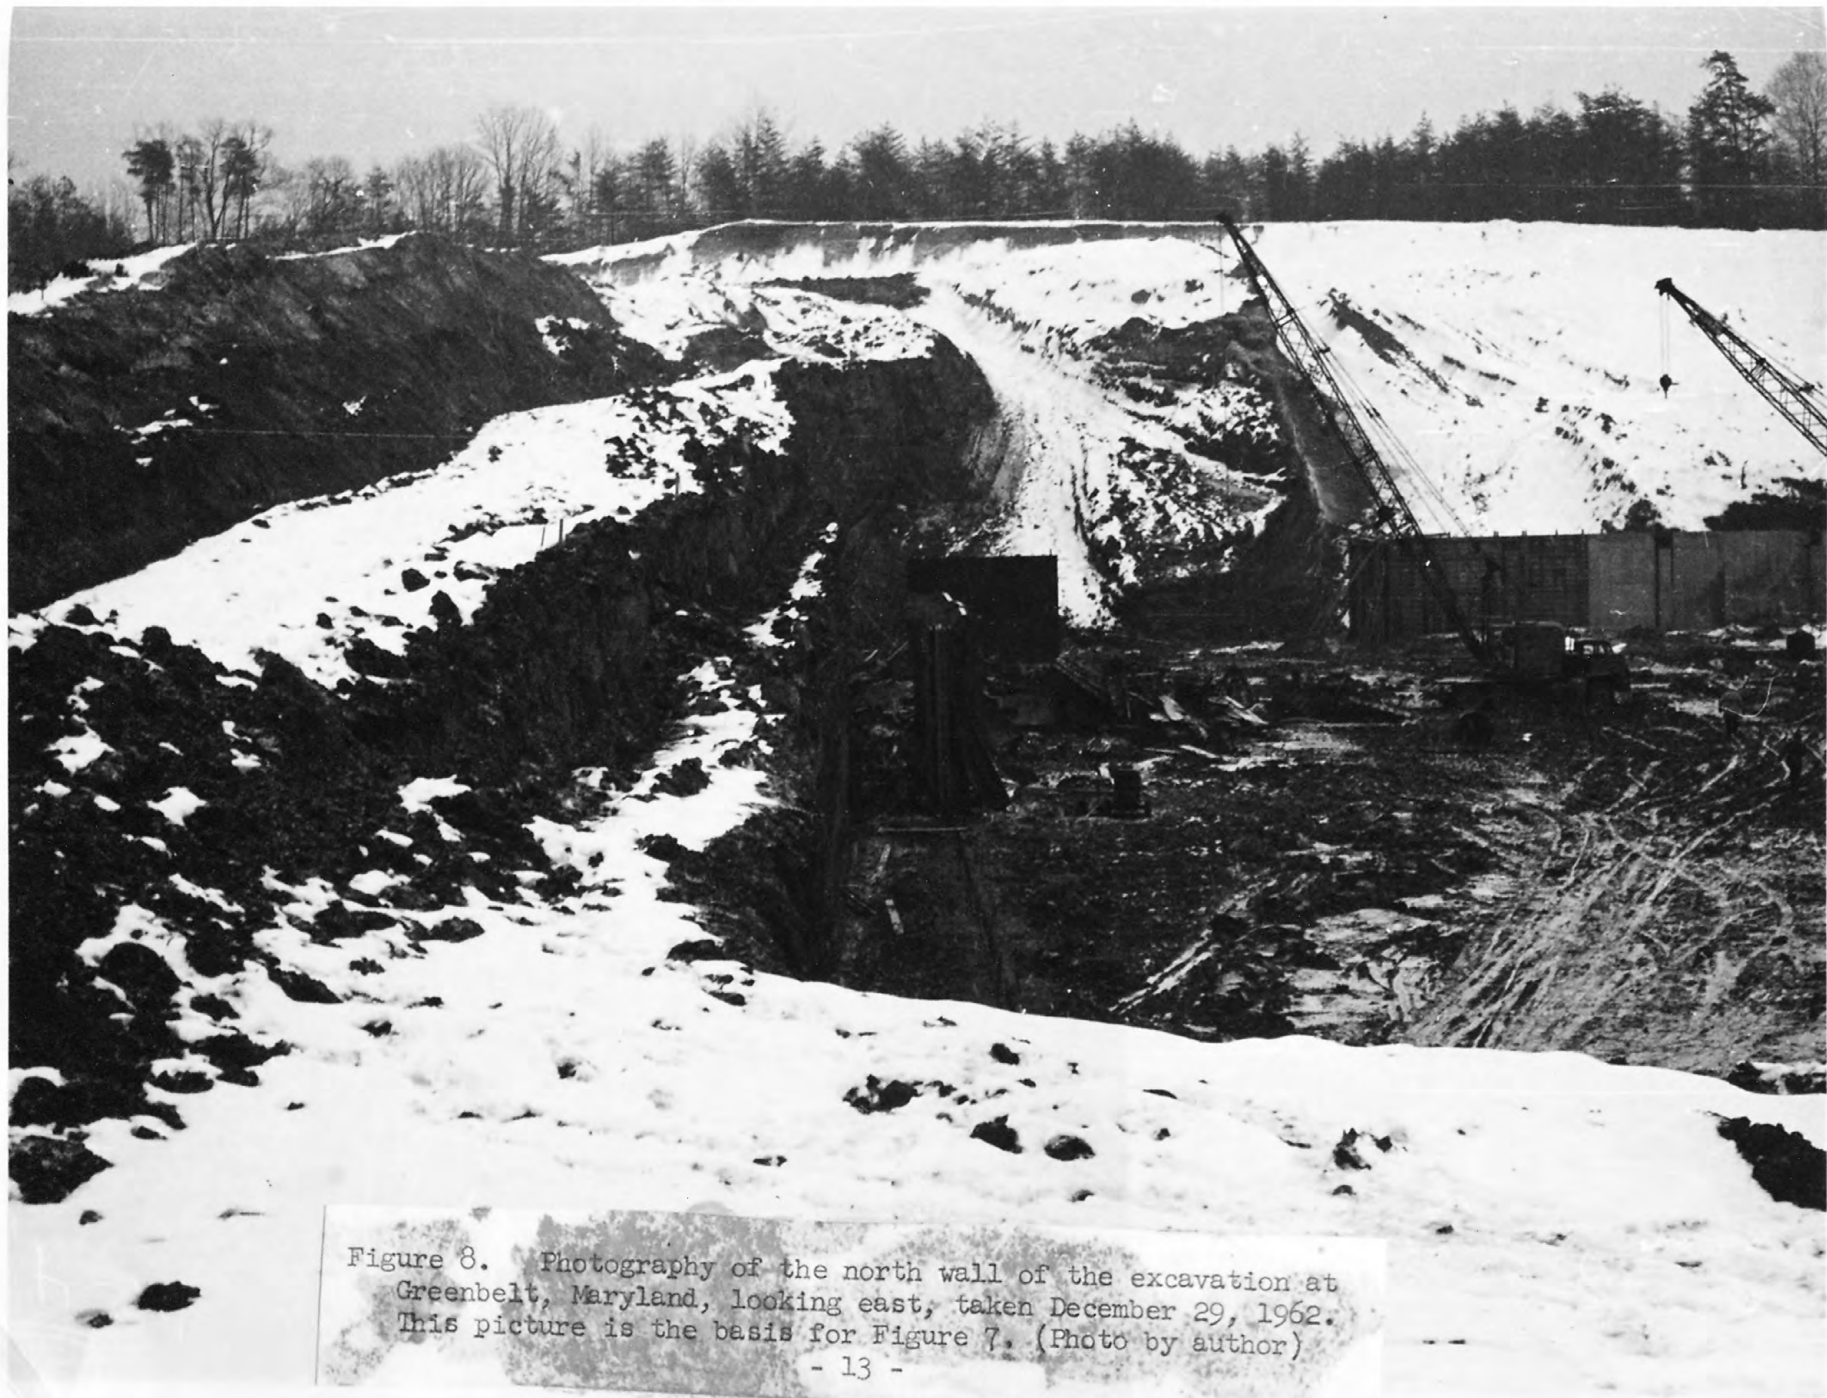
Figure 8. Photography of the north wall of the excavation at Greenbelt, Maryland, looking east, taken December 29, 1962. This picture is the basis for Figure 7. (Photo by author)
