UNITED STATES  
DEPARTMENT OF THE INTERIOR  
GEOLOGICAL SURVEY

EXTENT AND FREQUENCY OF FLOODS IN THE VICINITY  
OF EASTON, PA-PHILLIPSBURG, N.J.

George M. Farlekas

Open-file report

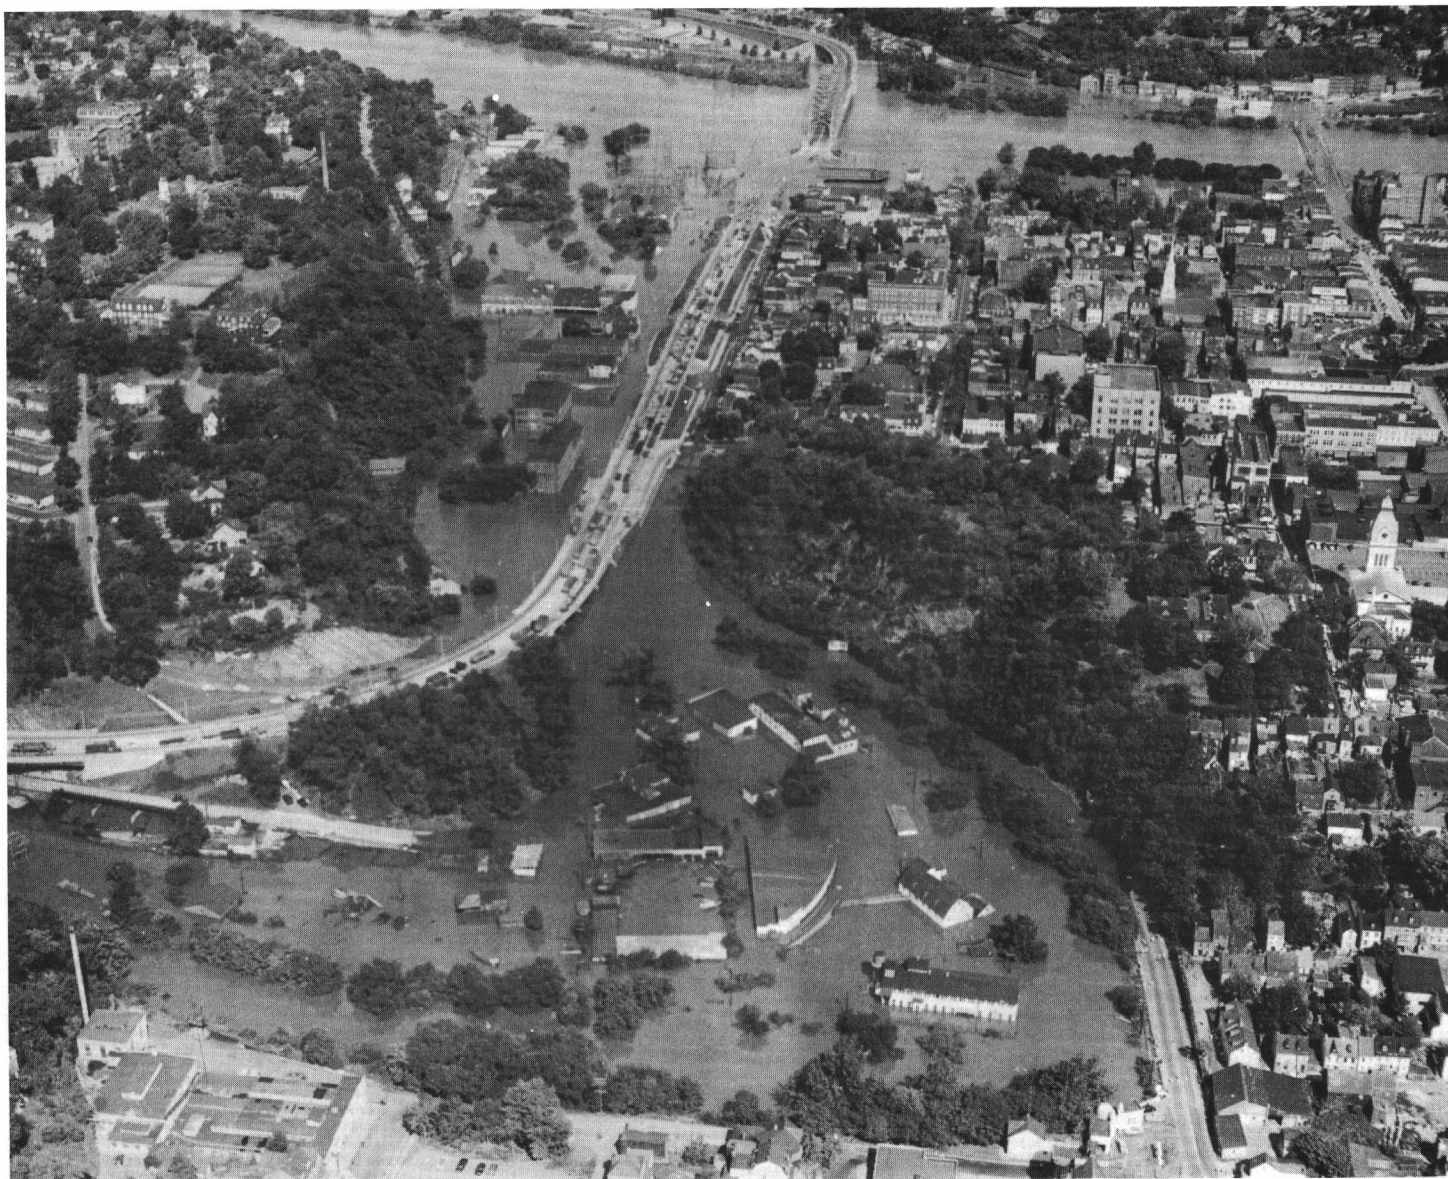
Figure 6.--Bushkill Creek at Easton, Pa., August 19, 1955. Extensive inundation along Bushkill Creek due to backwater from the Delaware River. Delaware River at top of photograph. Photograph by Easton Express.

Photographs (figs. 6-10) indicate the extent of the flood of August 19, 1955, in the Easton, Pa.-Phillipsburg, N.J. metropolitan area. The first four photographs (figs. 6-9) were taken prior to peak stage of the flood. Figure 10 was taken on August 20, 1955, as the river was receding.

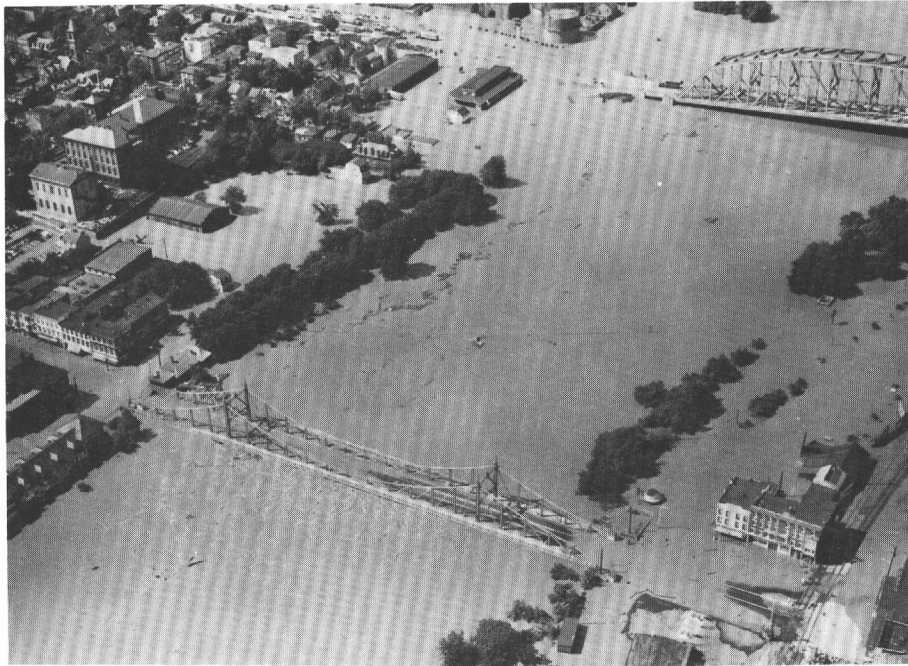
Figure 7.--Delaware River at Easton, Pa.-Phillipsburg, N.J., August 19, 1955. Approaches of Route 22-Bushkill Street Bridge (upper right) and Northampton Street Bridge (lower left) under water. Photograph by Easton Express.

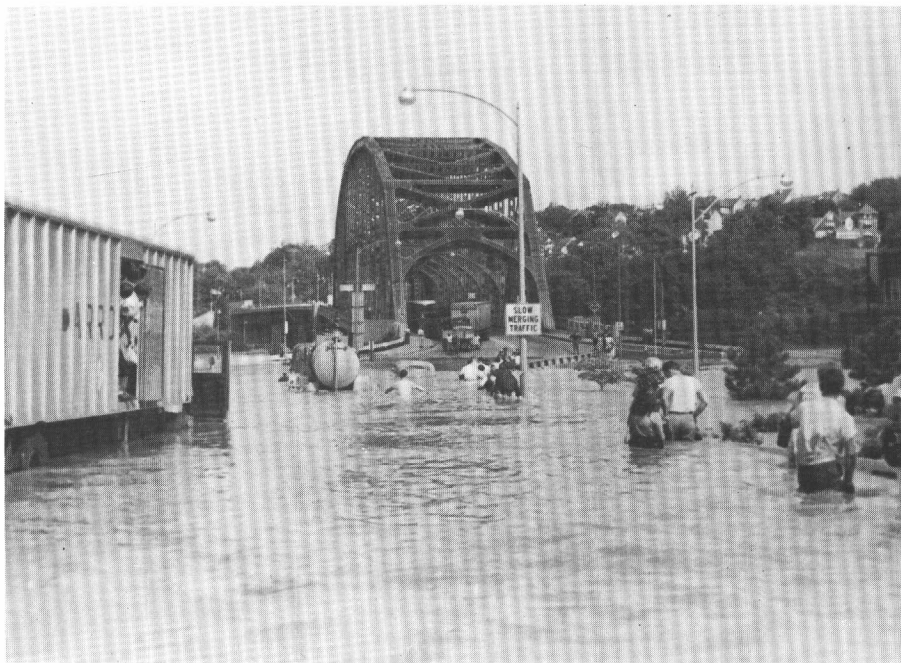
Figure 8.--Delaware River at Easton, Pa., August 19, 1955. Pennsylvania approach to Route 22-Bushkill Street Bridge under water. Photograph by Easton Express.

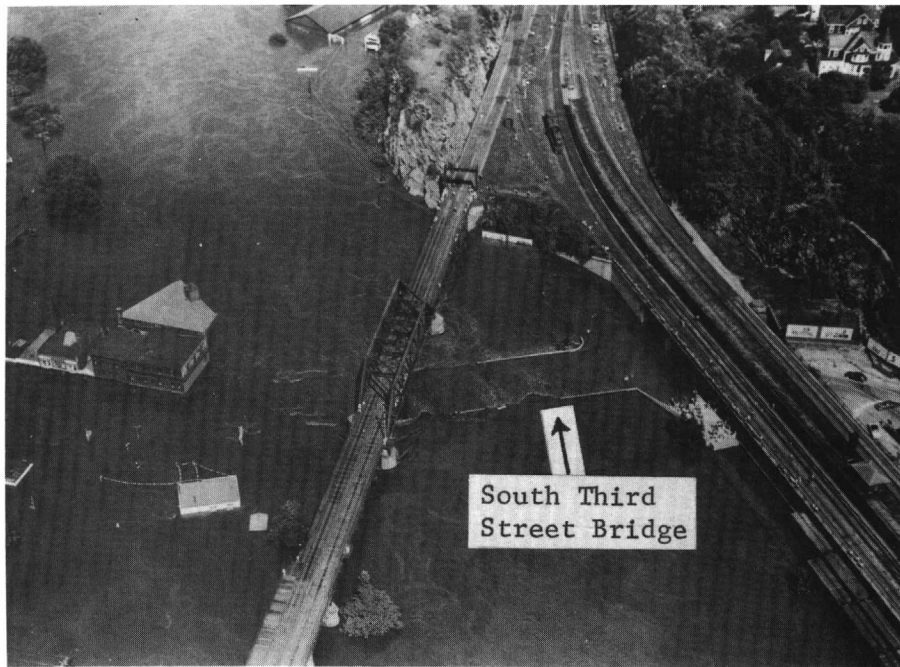
Figure 9.--Lehigh River at Easton, Pa., August 19, 1955. Handrail of South Third Street Bridge just above water surface in center of photograph. The Central Railroad of New Jersey Bridge crosses over the South Third Street Bridge in the center of photograph. Photograph by Easton Express.

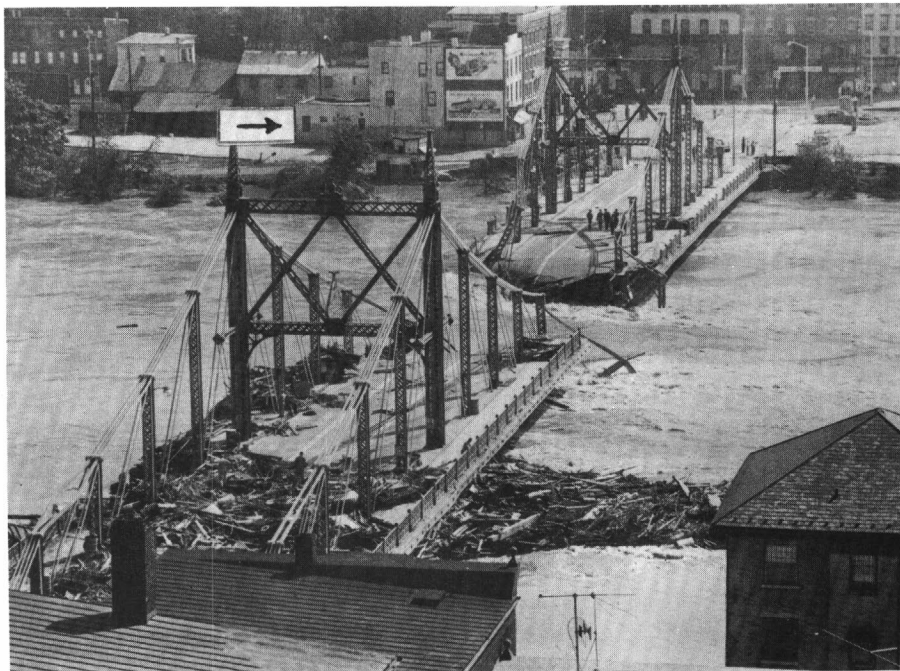
Figure 10.--Delaware River at Easton, Pa.-Phillipsburg, N.J., August 20, 1955. River receding. Center of Northampton Street Bridge severed. Arrow (upper left) indicates high-water level. Photograph by Easton Express.

Easton, Pa.-Phillipsburg, N.J. area. All bridges in the area were either inundated or their approaches flooded by the 1955 flood. The center portion of the Northampton Street Bridge was destroyed by the flood of 1955 (fig. 10).
