TECTONIC DEFORMATION, SUBAQUEOUS SLIDES AND DESTRUCTIVE WAVES

ASSOCIATED WITH THE ALASKAN MARCH 27, 1964 EARTHQUAKE:

AN INTERIM GEOLOGIC EVALUATION

George Plafker and L. R. Mayo

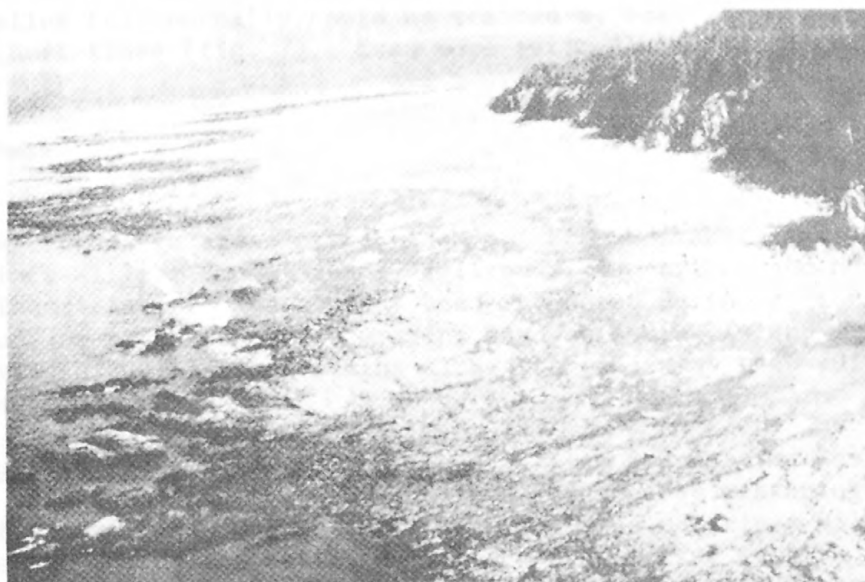
Figure 6. Surf-cut platform 1200 feet wide, near the southwest end of Montague Island which was exposed by about 30 feet of tectonic uplift.

and deltas to new higher base levels, and conversion of low-lying freshwater lakes into tidal lagoons. Similarly, uplifted areas show newly exposed reefs and islands along their shores as well as such features as uplifted sea cliffs, surf-cut platforms, sea caves, and drained intertidal lagoons (fig. 6).

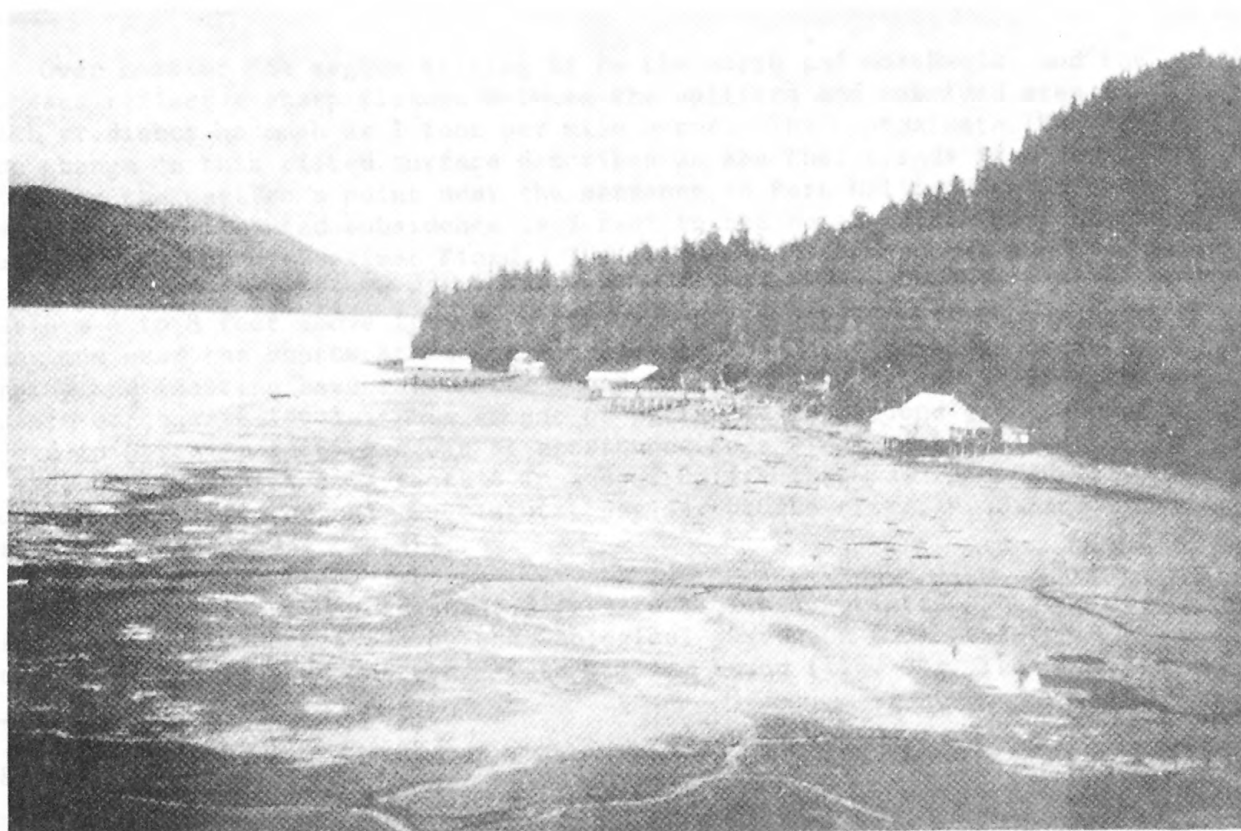
Figure 7. Canneries and fishermen's homes along Orca Inlet in Prince William Sound now above the reach of most tides due to 6 feet of uplift. Photo is taken at a 9-foot tide on July 27, 1964, which would have reached beneath the docks prior to the earthquake.

along the shoreline that normally could be reached by boat are now accessible only at the highest tides (fig. 7). Even more seriously affected are

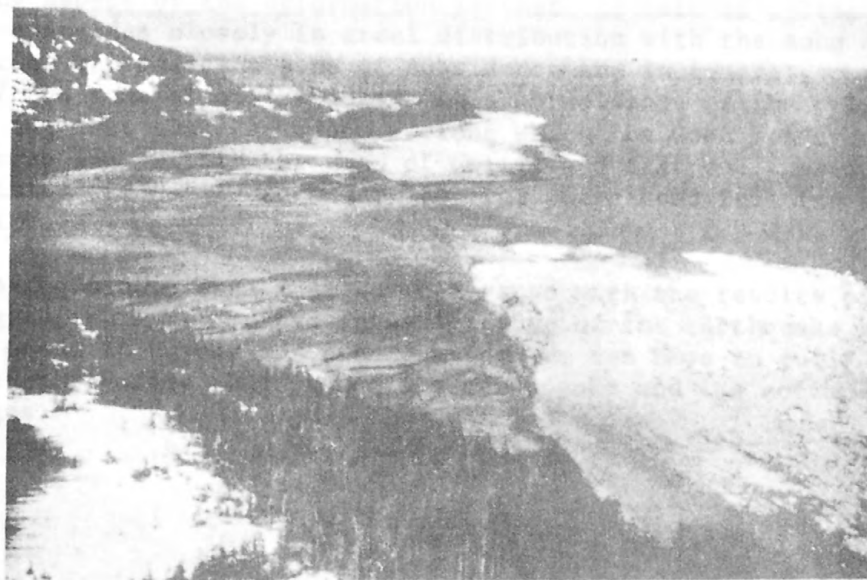
Figure 10. Air view toward the southwest of the Hanning Bay fault where it crosses a small cove between Hanning Bay and MacLeod Harbor. The northwest block (right) is relatively upthrown. The surf-cut platform is bleached white by the remains of calcareous organisms that normally live below mean tide level.

The shorter of the two faults found on Montague Island is exceptionally well exposed for a distance of 3 miles from the south shore of Hanning Bay almost to MacLeod Harbor (fig. 10). As with the Patton Bay fault, the

northwest side is upthrown and the fault plane dips steeply or is vertical wherever exposed. Vertical displacement ranges from about 5 feet at the shore of Hanning Bay to a maximum of 16 feet at the cove between Hanning Bay and MacLeod Harbor (fig. 11). The fault dies out to the south before reaching

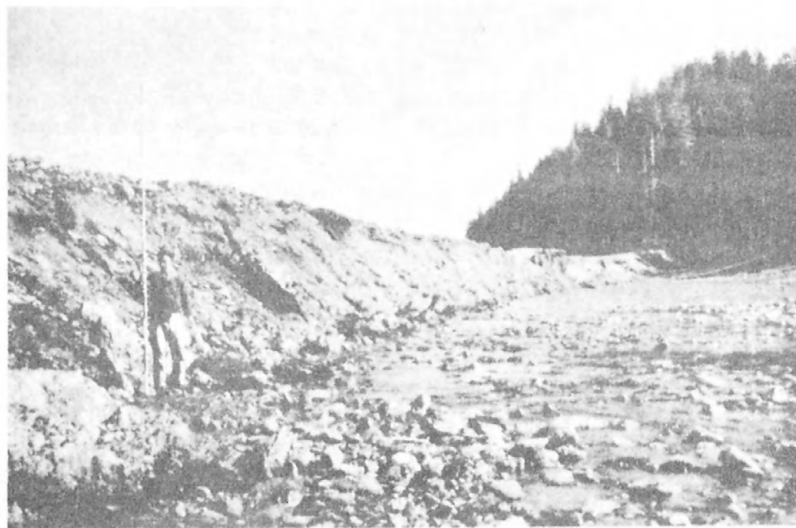
Figure 11. View of the Hanning Bay fault scarp looking northeast showing about 13 feet of vertical displacement in rock in the foreground and about 16 feet of displacement at the beach ridge in the background.

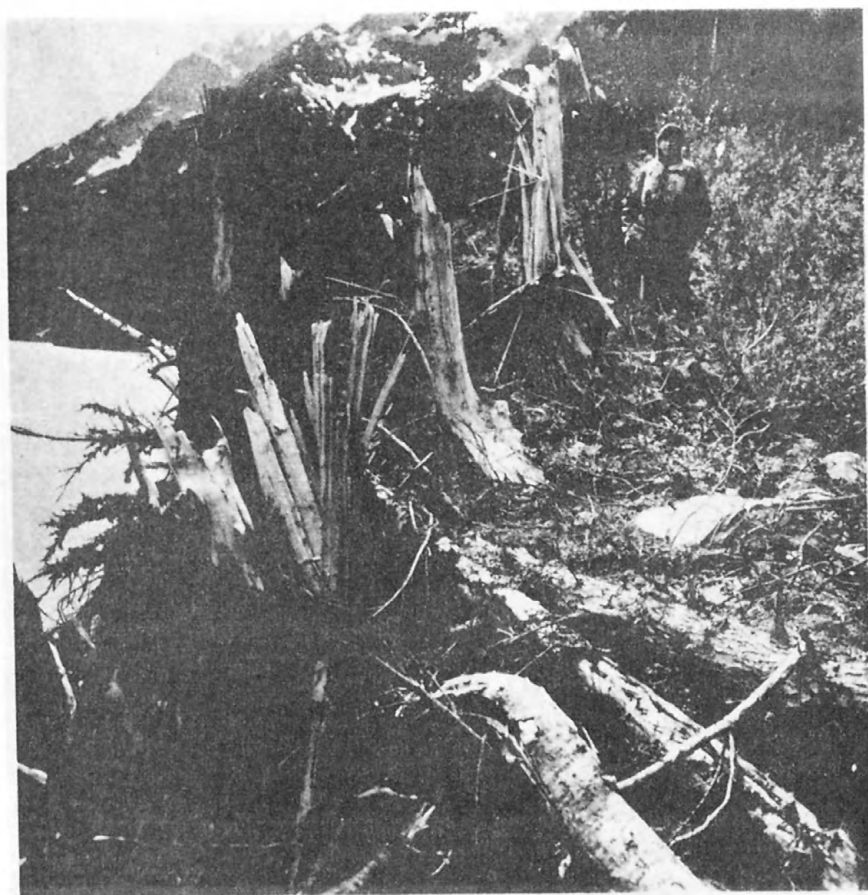
Figure 18. Living spruce trees 2 feet in diameter that were snapped off by a local wave at elevations between 88 and 101 feet above lower low water.

Another wave, which was generated on the west side of Shoup Bay, attained a maximum elevation of 125 feet near its inferred source, from which it moved southwestward toward Valdez Narrows and probably southward to the opposite shore of Port Valdez. To the west of Shoup Bay the wave surged to more than 125 feet above lower low water. The wave, which was traveling from east to west, broke several 24-inch-diameter trees at elevations between

88 and 101 feet and deposited barnacle-covered boulders estimated to weigh 1,700 pounds 88 feet above lower low water (figs. 17, 18, 19). This

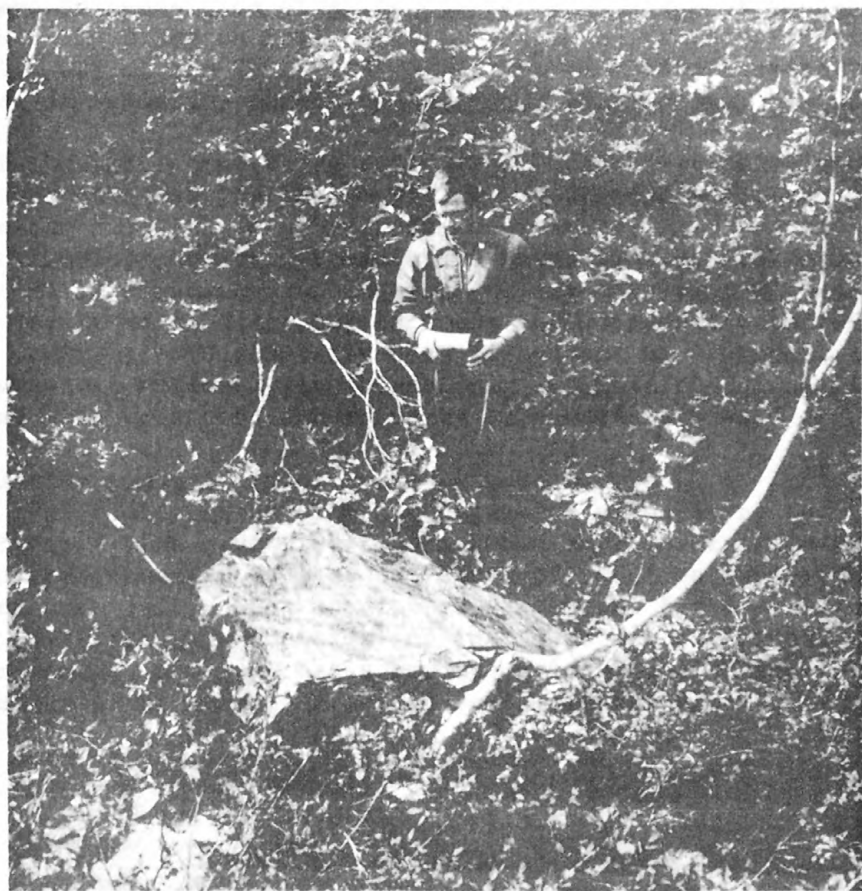
Figure 19. Boulder estimated to weigh 1,700 pounds thrown up to 88 feet elevation from the shoreline by a local wave.
