# EXTENT AND FREQUENCY OF FLOODS ON DELAWARE RIVER IN VICINITY OF BELVIDERE, N. J.

UNITED STATES DEPARTMENT OF THE INTERIOR  
U.S. GEOLOGICAL SURVEY,  
Prepared in cooperation with the  
DELAWARE RIVER BASIN COMMISSION

Trenton, New Jersey  
October 1966  
Open file report

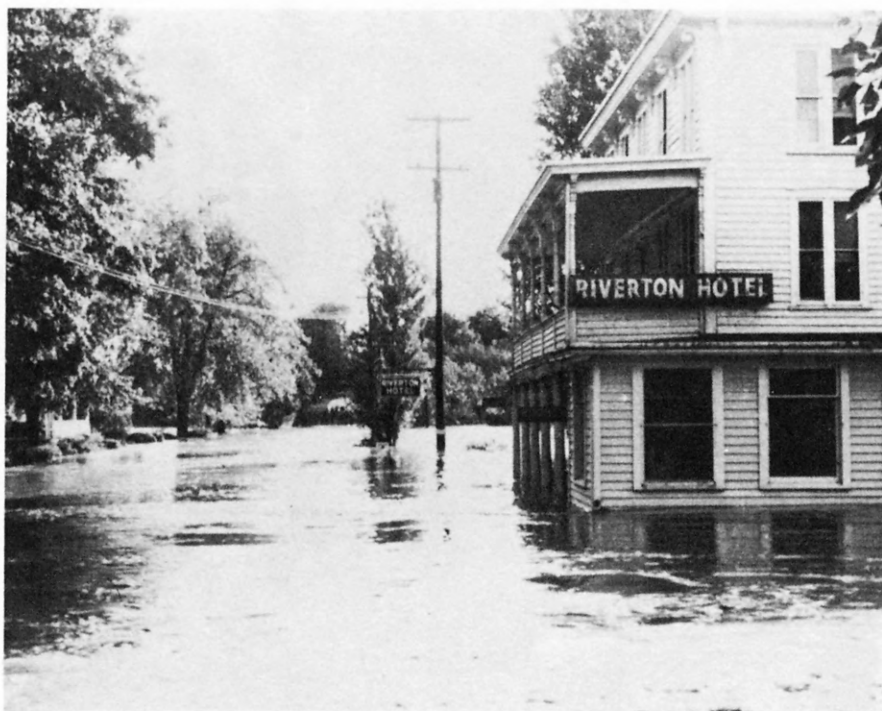
Figure 4.--Delaware River at Riverton, Pa., August 19, 1955. Road leading to Belvidere, N.J.-Riverton, Pa. bridge inundated. View looking west. Photograph by Easton Express.

Photographs (figs. 4-10) show the extent or comparison of the floods of August 1955 and October 1903 in the vicinity of Belvidere, N.J. A photograph (fig. 5) taken near the peak stage on August 19, 1955, shows flood waters over the bottom steel of the Belvidere, N.J.-Riverton, Pa. bridge. Figure 6 is given for comparison and shows the Delaware River at low stage in November 1965. Flood information pertaining to bridges in the area under study is given in table 3. All bridges in the area across the Delaware River were either inundated or their approaches were flooded by the August 1955 flood.

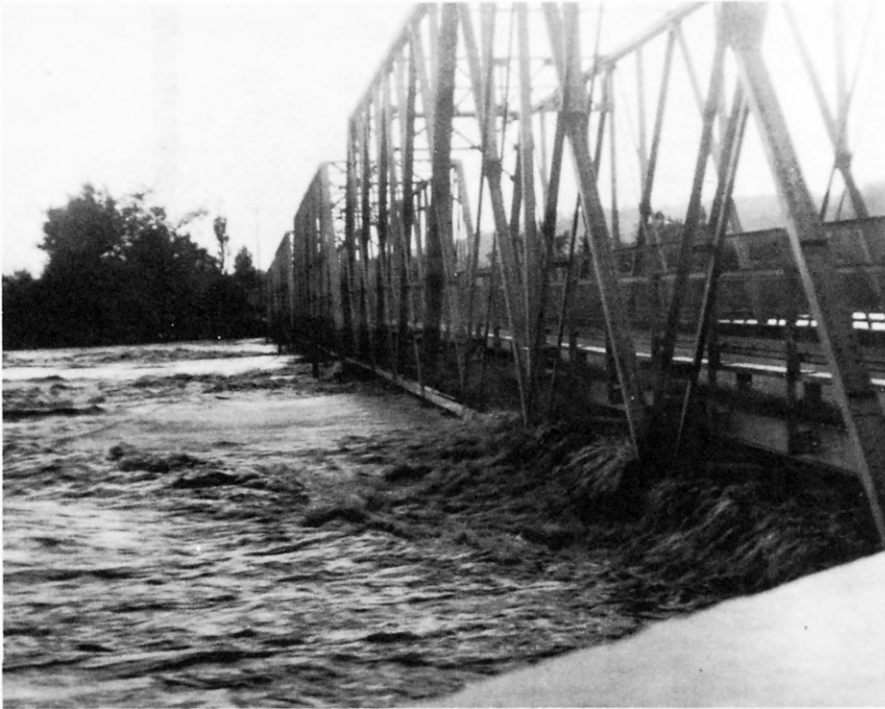
Figure 5.--Delaware River at Belvidere, N.J., August 19, 1955. Downstream side of Belvidere, N.J.-Riverton, Pa. bridge, view looking west. Delaware River near peak stage. Water flowing over part of bridge steel. Photograph by Delaware River Joint Toll Bridge Commission.

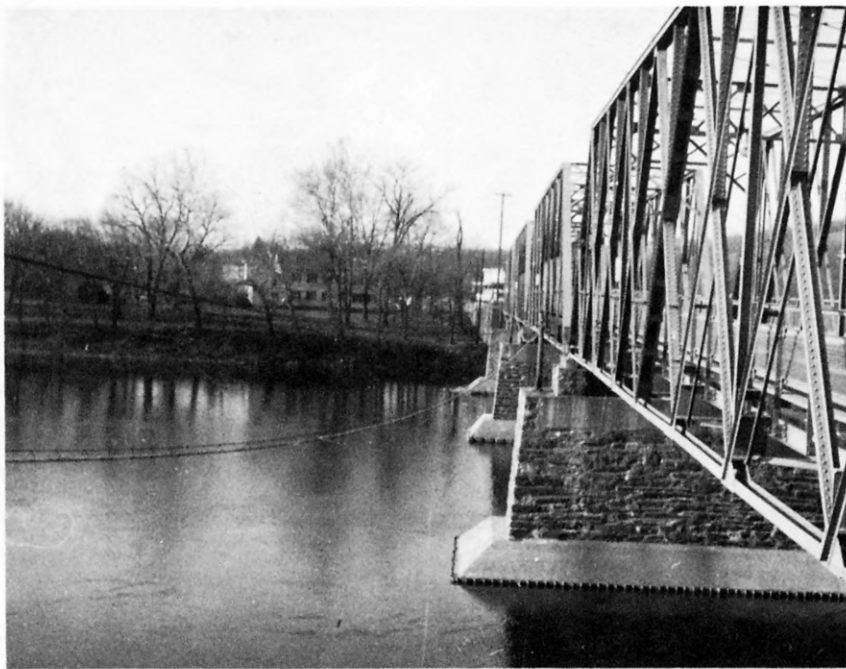
Figure 6.--Delaware River at Belvidere, N.J., November 1965. Downstream side of Belvidere, N.J.-Riverton, Pa. bridge, view looking west. Delaware River at low stage.

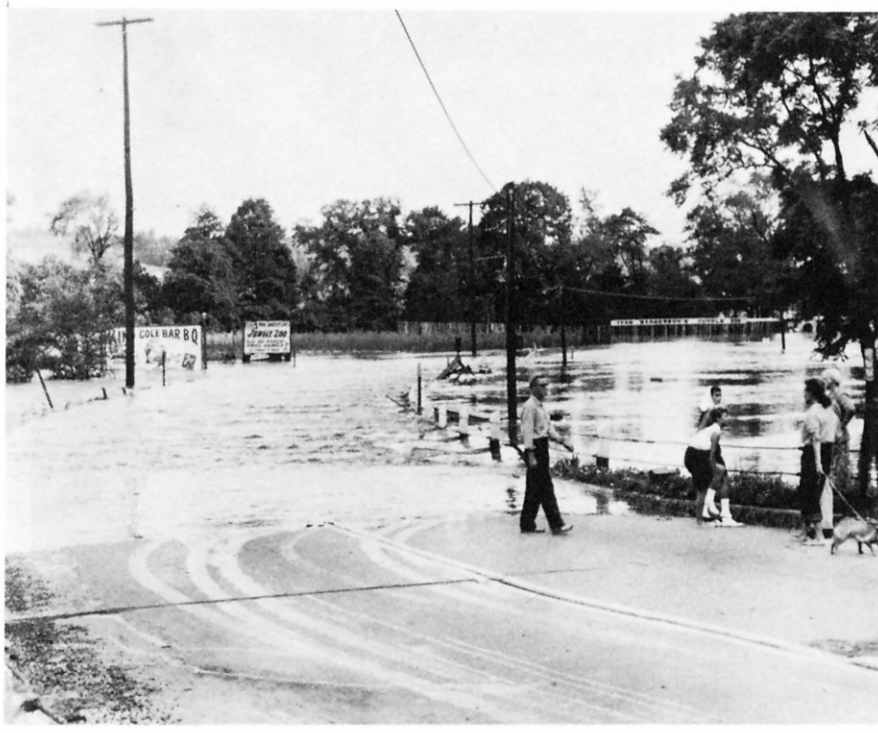
Figure 7.--Delaware River near Manunka Chunk, N.J., August 19, 1955. U.S. Route 46 (at mile 201.5) inundated at site of Ivan Sanderson's Jungle Zoo. Photograph by Easton Express.

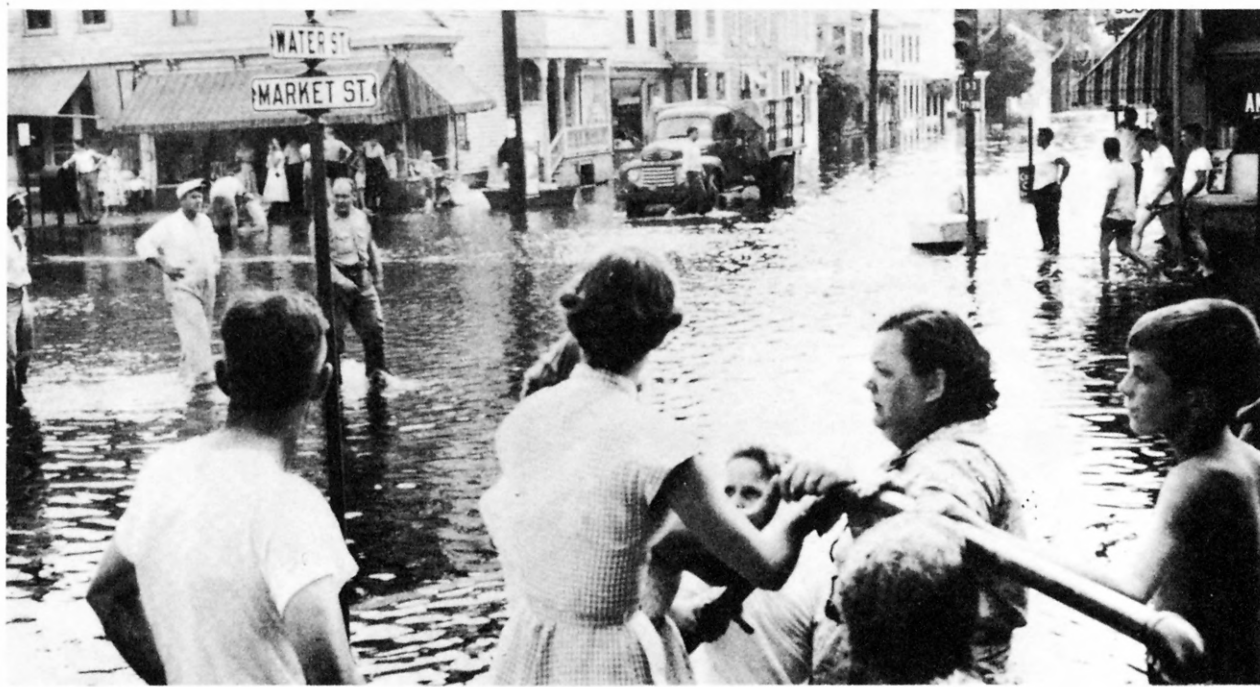
Figure 8.--Pequest River at Belvidere, N.J., August 19, 1955. Intersection of Market and Water Streets inundated. Photograph by Easton Express.

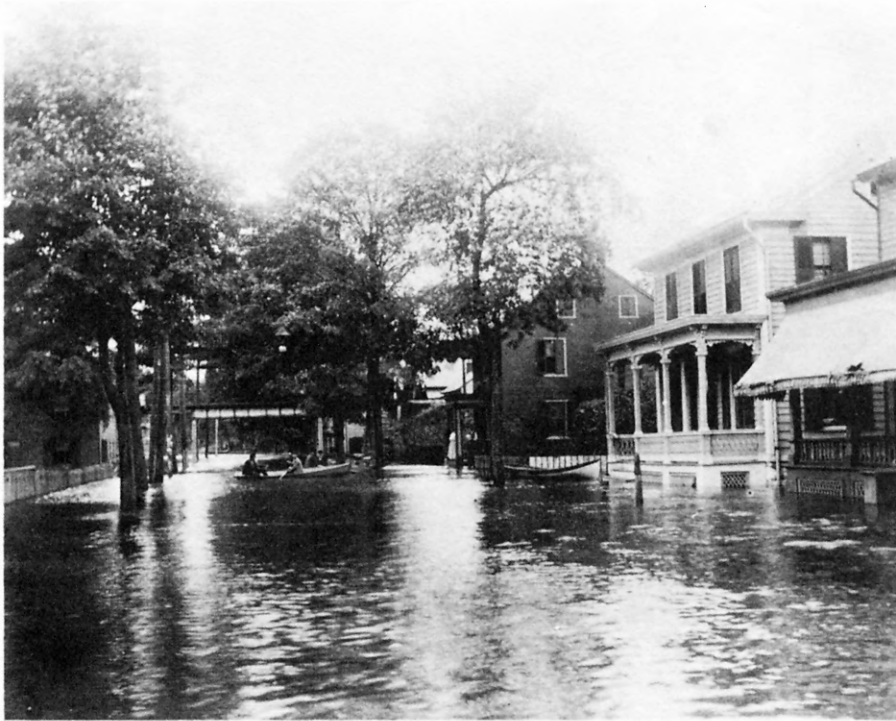
Figure 9.--Pequest River at Belvidere, N.J., October 10, 1903. Water Street looking west. Elevated railroad bridge over Water Street in background. Photograph by Harry W. Gross.

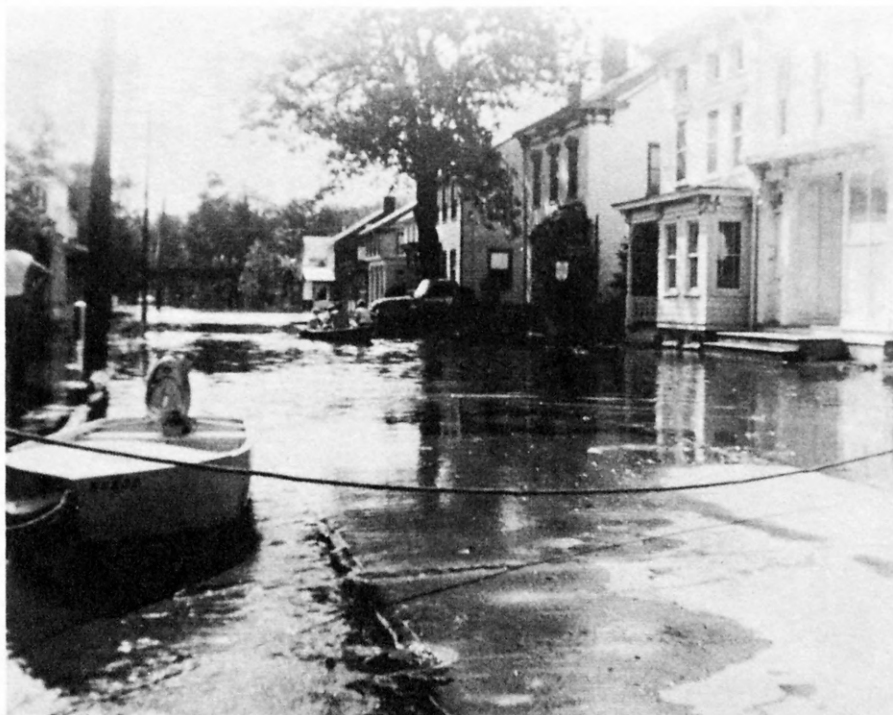
Figure 10.--Pequest River at Belvidere, N.J., August 19, 1955. View of Water Street looking west 52 years later. Elevated railroad bridge over Water Street in background. Photograph by Harry W. Gross.
