Runoff from a paved small watershed at
White Sands Missile Range, New Mexico

W. C. Ballance and J. A. Basler

Open-file report

July 1966

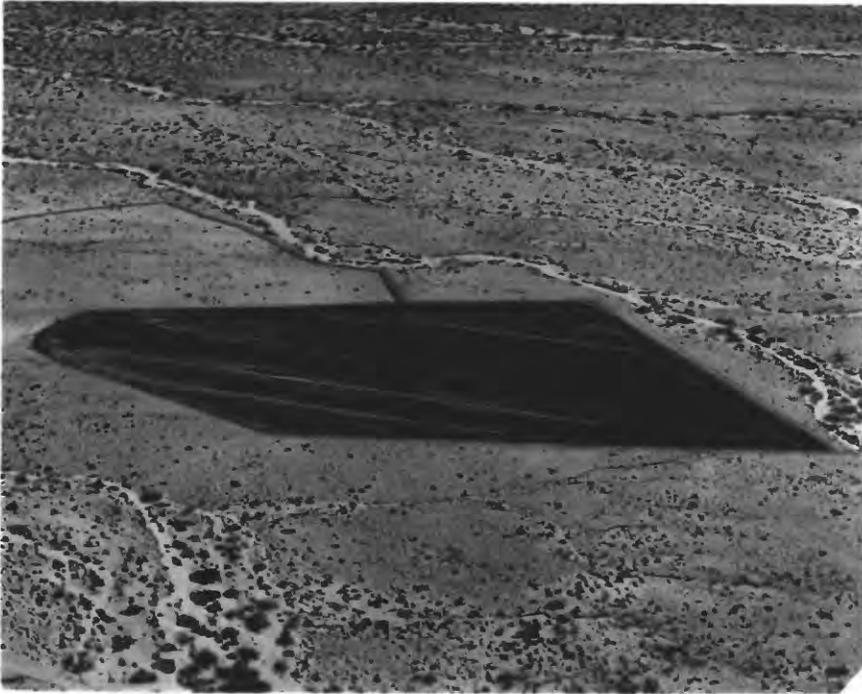
Plate 1.--Areal view showing the paved area of the watershed project.

Two small adjacent watersheds of about 9 acres each were selected just northwest of the Headquarters area. One watershed was cleared of native shrub and covered 1/8-inch with an asphaltic material; the other watershed was not disturbed. Plate 1 is an areal view showing the paved area of the watershed project. A recording rain gage was installed in each of the areas to record the precipitation and a V-notch weir (plate 2) was installed in each area to measure the runoff. Recording gages were installed to monitor height of water and duration of flow at each of the weirs. Infiltration pits were constructed downstream from each of the weirs to collect the runoff and a recording gage was placed in each pit to record the gage height and infiltration rate.

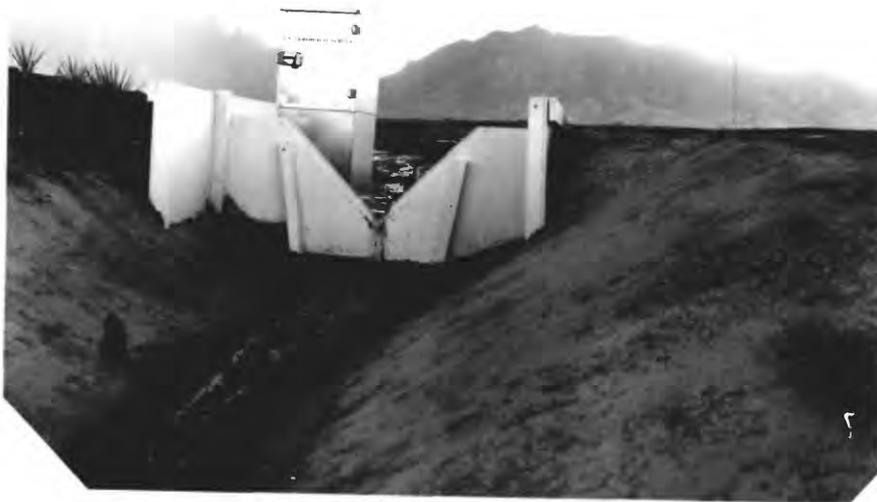
Plate 2.--V-notch weir and recorder shelter containing recording equipment.

The paving project has been installed about $2\frac{1}{2}$ years. Some of the pavement is in need of repair. Sand from the eroded areas fills the stilling basin and adversely affects the weir stage recorder, resulting in an error by recording less flow than actually occurred. Vegetation has penetrated the thin asphalt coating and cracks appear over a large part of the area. The yearly deterioration of the asphalt coating as it relates to collection efficiency has not been determined. However, a similar experimental project was conducted in Hawaii and the yearly deterioration of the asphalt and accompanying decrease in surface water run-off was noted.
