(200)  
R290  
no. 945

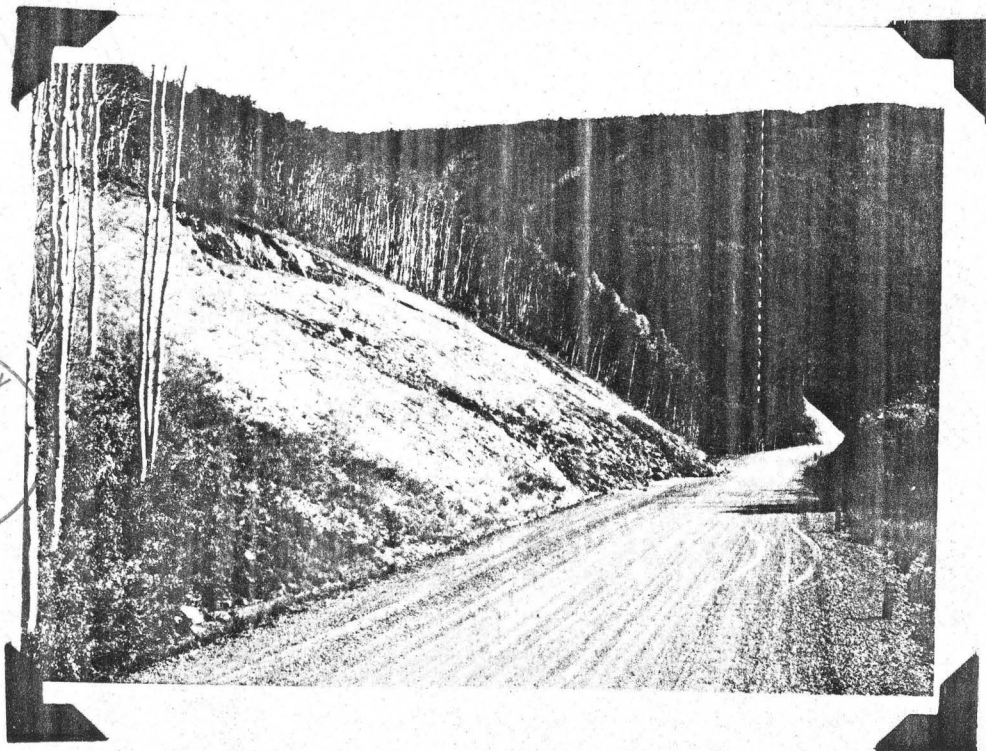
<sup>30</sup>  
Figure 36.--Recent slump in till along new road to Mesa Lakes.

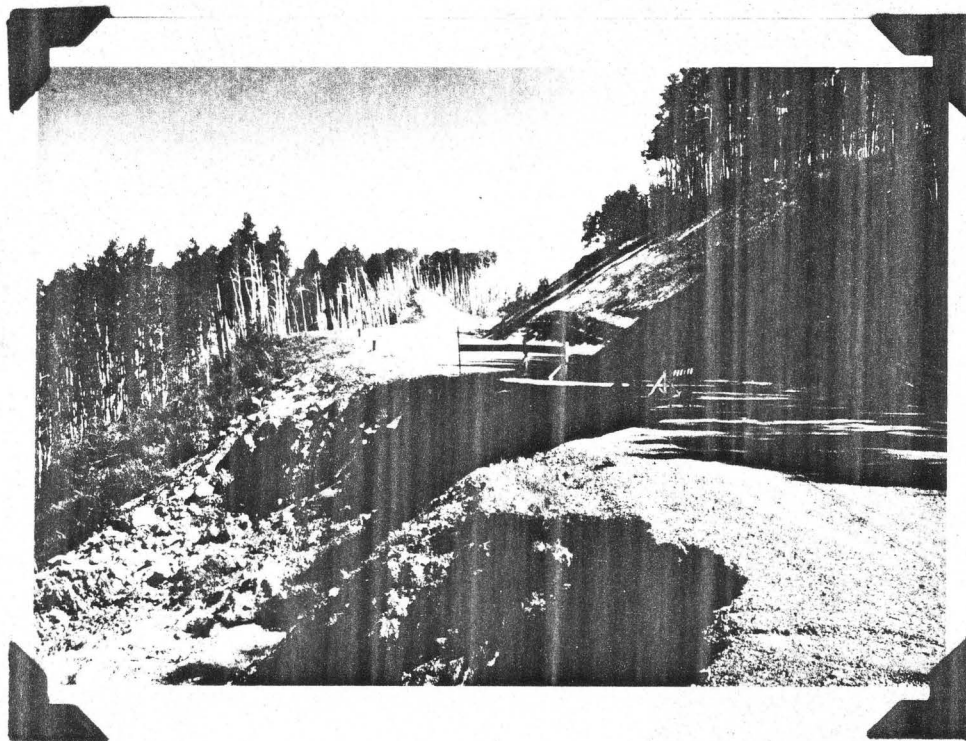
<sup>31</sup>  
Figure 37.--Recent slides on new road to Mesa Lakes. Developed on till and claystones of the post-Green River unnamed unit.
