(200)  
R 290  
no. 945

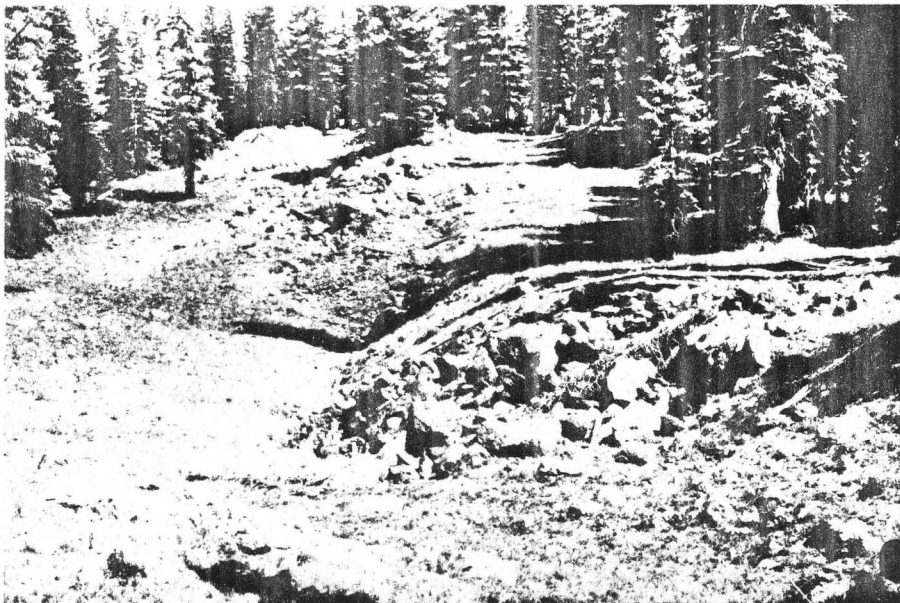
32  
Figure 32.--Incipient slump block on the northeast side of Grand Mesa. Slump is on the left.

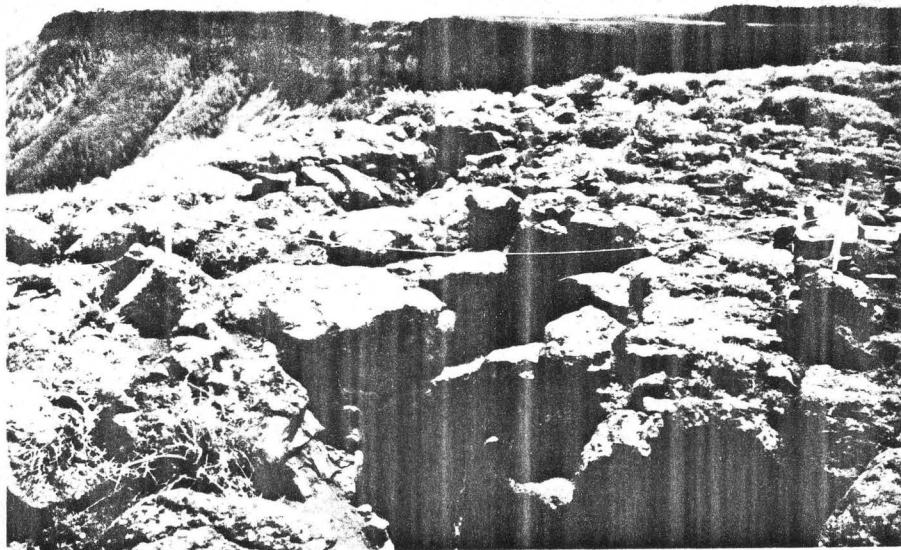
Figure 33.--Recent opening of fracture in basalt on west end of Grand Mesa. Slump is on the right.
