68-138

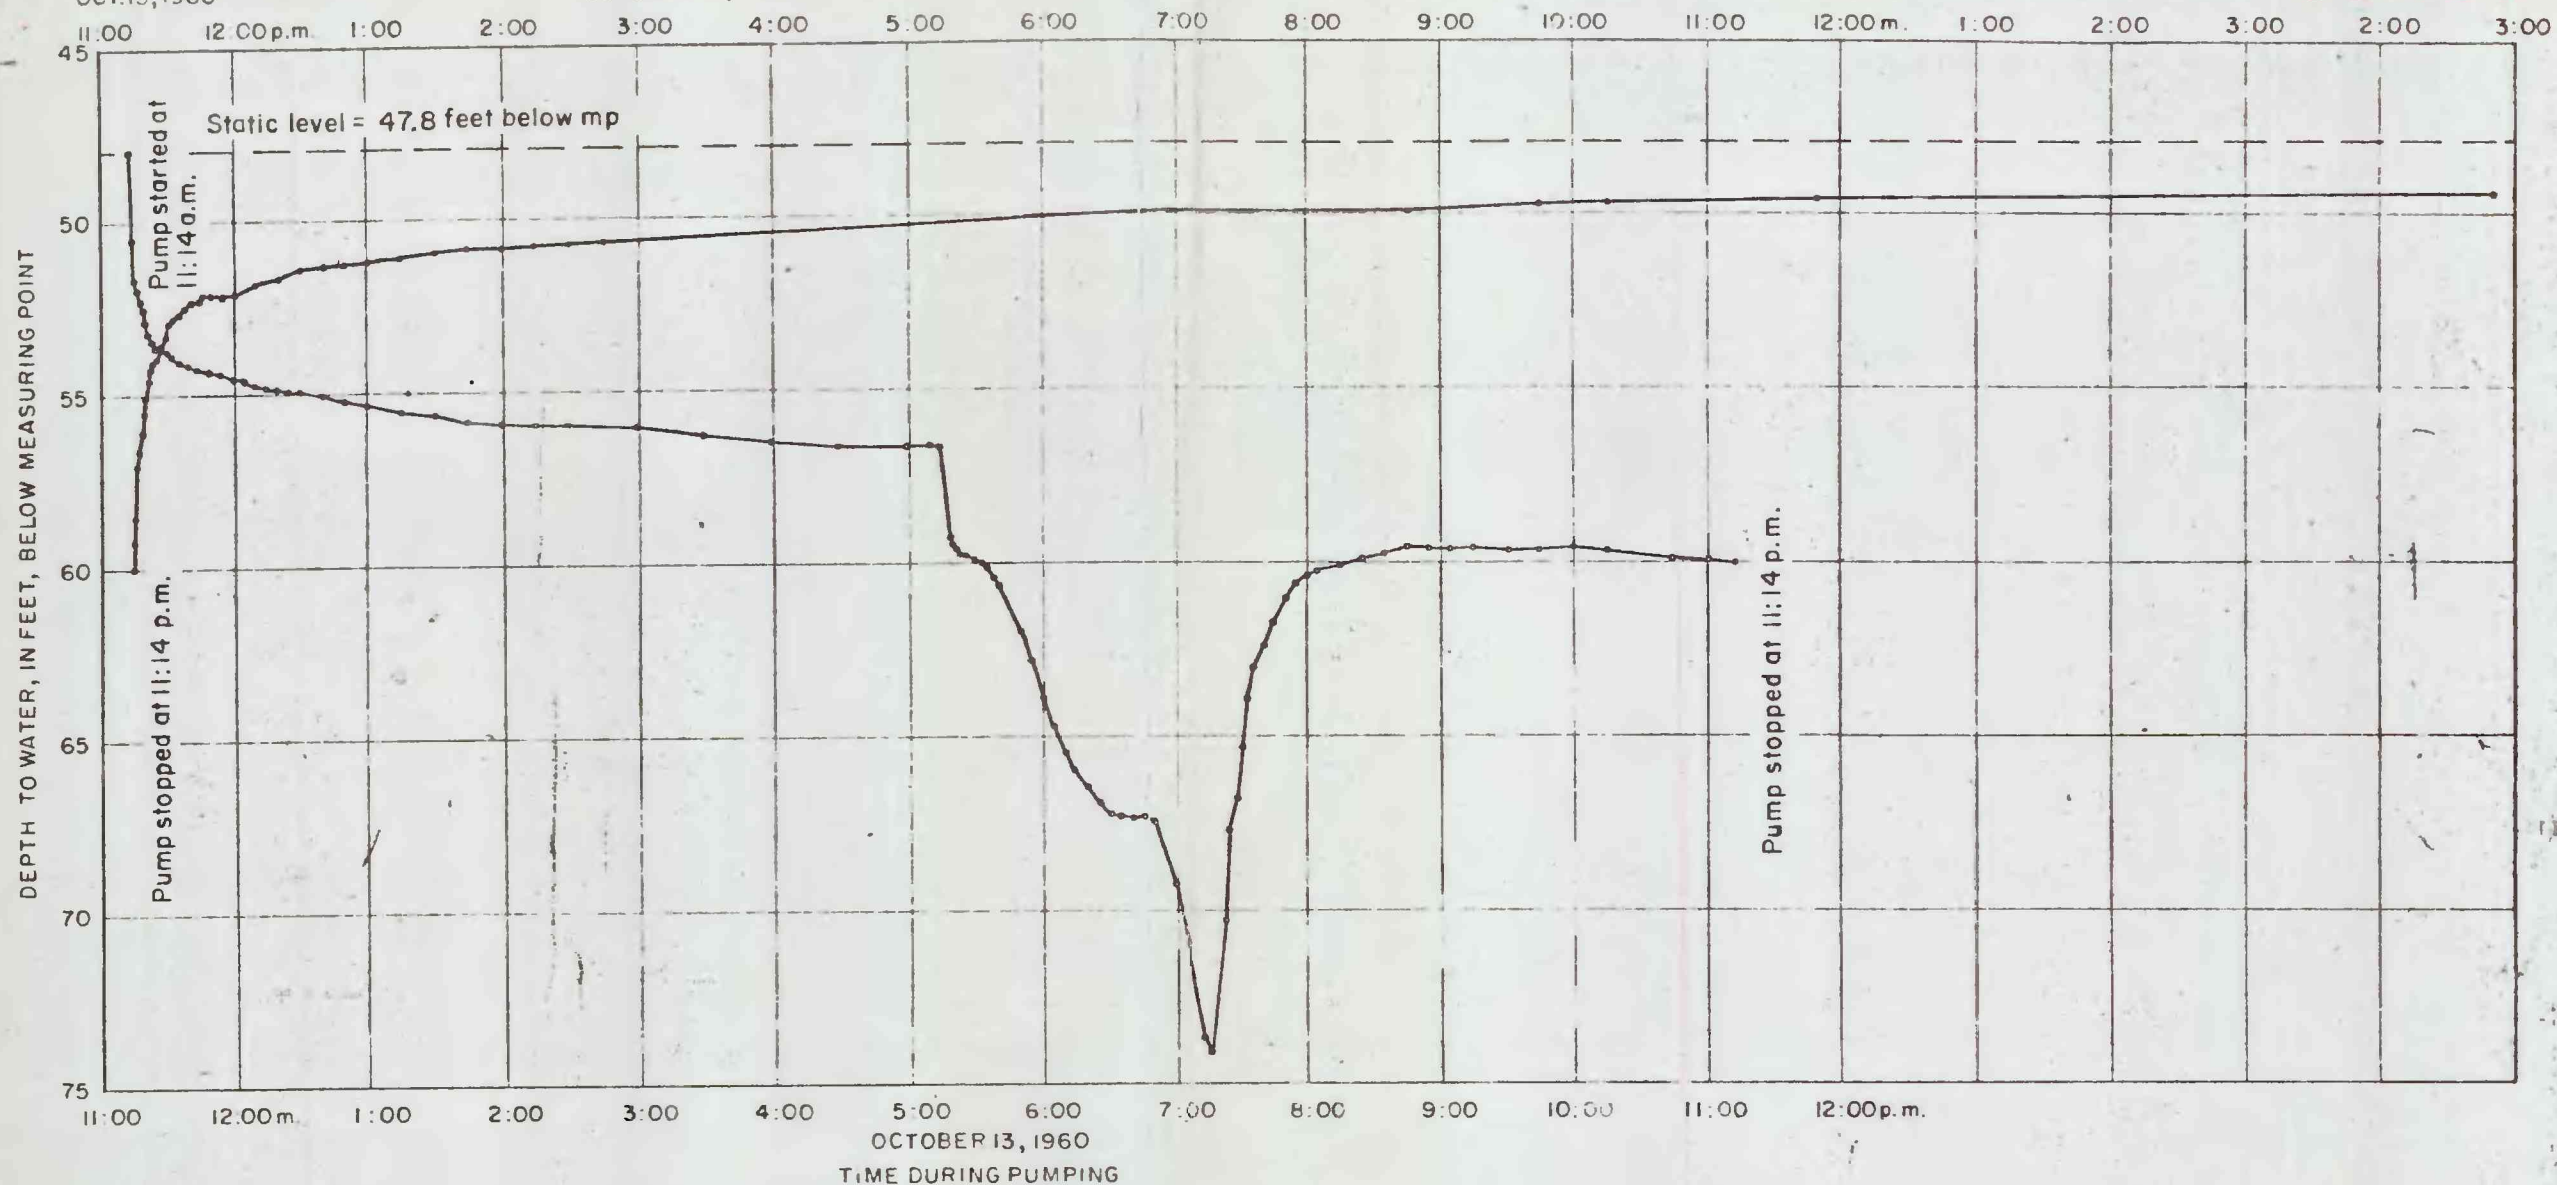
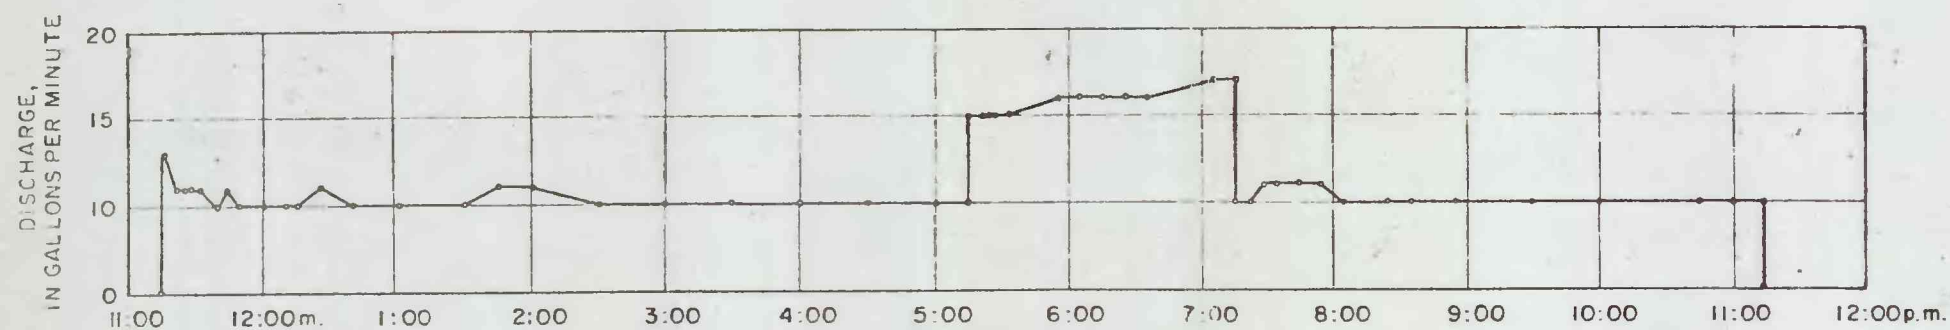
Figure 22.--Water levels during drawdown and recovery water levels and rate of discharge during performance test of well 21.4.22.222, Hazardous Test Area, White Sands Missile Range, N. Mex., October 13-14, 1960.
