FLOODS IN AND NEAR THE CHARLOTTE AMALIE AREA, ST. THOMAS, U.S. VIRGIN ISLANDS

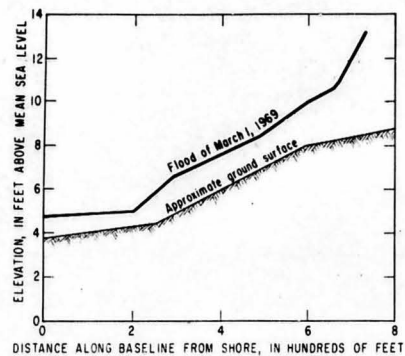
FIGURE 4.—Profile of the March 1, 1969 flood in the commercial section of Charlotte Amalie. (See map C for location of baseline.)
