Base by U.S. Geological Survey, 1967
 Research sponsored by the Appalachian Regional Commission under contract no. 69-21

LANDSLIDE SUSCEPTIBILITY MAP OF THE EMSWORTH QUADRANGLE, ALLEGHENY COUNTY, PENNSYLVANIA
 by J.S. Pomeroy, 1974

U. S. Geological Survey
 OPEN FILE MAP 74-75
 This map is preliminary and has not been edited for conformity with Geological Survey standards or nomenclature.

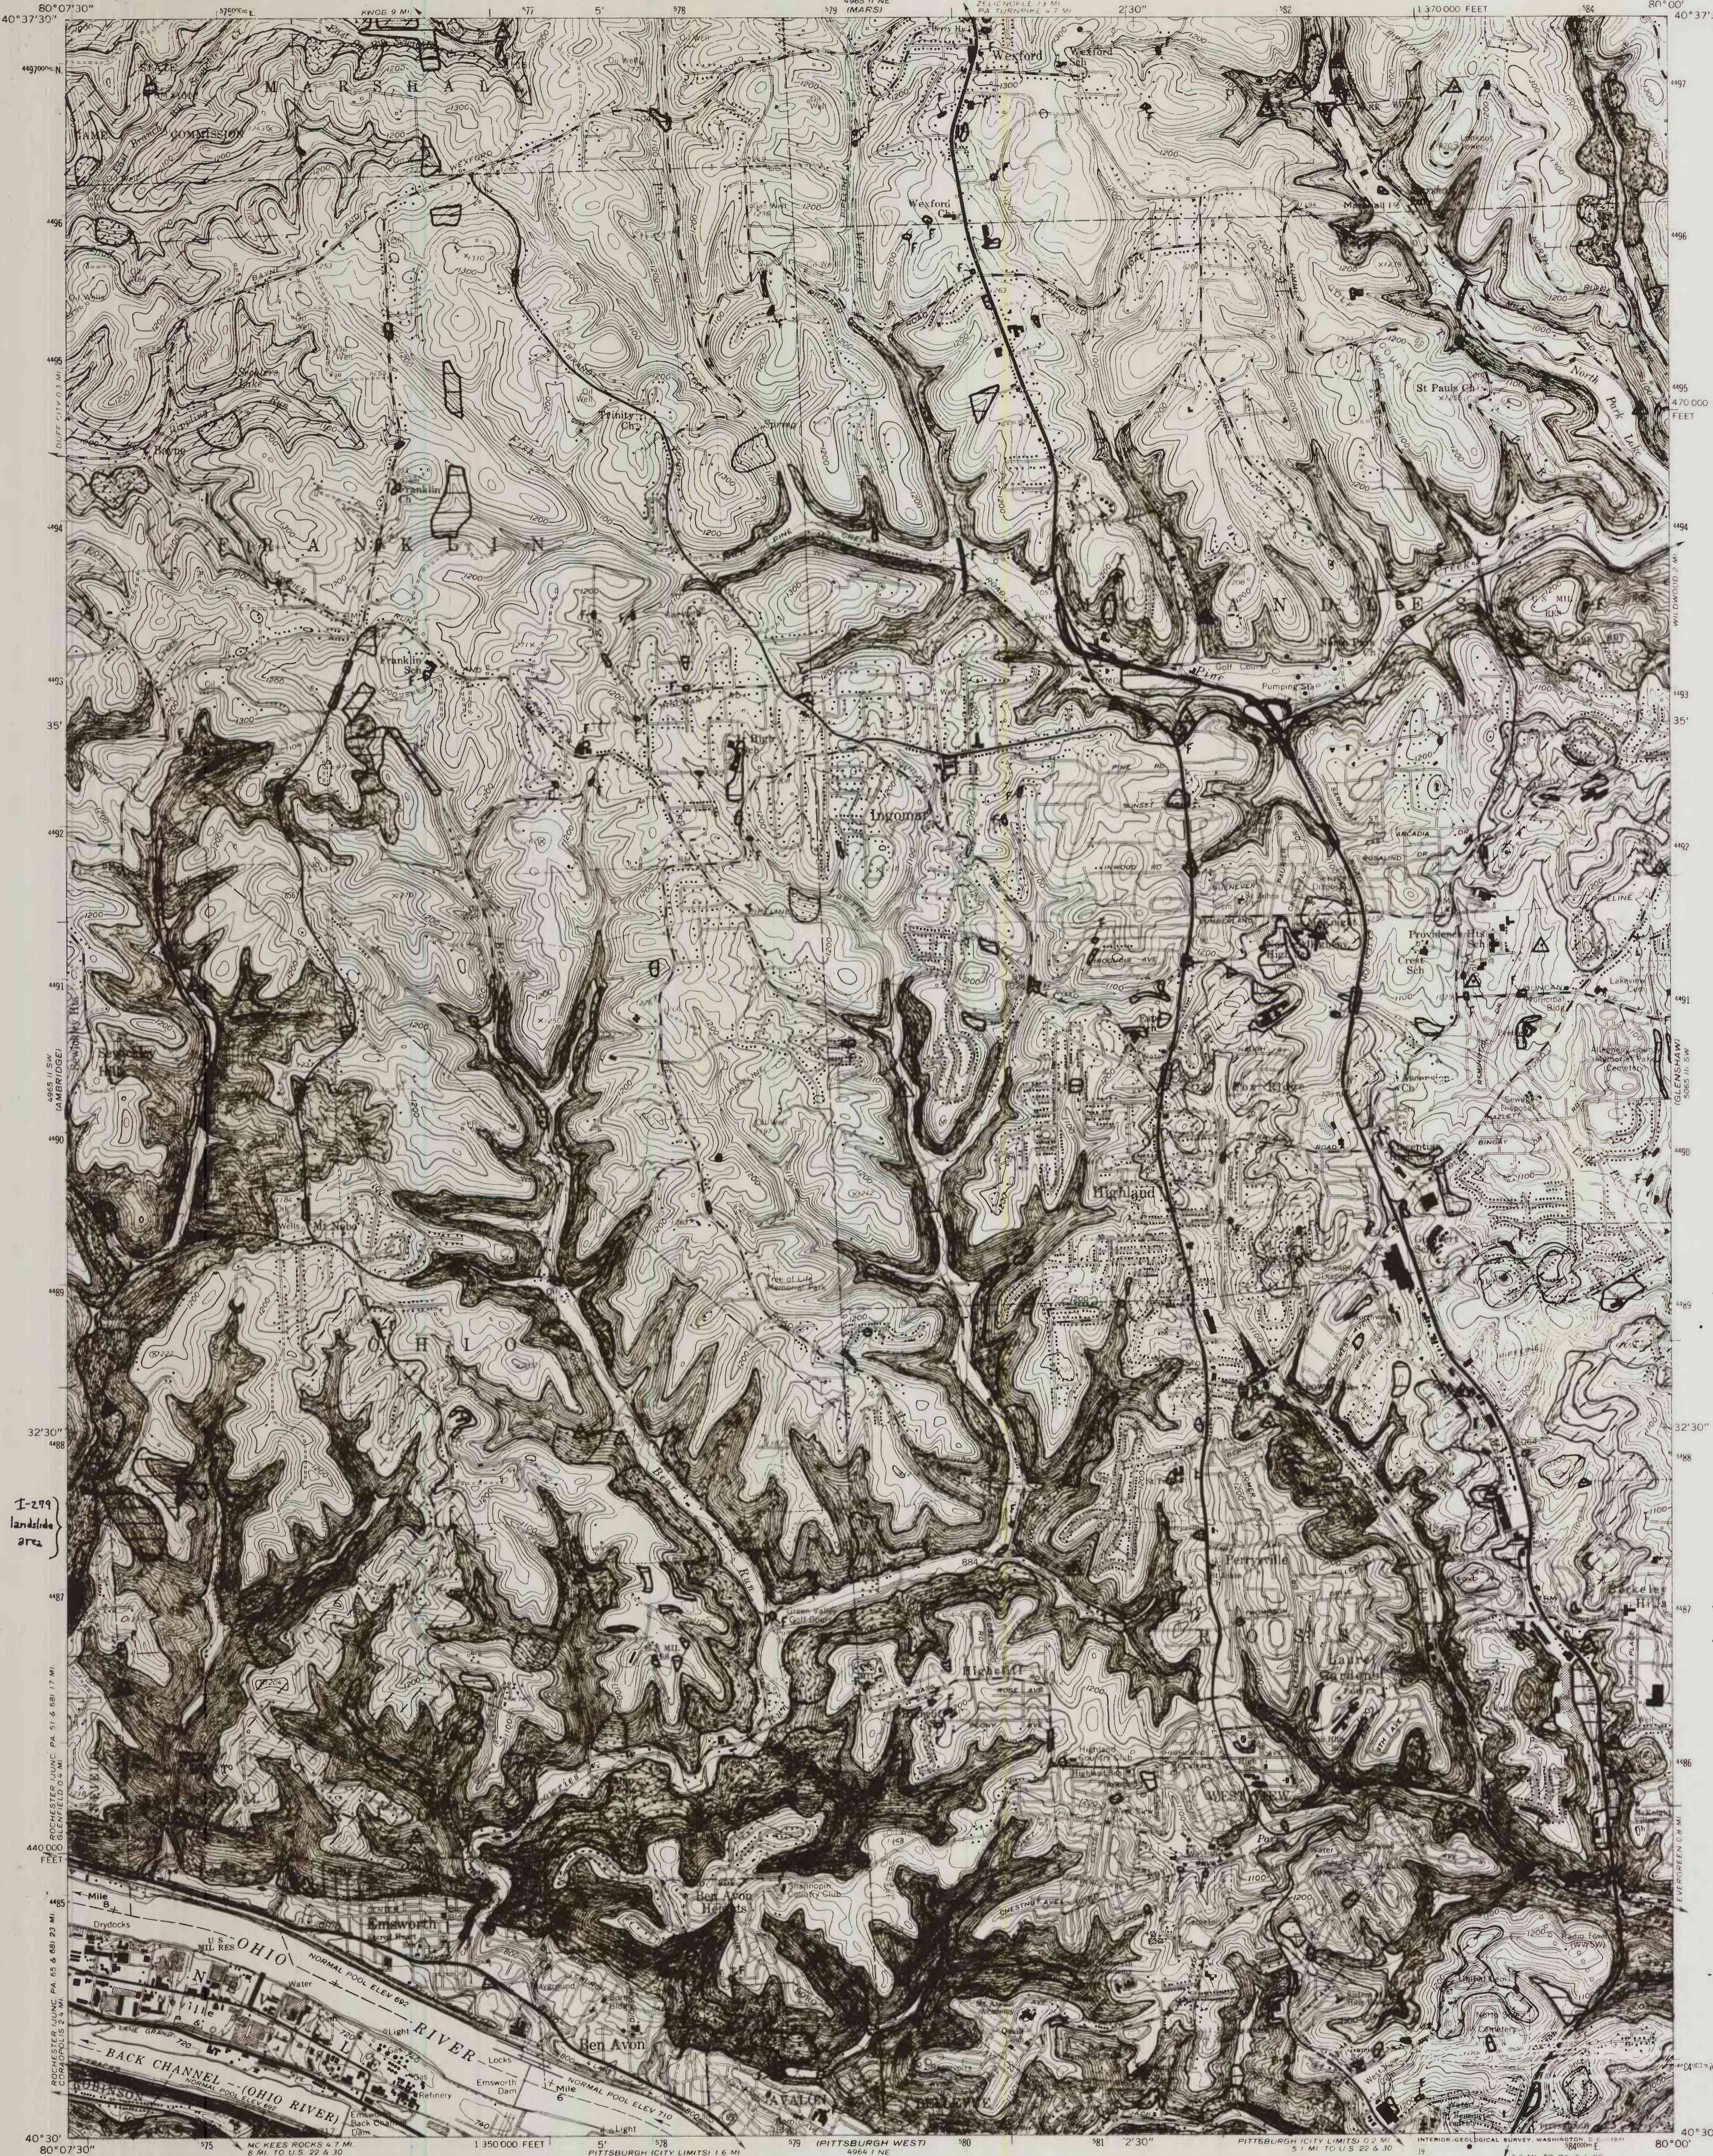
RECENT LANDSLIDES
 Dominantly earth slumps and earth flows; historically recorded or characterized by fresh scars. Small landslides enclosed by triangles.

PREHISTORIC LANDSLIDES
 Dominantly earth slumps and earth flows characterized by hummocky topography and slump benches; relatively stable in natural state but can be reactivated by excavation, loading and changes in ground and surface water conditions. Includes some probable recent landslides not covered by records examined.

SLOPES WITH CONSPICUOUS SOIL CREEP
 Clayey soils, generally less than 5 ft thick, commonly underlain by weathered shale; characterized by shallow, slow but distinct, downslope movement that can be greatly accelerated by overloading from fills or structures.

OUTCROP AREA OF THICK "RED BEDS" AND ASSOCIATED ROCKS
 Rock weathers rapidly on exposure; weathered rock and related soil commonly result in soil creep and landslides; cuts and fills in "red beds" generally not stable.

RELATIVELY STABLE GROUND
 Most slopes have little susceptibility to landsliding unless extensively modified by man; slight soil creep common on undisturbed slope.

STEEP SLOPES SUSCEPTIBLE TO ROCKFALL
 Dominantly thick-bedded sandstone and limestone, 1 to over 10 ft thick; subordinate flaggy sandy shale and interbedded shale; highly fractured and locally undercut by weathering of shale; in steep natural and cut slopes and cliffs, 15 to over 150 ft high.

MAN-MADE FILL
 Heterogeneous soil and rock material; variable susceptibility to slope failure depending on nature of materials, foundation conditions, design and construction. Fills in older urbanized areas mapped only where associated with recent landslides. Fills too small to be shown by pattern identified by letter "F".

NOTE
 Variations in slope sensitivity may occur at any specific point within a unit. Boundaries largely are inferred and information given is intended as a general guide and should not be construed as applicable to all localities within the area shown. This map cannot be used as a substitute for detailed engineering investigations of specific sites.

Map based on 1950 aerial photographs, field reconnaissance, 1952-74, soil surveys by U.S. Dept. Agriculture Soil Conservation Service, and existing geologic data. This map has not been edited or reviewed for conformity with Geological Survey standards and nomenclature.
