HYDRAULIC ANALYSIS OF FLOODFLOWS IN BUTTE BASIN AT STATE HIGHWAY 162  
GLENN AND BUTTE COUNTIES, CALIFORNIA

OPEN-FILE REPORT 74-198

Prepared in cooperation with the  
California Department of Transportation  
Division of Highways

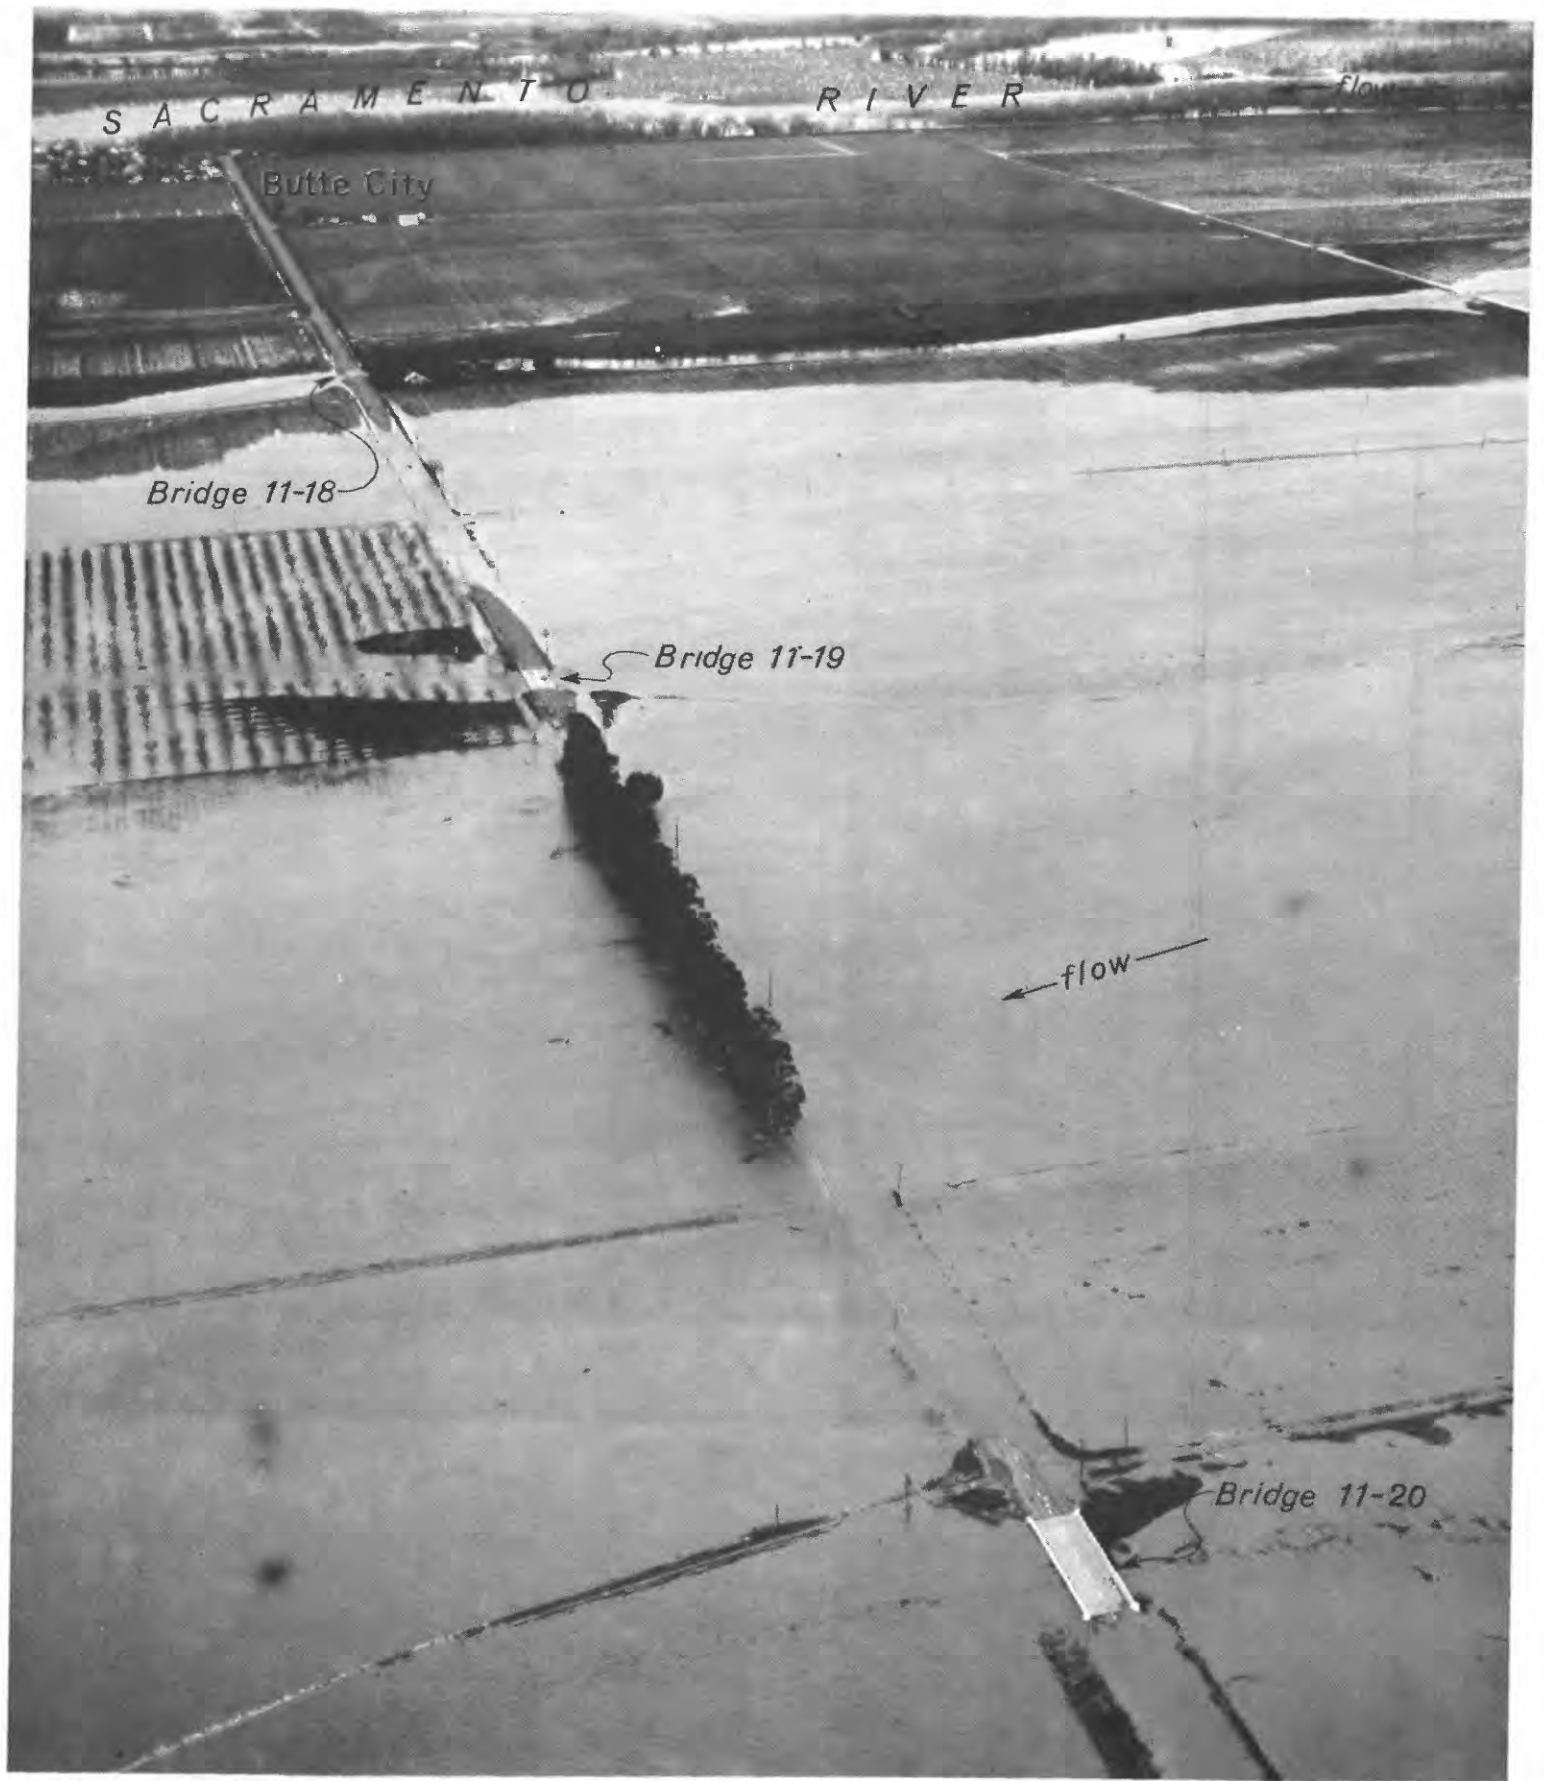
Inundation of State Highway 162 near Butte City during flood of January 24, 1970.

Frontispiece. Photograph showing inundation of State Highway 162  
near Butte City during flood of January 24, 1970.

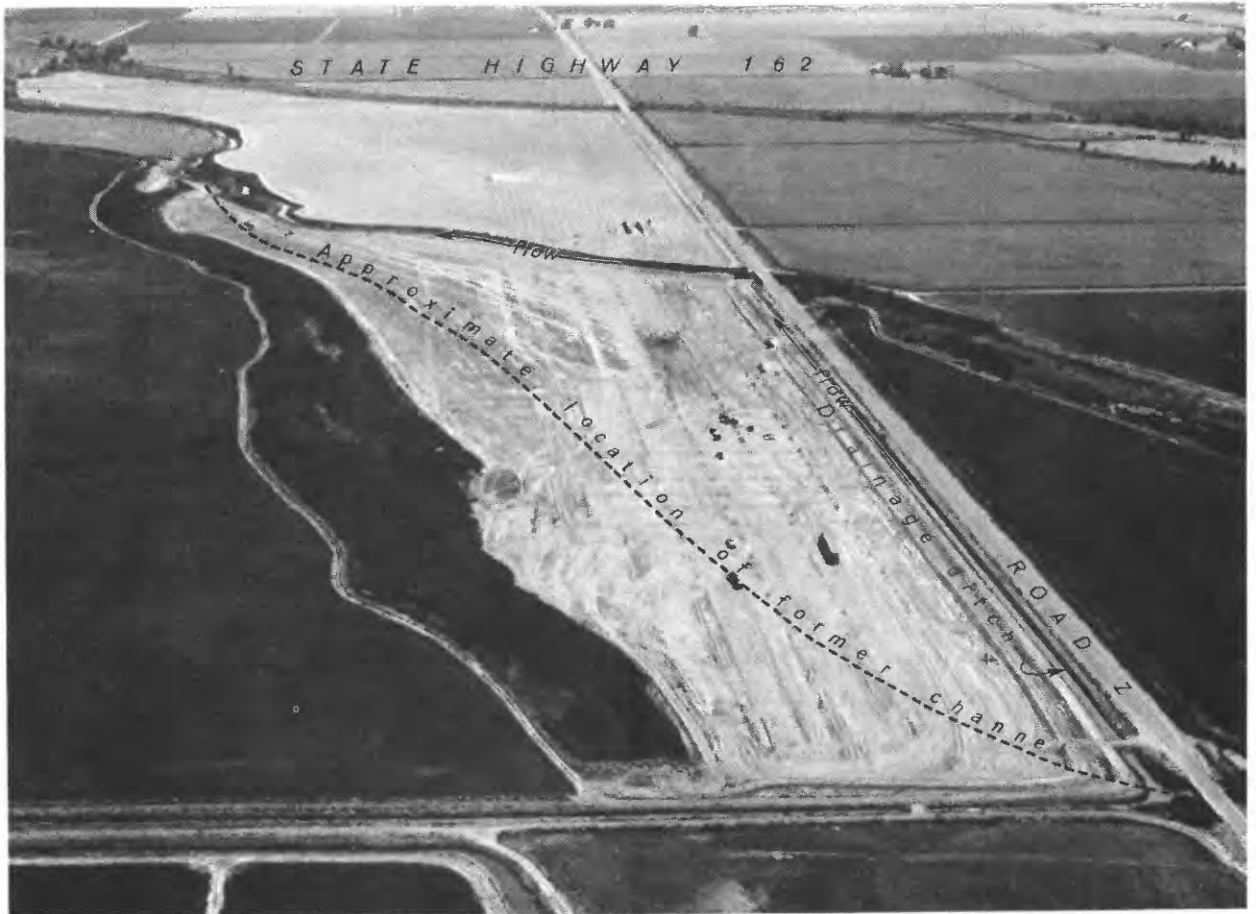
FIGURE 1.--Land leveling upstream from State Highway 162, July 31, 1973.

Land leveling (fig. 1) over the years has caused a redistribution of floodflow on the flood plain. The natural sloughs and depressions on the flood plain (pl. 1) have been altered by construction of low levees, or have been blocked off or leveled in such a way that flood waters reaching lower Butte Basin now occupy channels of insufficient capacity or flow over lands not previously inundated. The effect of land-leveling operations will be most noticeable for floods of lesser magnitude (90,000 to 110,000 ft<sup>3</sup>/s or 2550 to 3120 m<sup>3</sup>/s on the Sacramento River). Larger floods, those exceeding 110,000 ft<sup>3</sup>/s (3120 m<sup>3</sup>/s), may scour out many of the low levees and agricultural dikes, and inundate lands that historically have been flooded.

The changes in the land surface will affect the distribution of flows at State Highway 162. For example, a drainage ditch constructed in the spring of 1973 (fig. 1) and associated land leveling near Road Z, diverts all flow from a channel of Campbell Slough that formerly passed under bridge 11-24 to another channel that passes under bridge 11-31. Only during extreme floods will floodflows overtop the levees along the drainage ditch near Road Z and again pass through bridge 11-24. Because of the continual changes to the flood plain, which in turn affect distribution of floodflow, the relations established from data obtained during the period 1970-73 are primarily applicable to the conditions prevailing at the time data were collected.
