LANDSLIDE SUSCEPTIBILITY MAP OF PART OF THE BRIDGEVILLE 7 1/2' QUADRANGLE, ALLEGHENY COUNTY AND VICINITY, PENNSYLVANIA

by
William E. Davies

U.S. Geological Survey
OPEN FILE MAP 74-274
This map is preliminary and has not been edited for conformity with Geological Survey standards or nomenclature.

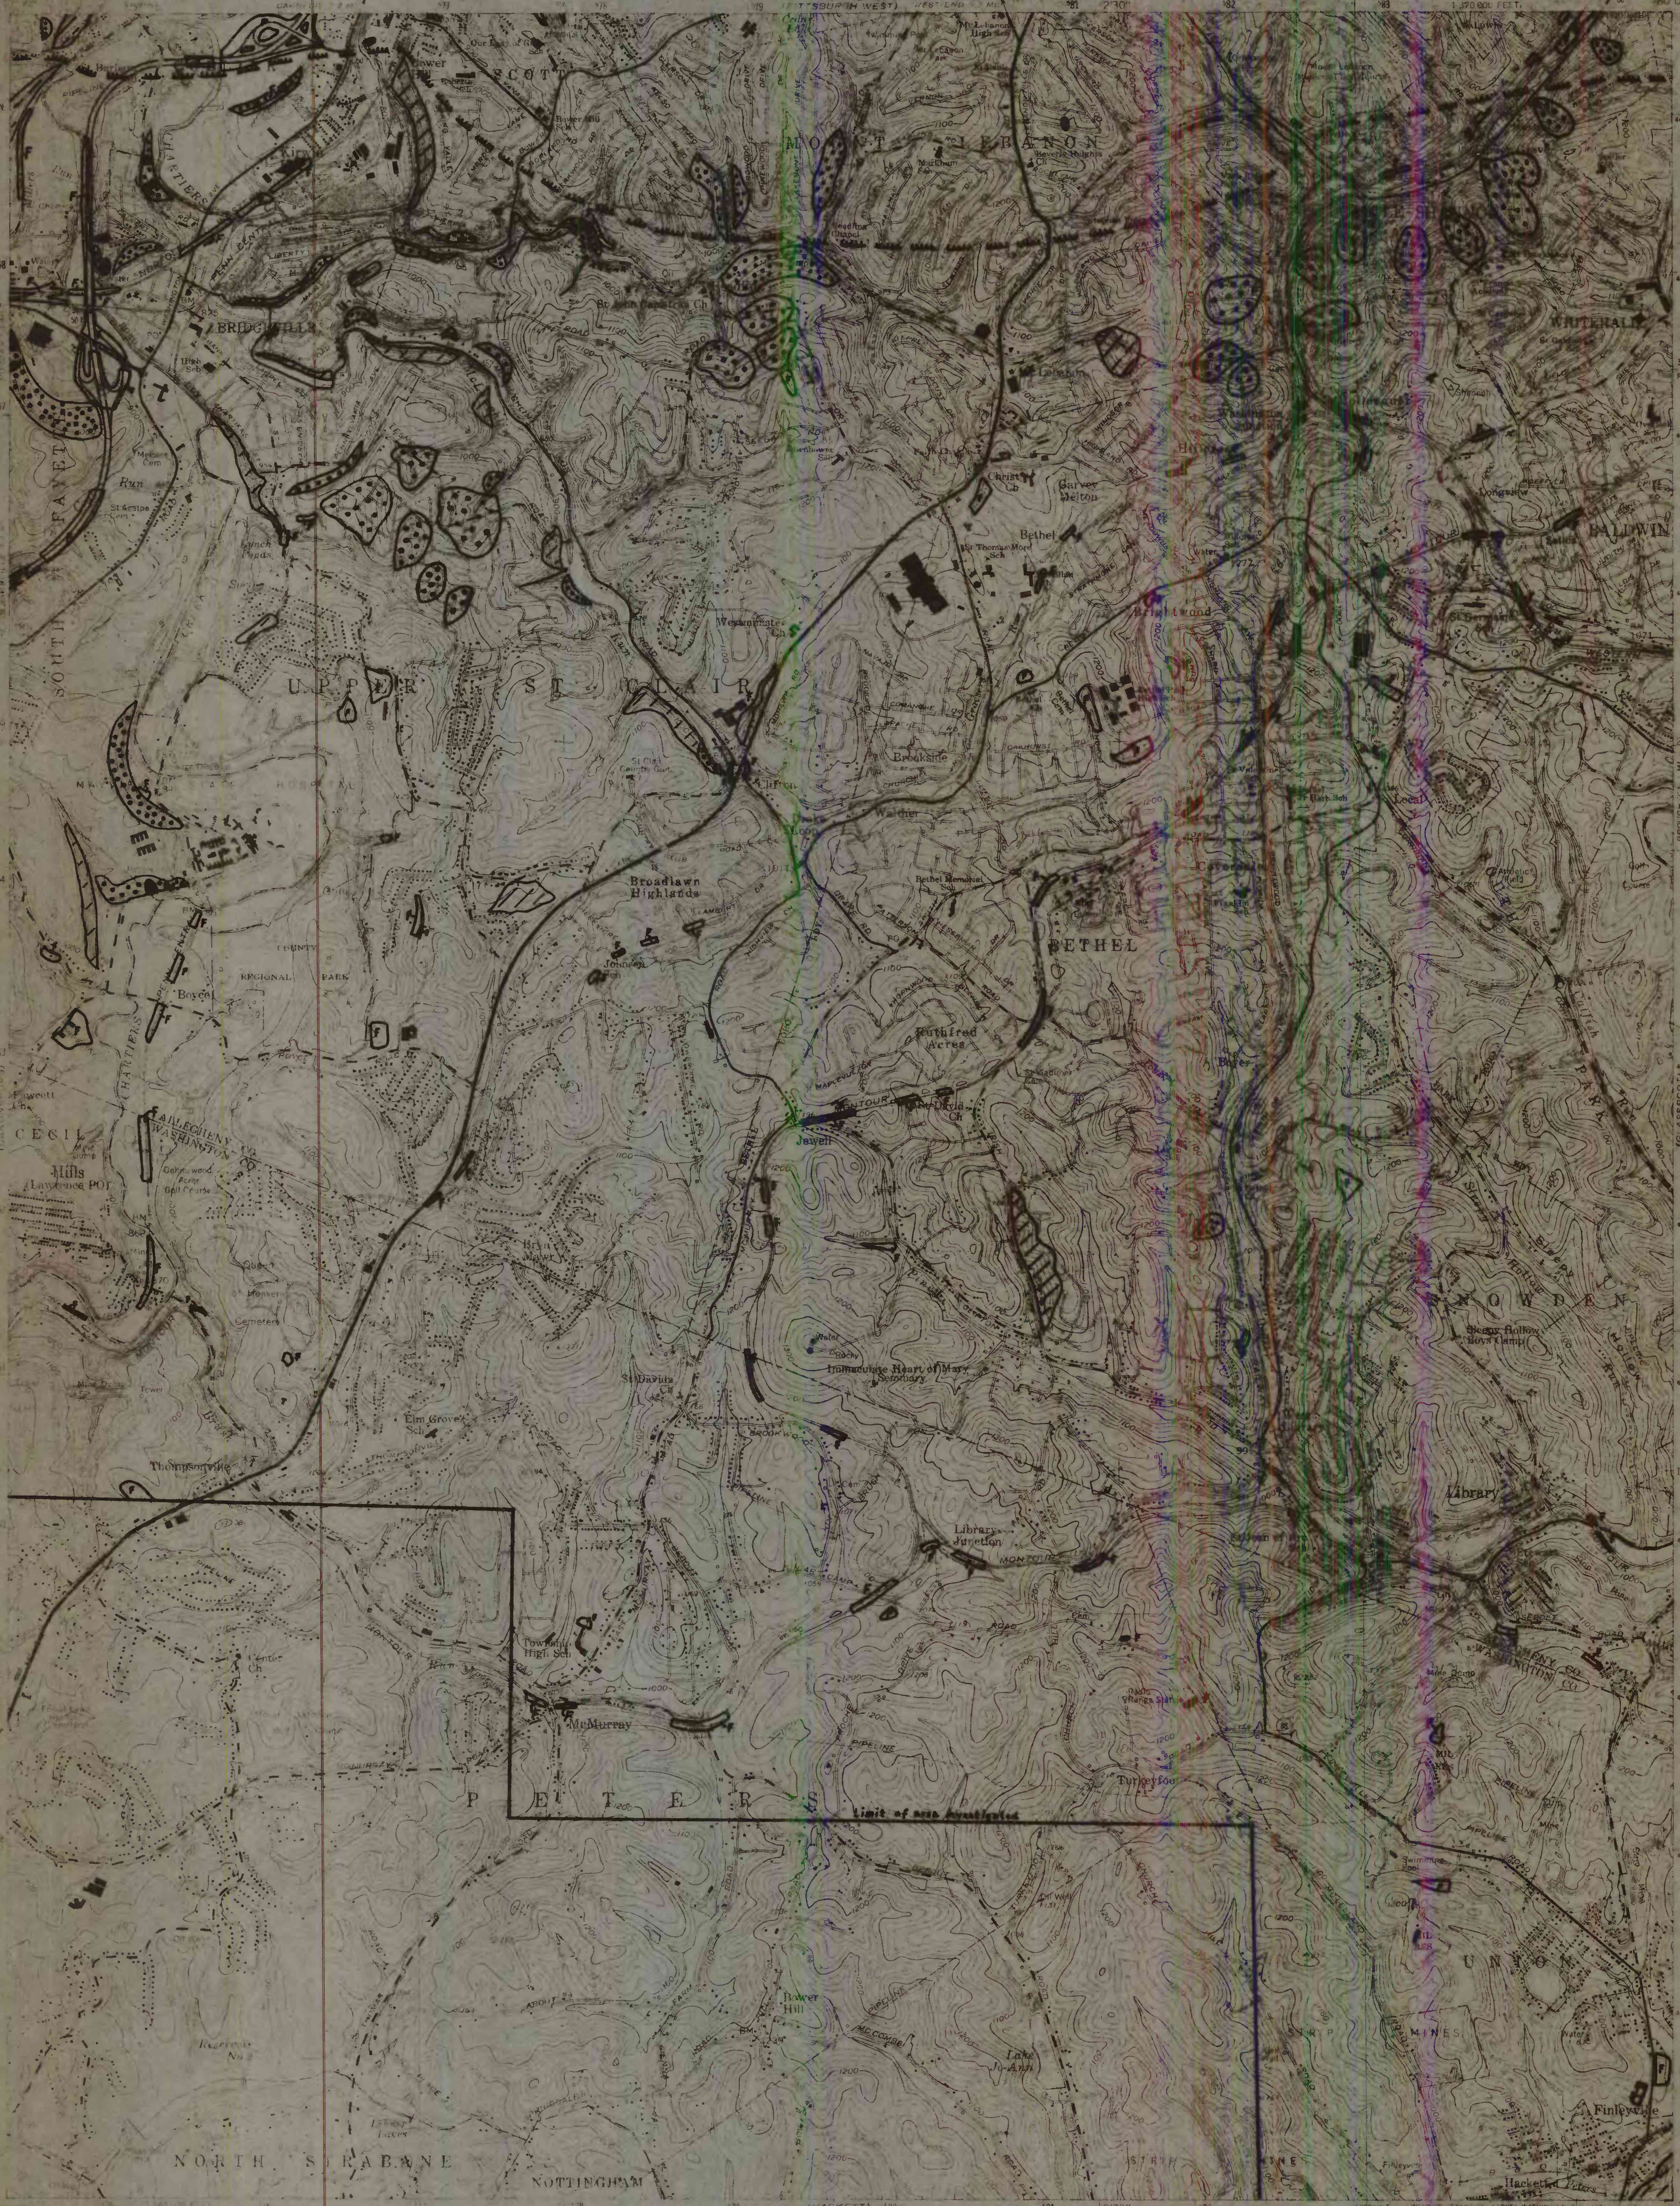
RECENT LANDSLIDES
Discontinuity with steep slopes and wash flows; structures destroyed or damaged by fresh slides. Small landslides indicated by triangles.

PERMANENT LANDSLIDES
Discontinuity with steep slopes and wash flows characteristic of hummocky topography and steep benches; generally stable in natural state but can be reactivated by excavation, loading and changes in ground and surface water conditions. Includes some probable recent landslides not covered by records examined.

SLOPES WITH CONSPICUOUS SOIL CREEP
Creeper soils, generally less than 5 ft thick, commonly underlain by weathered shales; characterized by shallow, slow but distinct, downslope movement that can be greatly accelerated by excavating from fills or structures.

RELATIVELY STABLE GROUND
Slopes have little susceptibility to landsliding unless extensively modified by heavy, slight soil creep common on well-sturbed slopes.

XXXX STEEP SLOPES SUSCEPTIBLE TO ROCKFALL
Commonly thick-bedded sandstones and limestones, 10 to 15 ft thick; subhorizontal flaggy sandy shales and interbedded shales; highly fractured and locally undercut by weathering of shales; in steep natural and excavated and cliffs, 15 to over 150 ft high.

MAN-MADE FILL
Heterogeneous soil and rock material; variable susceptibility to slope failure depending on nature of material, foundation conditions, design and construction. Fills in older urbanized areas mapped only where associated with recent landslides. Fills too small to be shown by pattern identified by letter "F".

GROUND WITH HIGHLY VARIABLE SLOPE CONDITIONS
On the rocky side of the dashed line, ground has been widely disturbed by past and present cut-and-fill operations related to residential and commercial development and (or) surface mining of coal. Thin colluvial covers of soil and weathered rock mantle the slope. These conditions combine to make uncertain the classification of slopes on the basis of conspicuous or relatively minor soil creep.
