LANDSLIDE SUSCEPTIBILITY MAP OF THE NEW KENSINGTON EAST 7 1/2' QUADRANGLE, ALLEGHENY COUNTY AND VICINITY, PENNSYLVANIA

by William E. Davies

U.S. Geological Survey
OPEN FILE MAP 74-283
This map is preliminary and has not been edited for conformity with Geological Survey standards or nomenclature.

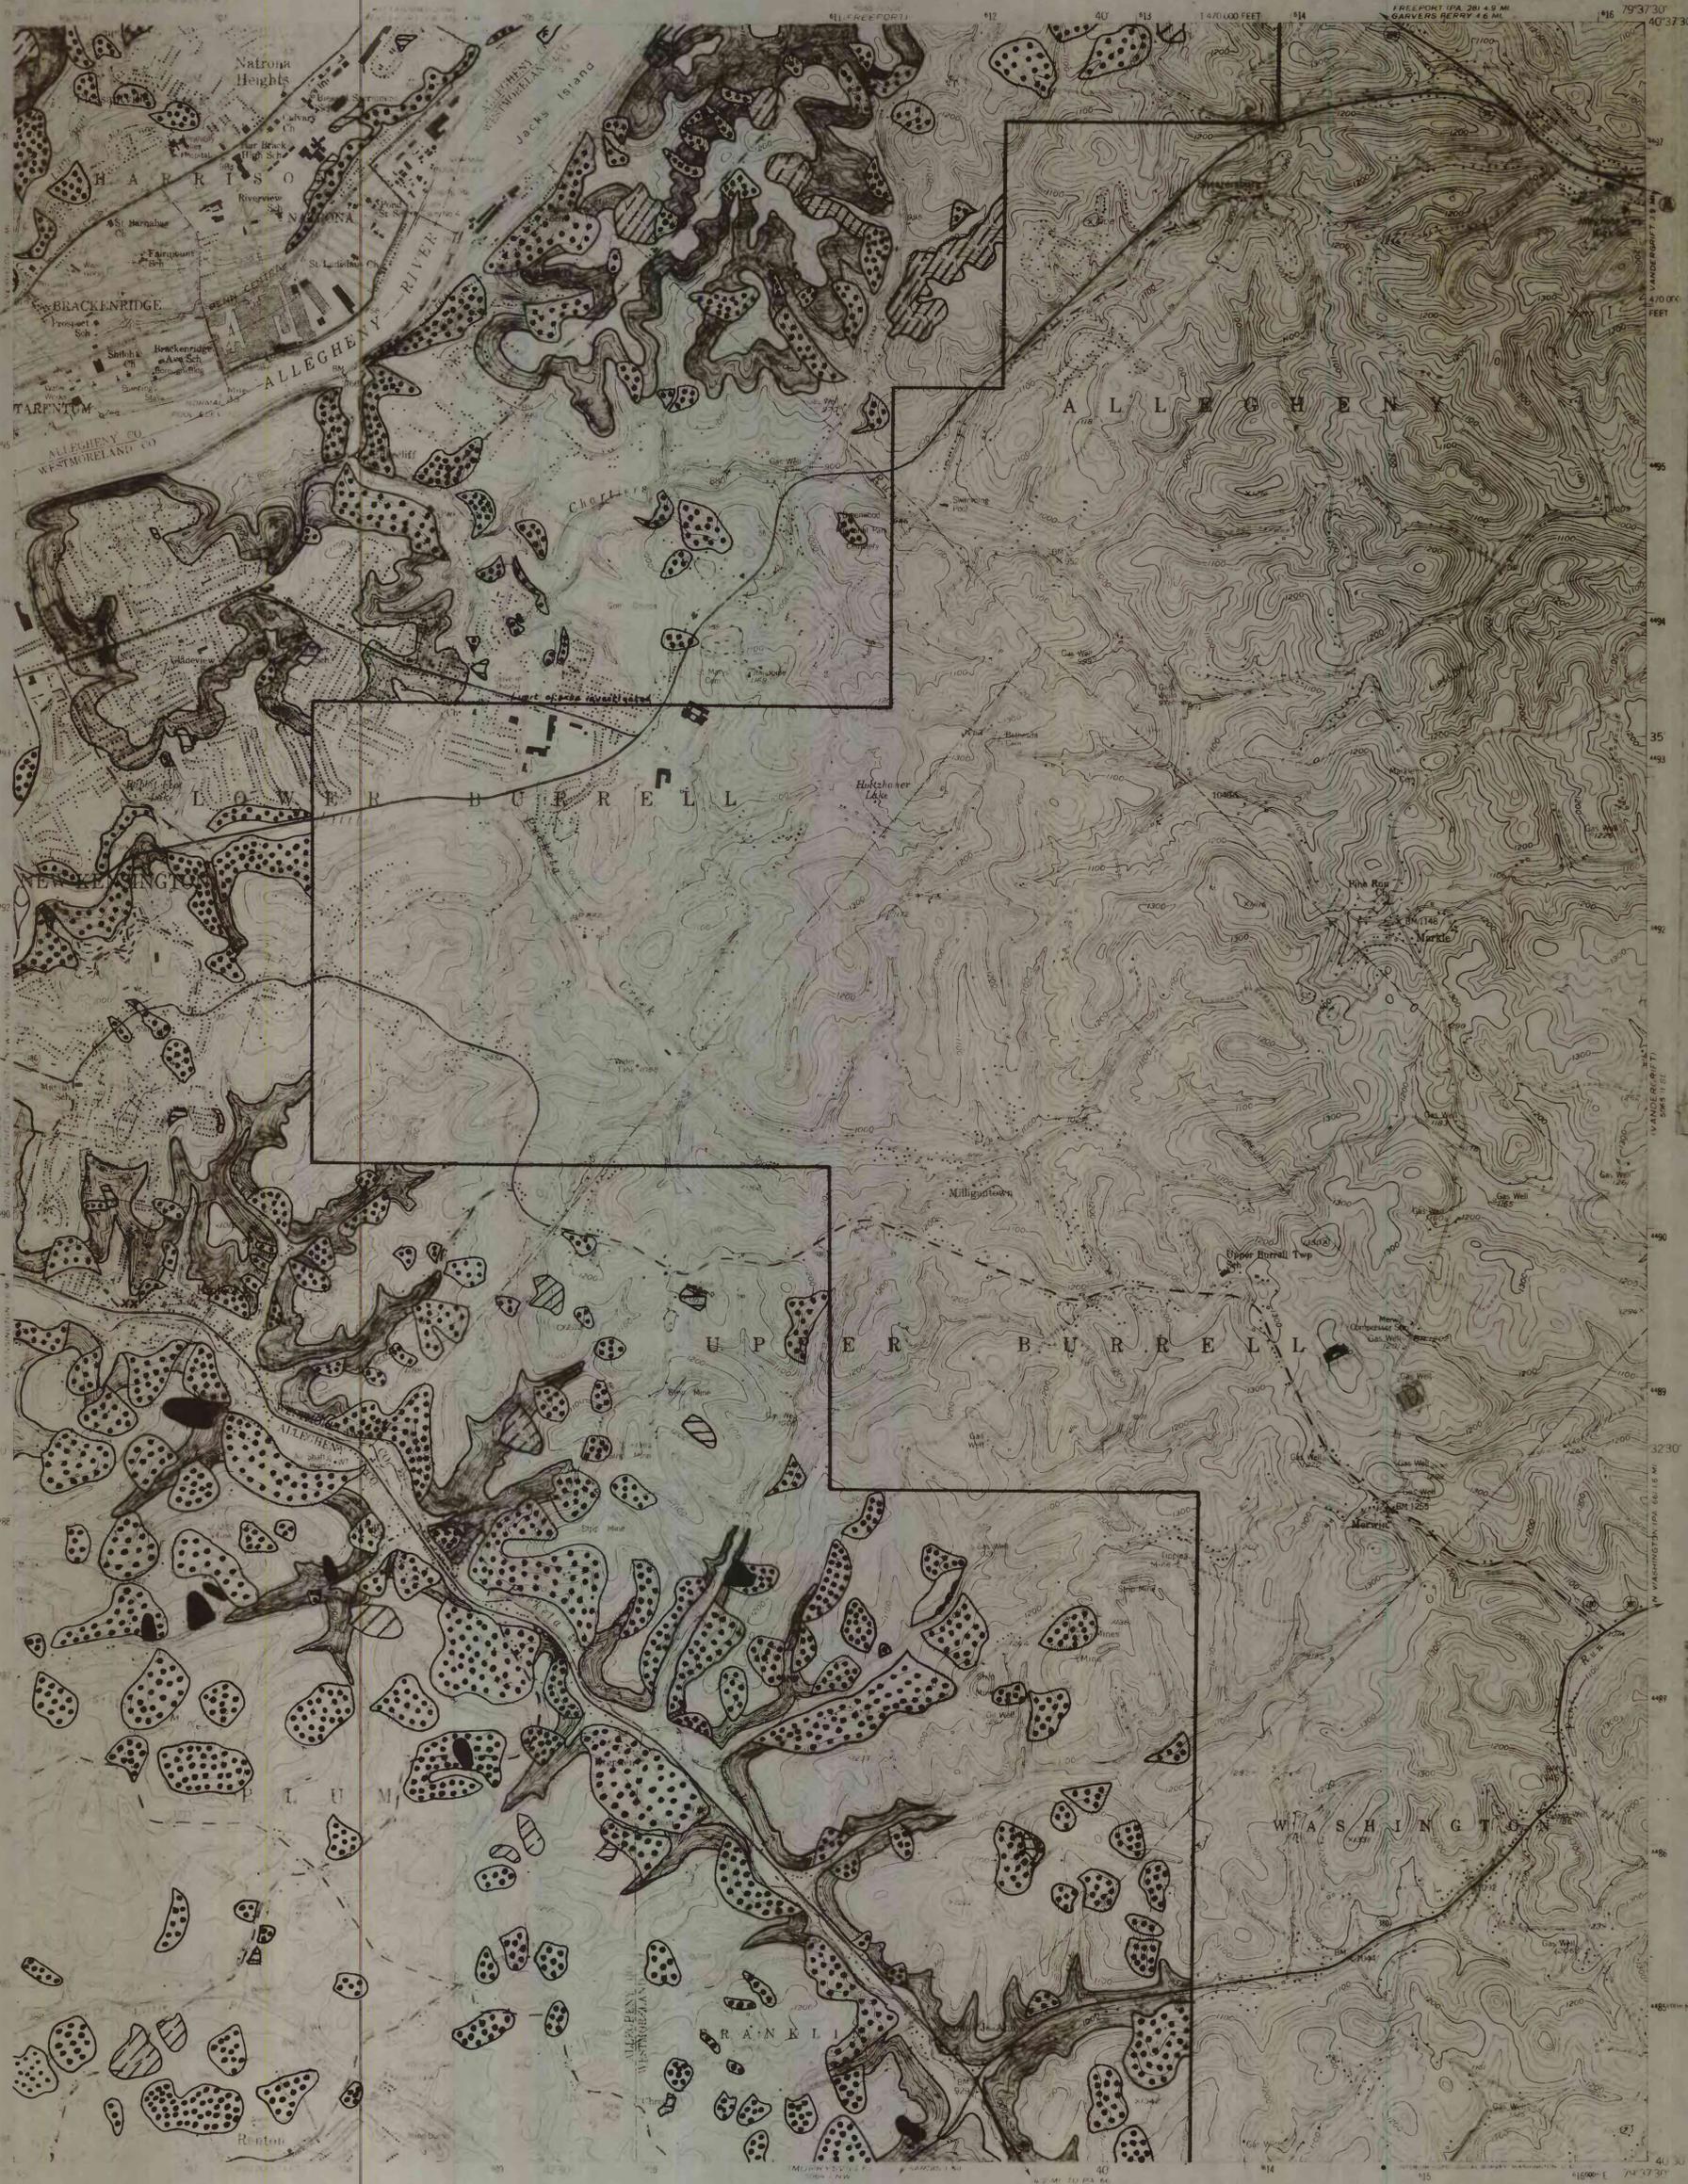
RECENT LANDSLIDES
Dominantly earth slumps and earth flows, historically recorded or characterized by fresh scars. Small landslides enclosed by triangles.

PREHISTORIC LANDSLIDES
Dominantly earth slumps and earth flows characterized by hummocky topography and slump benches; relatively stable in natural state but can be reactivated by excavation, loading and changes in ground and surface water conditions. Includes some probable recent landslides not covered by records examined.

SLOPES WITH CONSPICUOUS SOIL CREEP
Clayey soils, generally less than 5 ft. thick, commonly underlain by weathered shale; characterized by shallow, slow but distinct, downslope movement that can be greatly accelerated by overloading from fills or structures.

OUTCROP AREA OF THICK "RED BEDS" AND ASSOCIATED ROCKS
Rock weathers rapidly on exposure; weathered rock and related soil commonly result in soil creep and landslides; cuts and fills in "red beds" generally not stable.

RELATIVELY STABLE GROUND
Most slopes have little susceptibility to landsliding unless extensively modified by man; slight soil creep common on undisturbed slopes.

STEEP SLOPES SUSCEPTIBLE TO ROCKFALL
Dominantly thick-bedded sandstone and limestone, 1 to over 10 ft thick; subordinate foggy sandy shale and interbedded shale; highly fractured and locally undercut by weathering of shale; in steep natural and cut slopes and cliffs, 15 to over 150 ft high.

MAN-MADE FILL
Heterogeneous soil and rock material; variable susceptibility to slope failure depending on nature of material, foundation conditions, design and construction. Fills in older urbanized areas mapped only where associated with recent landslides. Fills too small to be shown by pattern identified by letter "F".

NOTE
Variations in slope sensitivity may occur at any specific point within a unit. Boundaries largely are inferred and information given is intended as a general guide and should not be construed as applicable to all localities within the area shown. This map cannot be used as a substitute for detailed engineering investigations of specific sites.

Map based on 1973 aerial photographs, field reconnaissance, 1973-74; soil surveys by U.S. Dept. Agriculture Soil Conservation Service, and existing geologic data. This map has not been edited or reviewed for conformity with Geological Survey standards and nomenclature.
