WATER-QUALITY AND GEOHYDROLOGIC DATA AT TWO SANITARY LANDFILL SITES NEAR ANCHORAGE, ALASKA

BY CHESTER ZENONE AND D.E. DONALDSON

1974
DEPARTMENT OF THE INTERIOR
UNITED STATES GEOLOGICAL SURVEY
OPEN-FILE REPORT

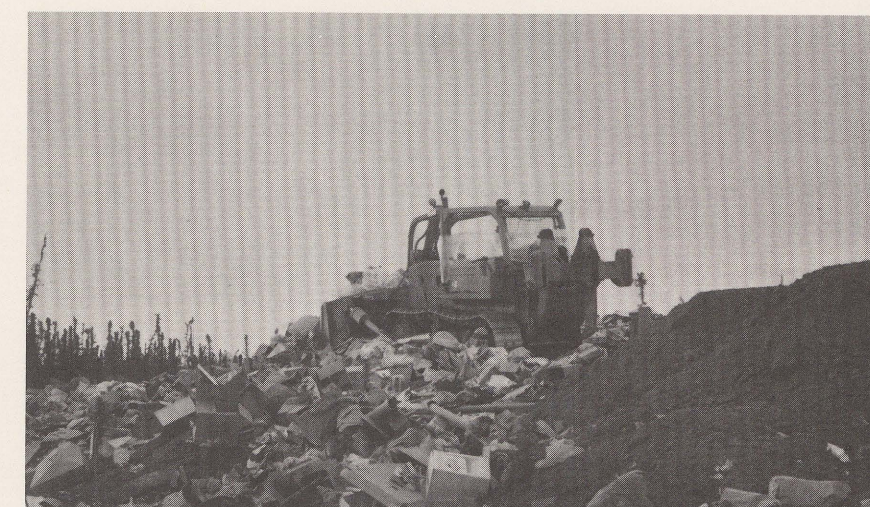
Bulldozer spreading and compacting refuse in typical landfill operation. Refuse is covered with at least 6 inches of clean fill (material at lower right) at the end of each day's operation.
