#### FLOOD OF APRIL 1975 AT MERIDIAN TOWNSHIP, MICHIGAN

## FLOOD OF APRIL 1975 AT MERIDIAN TOWNSHIP, MICHIGAN

By  
R.L. Knutilla and L.A. Swallow  
1975

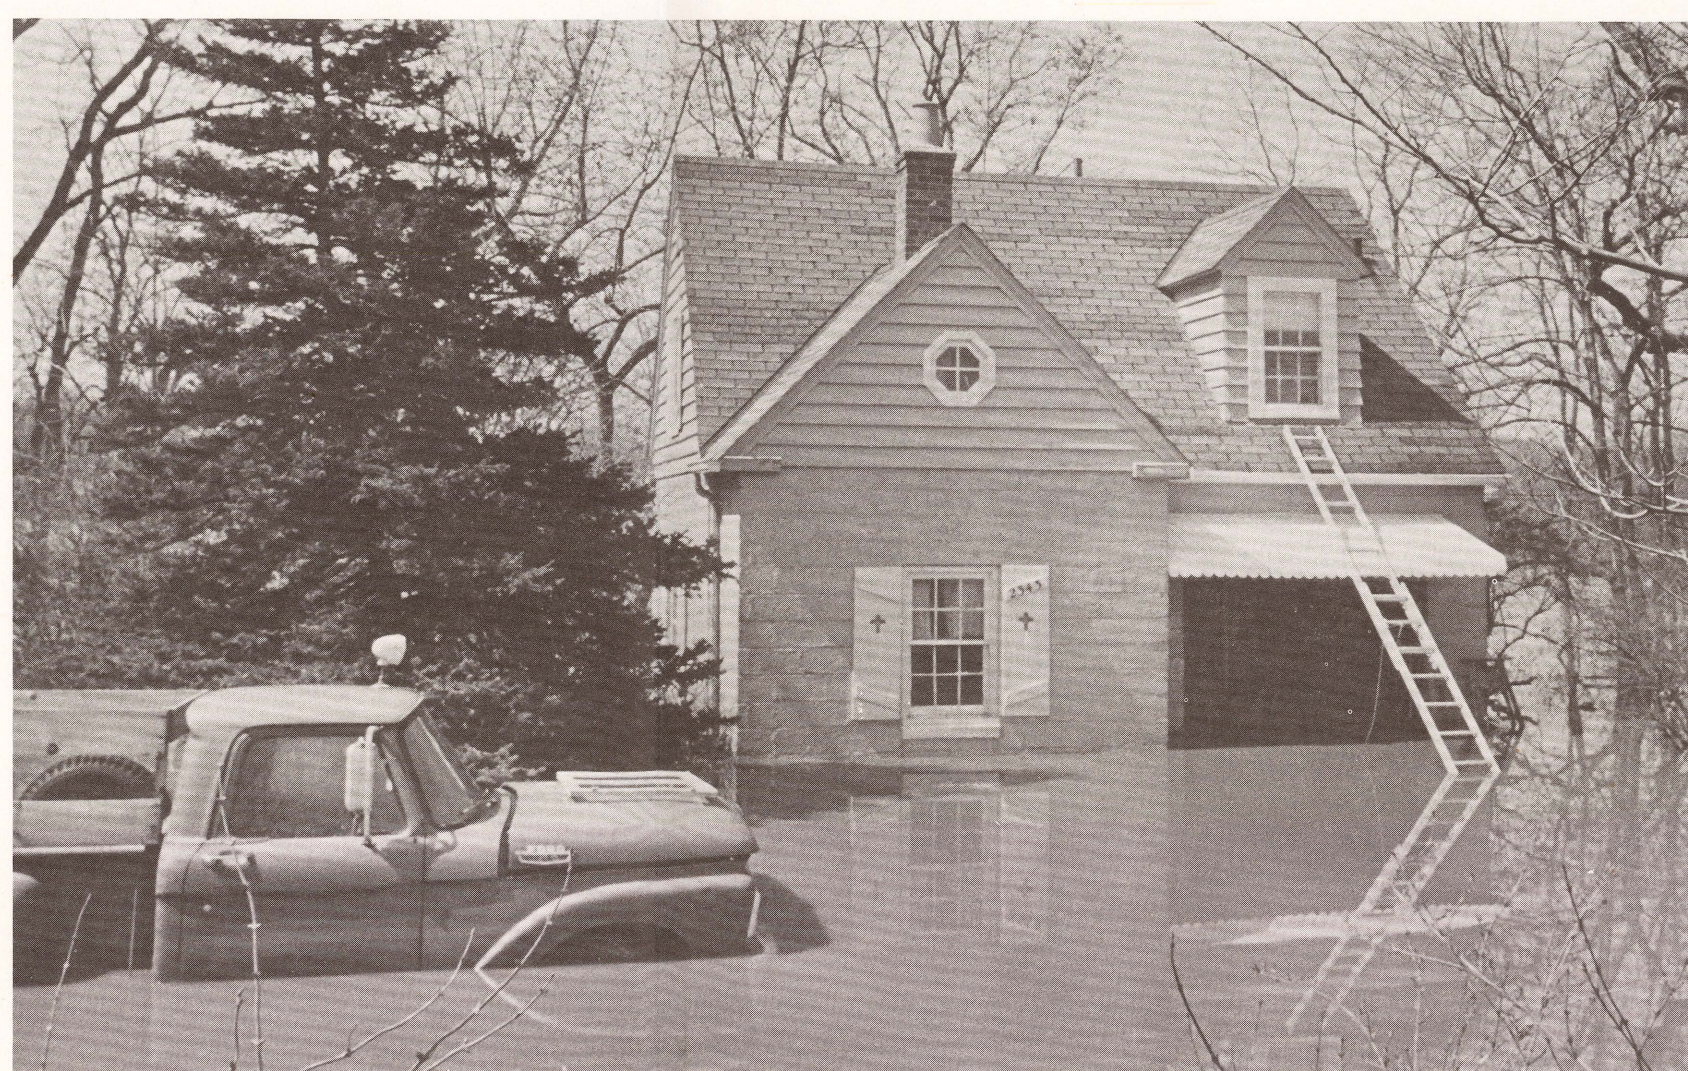
FIGURE 4.—Overflow of the Red Cedar River at Hamilton Street, Okemos.

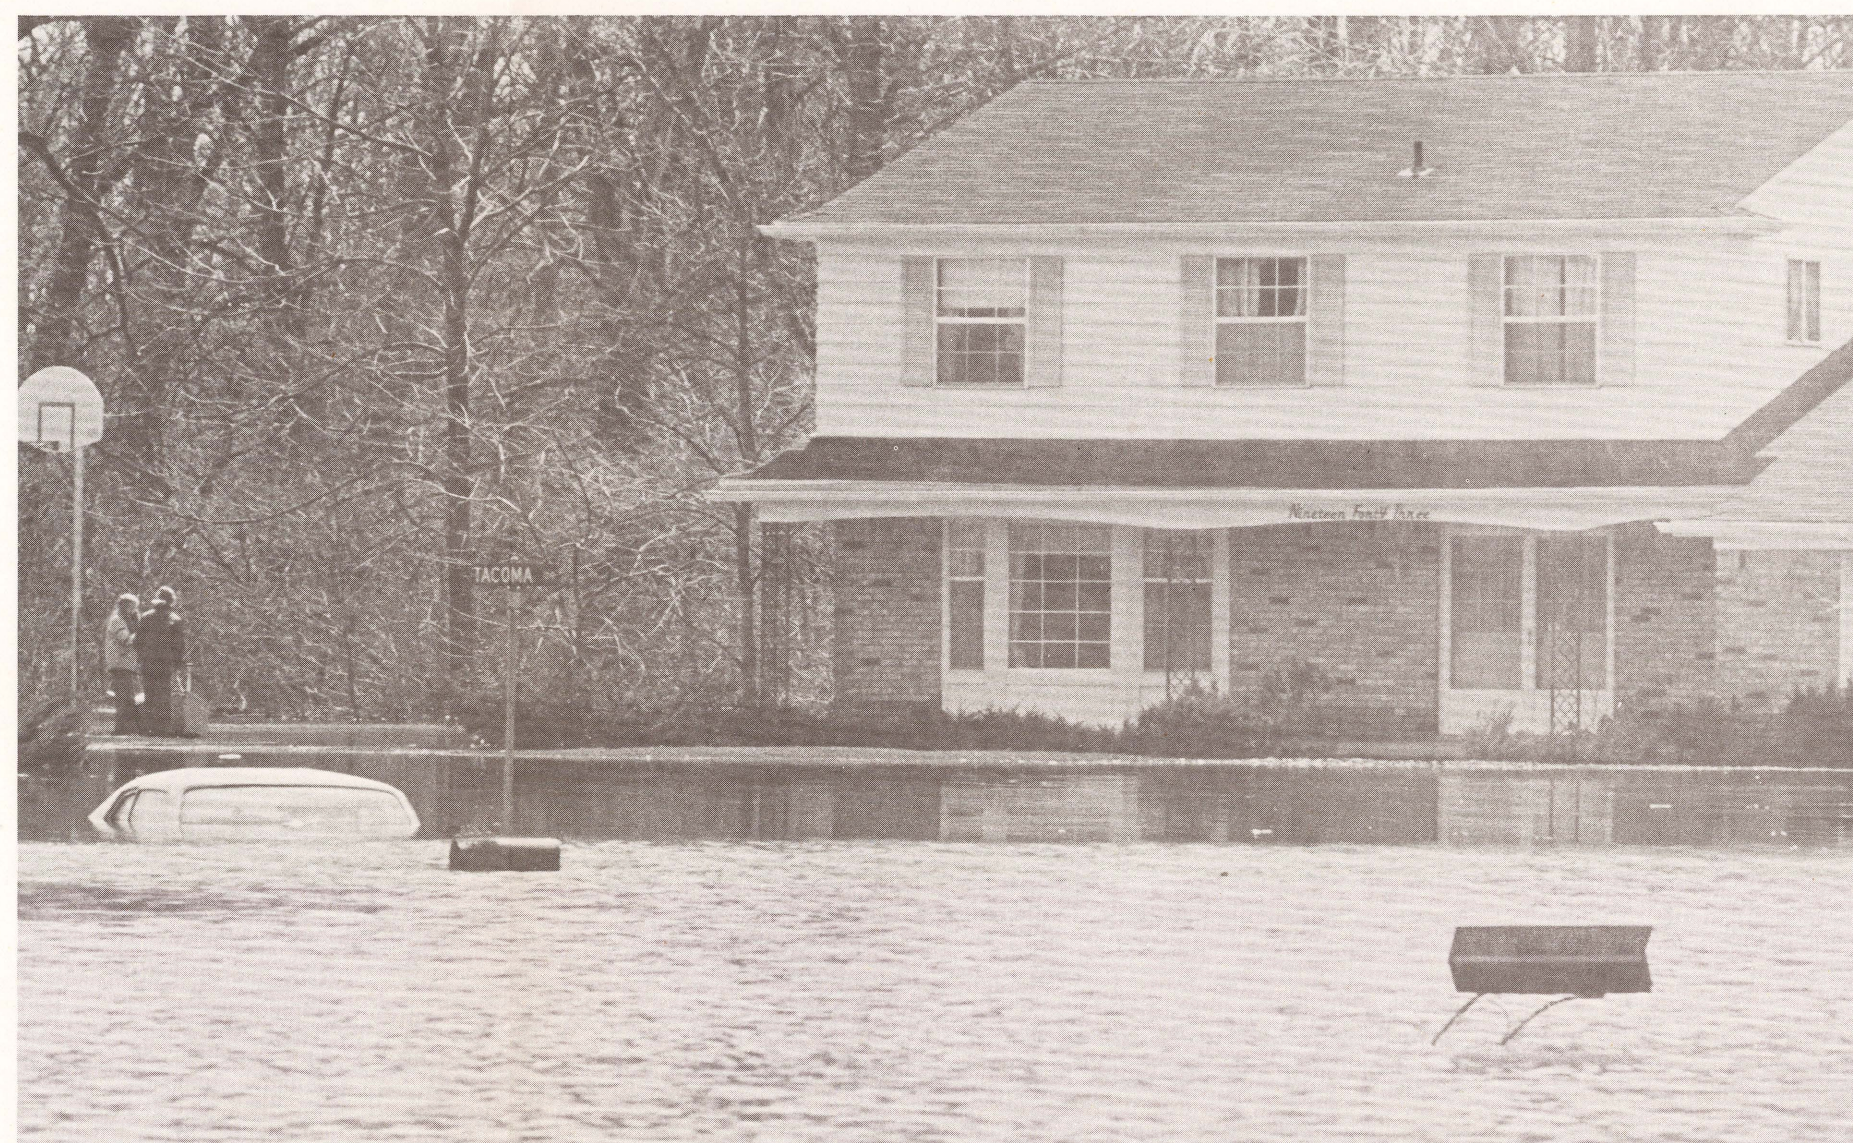
FIGURE 5.—Overflow of the Red Cedar River at Tacoma Drive, Okemos.

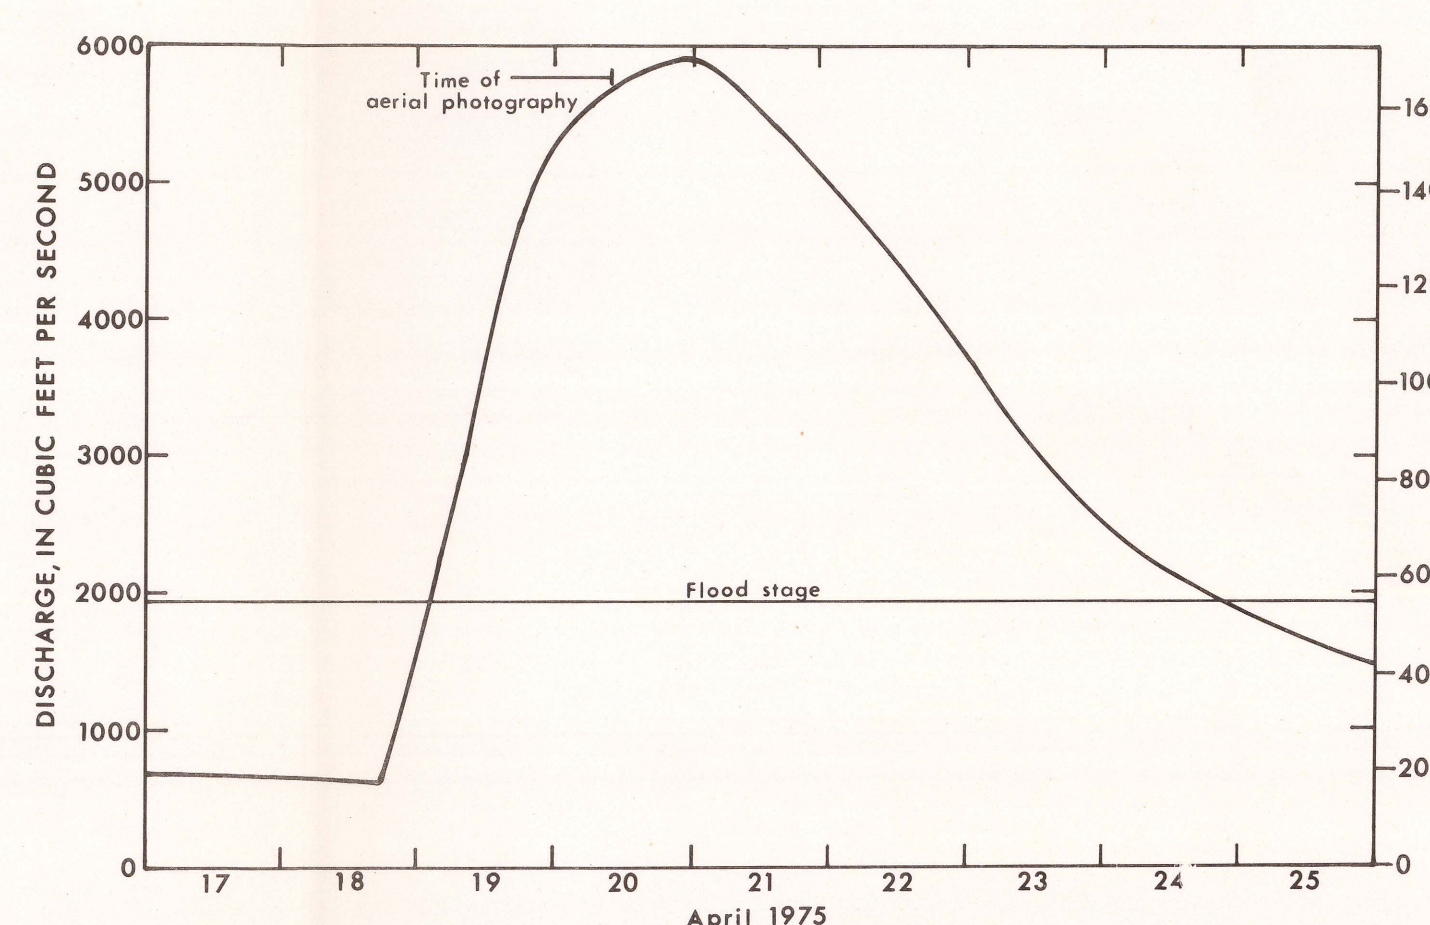
Figure 2.—Discharge hydrograph for the Red Cedar River at East Lansing.

Discharge data obtained at East Lansing are equivalent to those at the western boundary of Meridian Township. Discharge is about 10 percent lower at the eastern boundary. The discharge hydrograph for East Lansing is shown in figure 2. The peak discharge of 5,940 ft<sup>3</sup>/s (168 m<sup>3</sup>/s) occurred near midnight on April 20. This discharge is equivalent to a runoff of about 17 in (430 mm) per square mile of drainage area. This runoff is high, but it is low if compared to that of some nearby streams (table 2). Streams having small drainage areas had appreciably higher runoff than did the Red Cedar River.

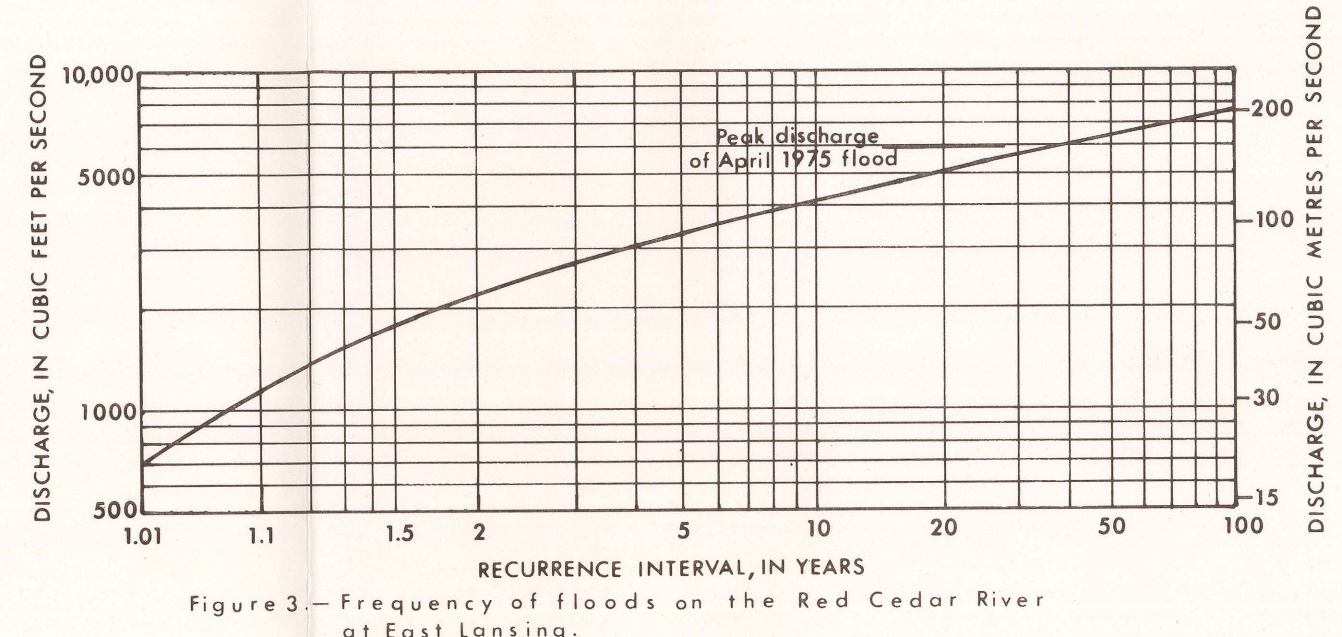
Figure 3.—Frequency of floods on the Red Cedar River at East Lansing.

The frequency with which a flood of a given magnitude can be expected to occur on the Red Cedar River at East Lansing can be determined from figure 3. The flood of April 1975 had a recurrence interval of about 40 years or about a 2.5 percent chance of occurrence in any year. Floods, however, do not occur at regular intervals nor can the chance of their occurrence be predicted. A flood equal to or greater than that of April 1975 can occur at any time. It is thus important to recognize potential flood problems and to adopt land use practices designed to protect communities against flood losses.
