MAP SHOWING LANDSLIDE DEPOSITS AND LATE TERTIARY AND QUATERNARY FAULTING IN THE
FT. GARLAND-SAN LUIS AREA, COLORADO-NEW MEXICO

U.S. Geological Survey
OPEN FILE REPORT
This map is preliminary and has not been edited or reviewed for conformity with Geological Survey standards or nomenclature.

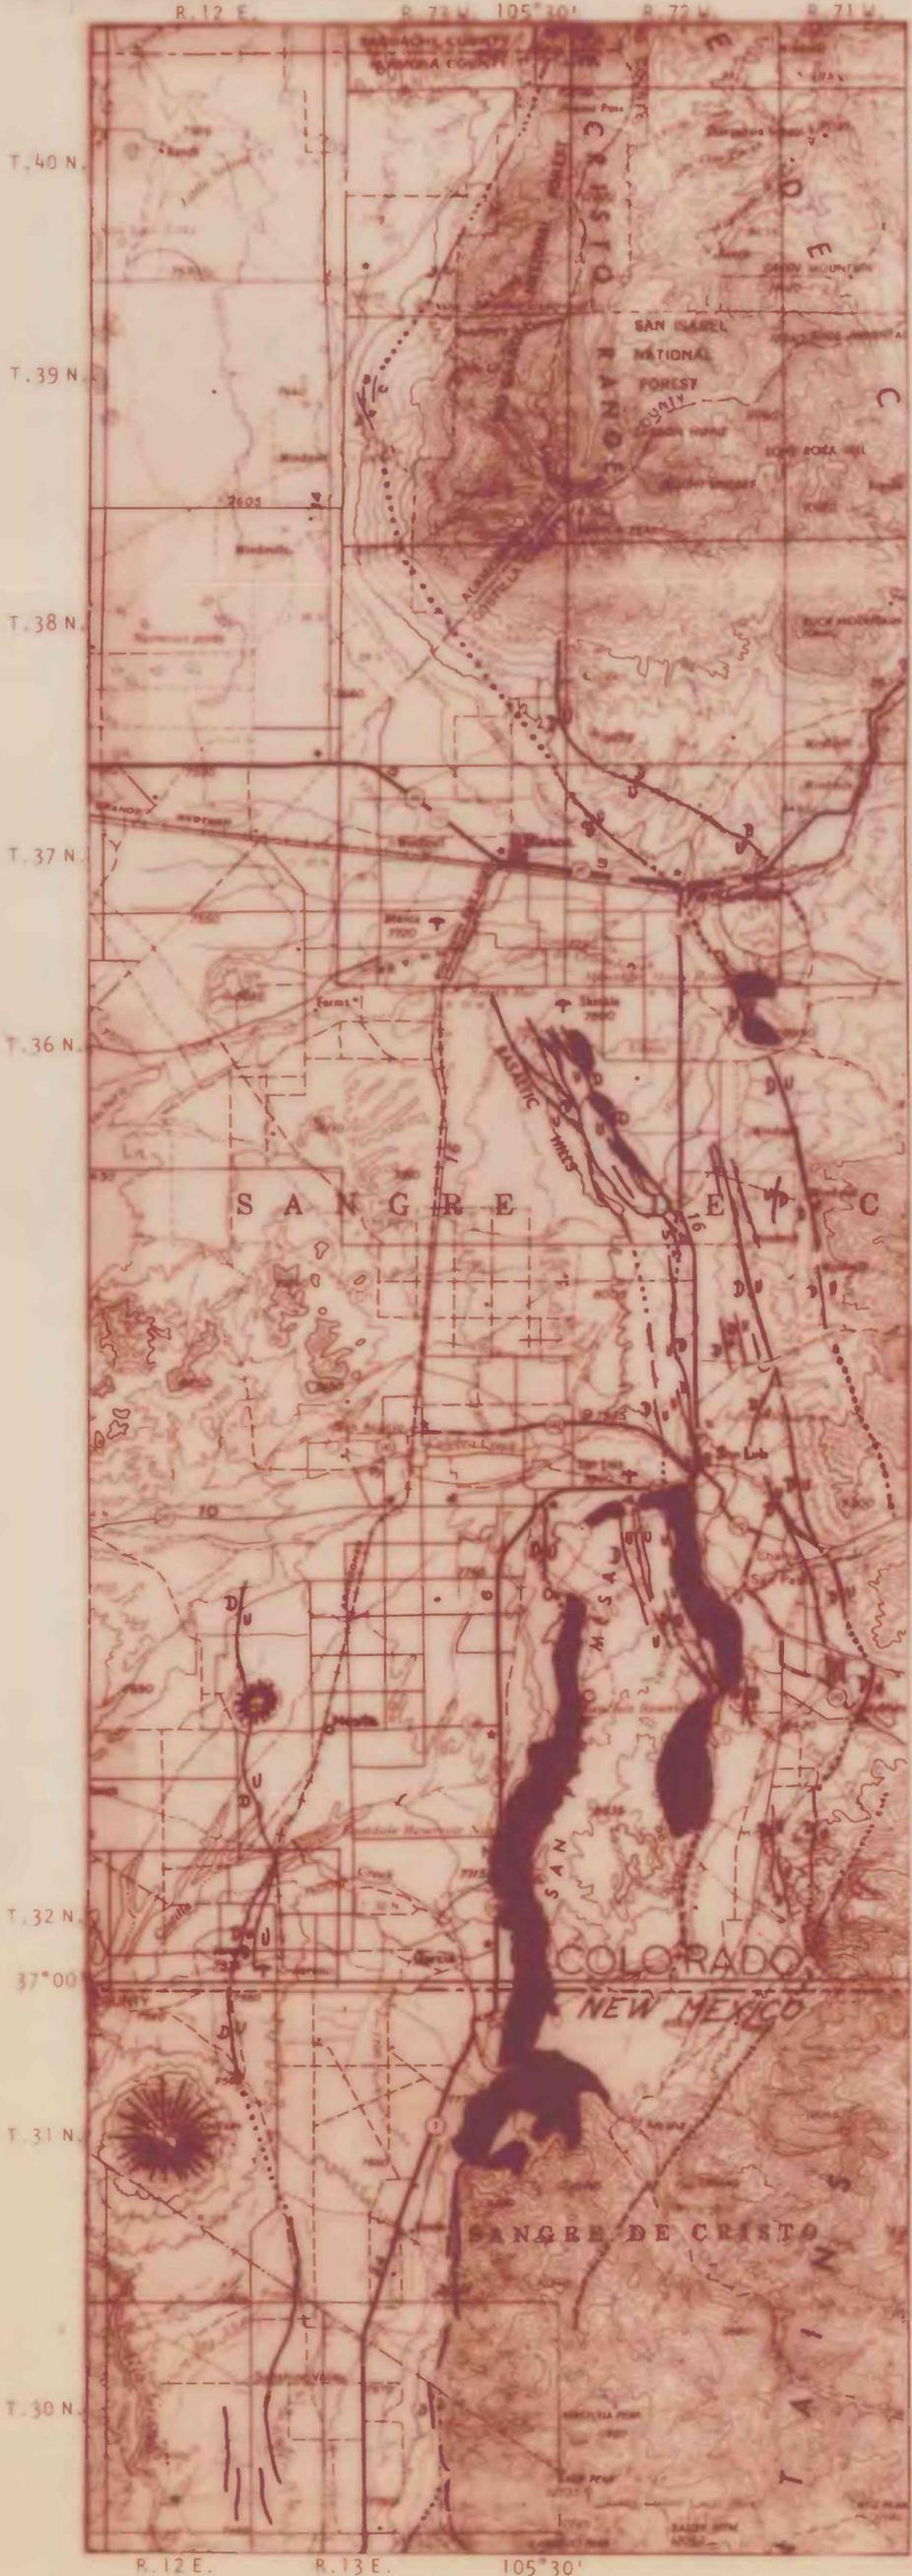
Landslide deposit--Fault scarps and landslide deposits mapped on small-scale (1:60,000) aerial photographs, and compiled on a 1:250,000-scale enlargement of the 1:250,000 Trinidad and Raton quadrangles, 1954-62. Field checks of the area were made in August and September 1975. Oblique aerial photographs were taken with low sun lighting Sept. 23, 1975. Visual inspection at that time confirmed most of the air-photo interpretation.

Fault--Dashed where approximately located; dotted where inferred. U, upthrown side; D, downthrown side

Volcanic cone
