LOW-FLOW CHARACTERISTICS AND MEAN ANNUAL DISCHARGE  
OF NORTH BRANCH MANITOWOC RIVER AT  
POTTER, WISCONSIN

Open-File Report 76-204

By B. K. Holmstrom

April 1976

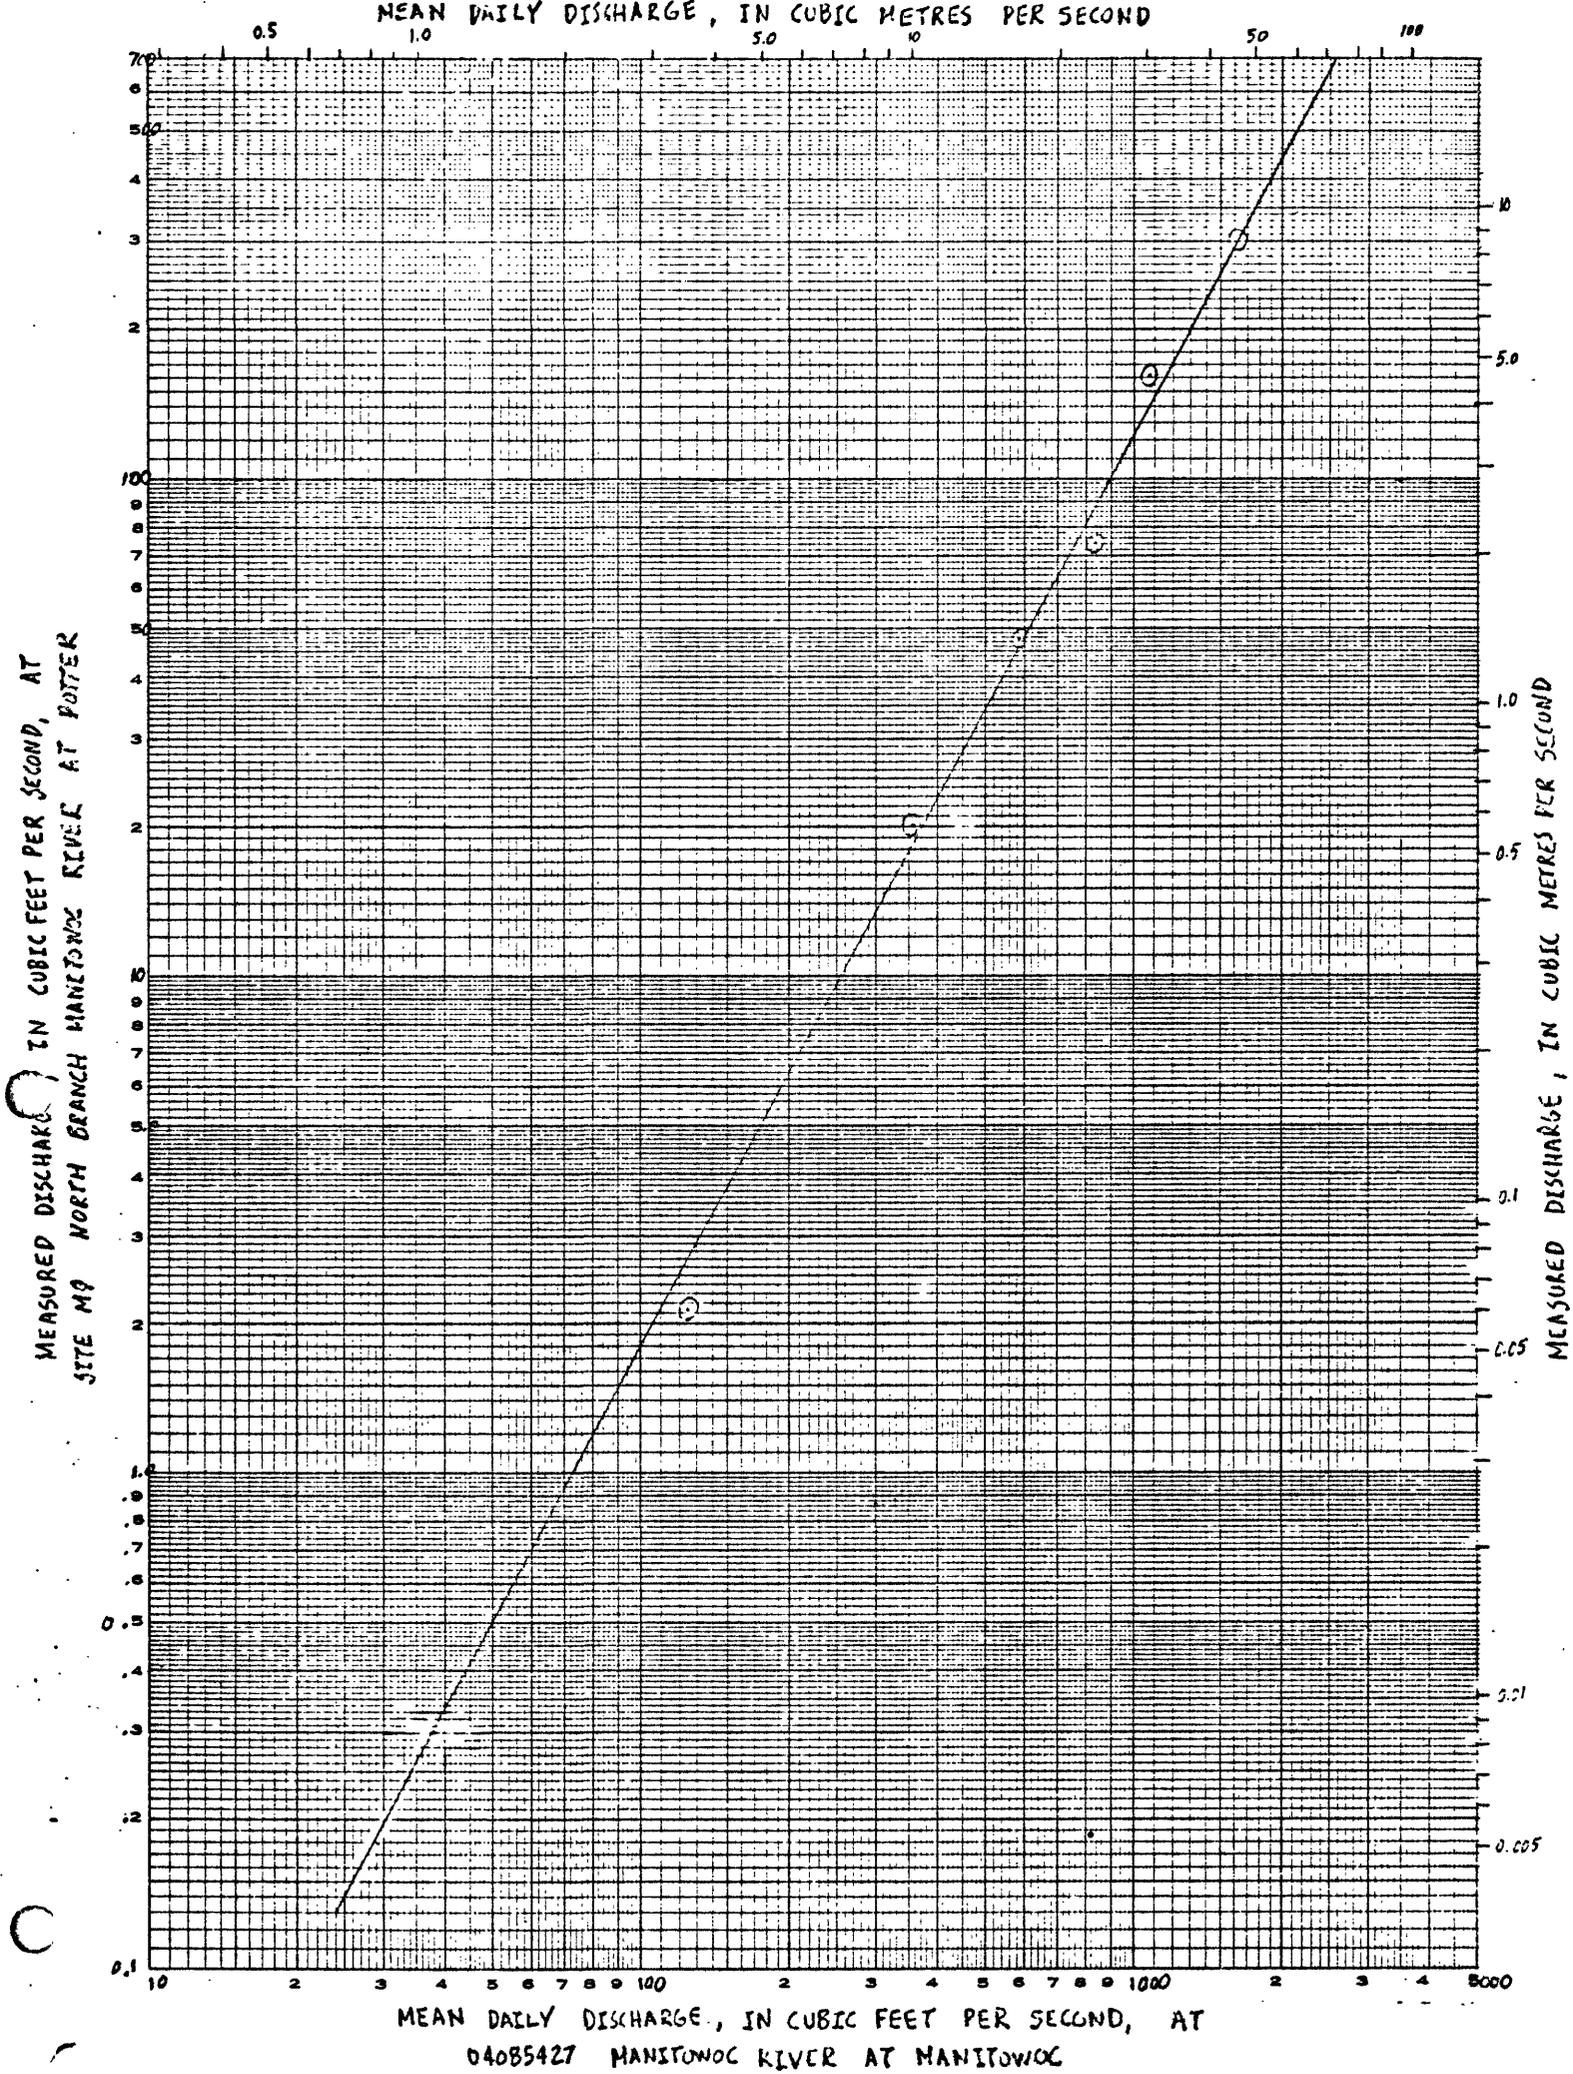
Figure 2... Relationship used to estimate mean daily discharge at site M9 North Branch Manistowoc River at Potter.

estimated daily discharge for the preceding 10 months was determined from a relationship (fig. 2) developed from the measured discharge at site M 9 and the recorded discharge at the gaging station 04085427, Manitowoc River at Manitowoc (not shown on map). The daily discharge at this gaging station (04085427) was transferred through the relation line in figure 2 to estimate the daily discharge at site M 9 for the 10-month period. The discharge at gaging station 04086000, Sheboygan River at Sheboygan (not shown on map) for June 1, 1974, to May 31, 1975, was 313 ft<sup>3</sup>/s (8.86 m<sup>3</sup>/s) compared to its long-term mean annual discharge of 234 ft<sup>3</sup>/s (6.63 m<sup>3</sup>/s). The mean discharge at site M 9 for June 1, 1974, to May 31, 1975, (table 4) was adjusted by the ratio of the long-term mean annual discharge to the June 1, 1974, to May 31, 1975, discharge at station 04086000. Station 04086000 (33 years of record) was used to make this adjustment because of the short period of record at station 04085427 (3 years of record). Using this method, the long-term mean annual discharge at site M 9 is estimated to be 27 ft<sup>3</sup>/s (0.76 m<sup>3</sup>/s).
