DISCUSSION

The accompanying map gives an inventory of the 1969 soil-slip scars and debris-flow channels and deposits in part of the Santa Clara River valley area. The map was prepared by interpretation of morphological features visible on high-quality black-and-white stereoscopic aerial photographs taken in August 1967 and July 1969 (scale 1:32,000). Only those features visible on the photographs were used in the determination of the nature and extent of the surficial units; only brief, widely scattered field checks were made.

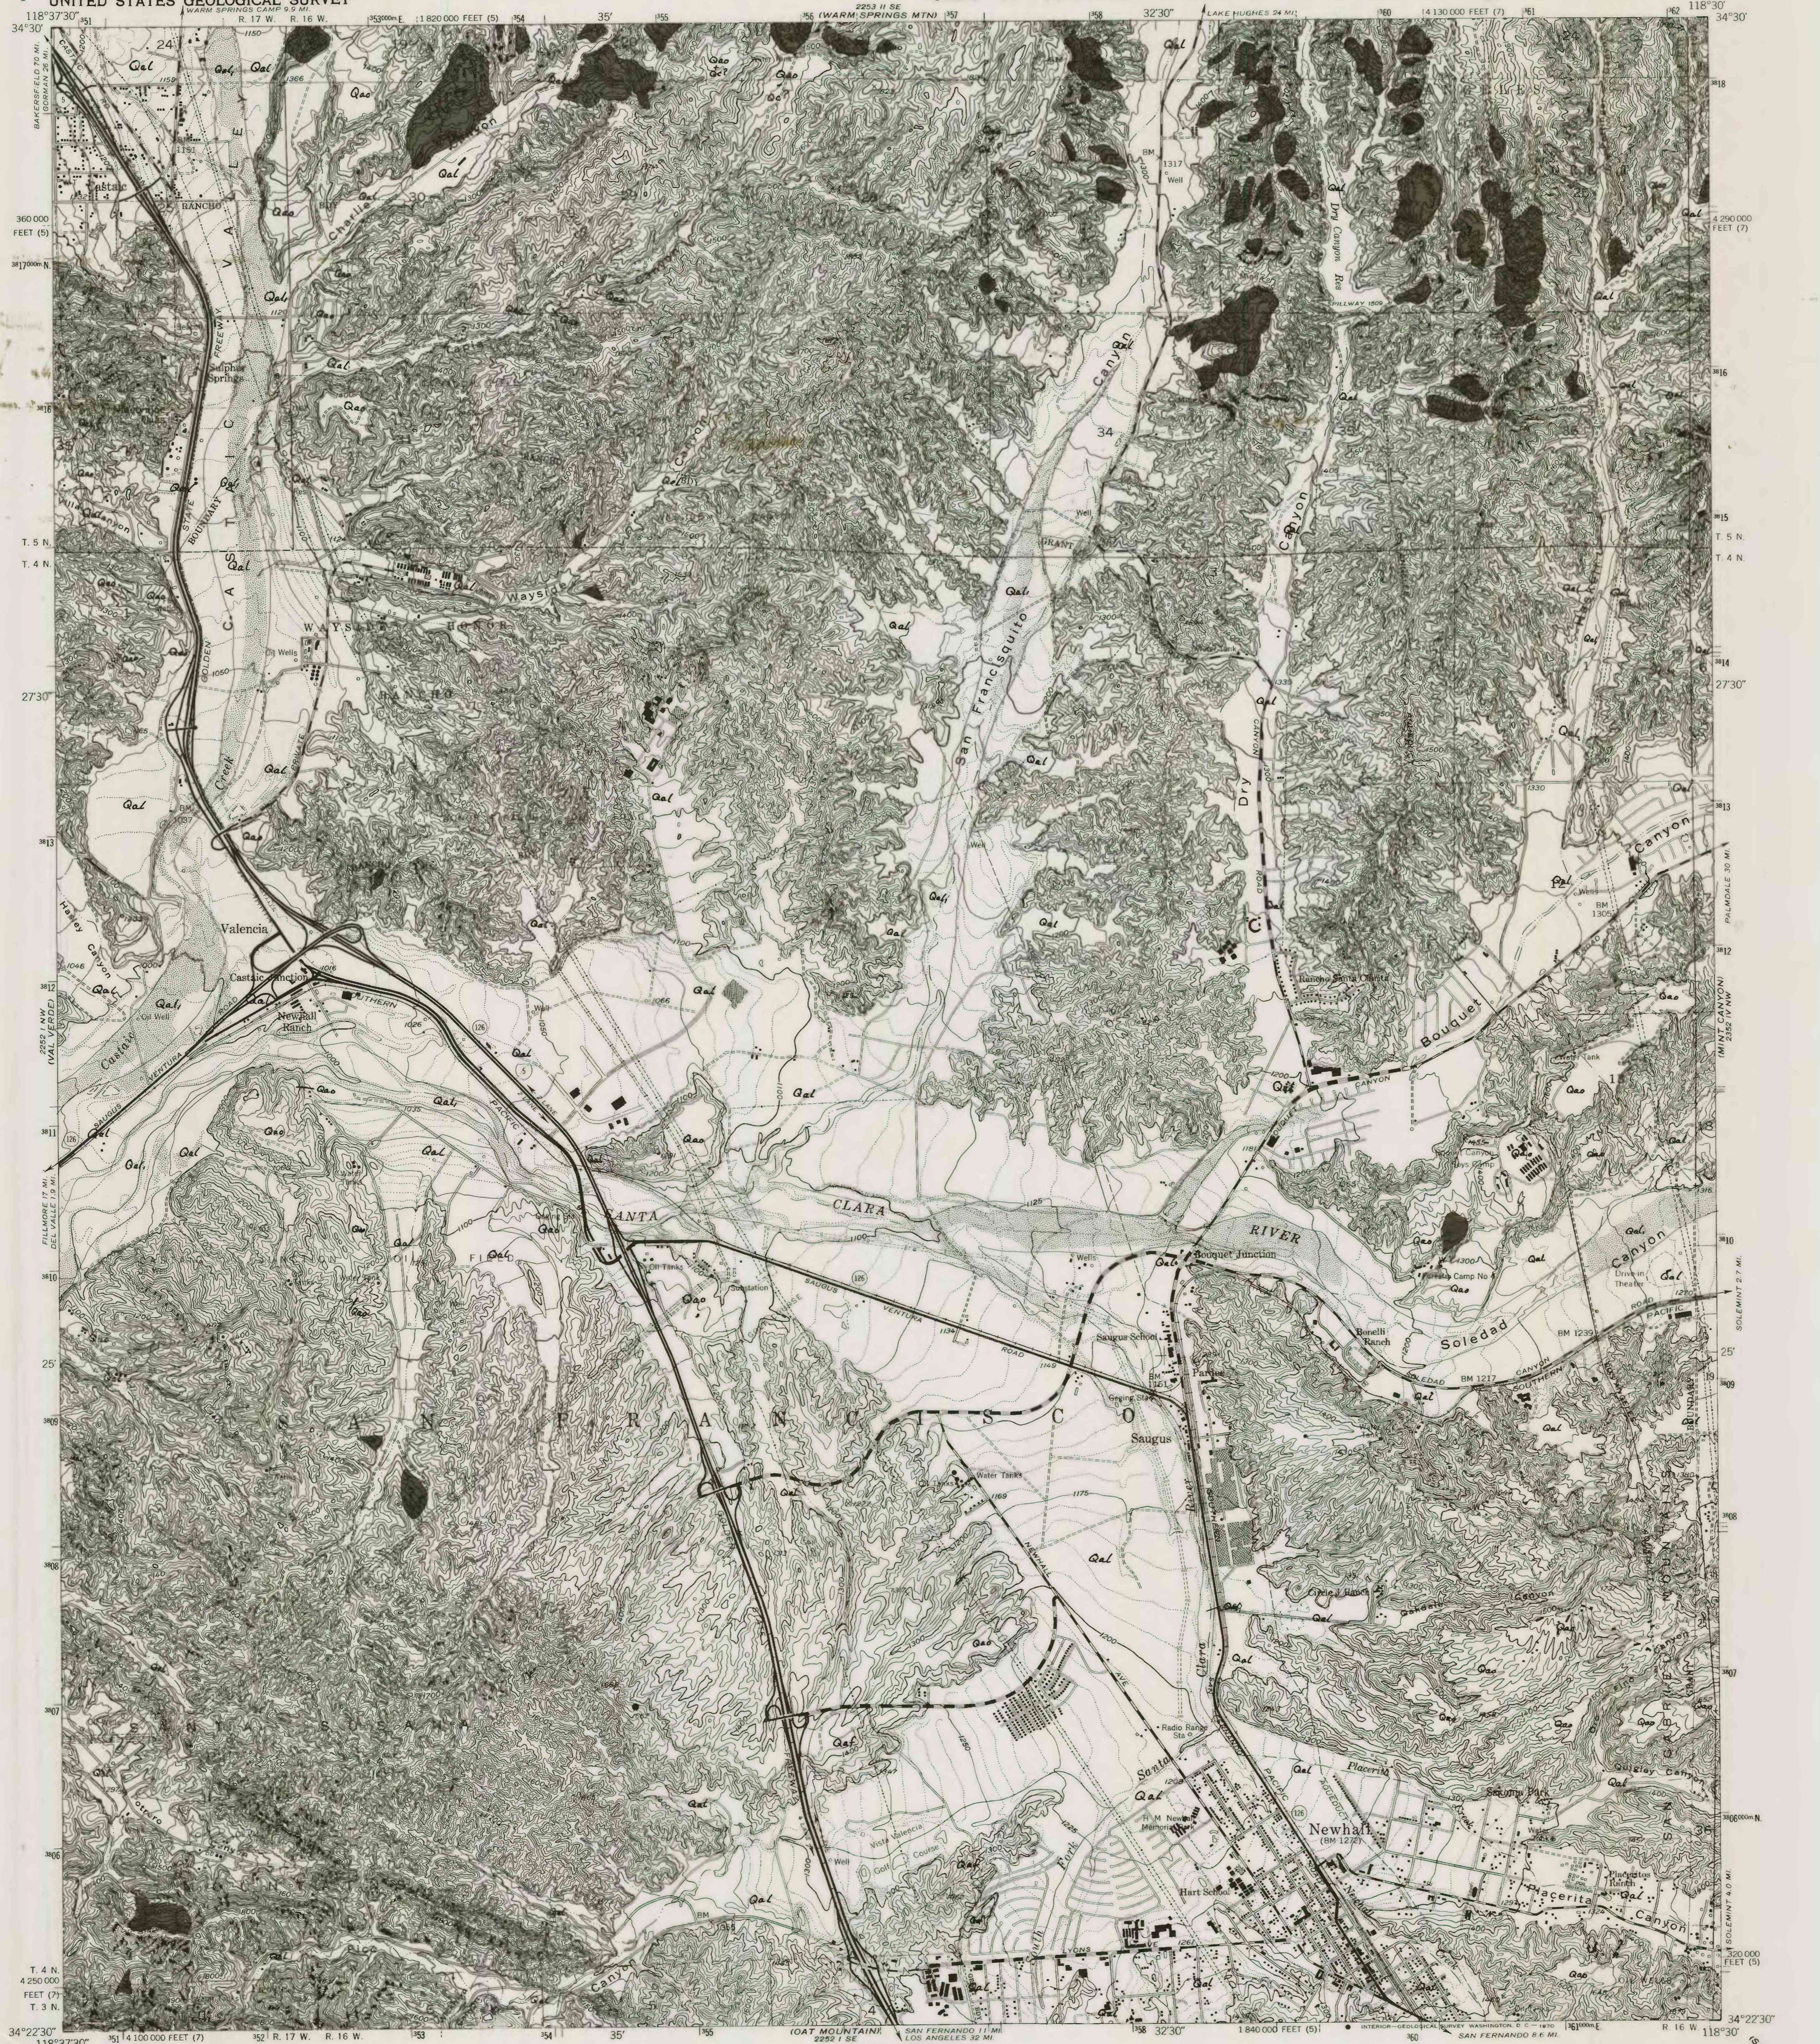
The map does not distinguish between areas of soil-slip scars, routes of subsequent debris flows, or areas of debris-flow deposition—all are included together. Most of the distinguishable debris-flow scars and deposits were confined to first- through third-order stream basins (Strahler, 1962), although some of the distinguishable largest flows are in higher-order basins. Most of the material transported by debris flows will eventually be transported onto major valley floors by fluvial flow.

Some large composite landslides, measured in square miles of areal extent, are difficult to recognize simply because they are so large. Such large landslides commonly contain obvious small satellite landslides that tend to attract attention away from the larger landslide. Landslides smaller than about 300 ft in maximum dimension were difficult to see on the photographs; those suspected of being landslides are marked by a query and are not bounded by contact lines. Areas with morphological features suggestive of but not definitely known to be landslides are queried. Some landslides too narrow to be shown accurately at the scale of this map are indicated by a single arrow. Within large landslides, internal satellite landslides and scarps are shown where they could be identified. Bedrock is not labeled.

Recognition and accuracy of delineation of the surficial deposits depends on: (1) age—the younger the feature, the more visible its morphology; (2) extent of areas concealed by deep shadow; (3) sun angle at time of photography; (4) height and density of vegetation; and (5) degree to which man has modified the landscape. Generally, the younger landslides have clearer, more distinctive landslide morphology. With increasing age a landslide is progressively modified and tends to blend with the normal morphology of the surrounding landscape; consequently the viewer's ability to recognize and delineate the landslide is diminished. Recognition based on surface features ceases completely with full integration of the landslide into the surroundings. Field observations also commonly fail to detect landslides largely or entirely integrated into the landscape. Such eroded landslides generally are recognized only in artificial exposures such as those produced by hillside grading operations.

Readily visible features of many landslides are the scarp and crown line. Distal and lower lateral limits are commonly difficult to identify on aerial photographs because: (1) erosion has modified or removed the distal part; (2) vegetation or shadow obscures the topographically low areas; or (3) the toe and lower lateral margins never formed distinctive morphology (some "incipient" landslides have well-defined scarps but did not develop distal parts).
