OAT MOUNTAIN, CALIF.
SE 1/4 SANTA SUSANA 10' QUADRANGLE
N3415-W11830/7.5

RECONNAISSANCE SURFICIAL GEOLOGIC MAPS OF THE NEWHALL, OAT MOUNTAIN, SANTA SUSANA, AND VAL VERDE 7.5' QUADRANGLES, LOS ANGELES AND VENTURA COUNTIES, SOUTHERN CALIFORNIA

by Douglas M. Morton 1976

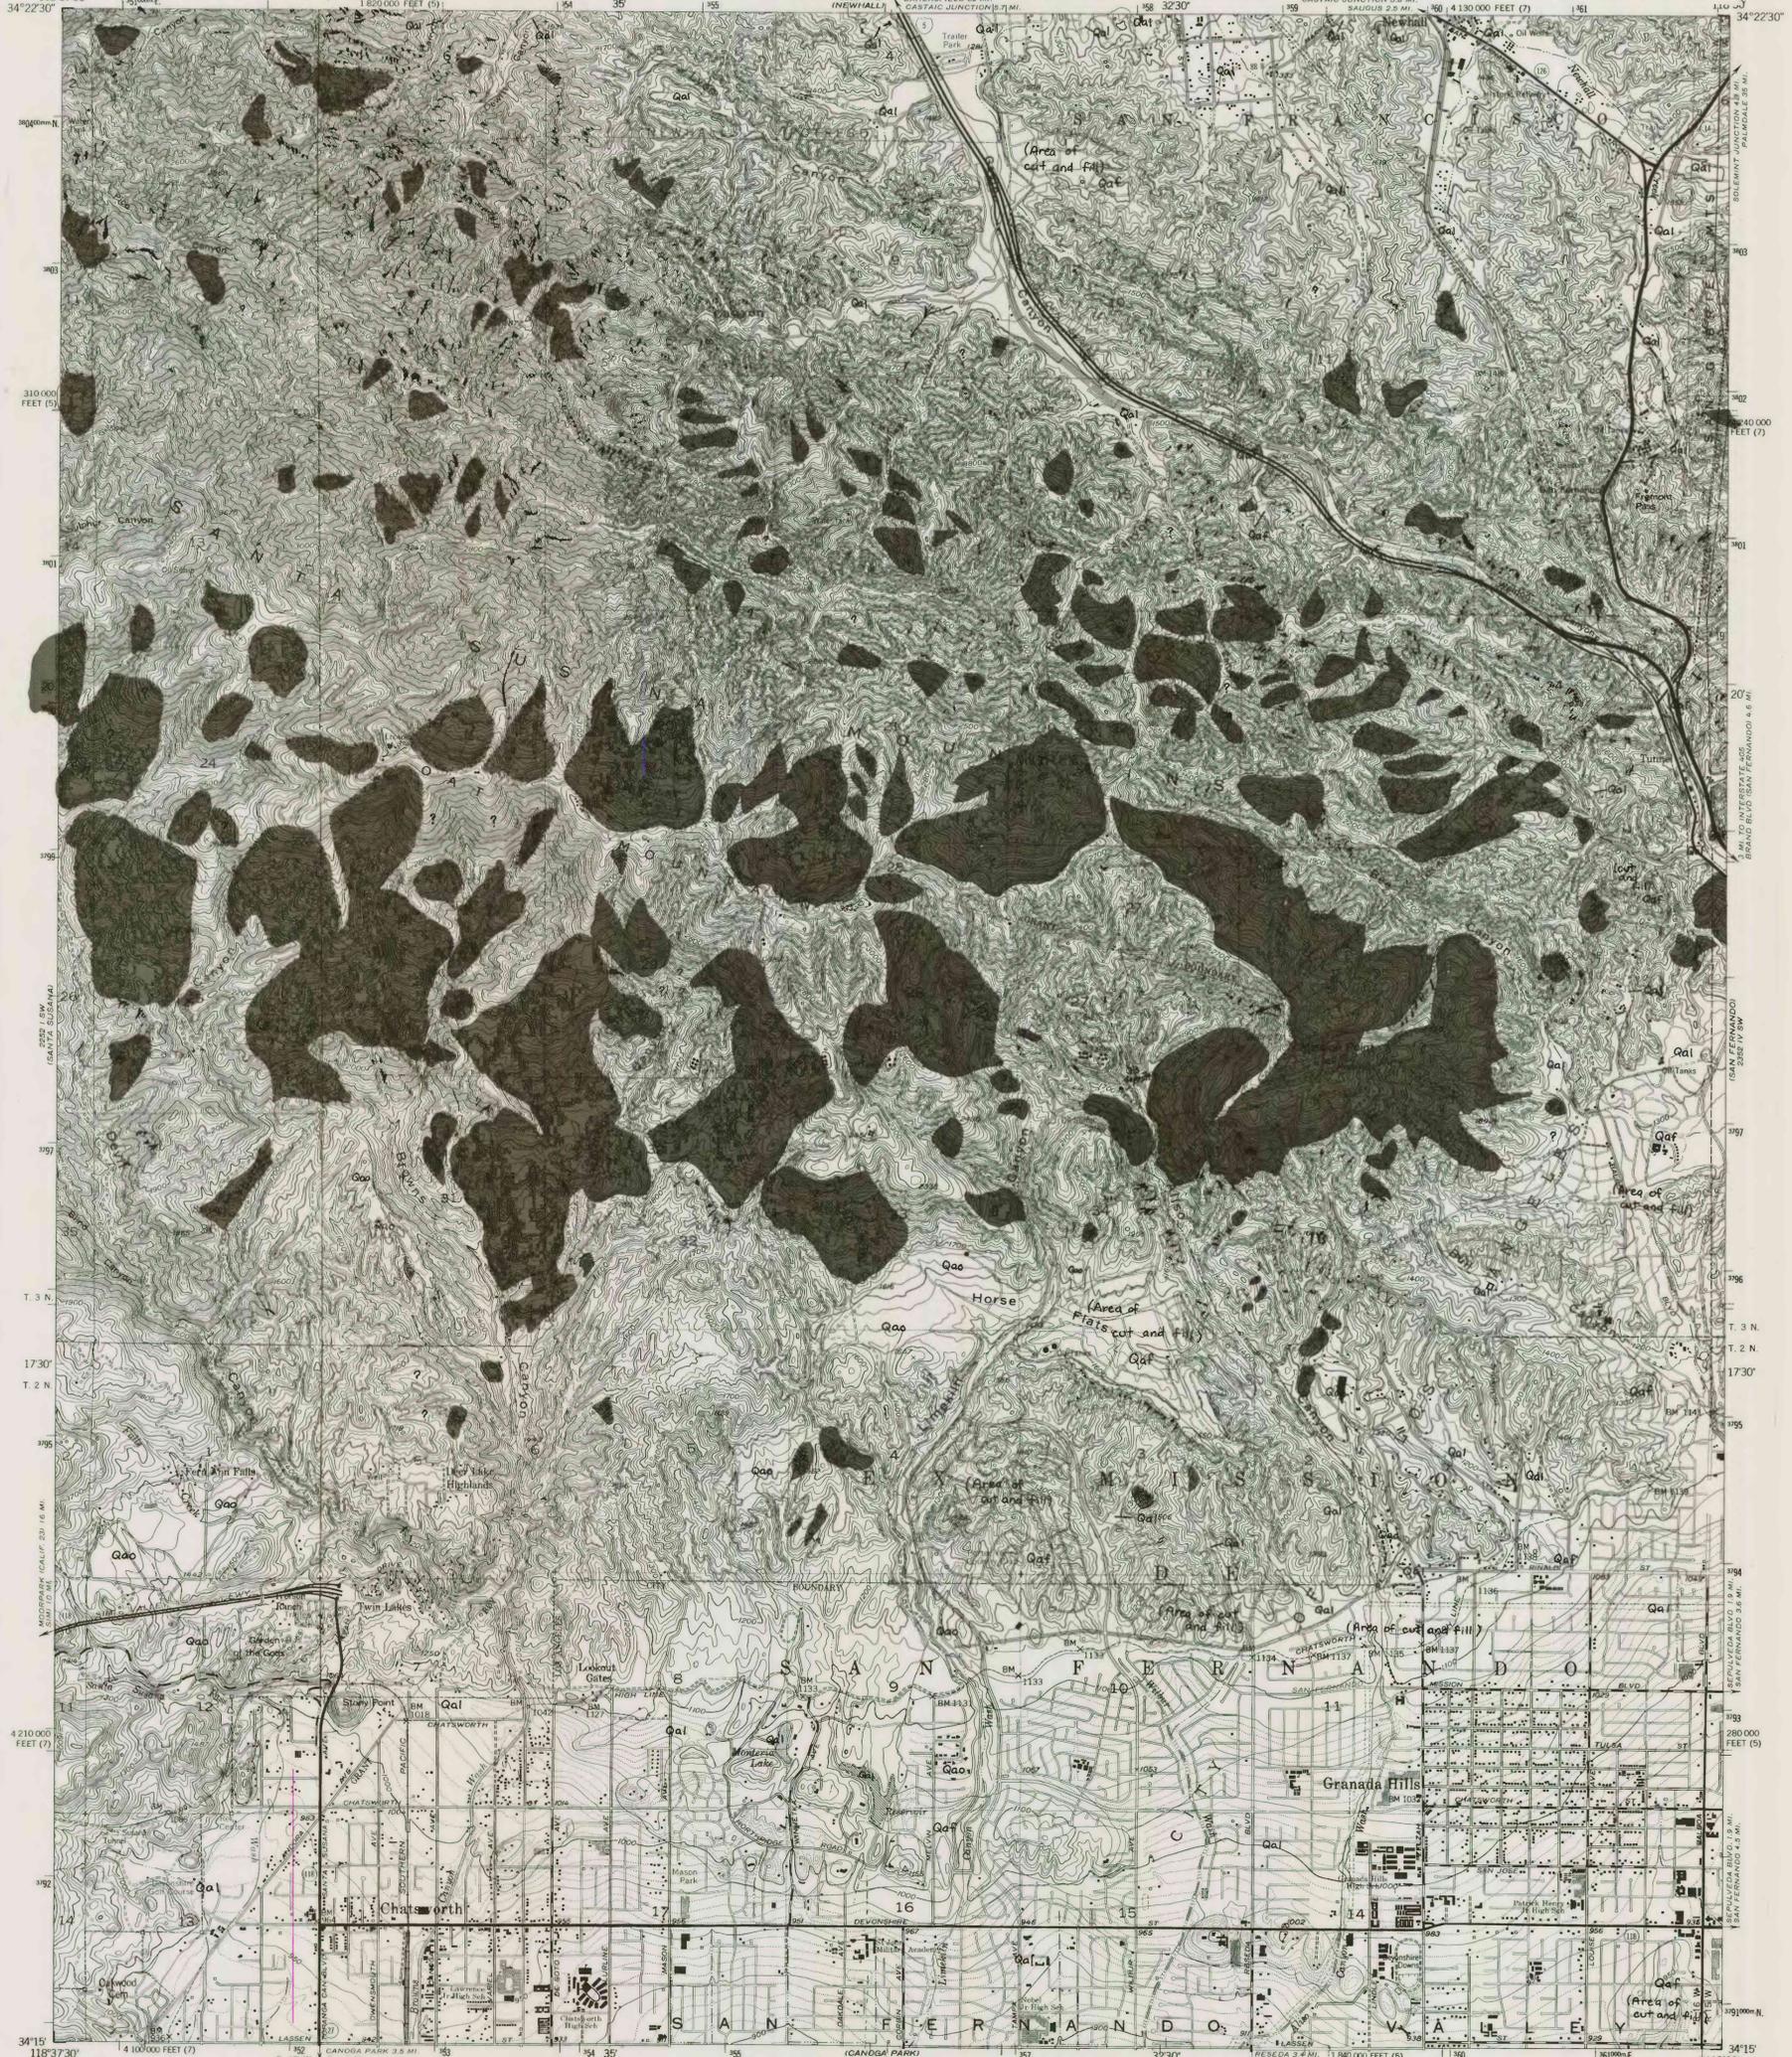
Only a few landslides other than soil slips formed in the mapped area during the spring of 1969. A few slump failures developed, most of which were reactivated pre-1969 landslides or new failures of landslide material within a part of a pre-1969 landslide deposit.

The accompanying map gives an inventory of the 1969 soil-slip scars and debris-flow channels and deposits in part of the Santa Clara River valley area. The map was prepared by interpretation of morphological features visible on high-quality black-and-white stereographic aerial photographs taken in August 1967 and July 1969 (scale 1:32,000). Only those features visible on the photographs were used in the determination of the nature and extent of the surficial units; only brief, widely scattered field checks were made.

The map does not distinguish between areas of soil-slip scars, routes of subsequent debris flows, or areas of debris-flow deposition—all are included together. Most of the distinguishable debris-flow scars and deposits were confined to first- through third-order stream basins (Strahler, 1952), although some of the distinguishable largest flows are in higher order basins. Most of the material transported by debris flows will eventually be transported onto major valley floors by fluvial flow.
