Fig. 11. Location and alignment of trenches and location of wells in Burial Ground 5-South (from Oak Ridge National Laboratory Engineering Drawing C-20923-EA-002-E)

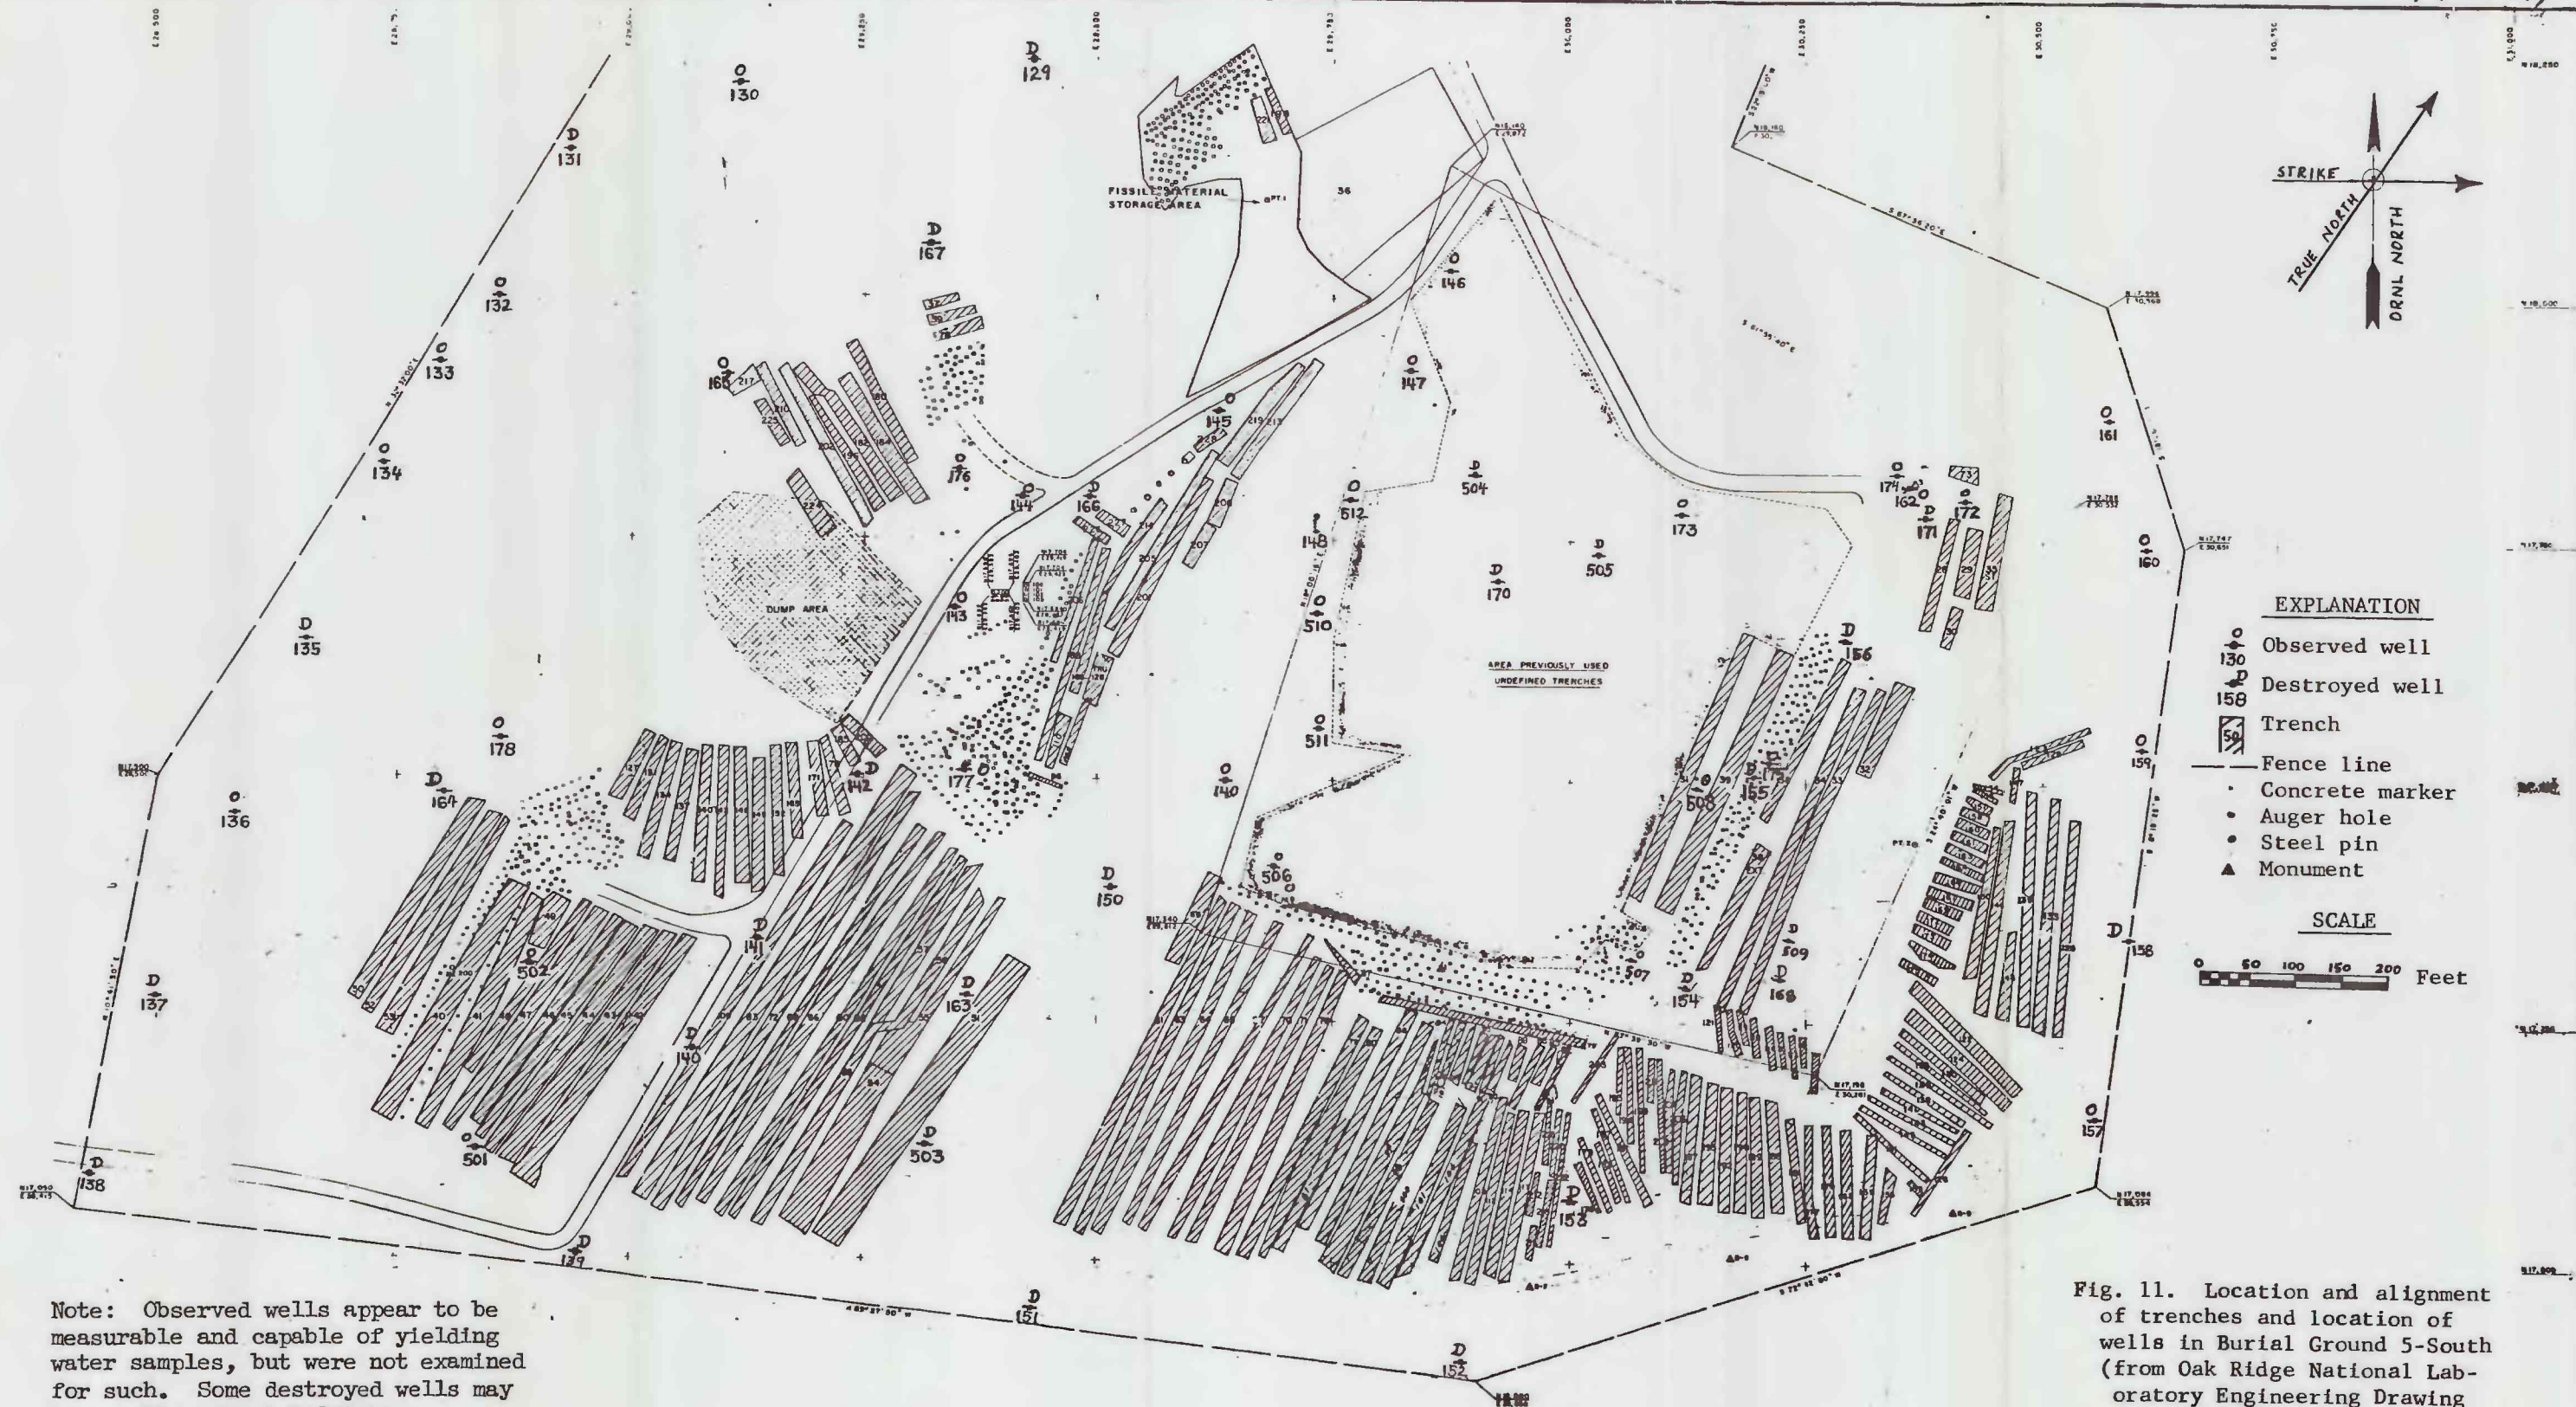
Note: Observed wells appear to be measurable and capable of yielding water samples, but were not examined for such. Some destroyed wells may be capable of rehabilitation. Location of wells is approximate.
