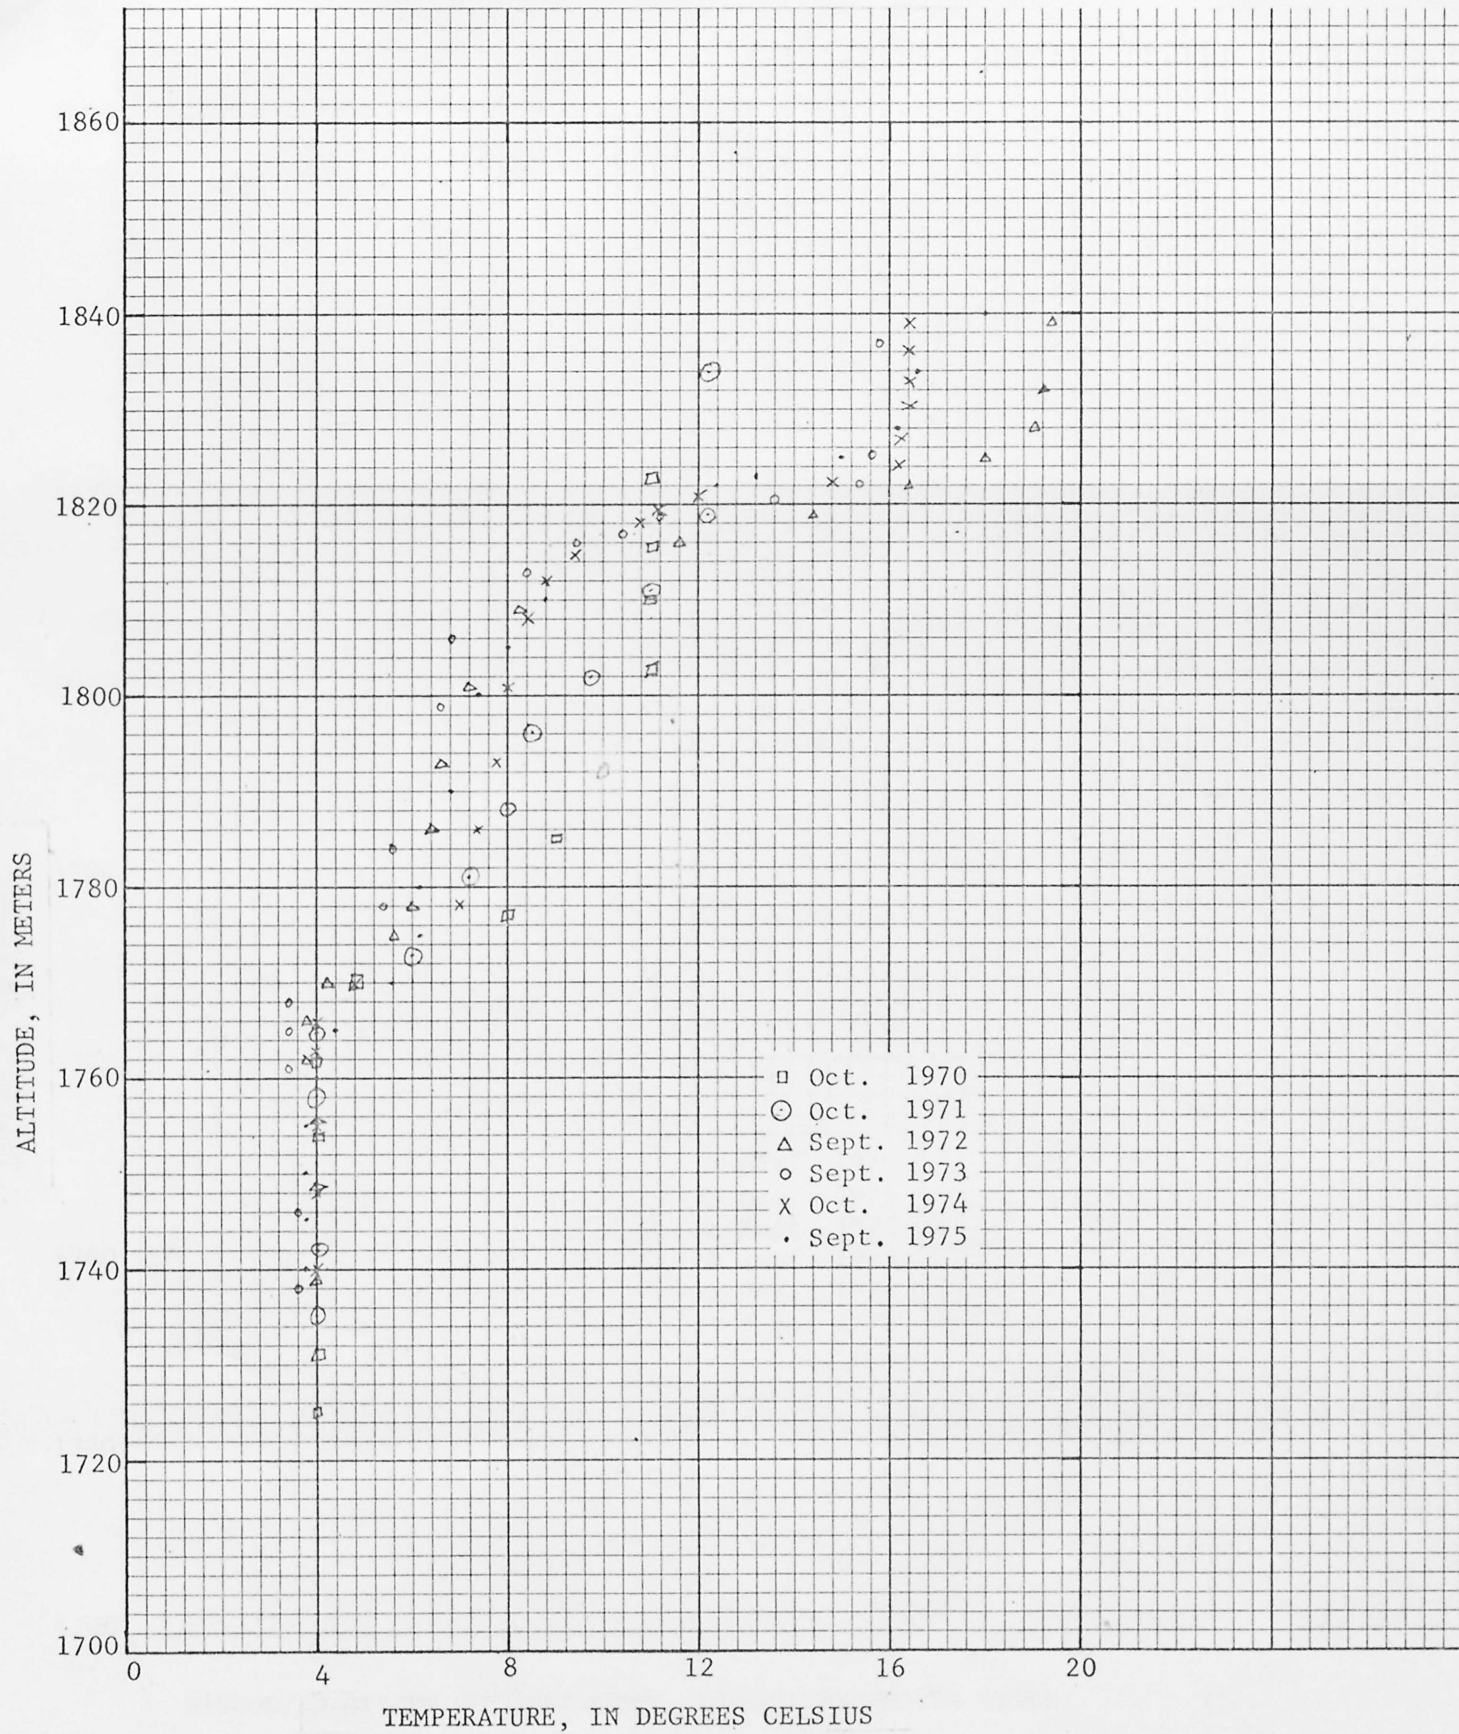
Figure 6.--Temperature, dissolved-oxygen concentration, and specific-conductance profiles at site 1 in Flaming Gorge Reservoir.
