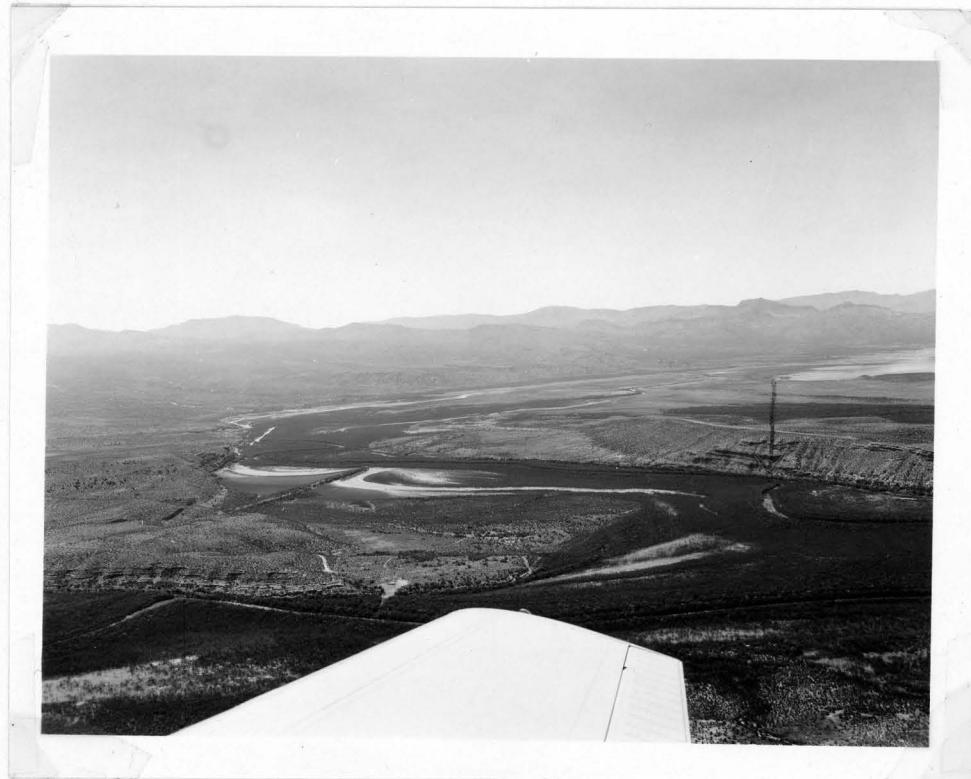
Figure 13.--View of the San Carlos Reservoir looking southwest. The San Carlos River enters the reservoir just beyond the ridge extending across the right center of the photograph. Note the off-channel ponds. The channel of the Gila River has been plugged (arrow). The elevated ridge parallel to the leading edge of the airplane wing (left center) is the fill for the approaches to an abandoned railroad bridge. Photographed April 20, 1965.
