LANDSLIDES AND RELATED FEATURES

OF THE BRIDGEVILLE, PA. QUADRANGLE

WILLIAM E. DAVIES and JOHN S. POMEROY

OPEN FILE MAP 78-1057 (C-16)

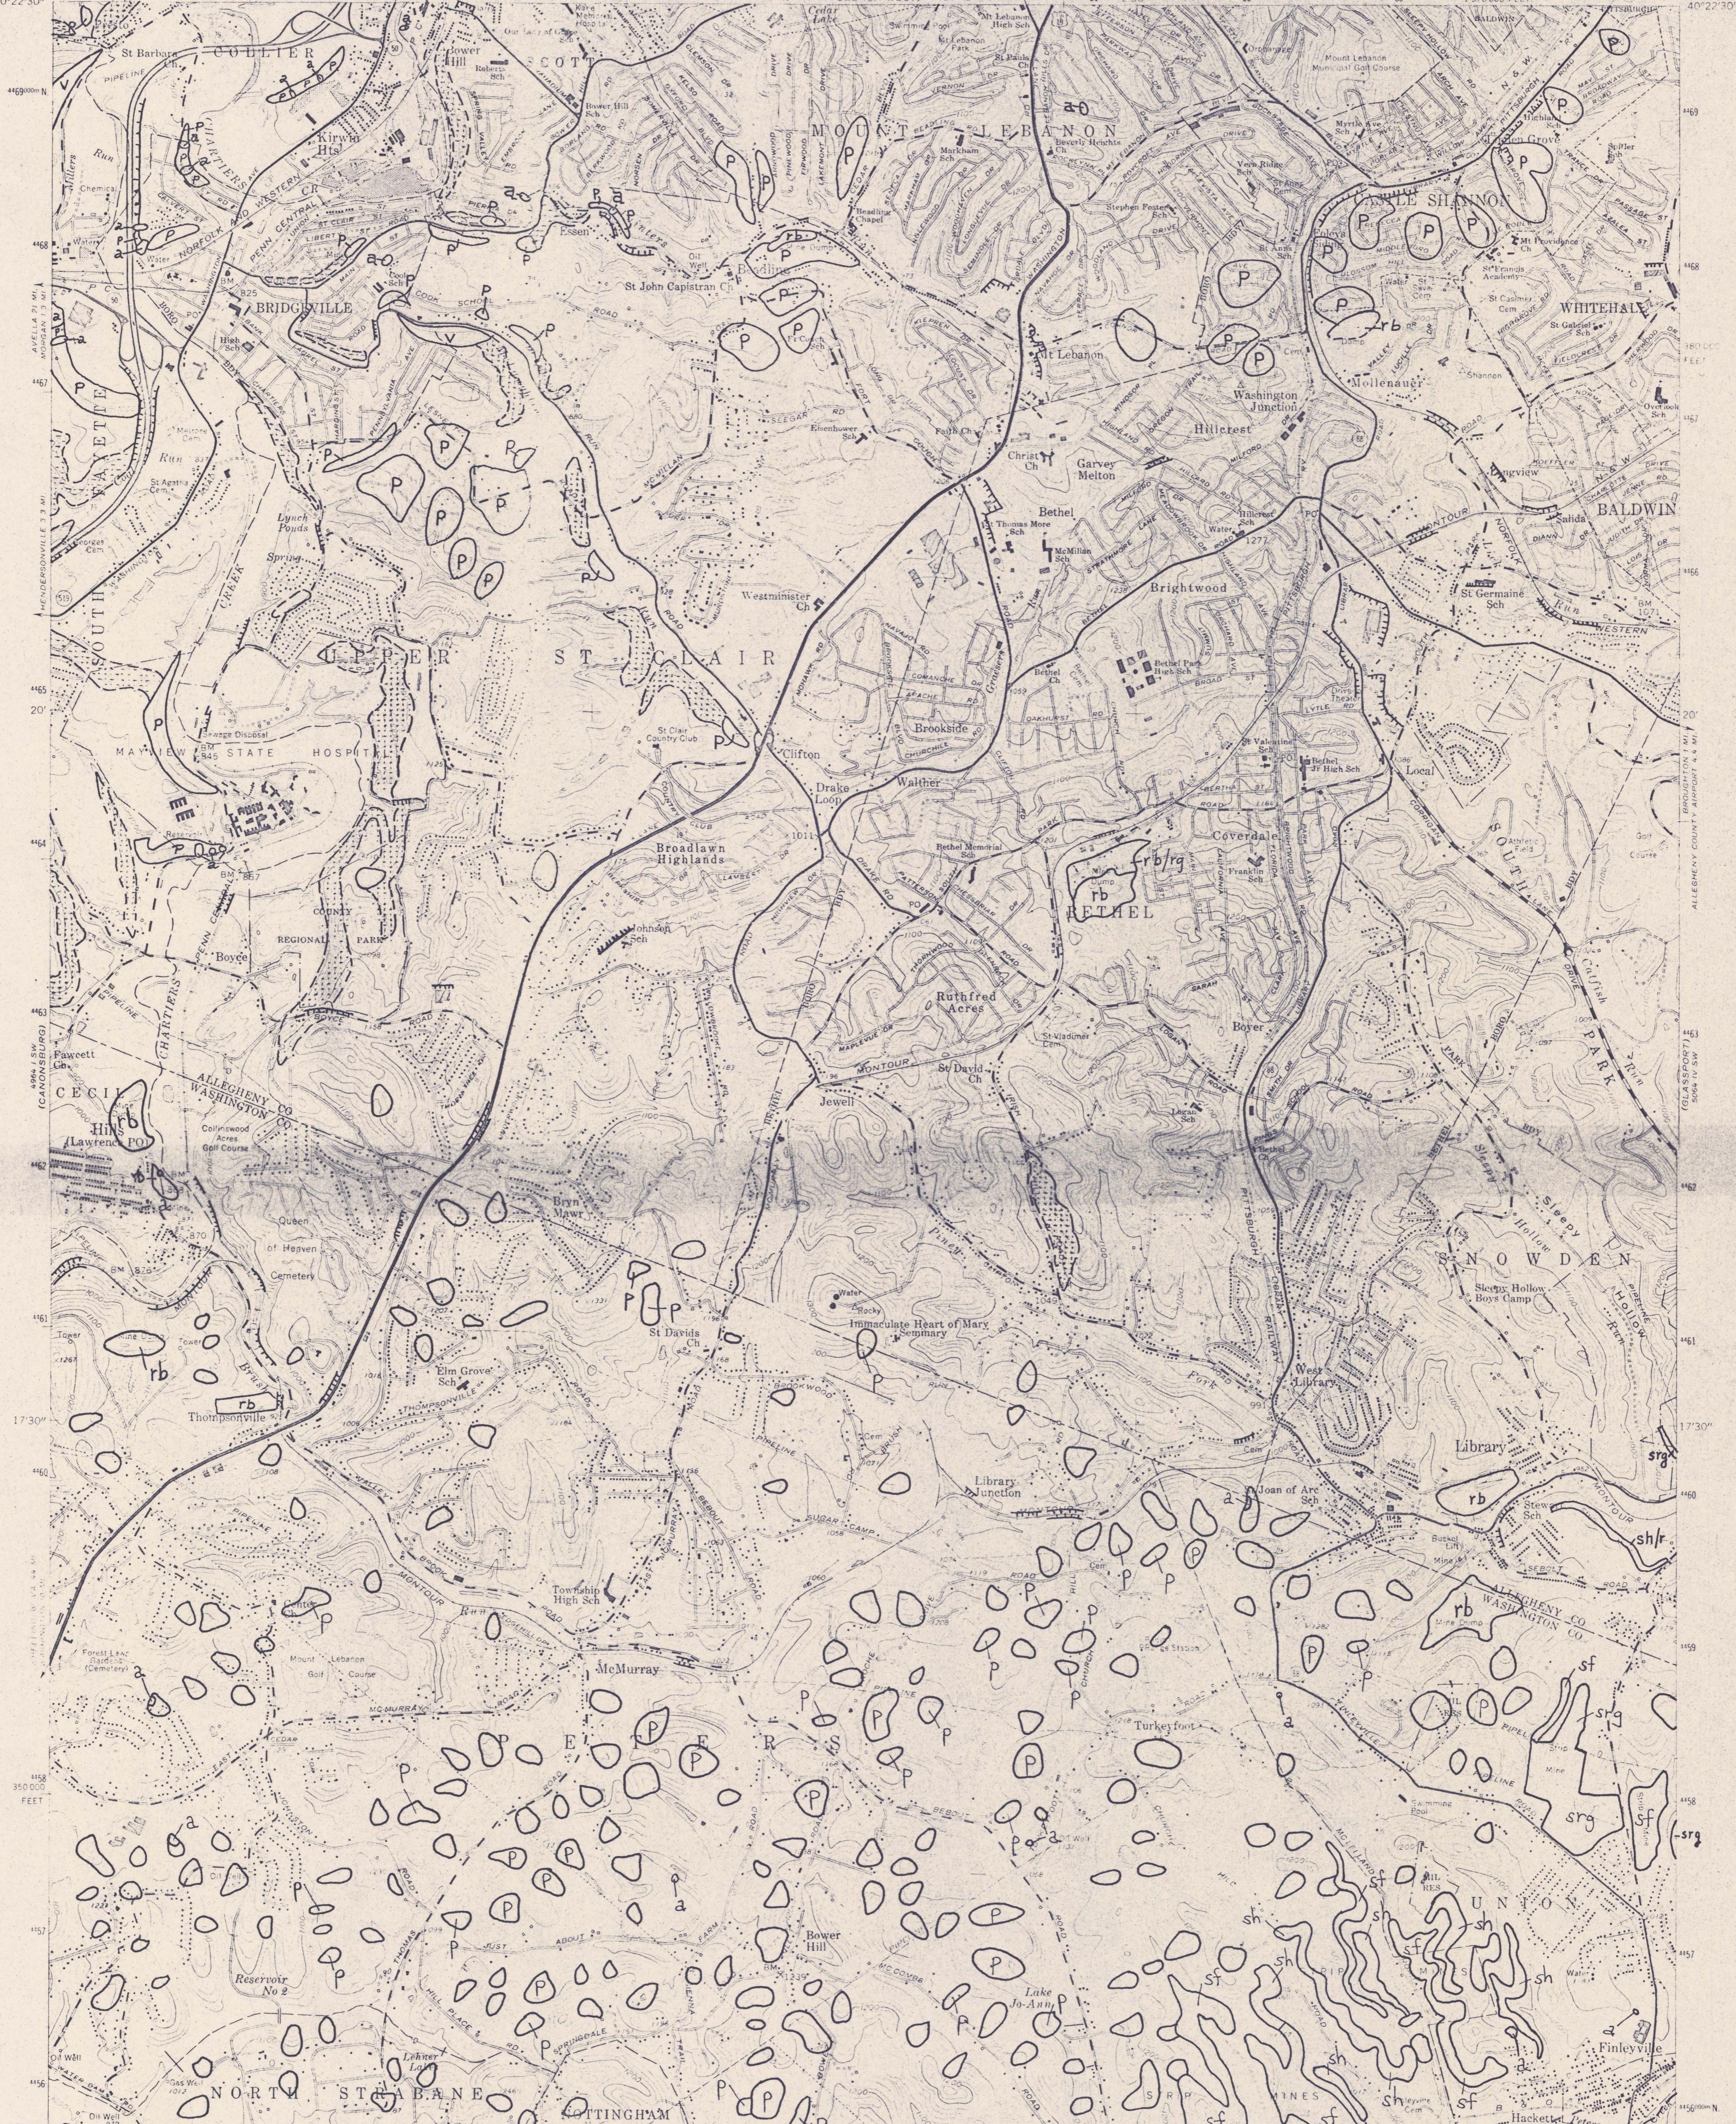
ACTIVE OR RECENTLY ACTIVE LANDSLIDE
Complex landslide composed of earthflow, debris slide,
earth and rock slump. Identified from historical
records, and from scars, debris and other field evidence.
Ground extremely unstable; sliding accelerated
by excavation, loading and changes in drainage
conditions. May include areas with several active
slides too small to be shown separately. Questioned
where doubtful.

LANDSLIDE
Area of extensive hummocky ground caused by earthflow
and earth and rock slump. Lacks clear evidence of
active sliding. Relatively stable in natural, undisturbed state, generally not affected by small structures
properly sited in areas away from the edge of the toe;
can be reactivated by extensive, rapid excavation,
loading, and changes in ground water and surface water
conditions. Area of old landslide probably includes
recent ones not identified from field evidence or
otherwise documented. Upslope boundary of landslide
generally defined by modified scarp, but downslope
(toe) may be gradational and not well defined. Questioned
where doubtful.

COLLUVIAL SLOPE
Valley wall along major streams with slope as steep
as 40° (85%); stony, clayey silt soil up to 50 ft.
(15 m) thick; commonly buttressed by a terrace or
bench at the toe of the slope; very susceptible
to sliding by cutting of toe area, removal of terrace
or bench, and overloading; landslide commonly acti-
vated without apparent cause.

AREAS SUSCEPTIBLE TO DEBRIS FLOWS AND DEBRIS AVALANCHES
Primarily shallow, narrow ravines and chutes with
accumulation of stony colluvium generally 10 ft. (3 m)
or less in thickness; susceptible to rapid movement
during intense rainfall. Most ravines designated
show evidence of former debris flows and avalanches.
Symbol - **a** - designates historical debris flow or
debris avalanche.

NOTE
Information shown is intended as a
general guide to ground conditions as of
the date of field check. Additional
landslides and rockfalls should be anticipated
in all map units. The map unit depicts
the dominant condition in the area
delimited and variations in slope stability
may occur at any point in the unit. This
map is suitable for general planning
purposes and as a supplement to more
detailed studies for site selection. The
map cannot be used as a substitute for
detailed geologic and engineering inves-
tigations to establish design and
construction criteria of specific sites.
Some symbols may not appear on this map because
the description is applicable to a series of maps.
