SCIO, OHIO
NE 1/4 SCIO 15' QUADRANGLE
N 4022.5 - W 8100/7.5

LANDSLIDES AND RELATED FEATURES
OF THE SCIO, OHIO QUADRANGLE

WILLIAM E. DAVIES AND GREGORY C. OHLMACHER

U. S. Geological Survey
OPEN FILE MAP 78-1057(D-8)

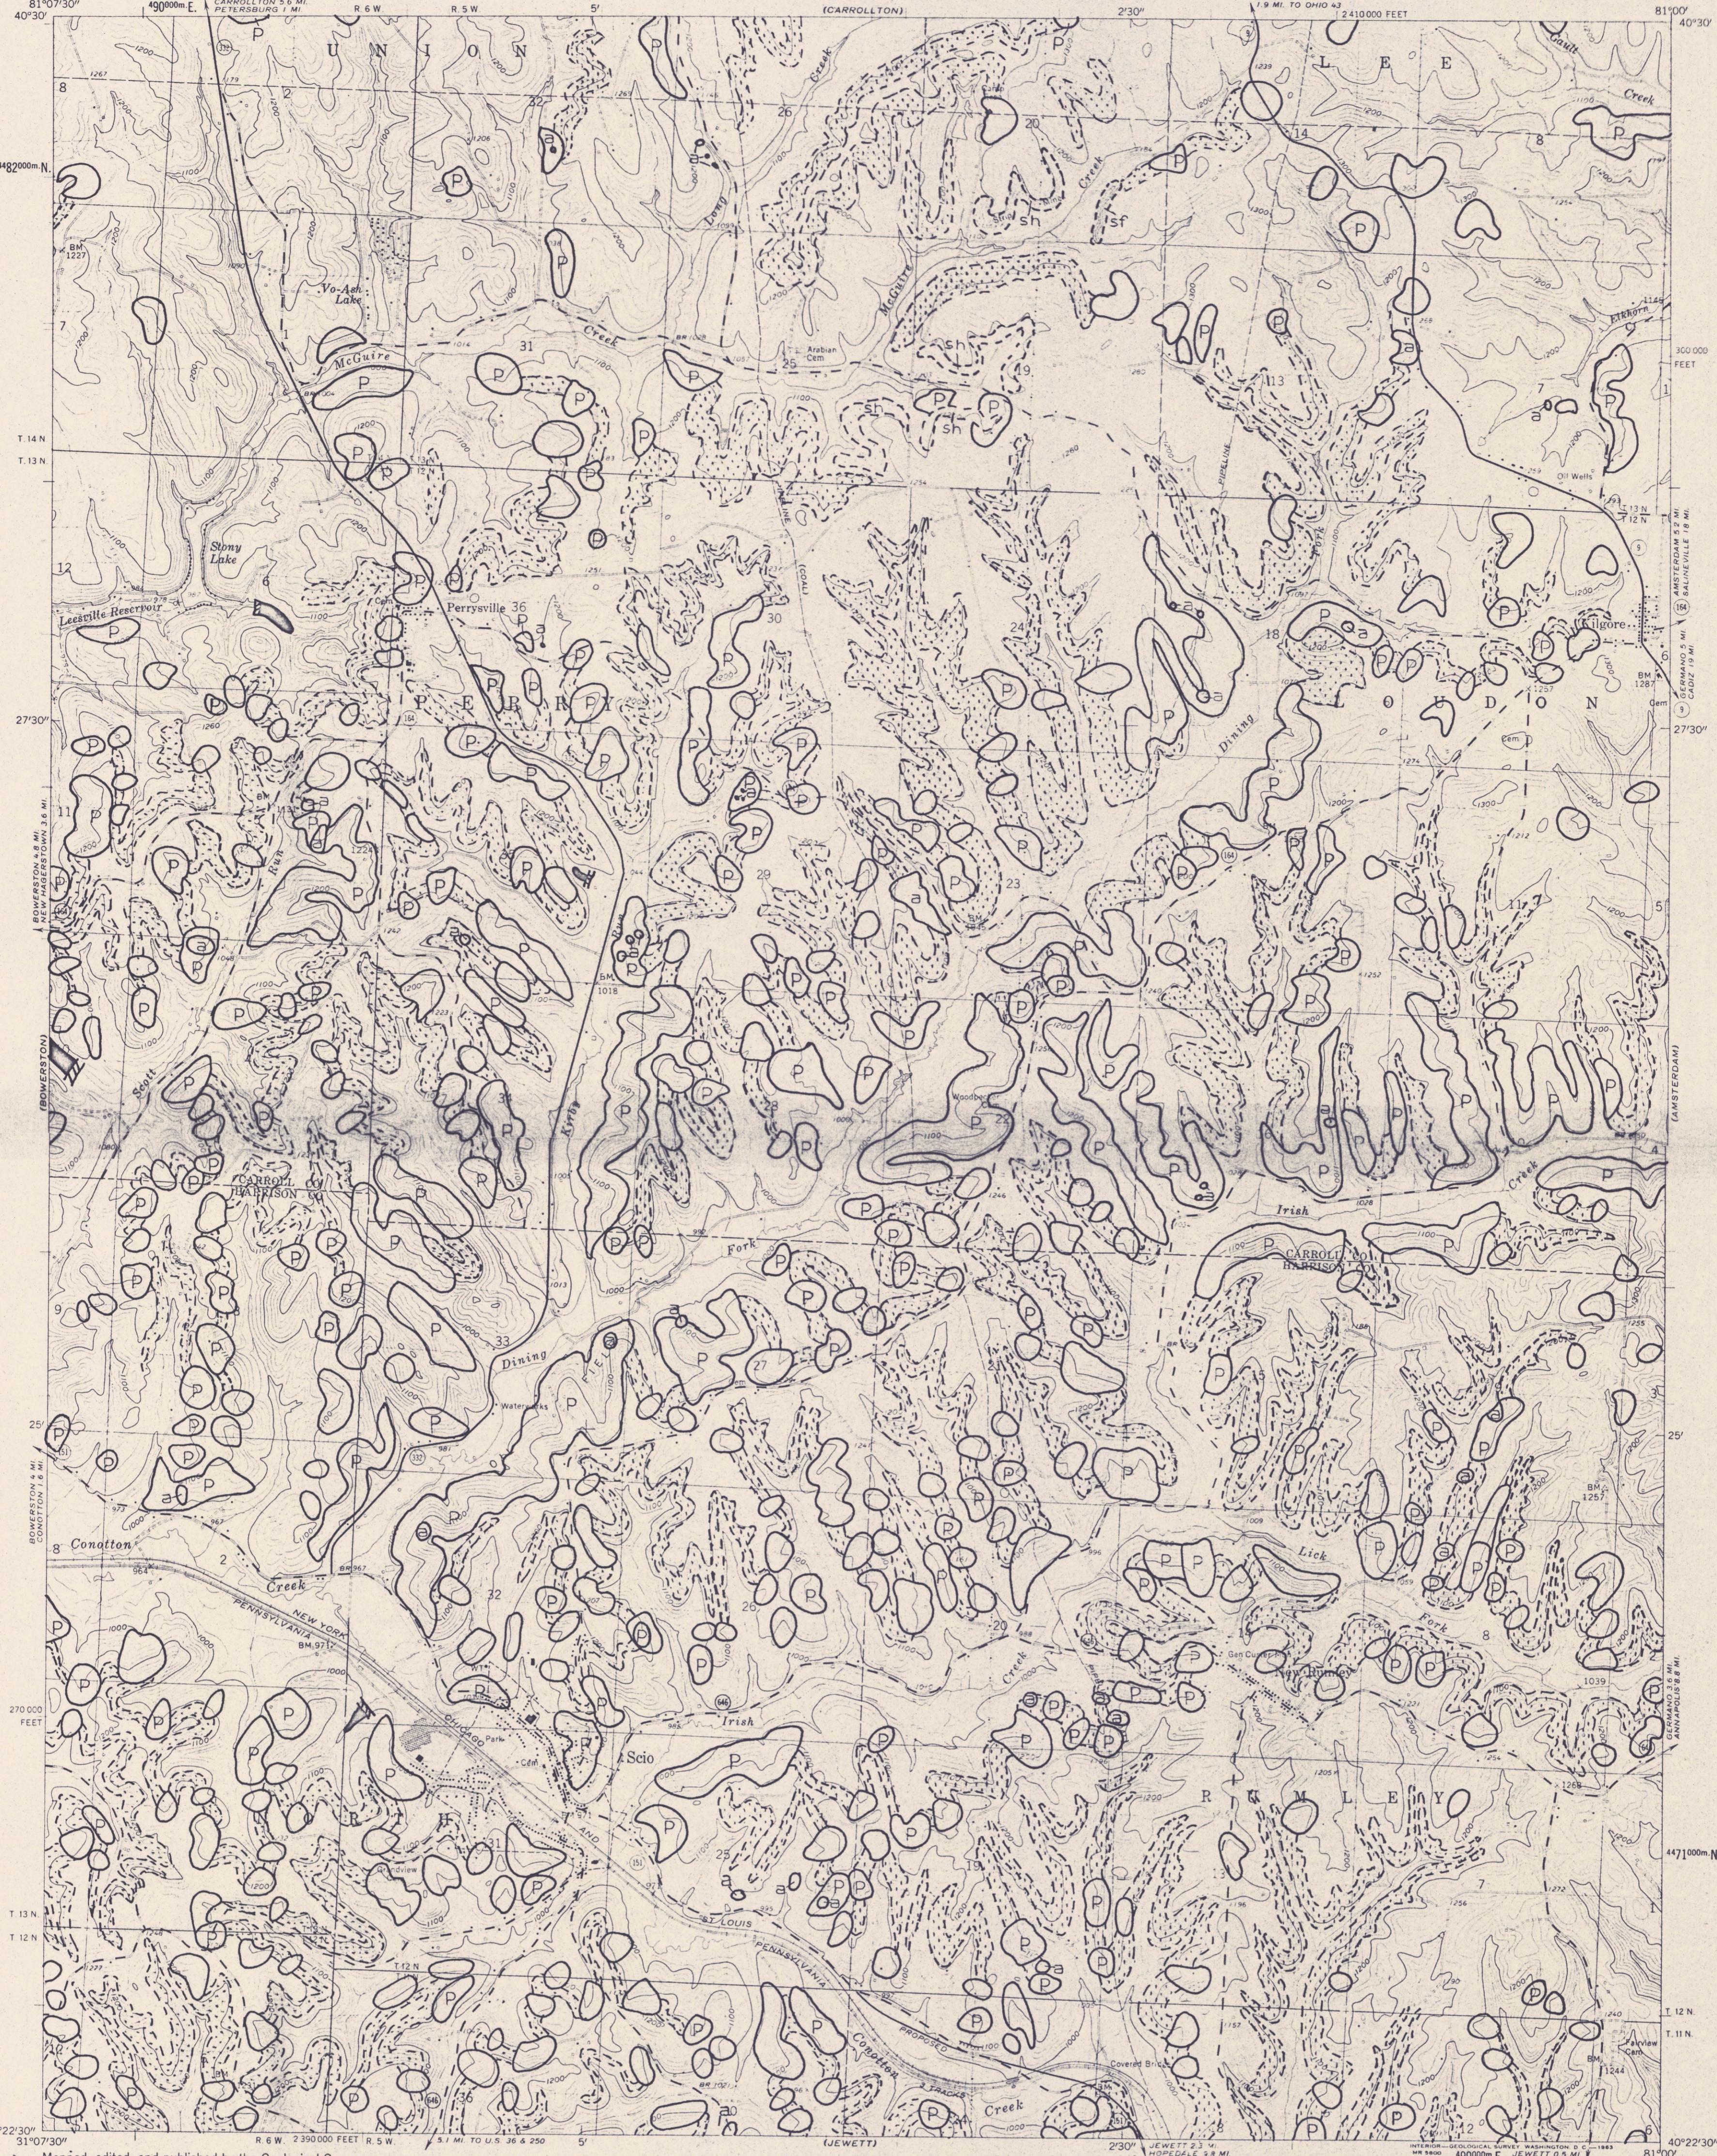
Landslides and related features interpreted
from aerial photographs:

Photointerpretation and field check 1976.
This map has not been edited or reviewed
for conformity with Geological Survey
standards and nomenclature.

ACTIVE OR RECENTLY ACTIVE LANDSLIDE

Complex landslide composed of earthflow, debris slide,
earth and rock slump. Identified from historical
records, and from scars, debris and other field evi-
dence. Ground extremely unstable; sliding accelerated
by excavation, loading and changes in drainage
conditions. May include areas with several active
slides too small to be shown separately. Questioned
where doubtful.

LANDSLIDE

Area of extensive hummocky ground caused by earthflow
and earth and rock slump. Lacks clear evidence of
active sliding. Relatively stable in natural, undis-
turbed state, generally not affected by small structures
properly sited in areas away from the edge of the toe;
can be reactivated by extensive, rapid excavation,
loading, and changes in ground water and surface water
conditions. Area of old landslide probably includes
recent ones not identified from field evidence or
otherwise documented. Upslope boundary of landslide
generally defined by modified scarp, but downslope
(toe) may be gradational and not well defined. Questioned
where doubtful.

COLLUVIAL SLOPE

Valley wall along major streams with slope as steep
as 40° (85%); stony, clayey silt soil up to 50 ft.
(15 m) thick; commonly buttressed by a terrace or
bench at the toe of the slope; very susceptible
to sliding by cutting of toe area, removal of terrace
or bench, and overloading; landslide commonly acti-
vated without apparent cause.

AREAS SUSCEPTIBLE TO DEBRIS FLOWS AND DEBRIS AVALANCHES

Primarily shallow, narrow ravines and chutes with
accumulation of stony colluvium generally 10 ft. (3 m)
or less in thickness; susceptible to rapid movement
during intense rainfall. Most ravines designated
show evidence of former debris flows and avalanches.
Symbol - a - designates historical debris flow or
debris avalanche.

AREAS SUSCEPTIBLE TO ROCKFALL

Steep, locally vertical, natural and man-made
slopes and cliffs, 15 ft. (4.5 m) or higher,
formed dominantly of sandstone, limestone, sandy
shale, mudstone and claystone. Interbedded mud-
stone, claystone and shale weather rapidly leaving
sandstone and limestone rock faces unsupported.

COVE UNDERLAIN BY CLAY LAYER

Rounded or U-shaped valley with steep concave
slope of valley floor (coves) and valley
heads underlain by clayey soils forming a
coherent layer generally 8 ft. (2.5 m) or less
in thickness. Zone of water common at the
base of the clay layer is under 2 to 8 ft. (0.6 -
2.5 m) artesian head. Clay soil is underlain by
claystone and shale. Clay slab moves as a coher-
ent mass up to 1 ft. (0.3 m) per year; very
susceptible to more rapid sliding when overloaded
by fill or structure, or by excavations that break
the continuity of slope. Recent soil slips (earth
flows) as much as 40,000 square feet (3,700 square
meters) in size are common.

SOIL AND ROCK SUSCEPTIBLE TO LANDSLIDES

Soil and rock similar to that involved in
landslides elsewhere in map area; primarily
areas underlain by claystone, mudstone and
shale associated with other rock types. Rock
weathers rapidly on exposure forming clayey soil
highly susceptible to sliding.

AREAS LEAST PRONE TO LANDSLIDES

Map areas in which no patterns or symbols are
shown; primarily valley floors, ridge tops and
broad benches; modification by excavation and
fill may lead to local landslides.
