M(200)R290 no.78-1057 Slides in man-made features a/f earth flow in fill

Sugarcreek, OH no. E-3 c.1

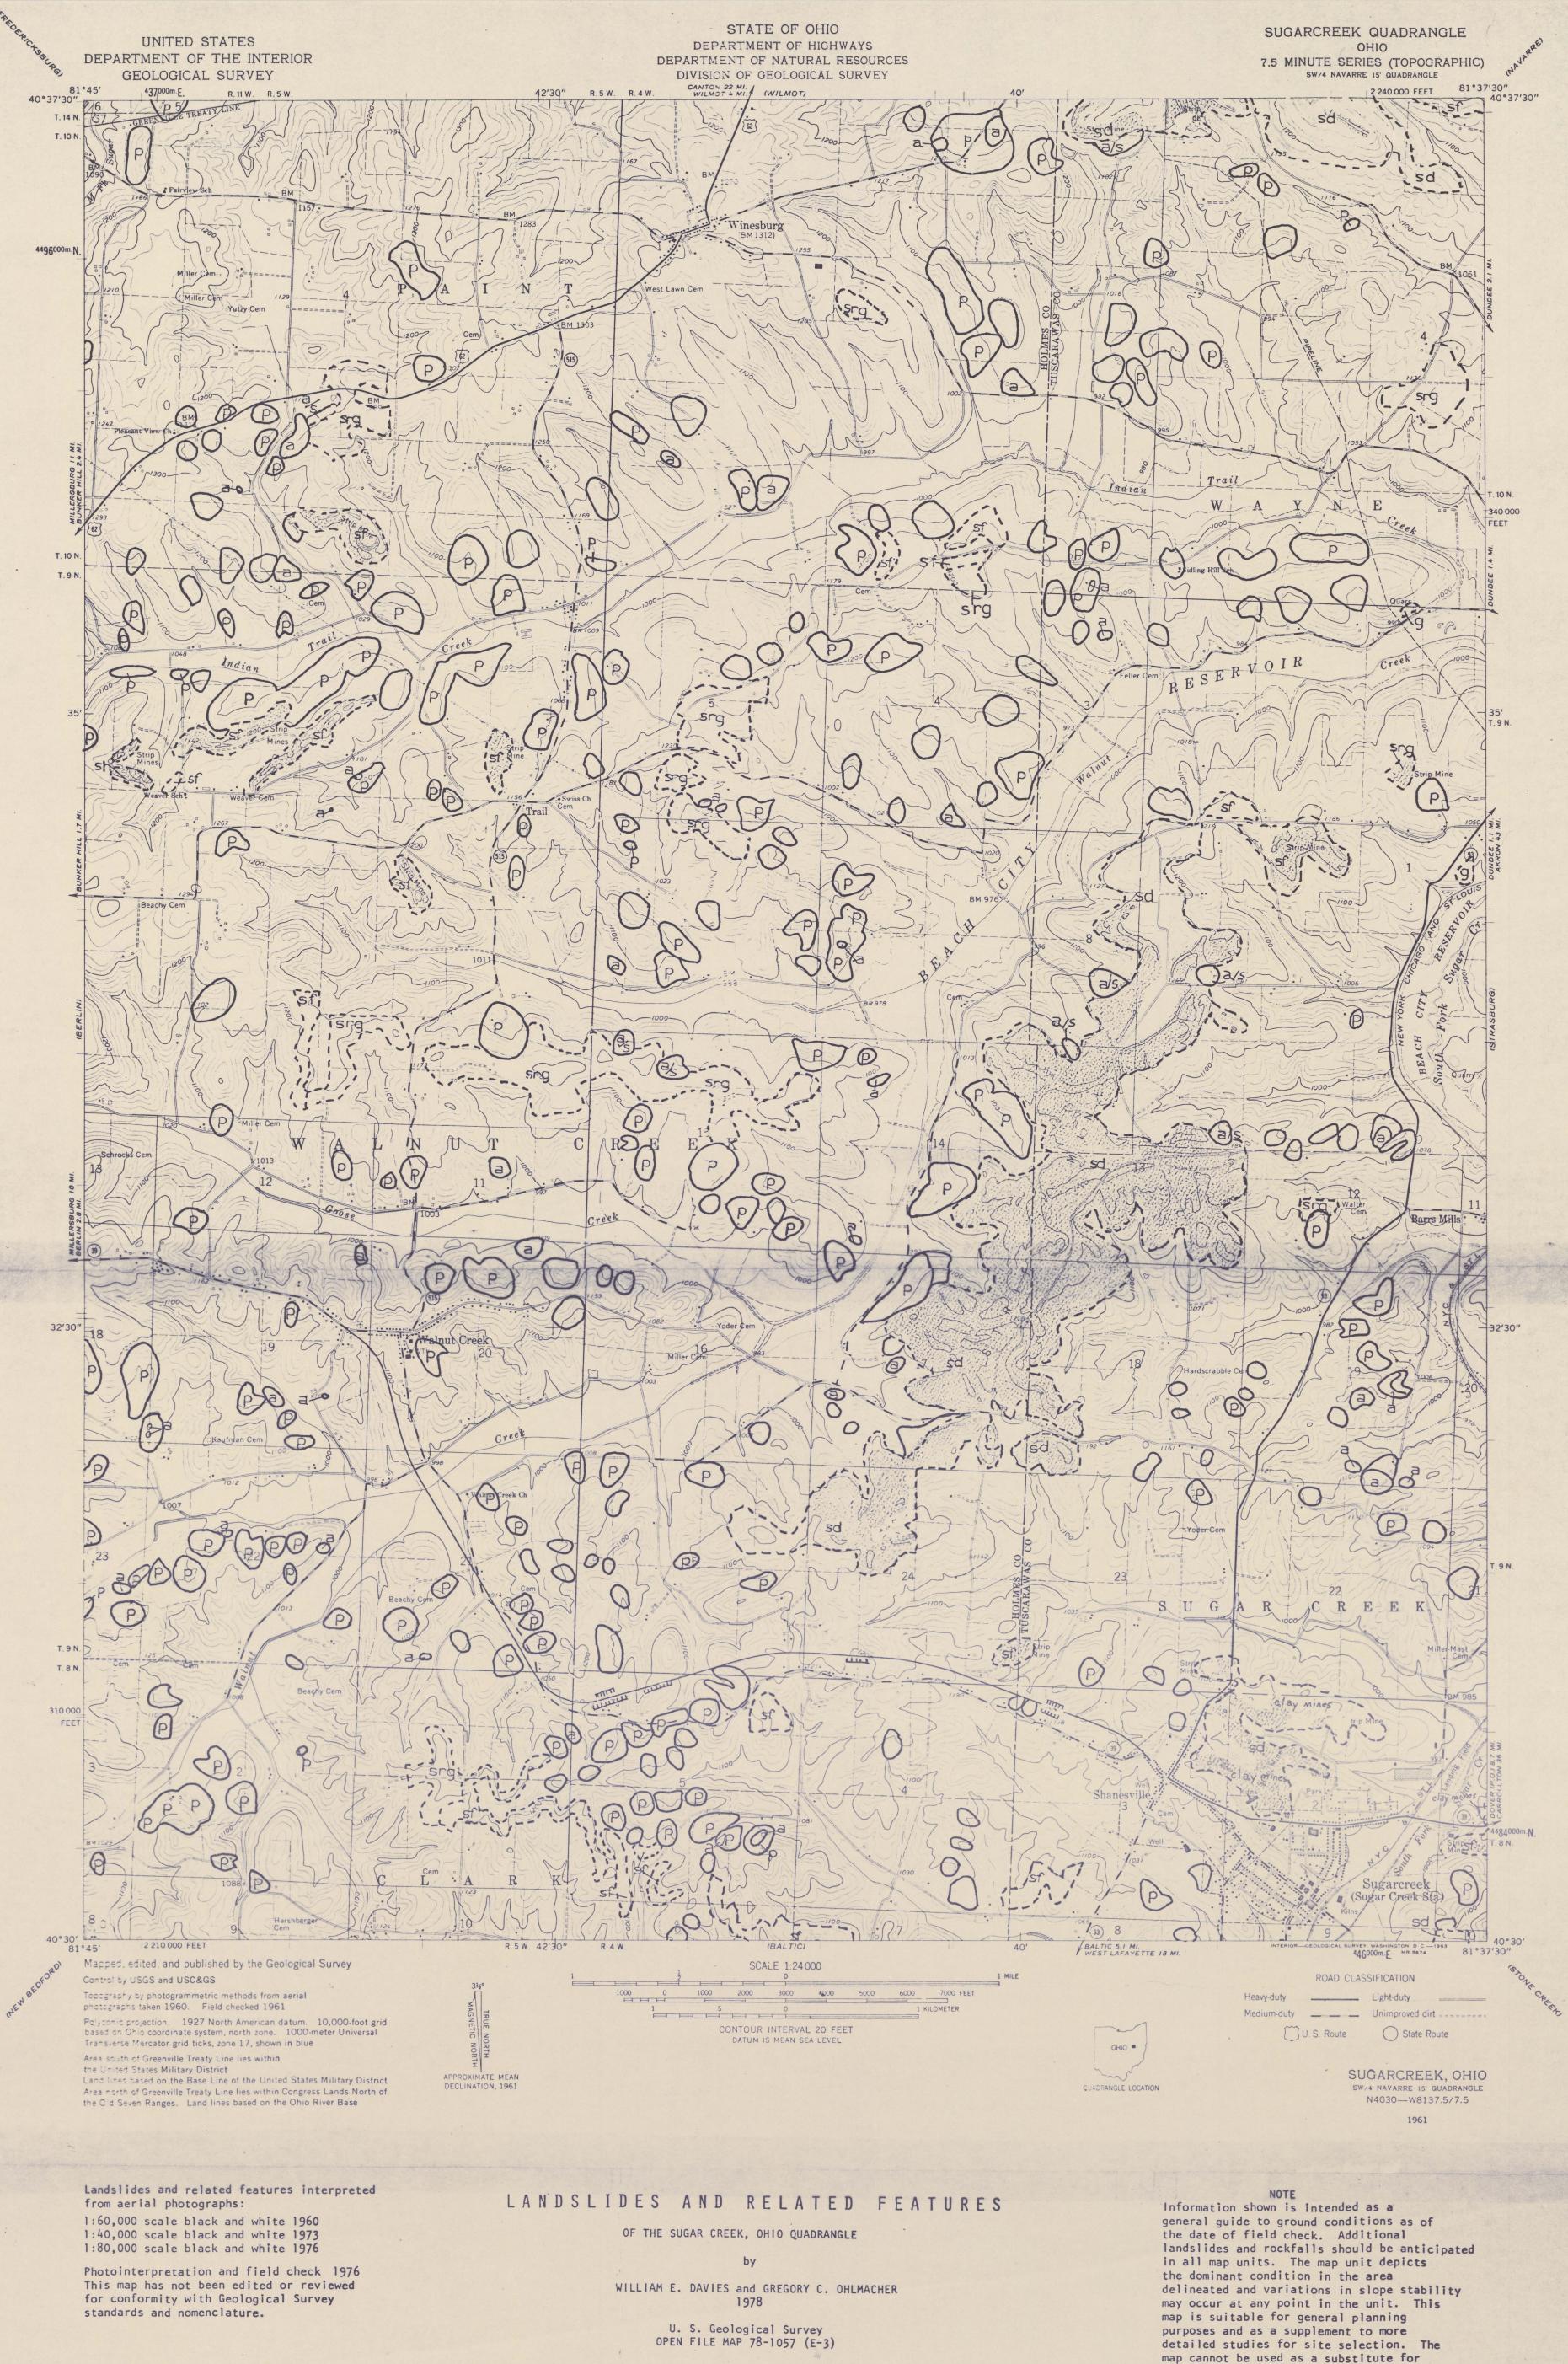
ACTIVE OR RECENTLY ACTIVE LANDSLIDE Complex landslide composed of earthflow, debris slide, earth and rock slump. Identified from historical records, and from scars, debris and other field evidence. Ground extremely unstable; sliding accelerated by excavation, loading and changes in drainage conditions. May include areas with several active slides too small to be shown separately. Questioned where doubtful.

LANDSLIDE Area of extensive hummocky ground caused by earthflow and earth and rock slump. Lacks clear evidence of active sliding. Relatively stable in natural, undisturbed state, generally not affected by small structures properly sited in areas away from the edge of the toe; can be reactivated by extensive, rapid excavation, loading, and changes in ground water and surface water conditions. Area of old landslide probably includes recent ones not identified from field evidence or otherwide documented. Upslope boundary of landslide generally defined by modified scarp, but downslope (toe) may be gradational and not well defined. Questioned where doubtful.

COLLUVIAL SLOPE Valley wall along major streams with slope as steep as 40° (85%); stony, clayey silt soil up to 50 ft. (15 m) thick; commonly buttressed by a terrace or bench at the toe of the slope; very susceptible to sliding by cutting of toe area, removal of terrace or bench, and overloading; landslide commonly activated without apparent cause.

AREAS SUSCEPTIBLE TO DEBRIS FLOWS AND DEBRIS AVALANCHES Primarily shallow, narrow ravines and chutes with accumulation of stony colluvium generally 10 ft. (3 m) or less in thickness; susceptible to rapid movement during intense rainfall. Most ravines designated show evidence of former debris flows and avalanches. Symbol - d - designates historical debris flow or debris avalanche.

AREAS SUSCEPTIBLE TO ROCKFALL Steep, locally vertical, natural and man-made slopes and cliffs, 15 ft. (4.5 m) or higher. formed dominantly of sandstone, limestone, sandy shale, mudstone and claystone. Interbedded mudstone, claystone and shale weather rapidly leaving sandstone and limestone rock faces unsupported.

COVE UNDERLAIN BY CLAY LAYER Rounded or U-shaped valley with steep concave slope of valley floor (coves) and valley heads underlain by clayey soils forming a coherent layer generally 8 ft. (2.5 m) or less in thickness. Zone of water commonly at the base of the clay layer is under 2 to 8 ft. (0.6 -2.5 m) artesian head. Clay soil is underlain by claystone and shale. Clay slab moves as a coherent mass up to 1 ft. (0.3 m) per year; very susceptible to more rapid sliding when overloaded by fill or structure and by excavations that break the continuity of slope. Recent soil slips (earth flows) as much as 40,000 square feet (3,700 square meters) in size are common.

SOIL AND ROCK SUSCEPTIBLE TO LANDSLIDING Soil and rock similar to that involved in landslides elsewhere in map area; primarily areas underlain by claystone, mudstone and shale associated with other rock types. Rock weathers rapidly on exposure forming clayey soil highly susceptible to sliding.

AREAS LEAST PRONE TO LANDSLIDES Map areas in which no patterns or symbols are shown; primarily valley floors, ridge tops and broad benches; modification by excavation and fill may lead to local landslides.
