LANDSLIDES AND RELATED FEATURES

OF THE KENSINGTON, OHIO QUADRANGLE

WILLIAM E. DAVIES and GREGORY C. OHLMACHER

1978
U. S. Geological Survey
OPEN FILE MAP 78-1057 (F-9)

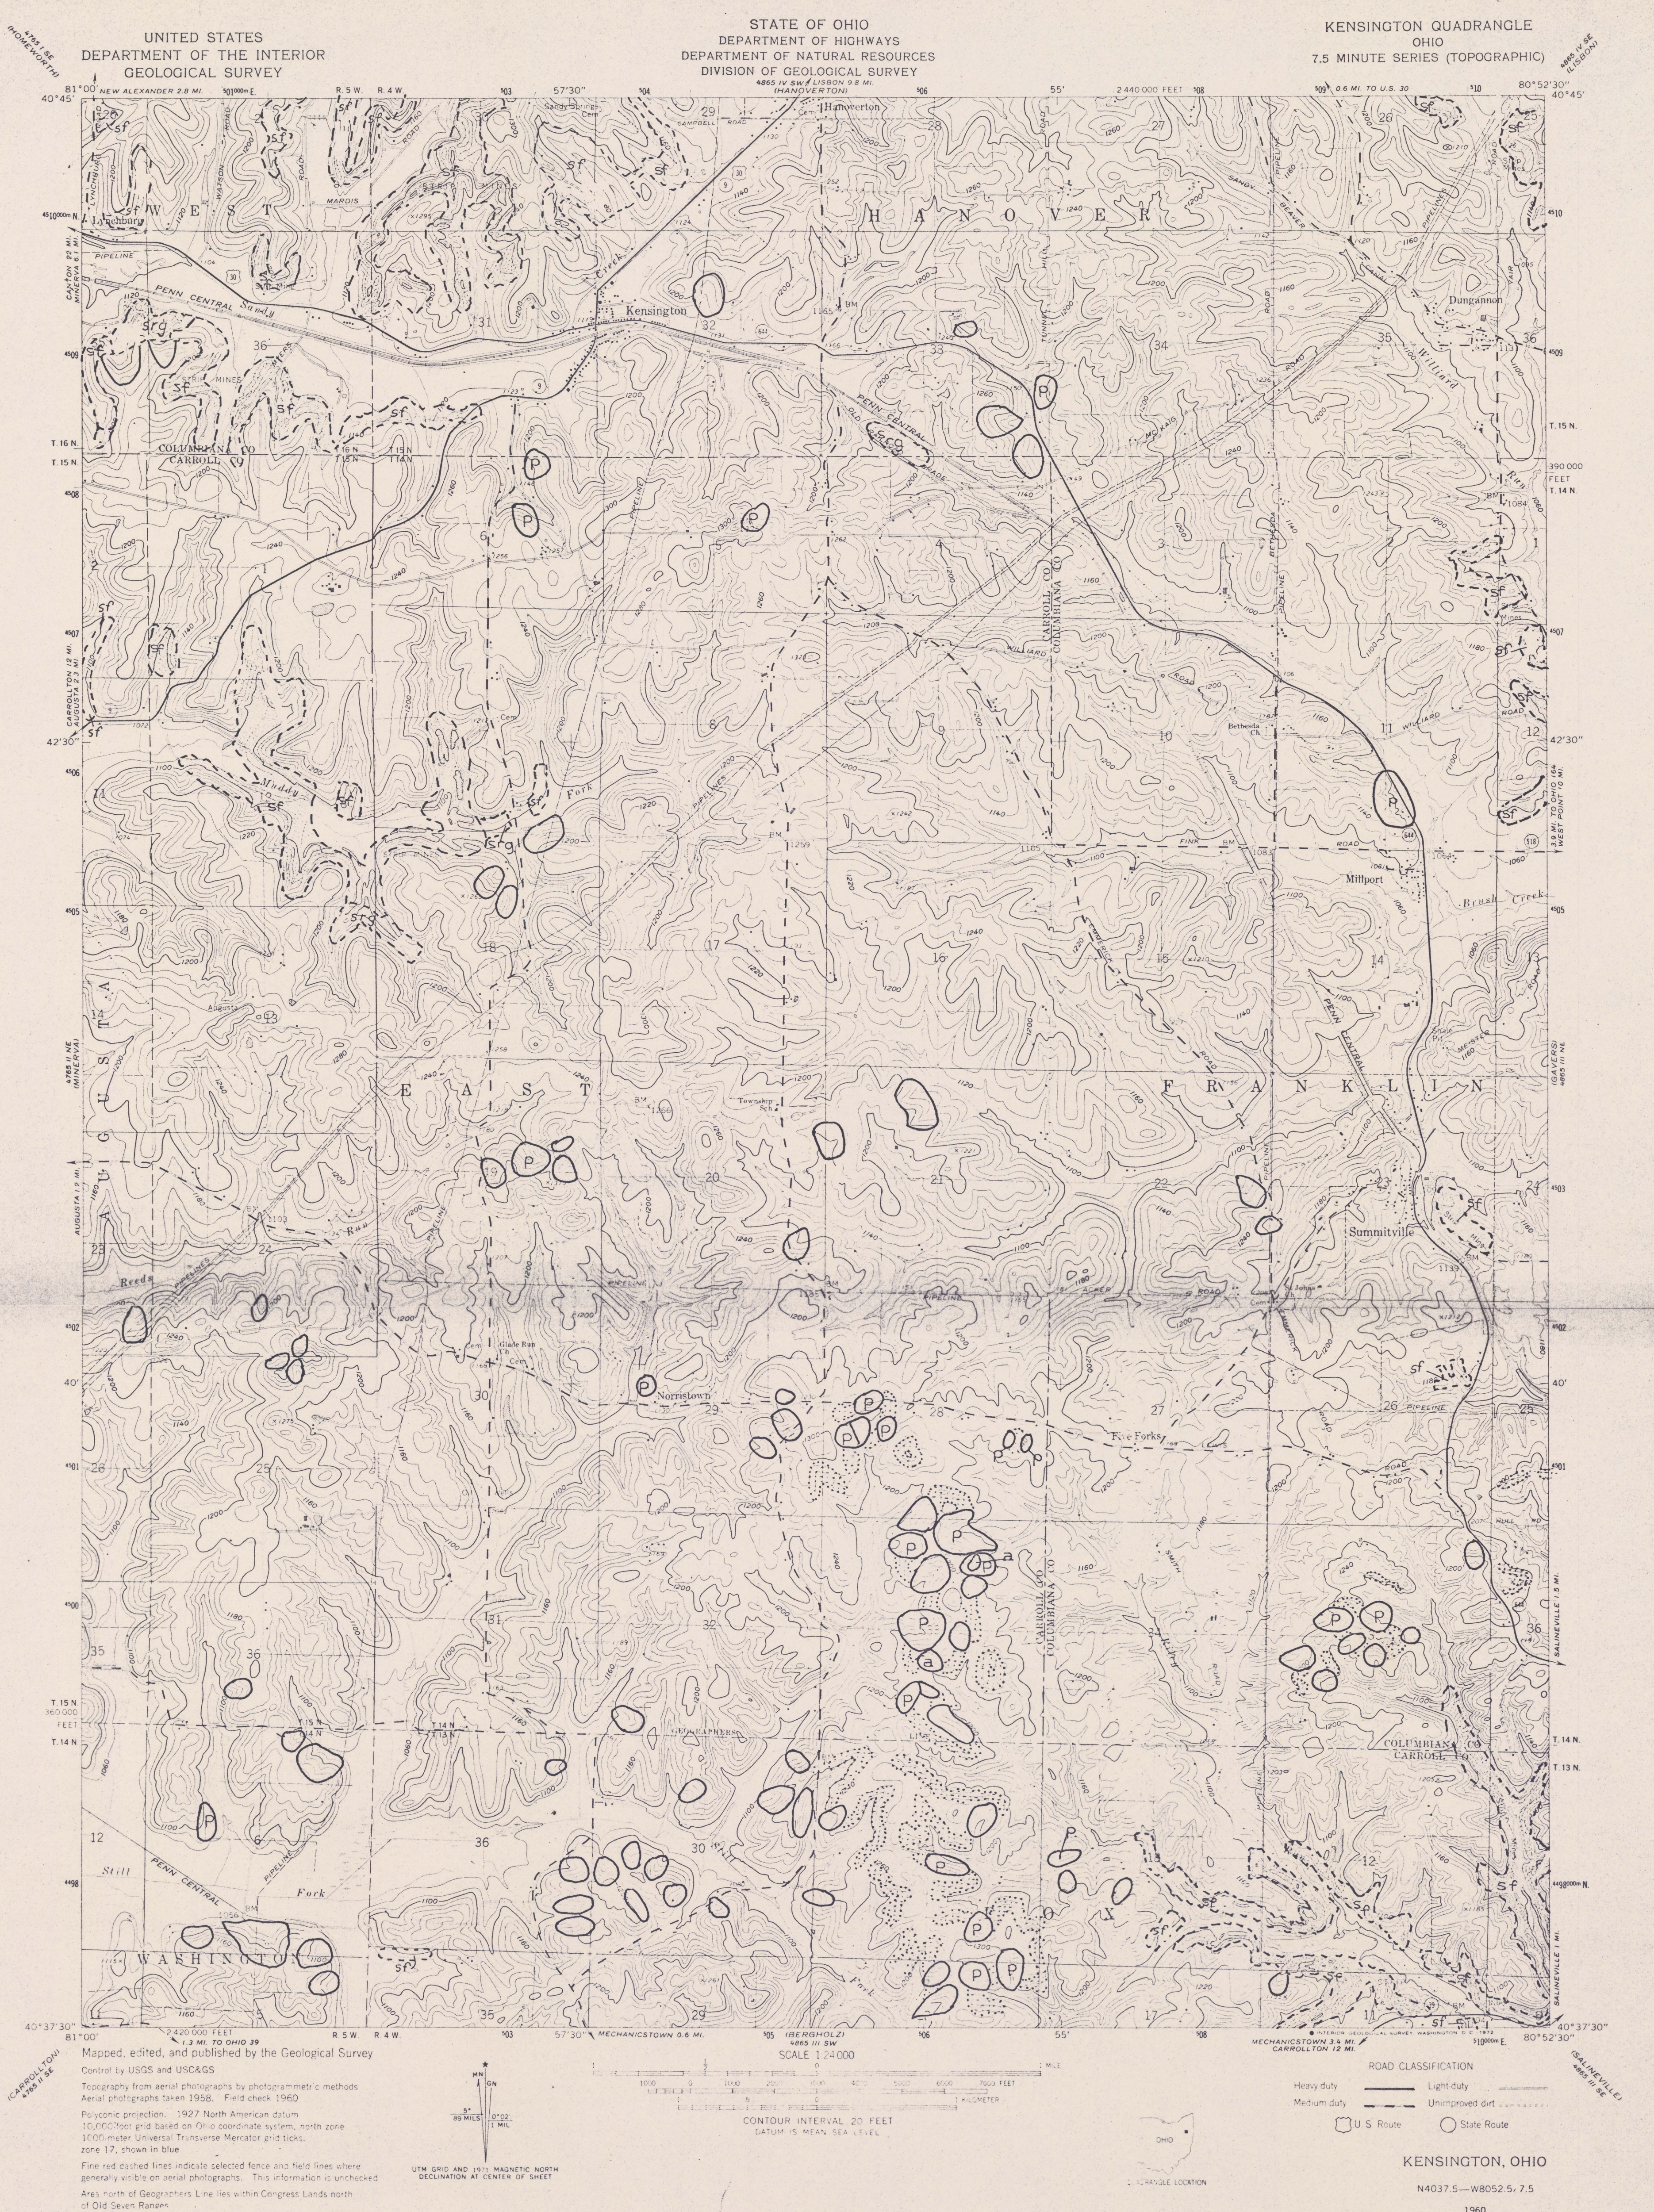
Landslides and related features interpreted from aerial photographs:
1:60,000 scale black and white 1960
1:80,000 scale black and white 1976

Photointerpretation and field check 1976
This map has not been edited or reviewed for conformity with Geological Survey standards and nomenclature.

Complex landslide composed of earthflow, debris slide, earth and rock slump. Identified from historical records, and from scars, debris and other field evidence. Ground extremely unstable; sliding accelerated by excavation, loading and changes in drainage conditions. May include areas with several active slides too small to be shown separately. Questioned where doubtful.

Area of extensive hummocky ground caused by earthflow and earth and rock slump. Lacks clear evidence of active sliding. Relatively stable in natural, undisturbed state, generally not affected by small structures properly sited in areas away from the edge of the toe; can be reactivated by extensive, rapid excavation, loading, and changes in ground water and surface water conditions. Area of old landslide probably includes recent ones not identified from field evidence or otherwise documented. Upslope boundary of landslide generally defined by modified scarp, but downslope (toe) may be gradational and not well defined. Questioned where doubtful.

Valley wall along major streams with slope as steep as 40° (85%); stony, clayey silt soil up to 50 ft. (15 m) thick; commonly buttressed by a terrace or bench at the toe of the slope; very susceptible to sliding by cutting of toe area, removal of terrace or bench, and overloading; landslide commonly activated without apparent cause.

Primarily shallow, narrow ravines and chutes with accumulation of stony colluvium generally 10 ft. (3 m) or less in thickness; susceptible to rapid movement during intense rainfall. Most ravines designated show evidence of former debris flows and avalanches. Symbol - a - designates historical debris flow or debris avalanche.

Steep, locally vertical, natural and man-made slopes and cliffs, 15 ft. (4.5 m) or higher. Formed dominantly of sandstone, limestone, sandy shale, mudstone and claystone. Interbedded mudstone, claystone and shale weather rapidly leaving sandstone and limestone rock faces unsupported.

Rounded or U-shaped valley with steep concave slope of valley floor (coves) and valley heads underlain by clayey soils forming a coherent layer generally 8 ft. (2.5 m) or less in thickness. Zone of water commonly at the base of the clay layer is under 2 to 8 ft. (0.6 - 2.5 m) artesian head. Clay soil is underlain by claystone and shale. Clay slab moves as a coherent mass up to 1 ft. (0.3 m) per year; very susceptible to more rapid sliding when overloaded by fill or structure and by excavations that break the continuity of slope. Recent soil slips (earth flows) as much as 40,000 square feet (3,700 square meters) in size are common.

Soil and rock similar to that involved in landslides elsewhere in map area; primarily areas underlain by claystone, mudstone and shale associated with other rock types. Rock weathers rapidly on exposure forming clayey soil highly susceptible to sliding.

Map areas in which no patterns or symbols are shown; primarily valley floors, ridge tops and broad benches; modification by excavation and fill may lead to local landslides.
