AVONMORE, PA.
N4030-W7922 S/7.5
1964
PHOTOREVISED 1973

LANDSLIDES AND RELATED FEATURES

OF THE AVONMORE, PA. QUADRANGLE
by
John S. Pomeroy
1979
U.S. Geological Survey
OPEN FILE MAP 79-1314 (E-5)

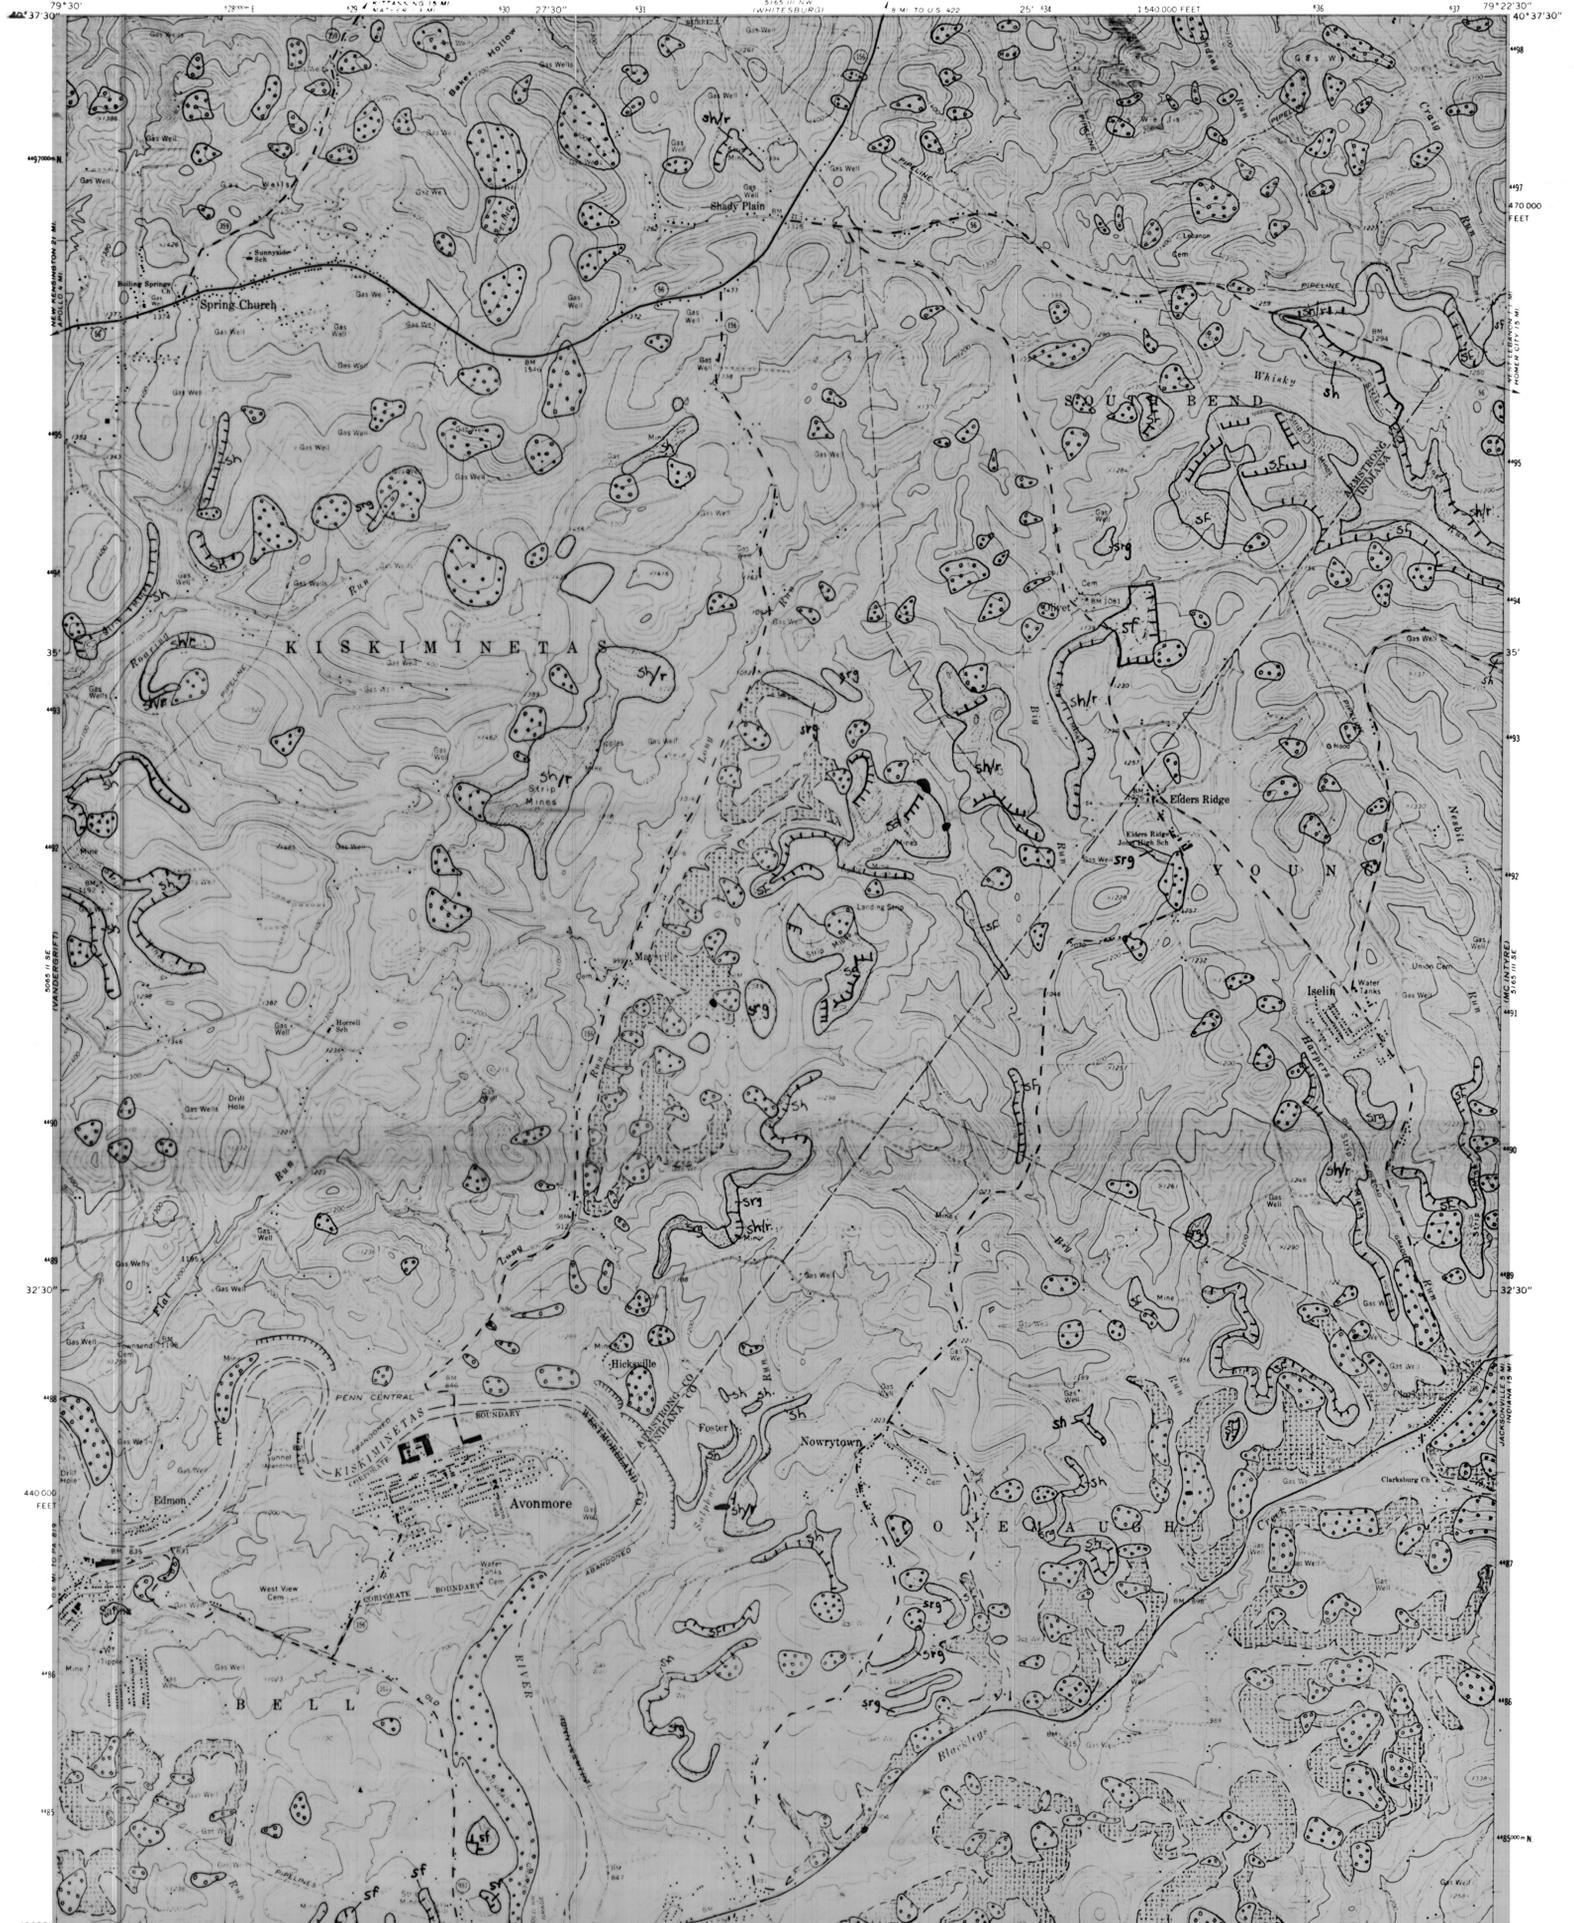
Landslides and related features interpreted from aerial photographs: 1:40,000 (black and white) 1974

Photointerpretation and field check 1976
This map has not been edited or reviewed for conformity with Geological Survey standards and nomenclature.

MAN-MADE FEATURES
Strip mines (combination of letter symbols indicates complex formed of more than one type of strip mine)
sh bench with high wall (In Allegheny County benches and furrows are shown by sh).
sf furrowed with high wall
sd multiple furrows and multiple benches
ss hilltop removed
srg reclaimed by grading
sru reclaimed by secondary use
sh/r regraded in part, high wall remains
Coal refuse banks
r identified on aerial photographs; not classified in field check
rb not burnt nor on fire
rbb burnt
rbd burning
rbs sludge
Quarries
q quarry site
qub spoil bank, quarry waste
Gravel pits
g site of gravel pit
Slides in man-made features
af earth flow in fill
a/s earth flow in strip castings
a/r earth flow in coal refuse

- ACTIVE OR RECENTLY ACTIVE LANDSLIDE**
Complex landslide composed of earthflow, debris slide, earth and rock slump. Identified from historical records, and from scars, debris and other field evidence. Ground extremely unstable; sliding accelerated by excavation, loading and changes in drainage conditions. May include areas with several active slides too small to be shown separately. Questioned where doubtful.

- OLD LANDSLIDE**
Area of extensive hummocky ground caused by earthflow and earth and rock slump. Lacks clear evidence of active sliding. Relatively stable in natural, undisturbed state, generally not affected by small structures properly sited in areas away from the edge of the toes; can be reactivated by extensive, rapid excavation, loading, and changes in ground water and surface water conditions. Area of old landslide probably includes recent ones not identified from field evidence or otherwise documented. Upslope boundary of landslide generally defined by modified scarp, but downslope (toe) may be gradational and not well defined. Questioned where doubtful.

- COMBINATION LANDSLIDE**
Area of recent and old slides in which individual slides are not identified.
- COLLUVIAL SLOPE**
Valley wall along major streams with slope as steep as 40° (85%); stony, clayey silt soil up to 50 ft. (15 m) thick; commonly buttressed by a terrace or bench at the toe of the slope; very susceptible to sliding by cutting of toe area, removal of terrace or bench, and overloading; slide commonly activated without apparent cause.

- SCREE**
Residual accumulations of coarse rock material lying on quartzite slopes of the Valley and Ridge province. Generally stable except where subjected to extreme rainfall.

- COLLUVIAL SLOPES WITH LANDSLIDES**
Landslides too small or obscure to map individually.
- AREAS SUSCEPTIBLE TO DEBRIS FLOWS AND DEBRIS AVALANCHES**
Primarily shallow, narrow ravines and chutes with accumulation of stony colluvium generally 10 ft. (3 m) or less in thickness; susceptible to rapid movement during intense rainfall. Most ravines and chutes designated show evidence of former debris flows and avalanches. Symbol & designates historical debris flow or debris avalanche.

- AREAS SUSCEPTIBLE TO ROCKFALL**
Steep, locally vertical, natural and man-made slopes and cliffs, 15 ft. (4.5 m) or more high; formed dominantly of sandstone, limestone, sandy shale, mudstone and claystone. Interbedded mudstone, claystone and shale weather rapidly leaving sandstone and limestone rock faces unsupported.

- SOIL AND ROCK SUSCEPTIBLE TO LANDSLIDING**
Soil and rock similar to that involved in landslides elsewhere in map area; primarily areas underlain by claystone, mudstone and chals associated with other rock types. Rock weathers rapidly on exposure forming clayey soil highly susceptible to sliding. Includes coves (U-shaped, shallow valleys) containing thick layers of clayey soil that are very susceptible to sliding where excavation breaks continuity of slope and where overloaded by artificial fill.

- AREAS LEAST PRONE TO LANDSLIDES**
Map areas in which no patterns or symbols are shown; primarily valley floors, ridge tops and broad benches; modification by excavation and fill may lead to local landslides.
Includes slopes where landslides are sparse.
