LANDSLIDES AND RELATED FEATURES

OF THE MCGEES MILLS, PA. QUADRANGLE

by
John S. Pomeroy
1979

U.S. Geological Survey
OPEN FILE MAP 79-1314 (H-10)

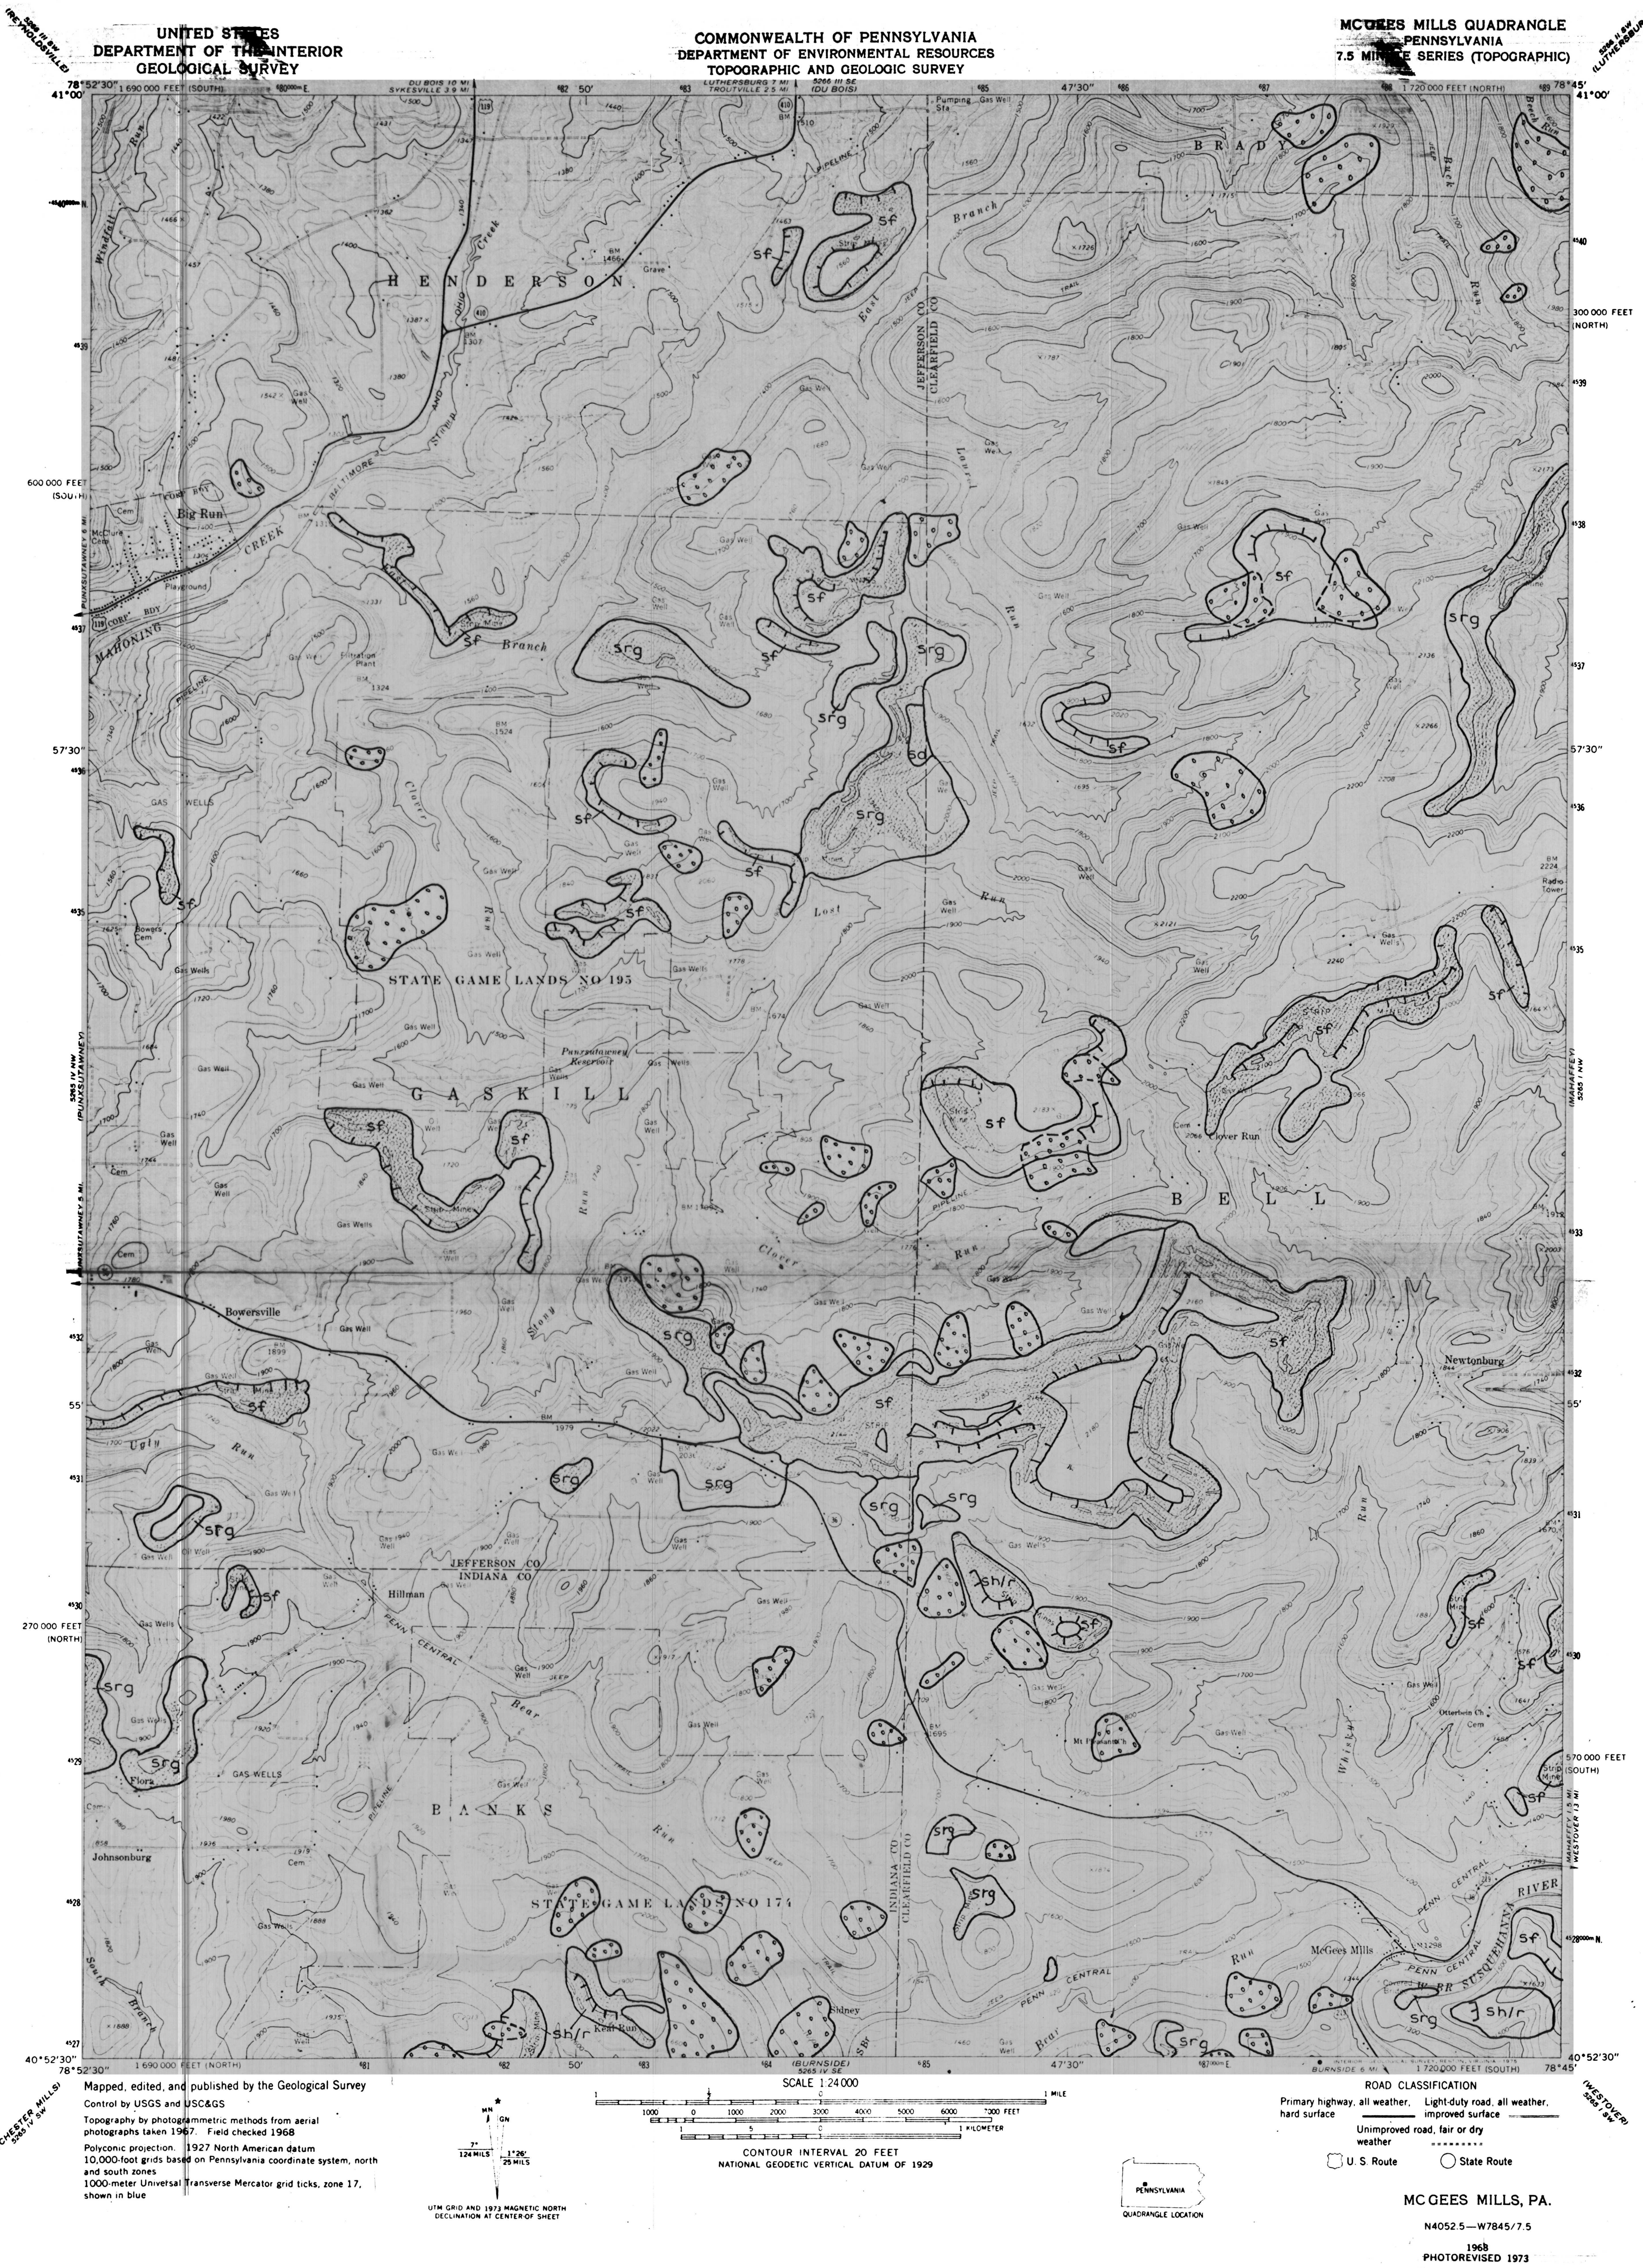
Landslides and related features interpreted
from aerial photographs:
1:78,000 (black and white) 1977

Photointerpretation and field check 1976
This map has not been edited or reviewed
for conformity with Geological Survey
standards and nomenclature.

- ACTIVE OR RECENTLY ACTIVE LANDSLIDE**
Complex landslide composed of earthflow, debris slide, earth and rock slump. Identified from historical records, and from scars, debris and other field evidence. Ground extremely unstable; sliding accelerated by excavation, loading and changes in drainage conditions. May include areas with several active slides too small to be shown separately. Questioned where doubtful.

- OLD LANDSLIDE**
Area of extensive hummocky ground caused by earthflow and earth and rock slump. Lacks clear evidence of active sliding. Relatively stable in natural, undisturbed state, generally not affected by small structures properly sited in areas away from the edge of the toe; can be reactivated by extensive, rapid excavation, loading, and changes in ground water and surface water conditions. Area of old landslide probably includes recent ones not identified from field evidence or otherwise documented. Upslope boundary of landslide generally defined by modified scarp, but downslope (toe) may be gradational and not well defined. Questioned where doubtful.

- COMBINATION LANDSLIDE**
Area of recent and old slides in which individual slides are not identified.
- COLLUVIAL SLOPE**
Valley wall along major streams with slope as steep as 40° (85%); stony, clayey silt soil up to 50 ft. (15 m) thick; commonly buttressed by a terrace or bench at the toe of the slope; very susceptible to sliding by cutting of toe area, removal of terrace or bench, and overloading; slide commonly activated without apparent cause.

- SCREE**
Residual accumulations of coarse rock material lying on quartzite slopes of the Valley and Ridge province. Generally stable except where subjected to extreme rainfall.

- COLLUVIAL SLOPES WITH LANDSLIDES**
Landslides too small or obscure to map individually.
- AREAS SUSCEPTIBLE TO DEBRIS FLOWS AND DEBRIS AVALANCHES**
Primarily shallow, narrow ravines and chutes with accumulation of stony colluvium generally 10 ft. (3 m) or less in thickness; susceptible to rapid movement during intense rainfall. Most ravines and chutes designated show evidence of former debris flows and avalanches. Symbol & designates historical debris flow or debris avalanche.

- AREAS SUSCEPTIBLE TO ROCKFALL**
Steep, locally vertical, natural and man-made slopes and cliffs, 15 ft. (4.5 m) or more high; formed dominantly of sandstone, limestone, sandy shale, mudstone and claystone. Interbedded mudstone, claystone and shale weather rapidly leaving sandstone and limestone rock faces unsupported.

- SOIL AND ROCK SUSCEPTIBLE TO LANDSLIDING**
Soil and rock similar to that involved in landslides elsewhere in map area; primarily areas underlain by claystone, mudstone and shale associated with other rock types. Rock weathers rapidly on exposure forming clayey soil highly susceptible to sliding. Includes coves (U-shaped, shallow valleys) containing thick layers of clayey soil that are very susceptible to sliding where excavation breaks continuity of slope and where overloaded by artificial fill.

- AREAS LEAST PRONE TO LANDSLIDES**
Map areas in which no patterns or symbols are shown; primarily valley floors, ridge tops and broad benches; modification by excavation and fill may lead to local landslides.
Includes slopes where landslides are sparse.
The first five digits of the open file number designate the specific 1:250,000 scale map sheet of which this quadrangle is a part. The last two digits designate the position of the quadrangle in a subdivision of the 1:250,000 scale map based on rows and tiers shown in the diagram to the right. The location of this quadrangle is shown by the black square.
