RECONNAISSANCE DATA ON LAKES IN THE ALPINE

LAKES WILDERNESS AREA, WASHINGTON

By David P. Dethier, Paul L. Heller, and  
Sally A. Safioles

Open-File Report 79-1465

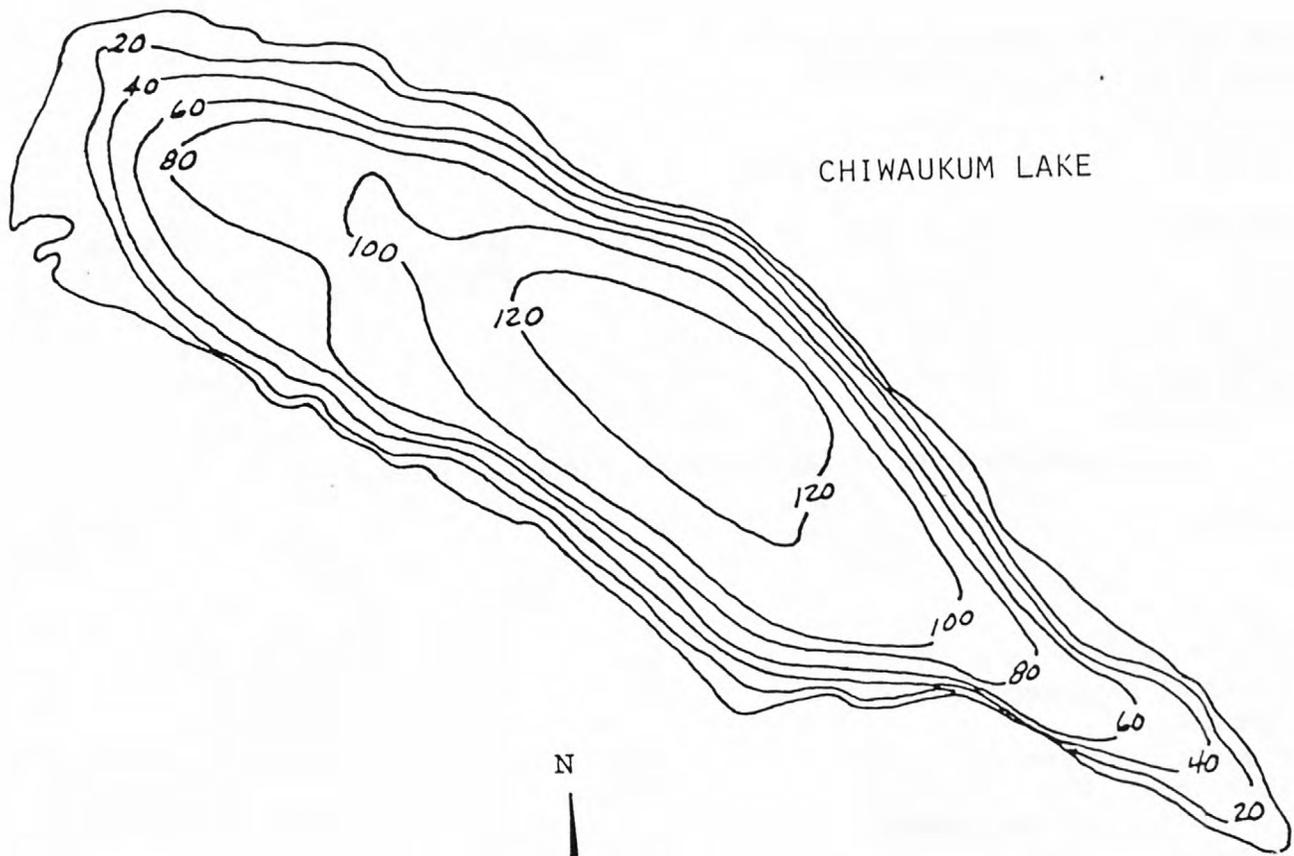
CHIWAUKUM LAKE

— 40 —  
 Line of equal  
 water depth  
 Interval 20 feet

Chiwaukum Lake, Chelan County. From  
 U.S. Geological Survey, September 10, 1974.

No aquatic macrophytes were observed. Floating logs were observed near the outlet.

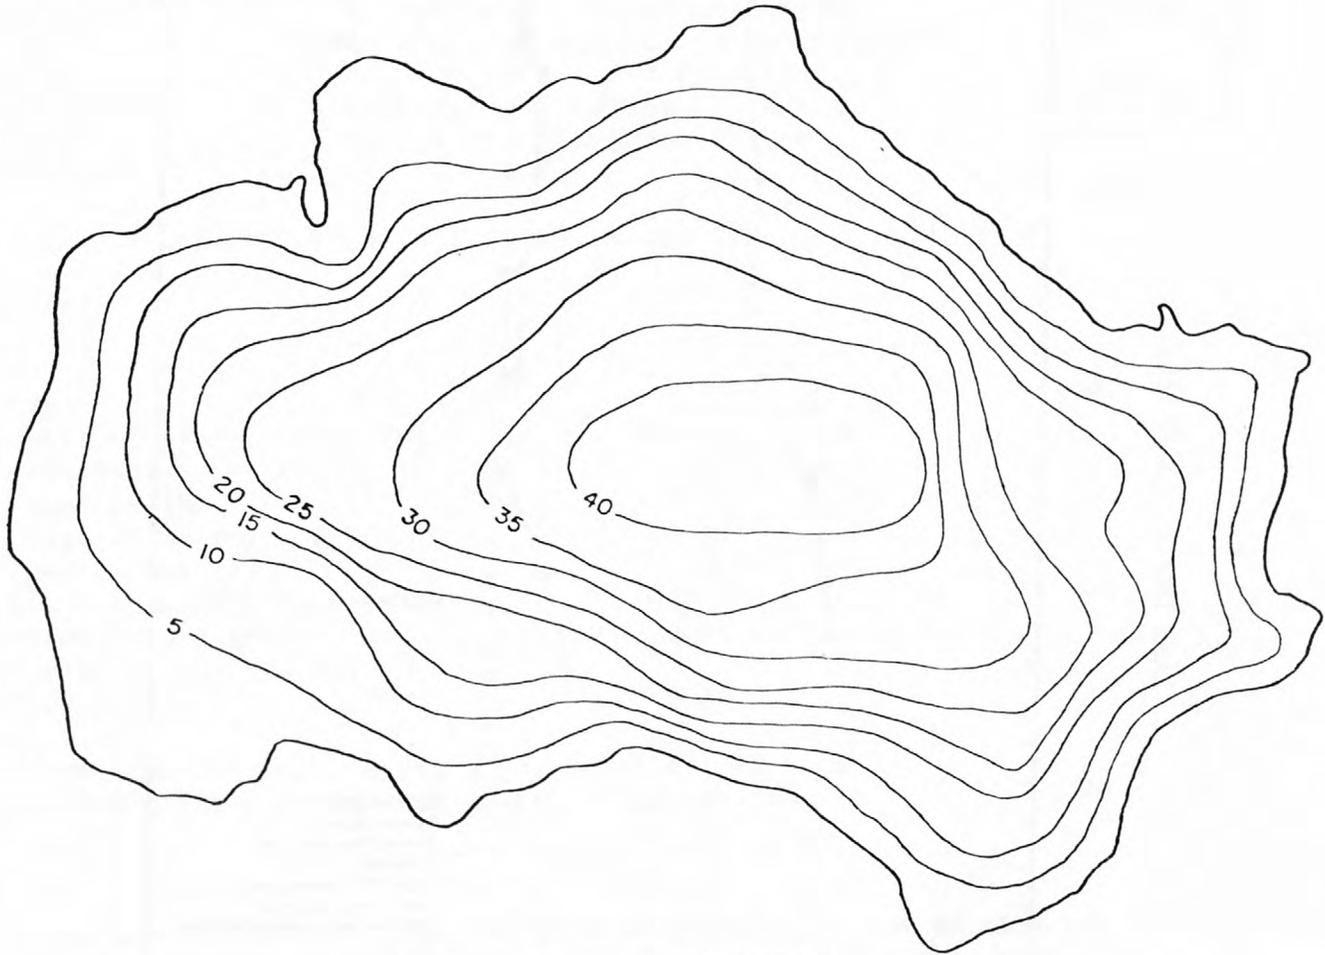
ENCHANTMENT 2 LAKE

Contour interval 5 meters

Enchantment 2 Lake, Chelan County. From  
U.S. Geological Survey, September 11, 1978.

A small, deep lake surrounded by bedrock; minor amounts of talus are also present. Zooplankton were abundant. Dissolved oxygen was slightly depleted in waters near the lake bottom.

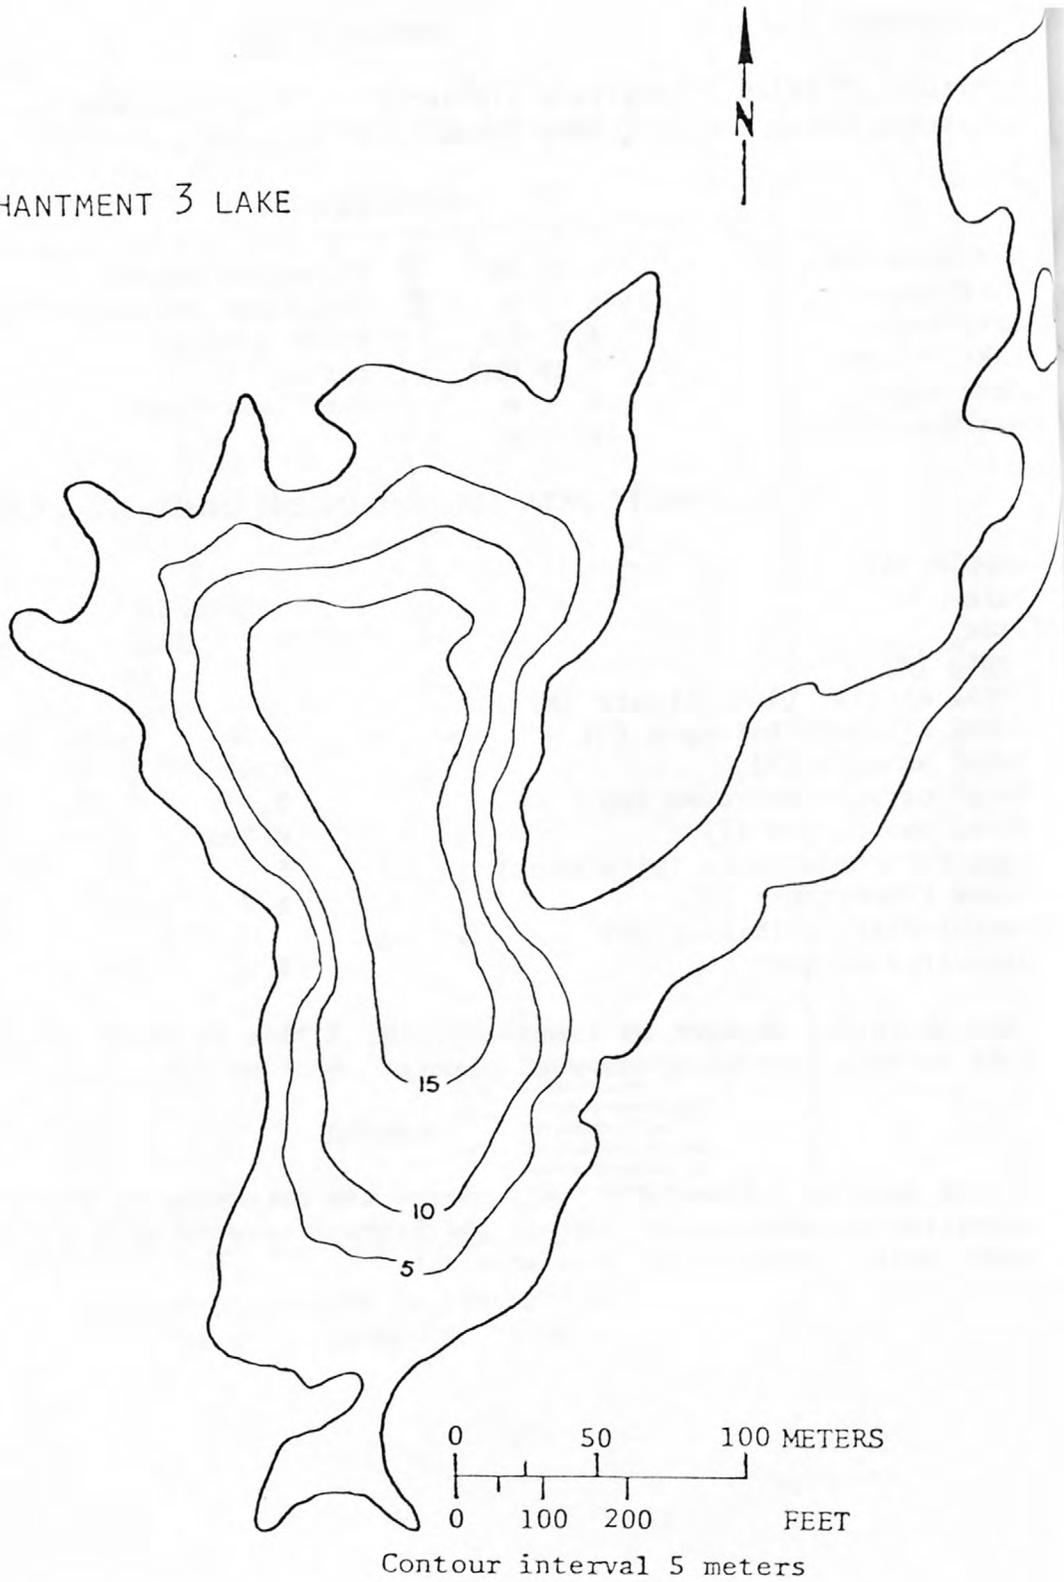
ENCHANTMENT 3 LAKE

Enchantment 3 Lake, Chelan County. From  
U.S. Geological Survey, September 11, 1978.

A shallow lake with a long, narrow arm extending to the northeast. The shoreline is composed of bedrock and bedrock covered with a thin mantle of sandy soil. Zooplankton were abundant.

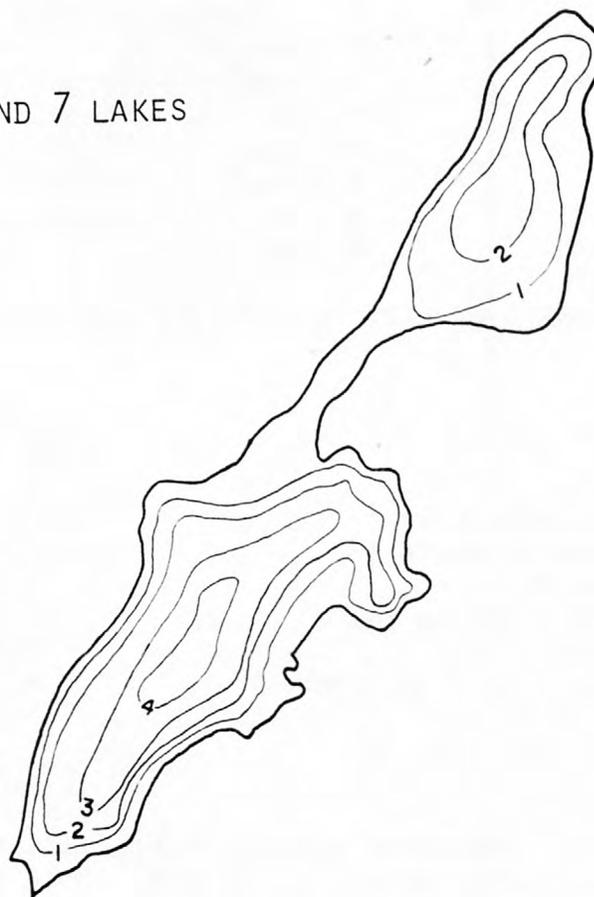
ENCHANTMENT 6 AND 7 LAKES

Enchantment 6 and 7 Lakes, Chelan County. From  
U.S. Geological Survey, September 10, 1978.

A small, shallow lake. The shoreline is composed of bedrock, talus, and small, permanent snowfields. No zooplankton were observed. The lake flows into Enchantment 6. Lake was partly covered with ice at the time of sampling.

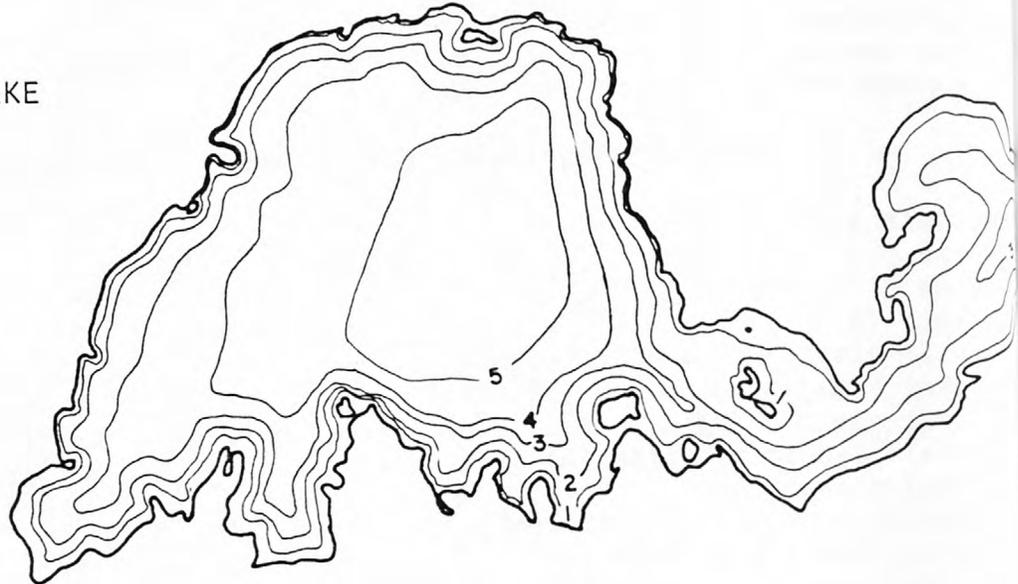
HORSESHOE LAKE

Horseshoe Lake, Chelan County. From  
U.S. Geological Survey, August 8, 1978.

A small, shallow lake. The south shore of the lake is composed of bedrock, sandy glacial till, and small areas of wet soils; the north shore of the lake is composed of bedrock and talus. No zooplankton were observed, but freshwater shrimp and salamanders were abundant. The lake level drops at least 1-2 m during dry periods.

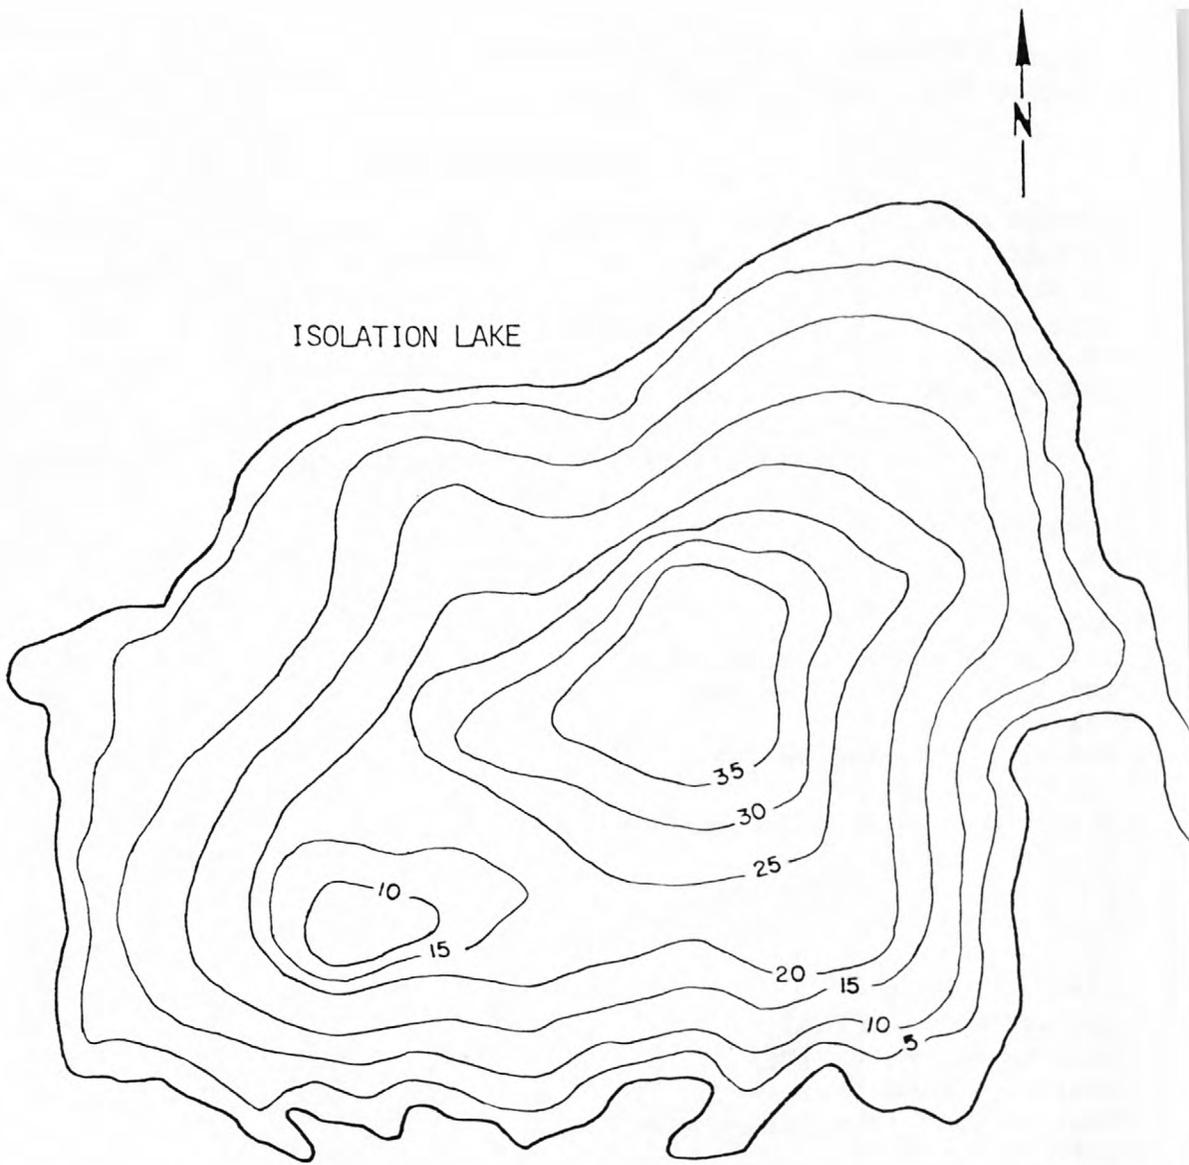
ISOLATION LAKE

Contour interval 5 meters

Isolation Lake, Chelan County. From  
U.S. Geological Survey, September 10, 1978.

A deep, moraine-dammed lake with a glacier located at the south end. The lakeshore is composed of bedrock, coarse morainal material, and permanent snow and ice. The water is slightly cloudy from glacial silt. No zooplankton were observed. The lake contained a large number of icebergs.

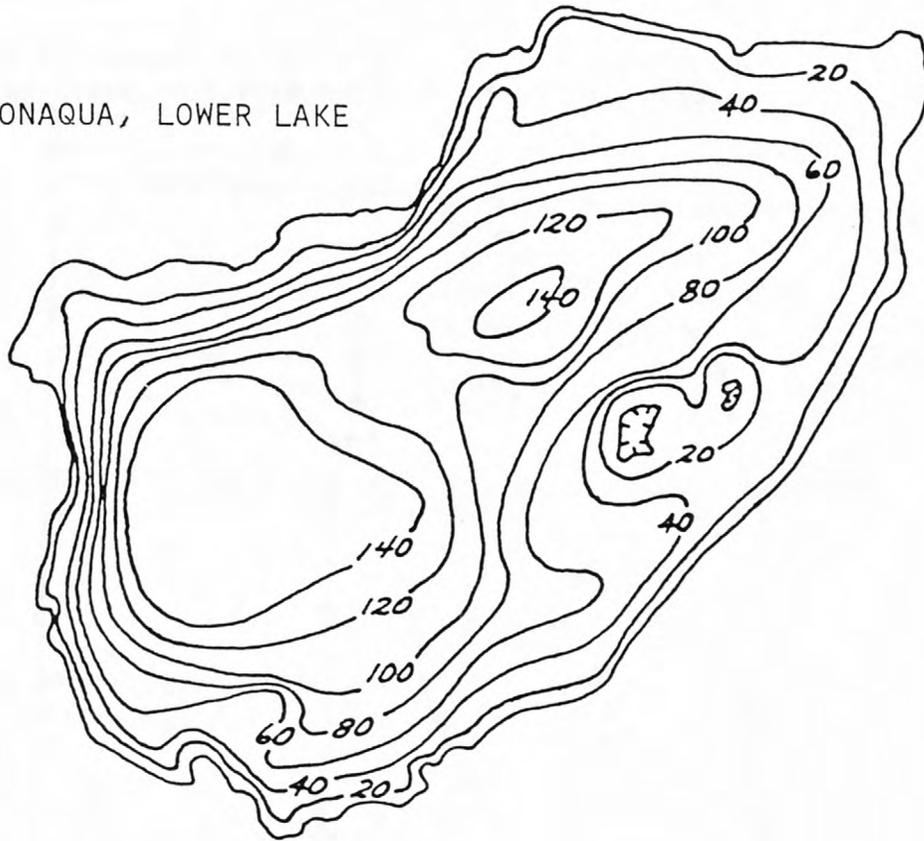
KLONAQUA, LOWER LAKE

Line of equal  
water depth  
Interval 20 feet

Klonauqua, Lower Lake, Chelan County. From  
U.S. Geological Survey, September 11, 1974.

The lake is fed by Upper Klonaqua Lake. The water is used for irrigation purposes. The lake is stabilized by a small dam at the outlet. No aquatic macrophytes were observed.

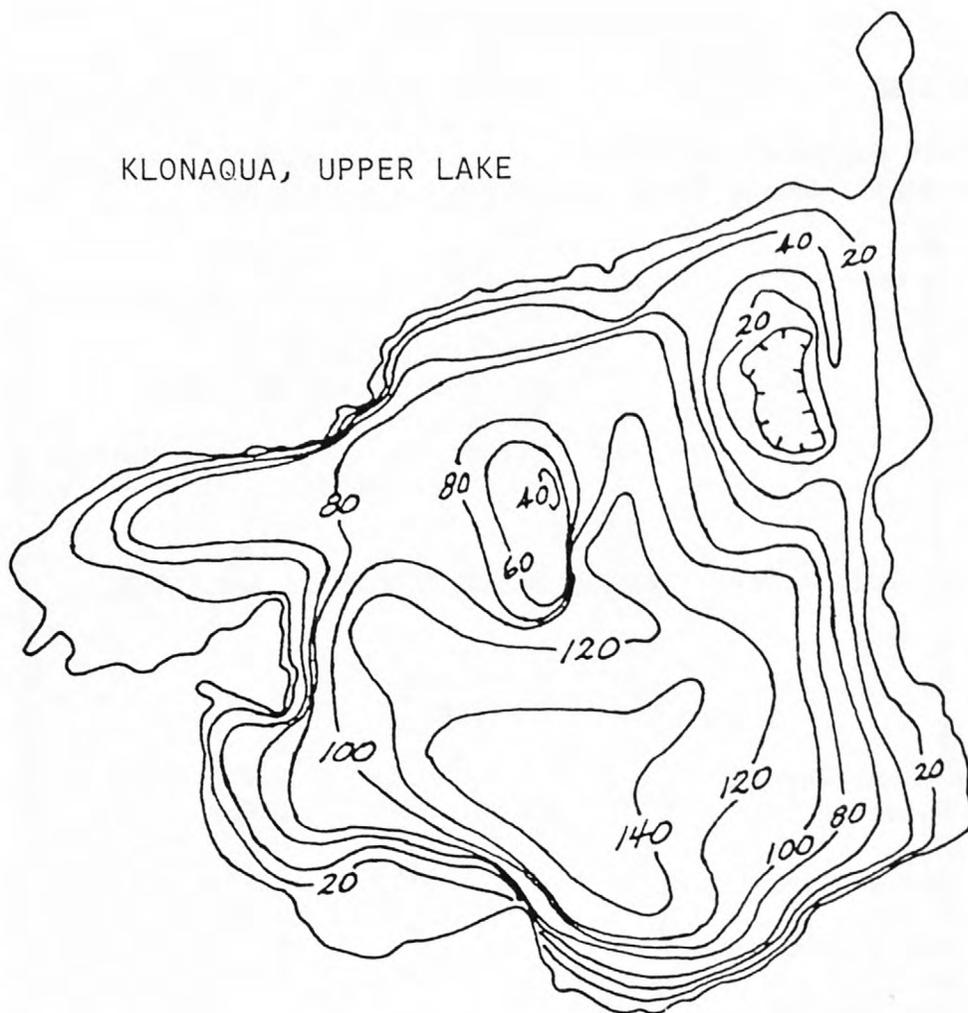
KLONAQUA, UPPER LAKE

Klon aqua, Upper Lake, Chelan County.

From U.S. Geological Survey, September 9, 1974.

The water is used for irrigation purposes. The DO concentration was high throughout the entire water column. No aquatic macrophytes were observed.

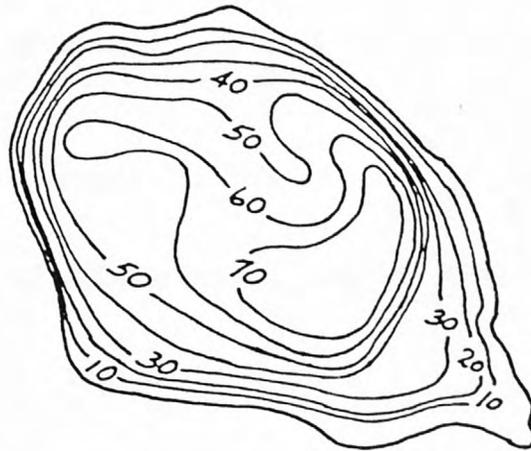
LOCH EILEEN LAKE

Line of equal  
water depth  
Interval 10 feet

Loch Eileen Lake, Chelan County. From  
U.S. Geological Survey, September 10, 1974.

The DO concentration was high throughout the entire water column. No aquatic macrophytes were observed.

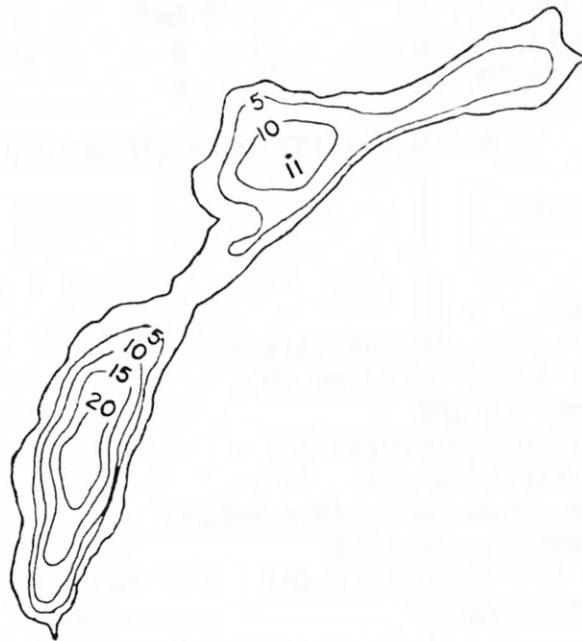
NADA LAKE

Nada Lake, Chelan County. From  
U.S. Geological Survey, September 12, 1978.

An elongate lake with a narrow, shallow area separating two deeper pools. The lake shore is composed of vegetated till and colluvium, with minor amounts of bedrock and talus. Zooplankton were abundant and a variety of species were observed. The poor clarity of the lake may in part be due to the presence of an algal bloom. Dissolved-oxygen levels were depleted in deeper lake waters.

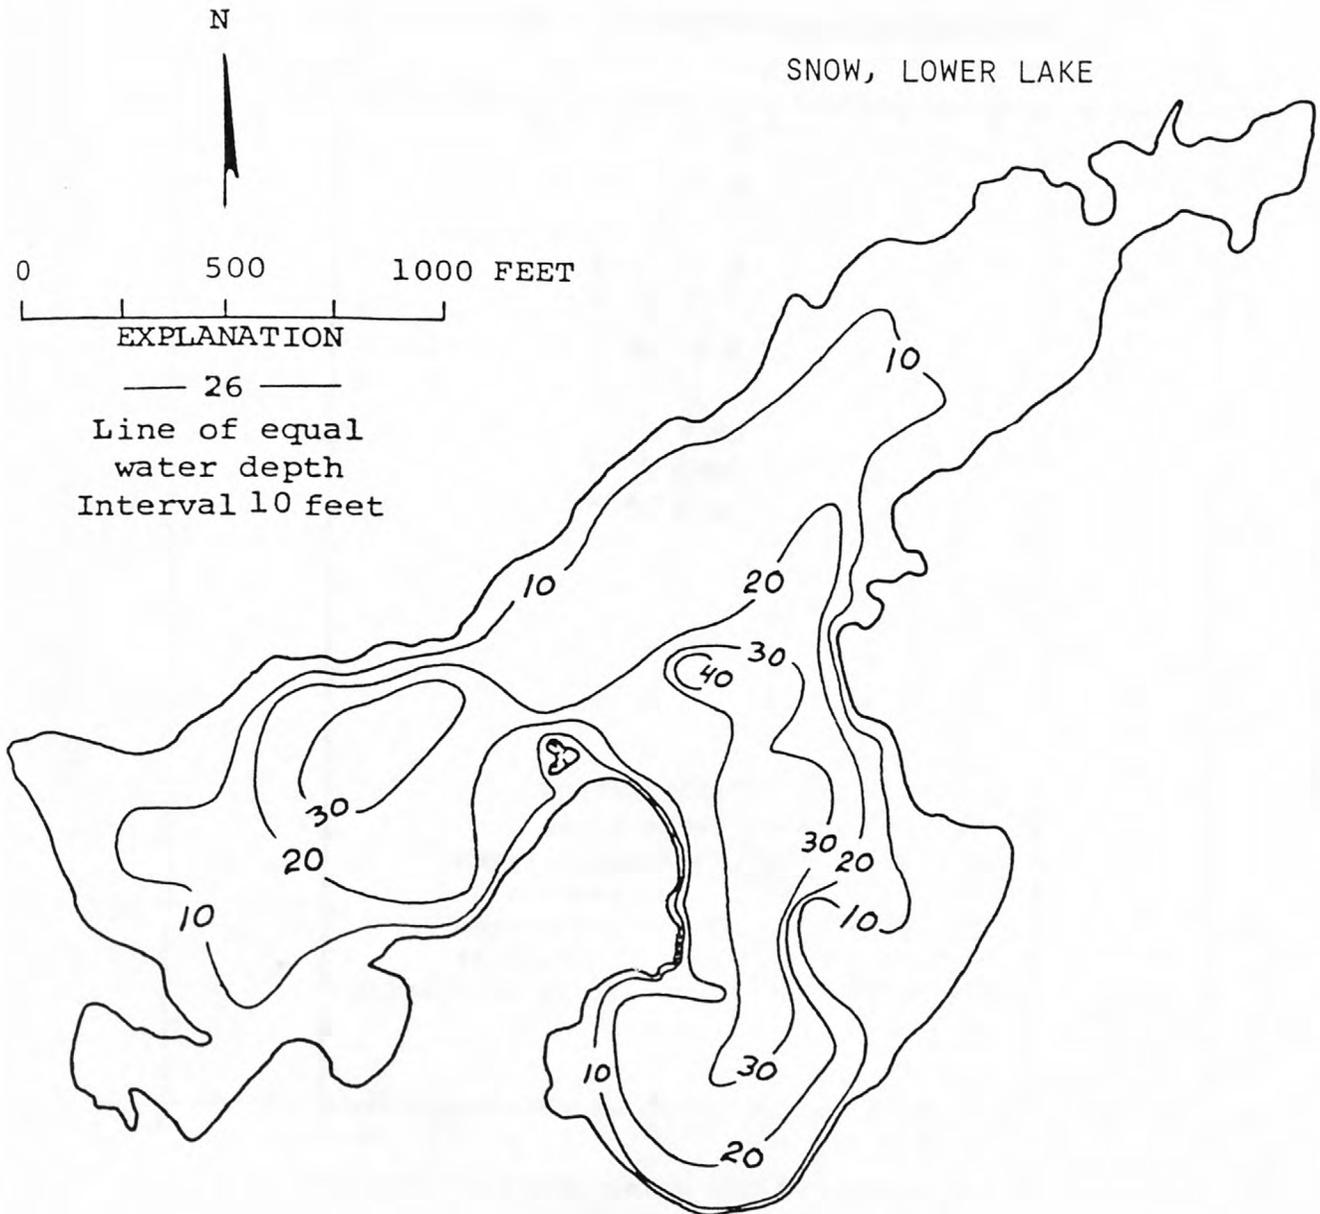
Snow, Lower Lake, Chelan County. From  
U.S. Geological Survey, September 12, 1974.

A large, shallow lake with numerous small islands. The lakeshore is largely forested. The lake is part of the U.S. Bureau of Reclamation Snow Lakes Project. Lake stage is controlled by a dam at the outlet and the water is used for irrigation purposes. When full, the lake water backs into Upper Snow Lake. Zooplankton were abundant. Numerous floating logs were present.

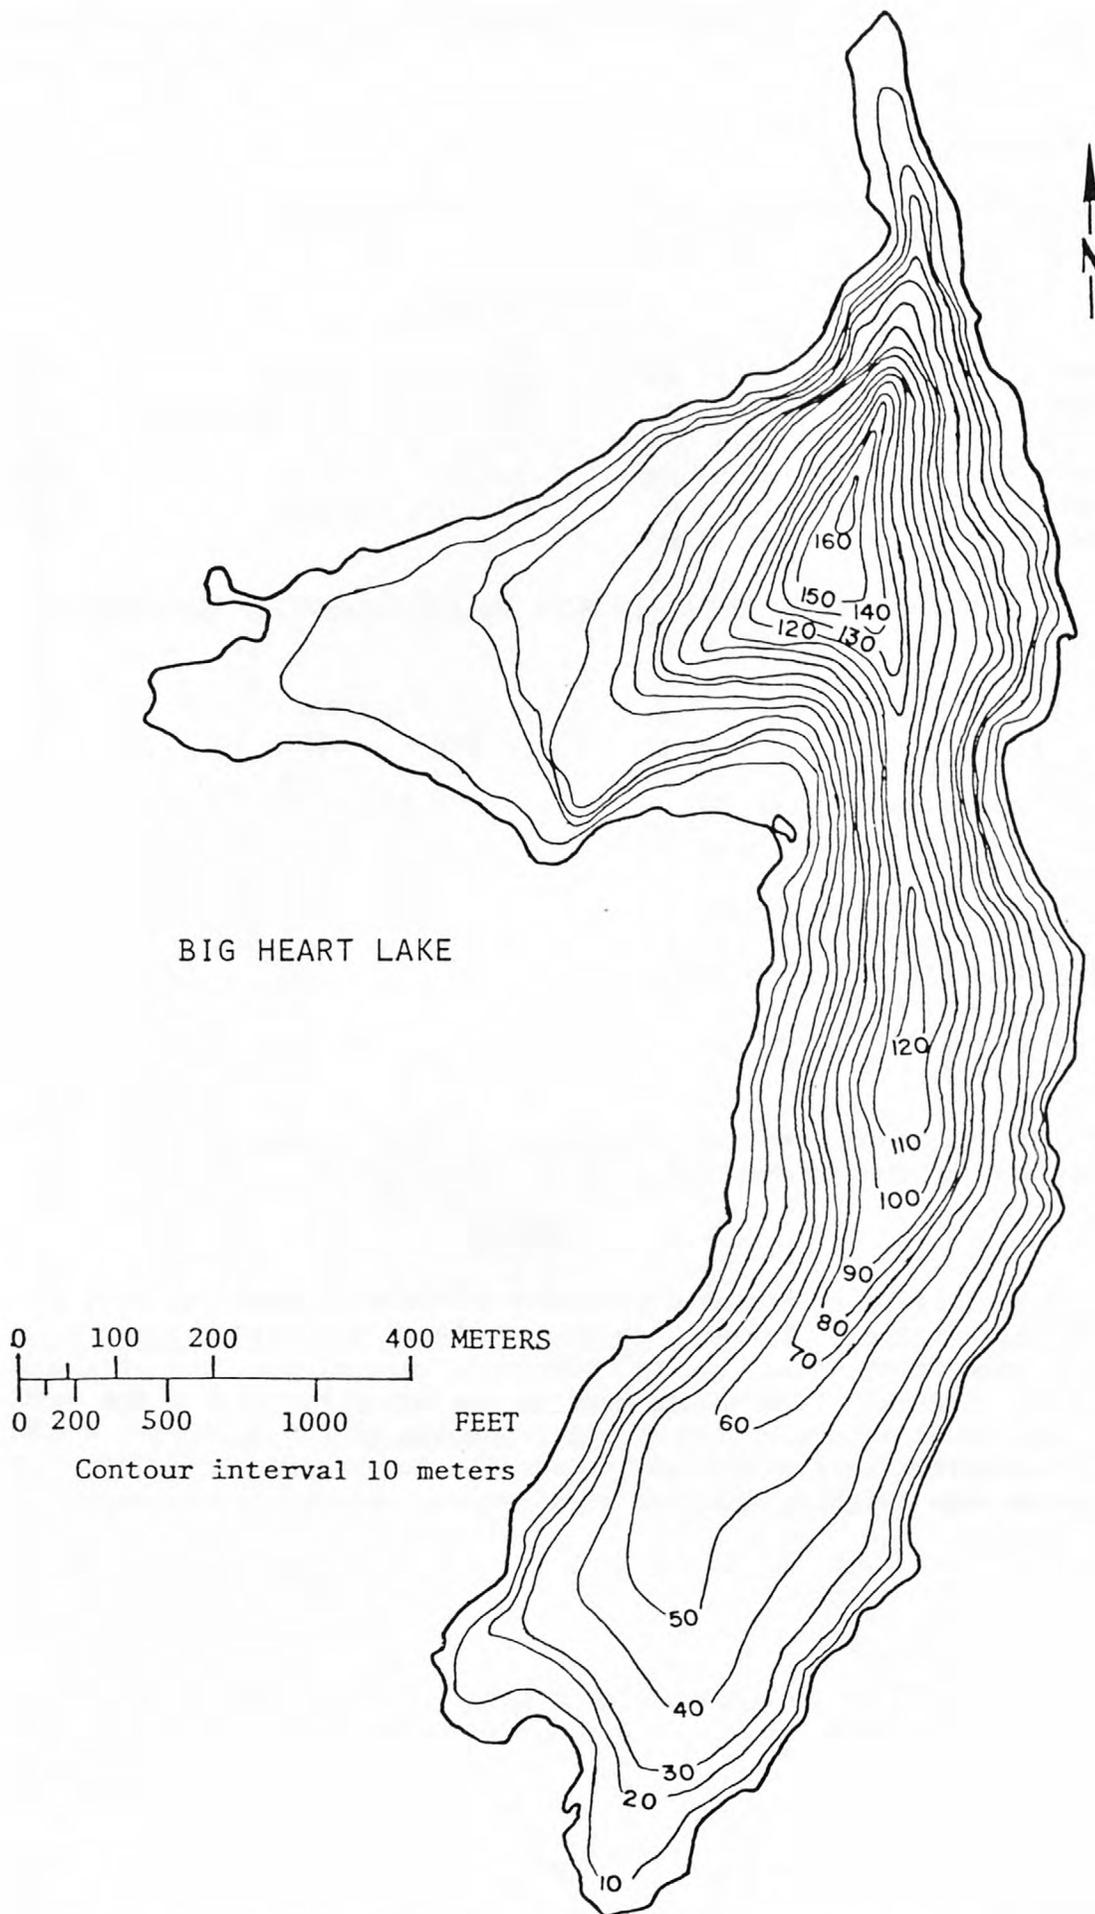
Big Heart Lake, King County. From  
U.S. Geological Survey, August 3, 1978.

A fjord-like lake with several arms: the deepest measured lake in the Alpine Lakes Wilderness Area. Forested colluvial slopes dominate the north, northwest, and south ends of the lake; bedrock surrounds most of the rest of the lake. Moraines are present 10-20 meters beneath the water surface in the west and south arms. Lake level is controlled by a bedrock lip on the northeast end of the lake. Zooplankton were moderately abundant. Below a depth of about 12 m the water column was slightly depleted of dissolved oxygen.

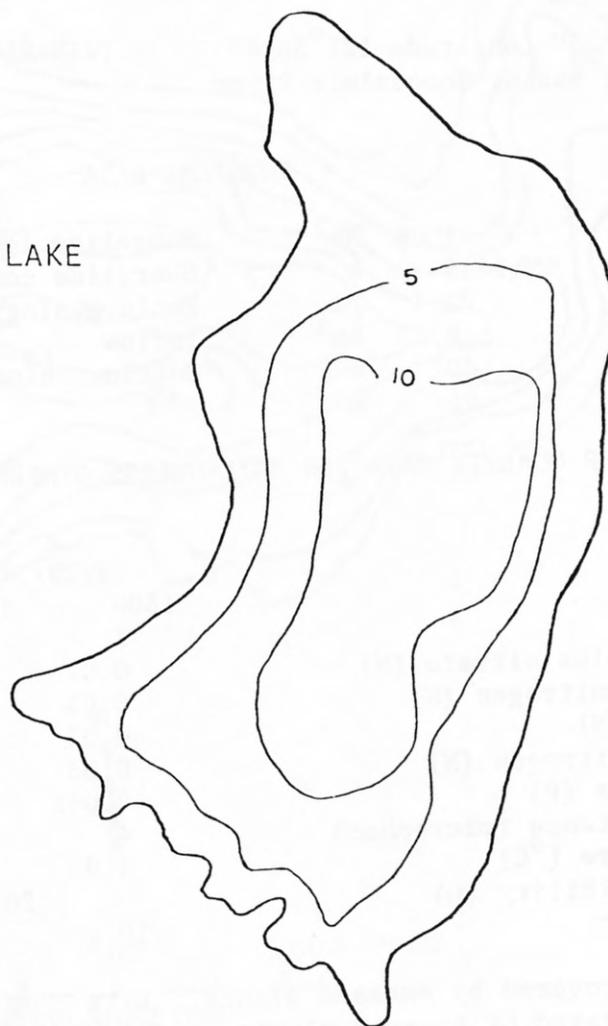
BONNIE LAKE

Contour interval 5 meters

Bonnie Lake, King County. From  
U.S. Geological Survey, August 23, 1978.

A small lake surrounded by forests except on the south side, which is largely composed of vegetated bedrock and talus. No zooplankton were observed and no dissolved-oxygen measurements were made.

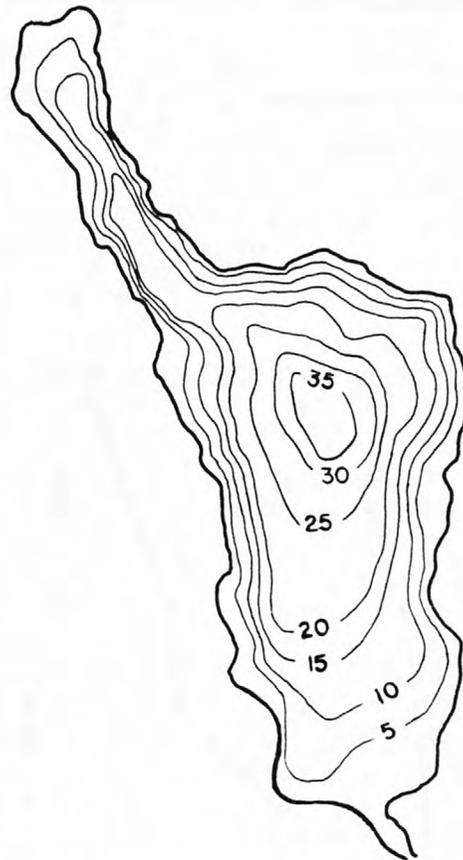
DELTA LAKE

Delta Lake, King County. From  
U.S. Geological Survey, August 30, 1978.

A deep lake surrounded by forested slopes and avalanche tracks. A large delta has been built into the lake by streams flowing from Otter, Angeline, and Big Heart Lakes. No zooplankton were observed. Dissolved-oxygen levels were depleted in the deeper waters. The north end of the lake contained a large log jam.

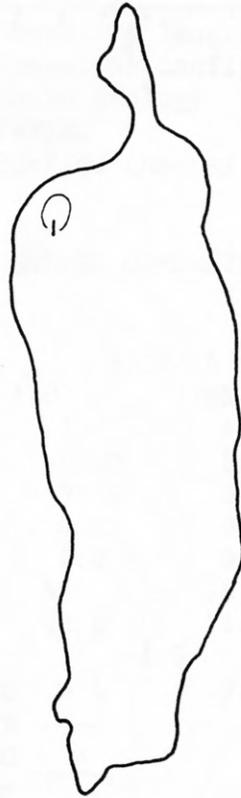
EMERALD LAKE

Emerald Lake, King County. From  
U.S. Geological Survey, August 22, 1978.

A very shallow lake with a stream channel running through it. Small wet areas are located near the lake, which is surrounded by forested till. No zooplankton were observed.

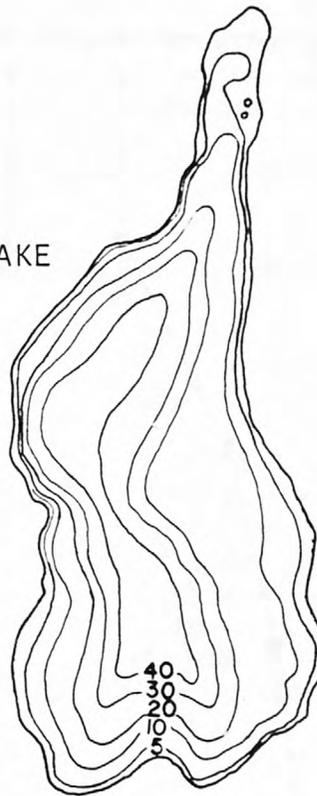
ILSWOOT LAKE

Ilswoot Lake, King County. From  
U.S. Geological Survey, August 25, 1978.

A deep lake with impaired visibility because of suspended silt. The silt appears to come from Cloudy Lake, to the south, and in drainage through talus on the east side of Ilswoot. The west shore of the lake is composed of tree-covered colluvium and bedrock, and a talus slope is located on the east shore. No zooplankton were observed.

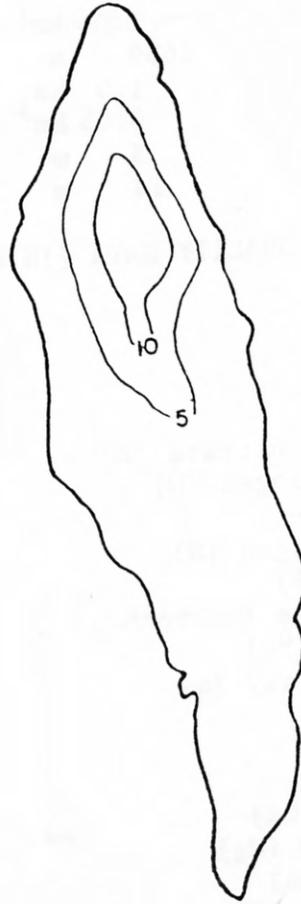
JADE LAKE

Contour interval 5 meters

Jade Lake, King County. From  
U.S. Geological Survey, August 22, 1978.

A shallow lake with a large drainage basin; the shore is composed of talus, bedrock, and forested colluvial slopes. Small areas of wet soils were noted on the southeast shore. No zooplankton were observed. Dissolved-oxygen concentrations were highly depleted in bottom waters.

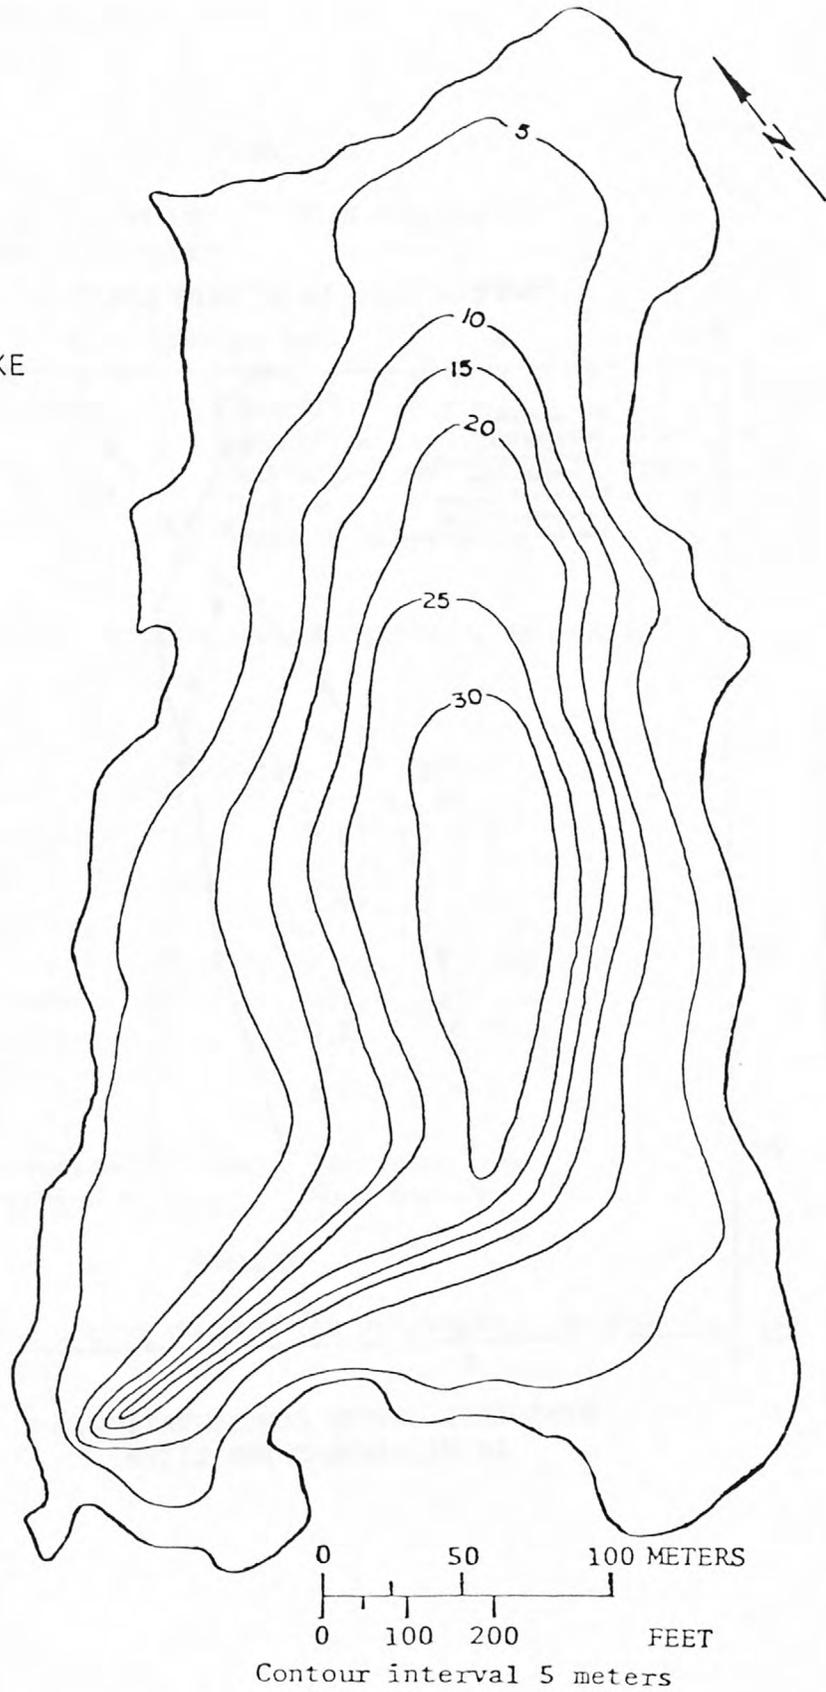
LITTLE HEART LAKE

Little Heart Lake, King County. From  
U.S. Geological Survey, August 3, 1978.

The lake is surrounded by forested slopes and talus. No zooplankton were observed. Some dissolved-oxygen depletion was noted in the bottom waters, while layers near the surface were slightly supersaturated. A large number of logs blocked the northern side of the lake.

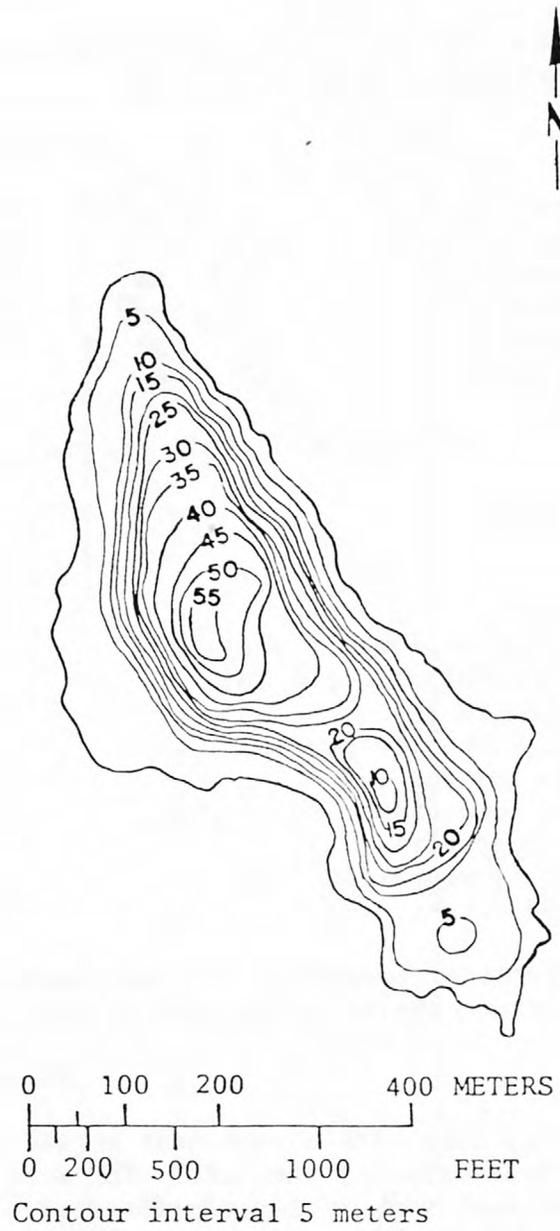
LOCKET LAKE

Locket Lake, King County. From  
U.S. Geological Survey, August 24, 1978.

A deep lake with a prominent moraine located some 10 m below the surface on the southwest side of the lake. The west shore of the lake is composed of talus, while the east side is largely forested slopes. No zooplankton were observed. The dissolved oxygen was depleted in the lake beneath the surface waters.

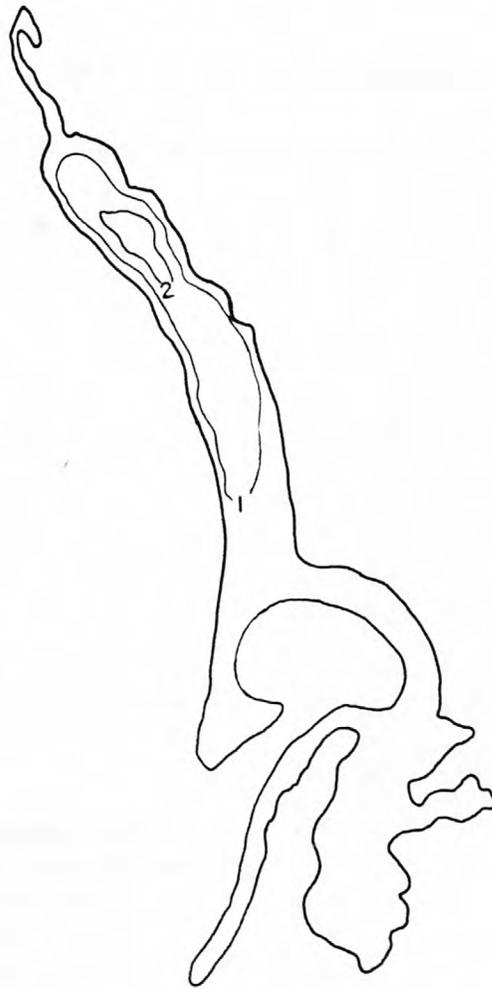
OPAL LAKE

Opal Lake, King County. From  
U.S. Geological Survey, August 22, 1978.

A small, shallow lake with a stream channel running through it. There is an extensive swamp on the south end of the lake; most of the lakeshore is composed of forested till. No zooplankton were observed.

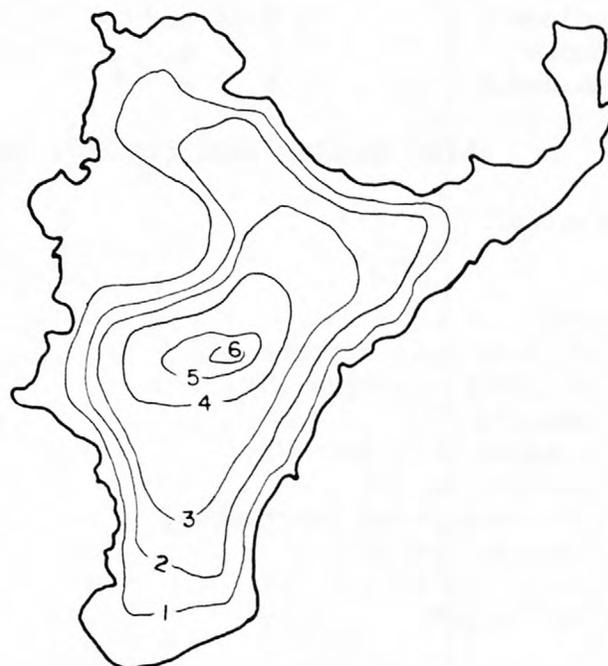
TAHL LAKE

Tahl Lake, King County. From  
U.S. Geological Survey, August 24, 1978.

A small, shallow lake surrounded by bedrock, talus, and minor amounts of vegetated talus. Zooplankton were moderately abundant. No dissolved-oxygen samples were collected.

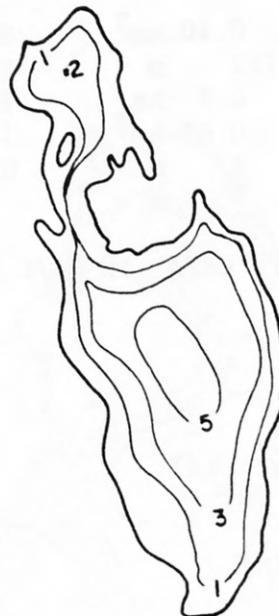
TANK, NORTH LAKE

Tank, North Lake, King County. From  
U.S. Geological Survey, August 23, 1978.

A small, shallow lake completely surrounded by bedrock and snowfields. The area draining into this lake is largely bedrock with only minor amounts of vegetation. No zooplankton were observed.

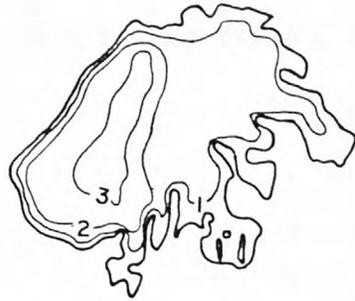
TOP LAKE POTHOLE LAKE

Top Lake Pothole Lake, King County. From U.S. Geological Survey, August 28, 1978.
