EFFECTS OF URANIUM DEVELOPMENT ON EROSION AND ASSOCIATED
SEDIMENTATION IN SOUTHERN SAN JUAN BASIN, NEW MEXICO

Maurice E. Cooley

U. S. Geological Survey

U. S. Geological Survey Open-File Report 79-1496

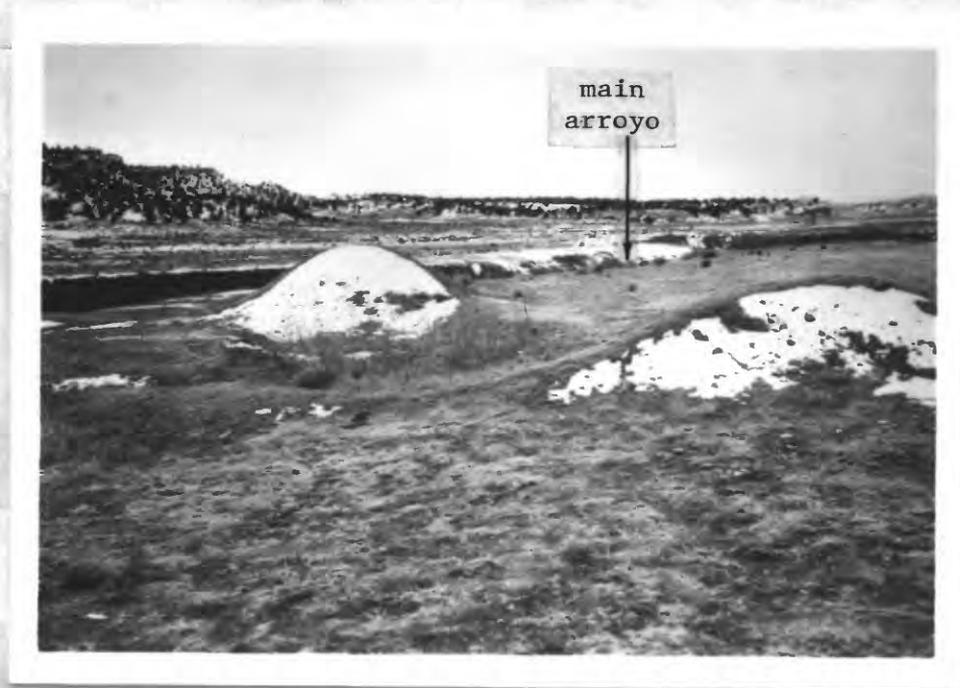
Figure 2. Old mud pit about 2 feet deep at exploratory test well near the Church Rock mines. Vegetation was re-established at this site before effects of accelerated erosion could occur. Vegetation is partly re-established in the pit and on the two rounded debris piles at opposite ends of the pit. Little sediment is now being eroded from the debris piles. The mud pit is slowly being filled. Most mud pits have only slight effects on runoff, erosion, or sedimentation.

Abandoned, unfilled mud pits about 2 feet deep at drilling sites (fig. 2) also have only slight effects on erosion. In some cases drilling mud is allowed to run off into arroyos, a condition that increases sediment content of streamflow.

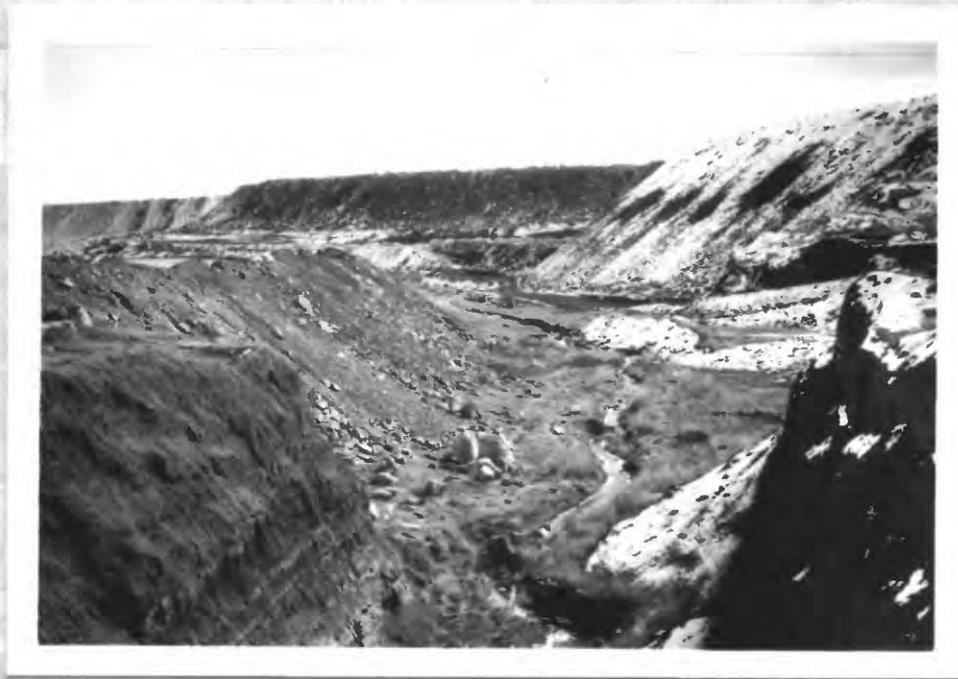
Figure 3. Channel of Rio Paguate through the Jackpile-Paguate mine area. View downstream (southeast) from northern edge of mine area. Before the mining operations, Rio Paguate flowed in a channel or arroyo that was about 40 feet deep and 100-300 feet wide. Dumping of mine debris has caused some narrowing of the channel. Erosion of the unconsolidated debris adds considerable bedload and suspended sediment to the river. During large flows the river cuts laterally into debris piles. Cobbles and boulders in the mine debris help retard cutting, but they are moved during large floods. Vegetation growing in the channel, the absence of fresh scars on the lower slopes of the debris piles, the distribution of boulders along the base of the debris piles, and the configuration of the low-flow channel is evidence that large floods have not occurred recently. Narrow bands of ice (white) are along the edges of the low-flow channel. An exposure of dark gray Cretaceous shale is at lower left.

The Church Rock mines, the Jackpile-Paguete mine, and the St. Anthony's mine are near arroyos that are 20 to 40 feet deep. Mine-waste deposits and earthworks associated with the mining activity have modified severely or diverted the stream channels. A series of dams built upstream from the main area of mine-mill activity of the Church Rock mines has caused partial filling of the arroyo. At places in the area of mine-mill activity, the arroyo is nearly obliterated, even though the present channel approximately follows its old course (fig. 8). The channels of Rio Paguate through the Jackpile-Paguete mine (fig. 3) and Arroyo del Valle through St. Anthony's mine are now confined between huge piles of mine wastes. Large floods through the mine areas would cause much lateral cutting and associated slumping of the unconsolidated rubble and would transport sediment from the mine areas. The amount of sediment obtained from the mine areas is not known, but it is believed by the author to be substantial. For example, sediment derived from waste piles of the Jackpile-Paguete mine has resulted in the buildup of broad sandbars as much as 4 feet high in the channel of Rio Paguate downstream from the mine.

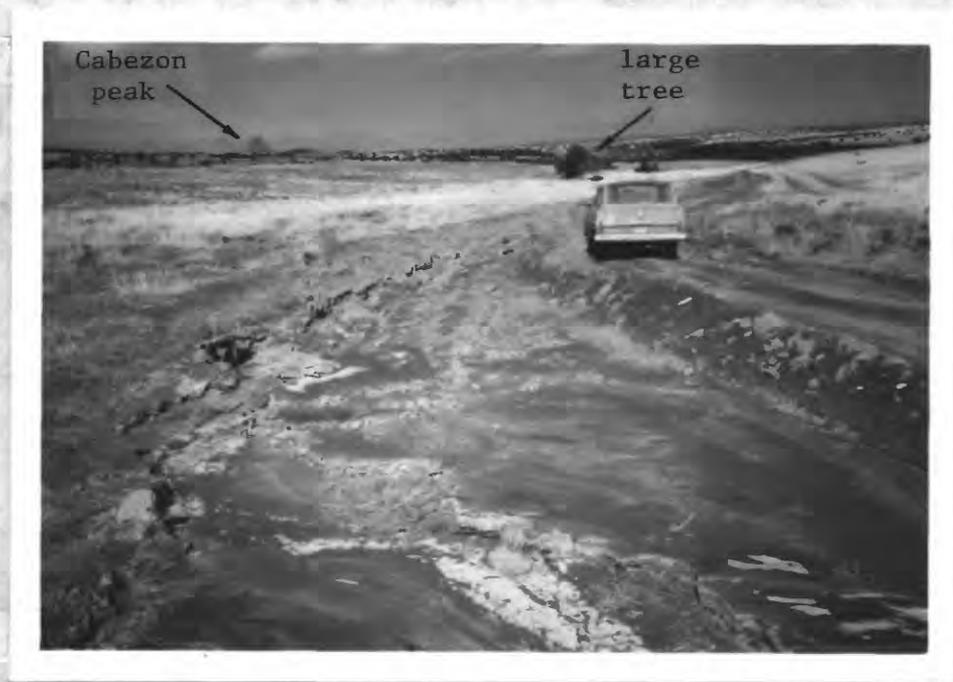
Figure 4. Erosion along a newly bulldozed road that was caused by flow discharged from the Bokum Resources mine near Marquez. This mine road, located in sec. 7, T. 12 N., R. 3 E., has been in operation for only a short time. Easily erodable grass-covered alluvial slopes beyond the bulldozed area do not contain arroyos or gullies. Sustained flow along the road and on the slopes will eventually form gullies. View is northward toward the volcanic Cabezon Peak.

Erosional effects of mining operations are more severe on relatively steep slopes or near main drainages than at relatively level sites. Steeply sloping areas are more unstable and are therefore favorable locales for initiating or accelerating sheet or gully erosion (fig. 4) with the associated increase of the sediment content of the runoff.

Runoff originating in the mining area could be diverted by dikes in order to reduce runoff rates and to prevent the formation of new gullies or the expansion of old ones. Sediment will accumulate upstream of erosion control dams built across channels.

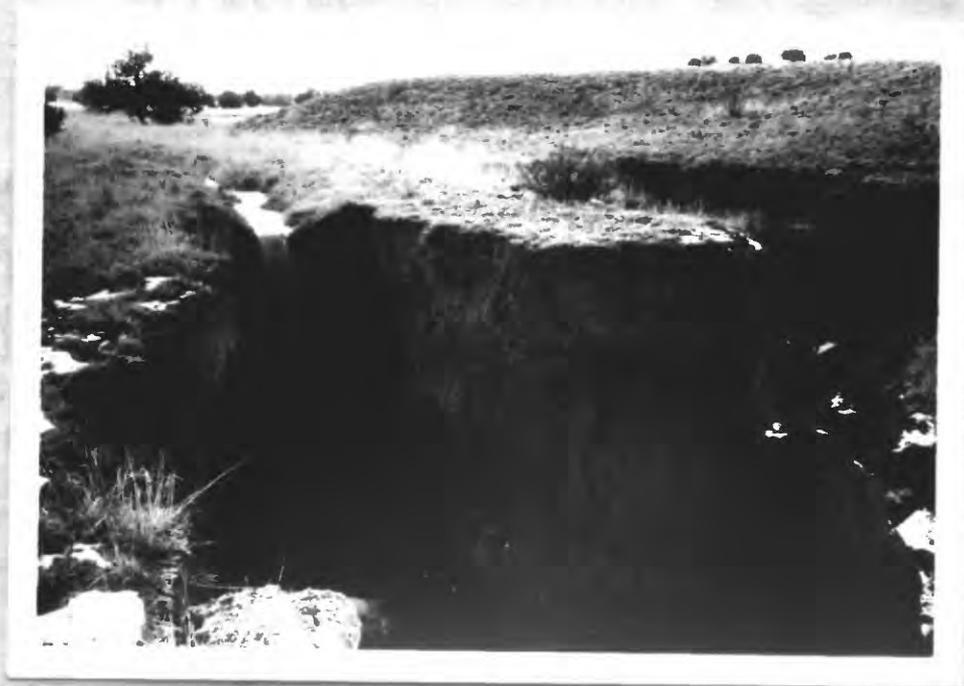
Figure 6. Flow from Bokum Resources mine cascading over a headcut of a discontinuous arroyo. The arroyo has a maximum depth of 16.5 feet. The main headcut at upper left and the smaller headcut at upper right have extended by about 25 and 8 feet, respectively. Freshly scarred, vertical arroyo walls are evidence of the headward cutting.

Water from the Bokum Resources mine near Marquez has caused some headcutting of discontinuous arroyos (fig. 6) since the mine has been in operation. In about 1 year, two of the arroyos about 1 mile downstream from the mine have extended headward about 25 and 8 feet, respectively. In the area near the mine, no appreciable downcutting or filling of arroyos was observed.

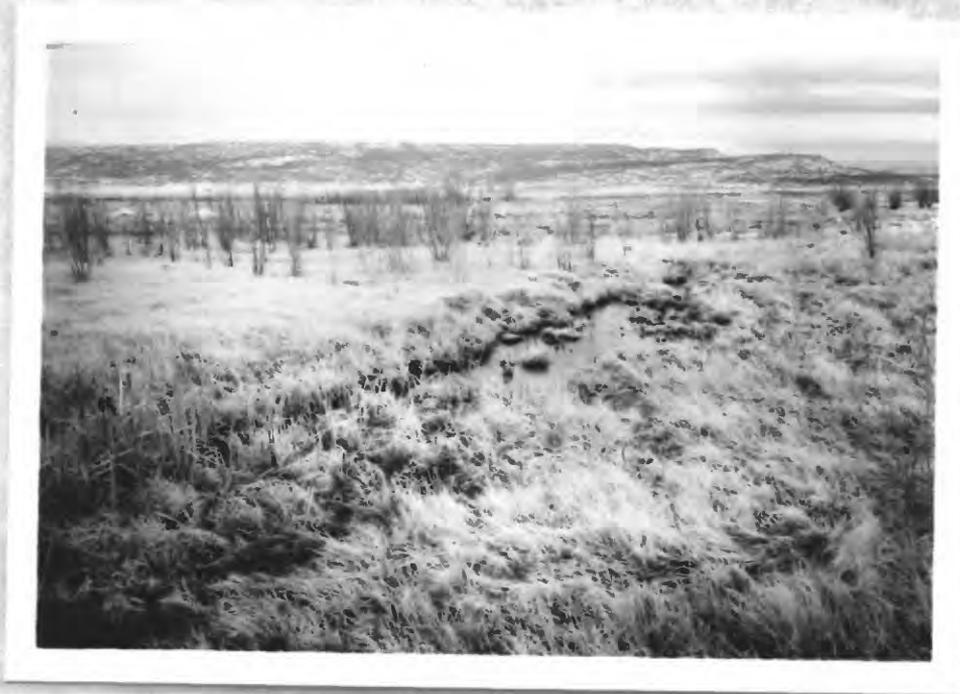
Figure 7. Mine and mill effluent spread out on an undissected alluvial valley floor in Ambrosia Lake area. The effluent supports a dense stand of tall grasses and a few shrubs whereas the adjacent slopes are mantled by short grasses. Virtually no erosion occurs in the flood area due to the low gradient of the slope and lack of channels. The water not used by plants is evaporated or infiltrates the underlying alluvium. None of the water reaches streams as overland flow.

Part of the water obtained from the mines and mills in the Ambrosia Lake area is spread over and irrigates gentle grass-covered slopes that are characteristic of the area (fig. 7). These irrigated slopes support a dense stand of tall grasses and a few shrubs, whereas adjacent non-irrigated slopes are mantled by only short grasses. The gradients of the slopes are low and virtually no erosion occurs. The water that is not used by plants is evaporated or seeps into the alluvial deposits that underlie the slopes.

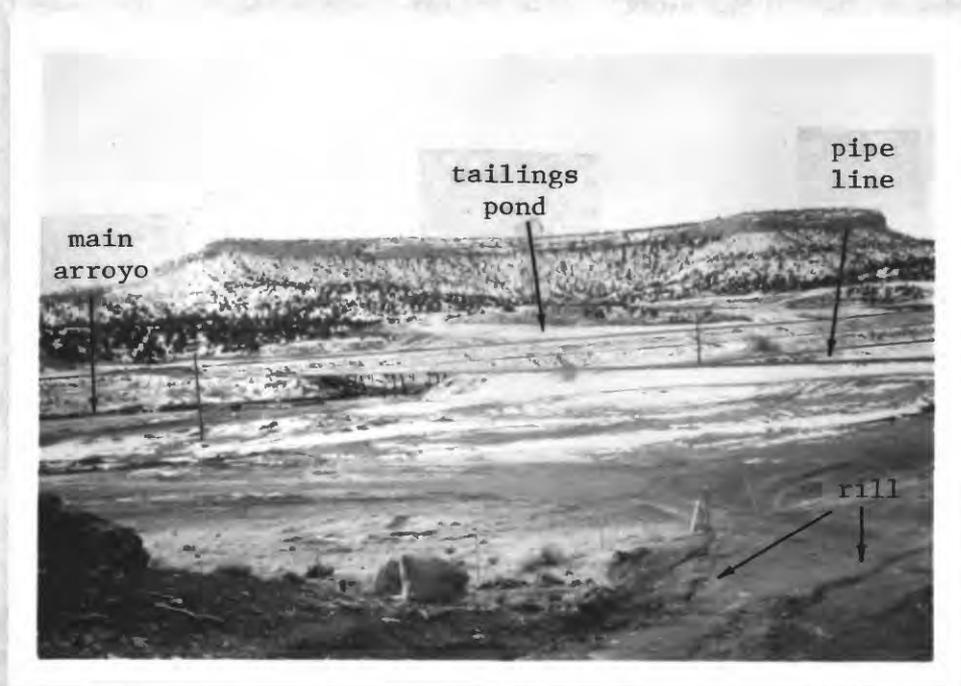
Figure 8. View of some of the operations at the Church Rock mines. View is southeastward across valley that is underlain by easily erodible fine-grained alluvium. Main arroyo, a tributary of the North Fork of the Puerco River, is nearly obliterated by dikes, road fills, tailings pond, and other features. Pipeline leading from the mill to the tailings pond crosses the arroyo at center. All disturbed areas are subject to sheet erosion, possibly gully erosion, and some wind deflation. Small rills have formed along an old dirt road at lower right. Runoff from the disturbed areas transports relatively large amount of sediment to the main arroyo.
