HOLLISTER QUADRANGLE
CALIFORNIA
7.5 MINUTE SERIES (TOPOGRAPHIC)
SW¼ HOLLISTER 1' QUADRANGLE

SAN FRANCISCO BAY REGION
SHEET 3 OF 3

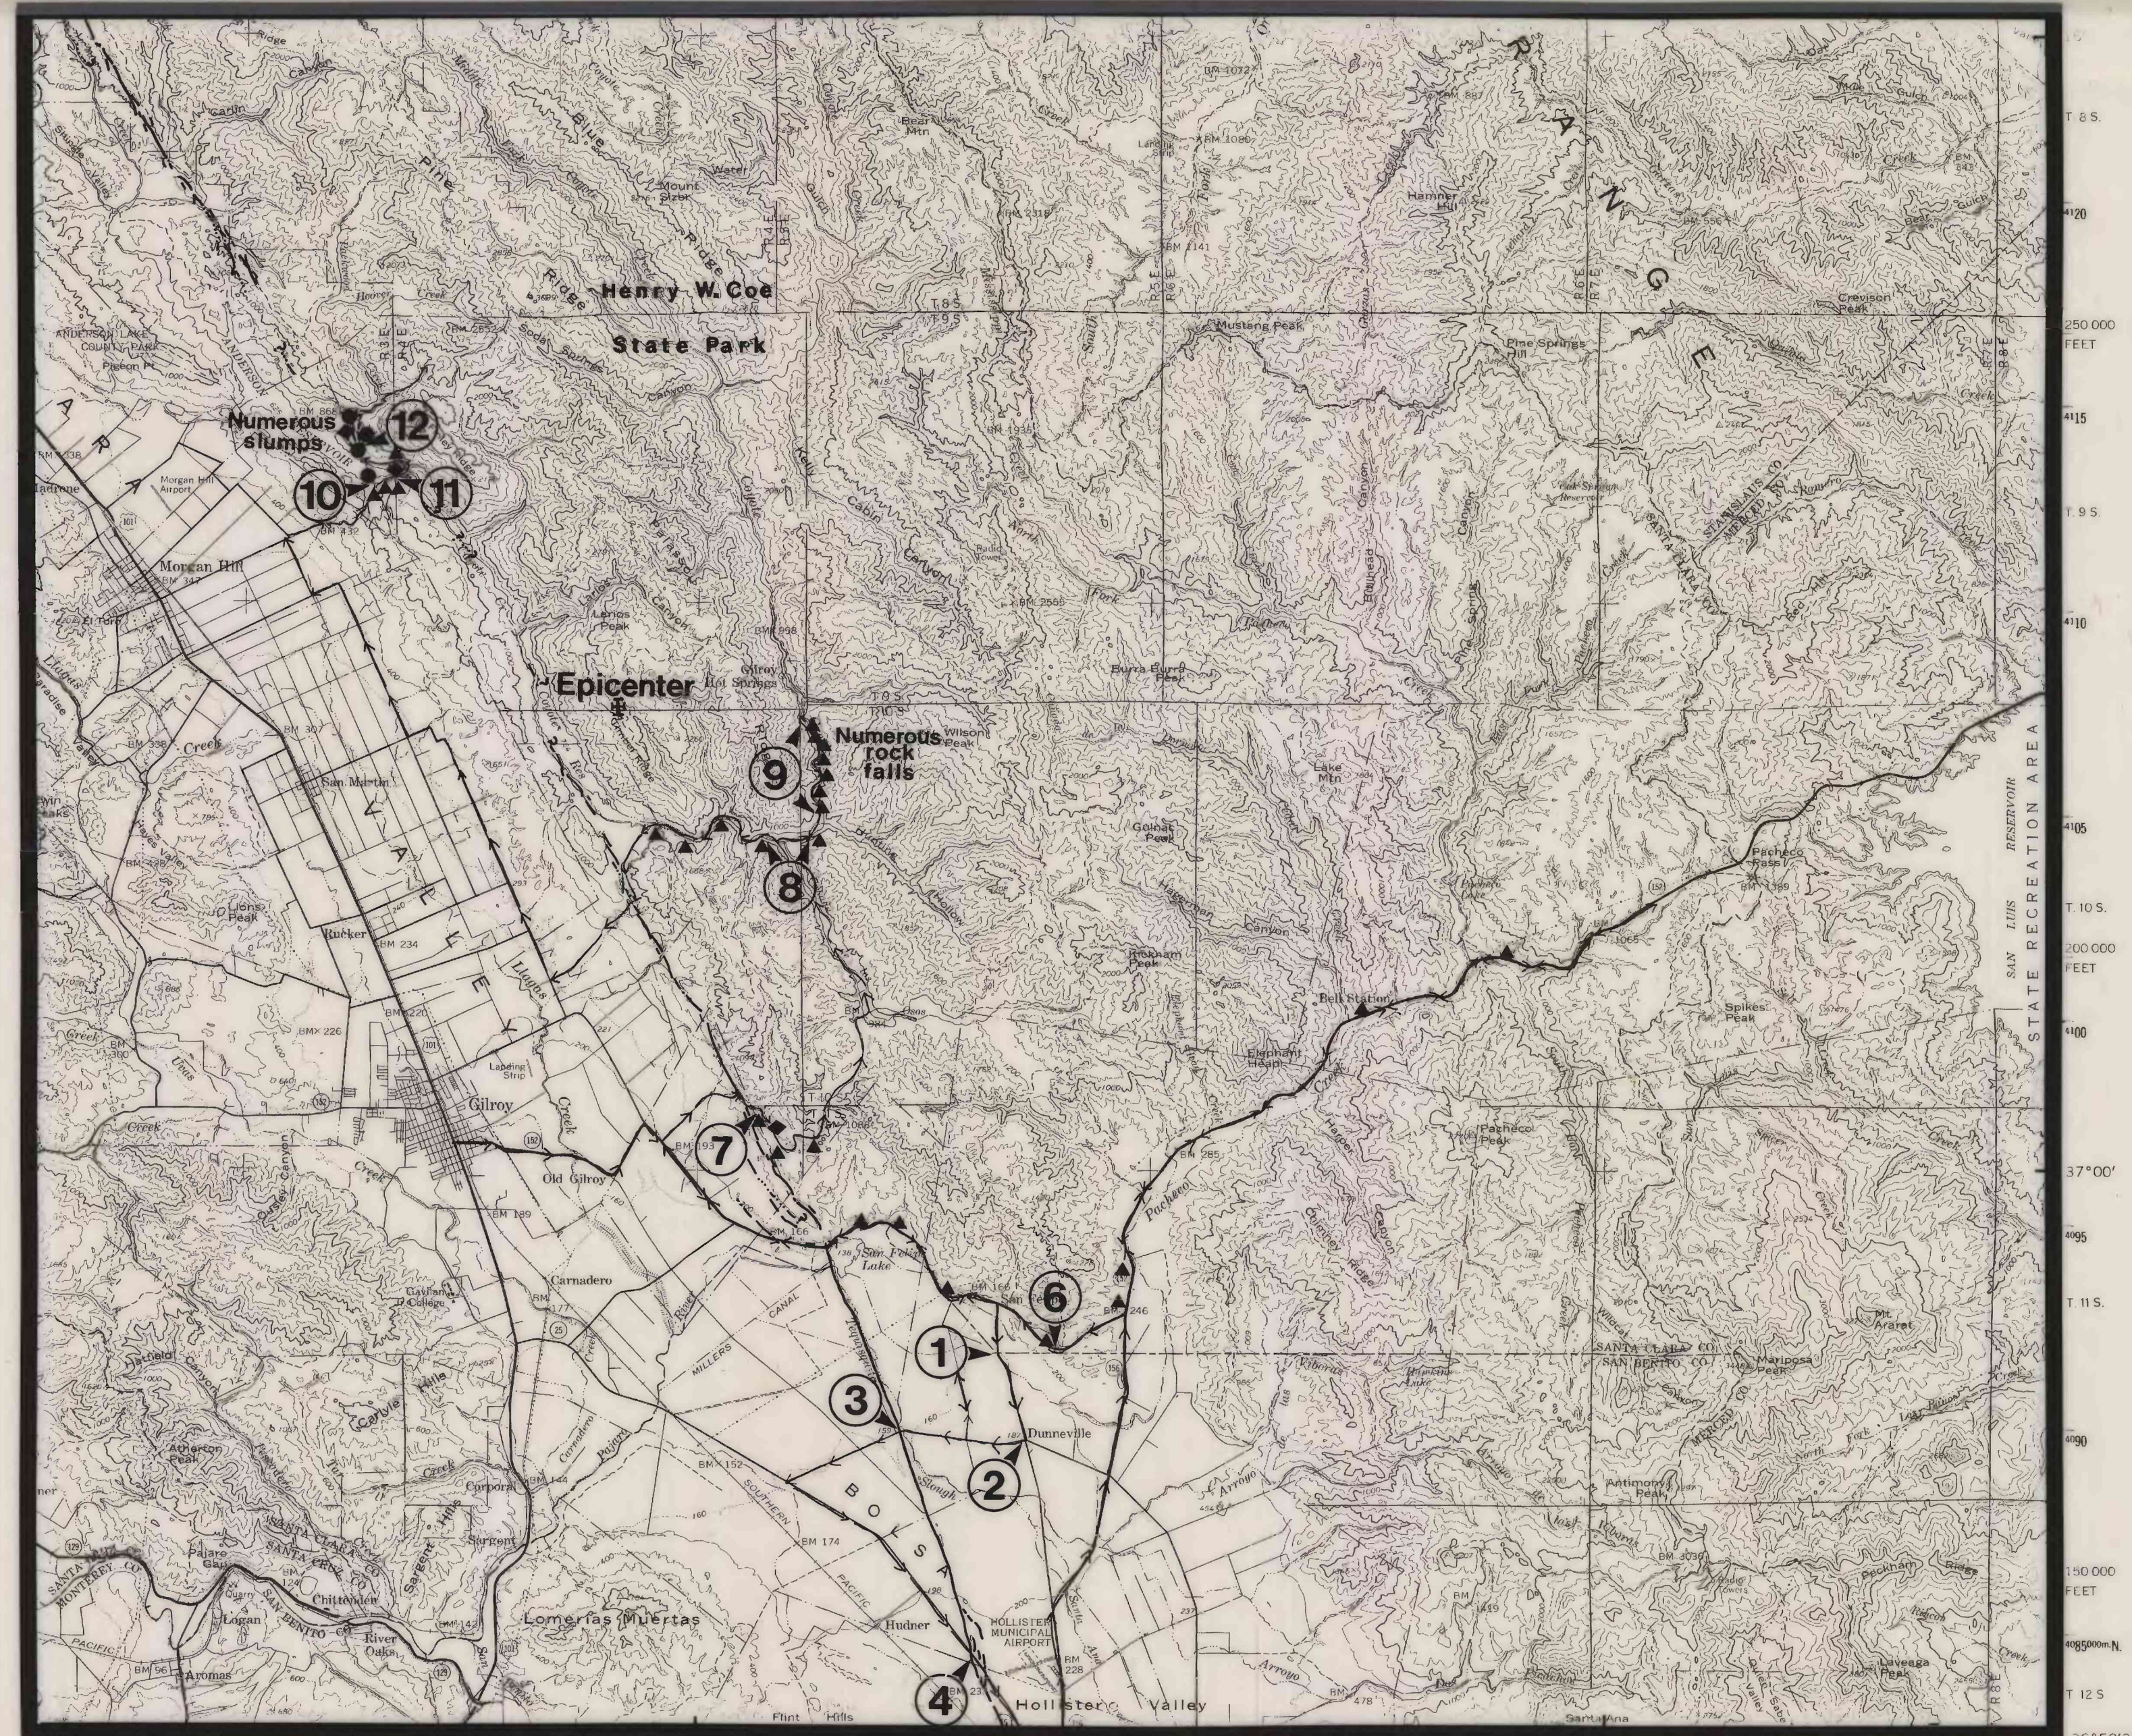
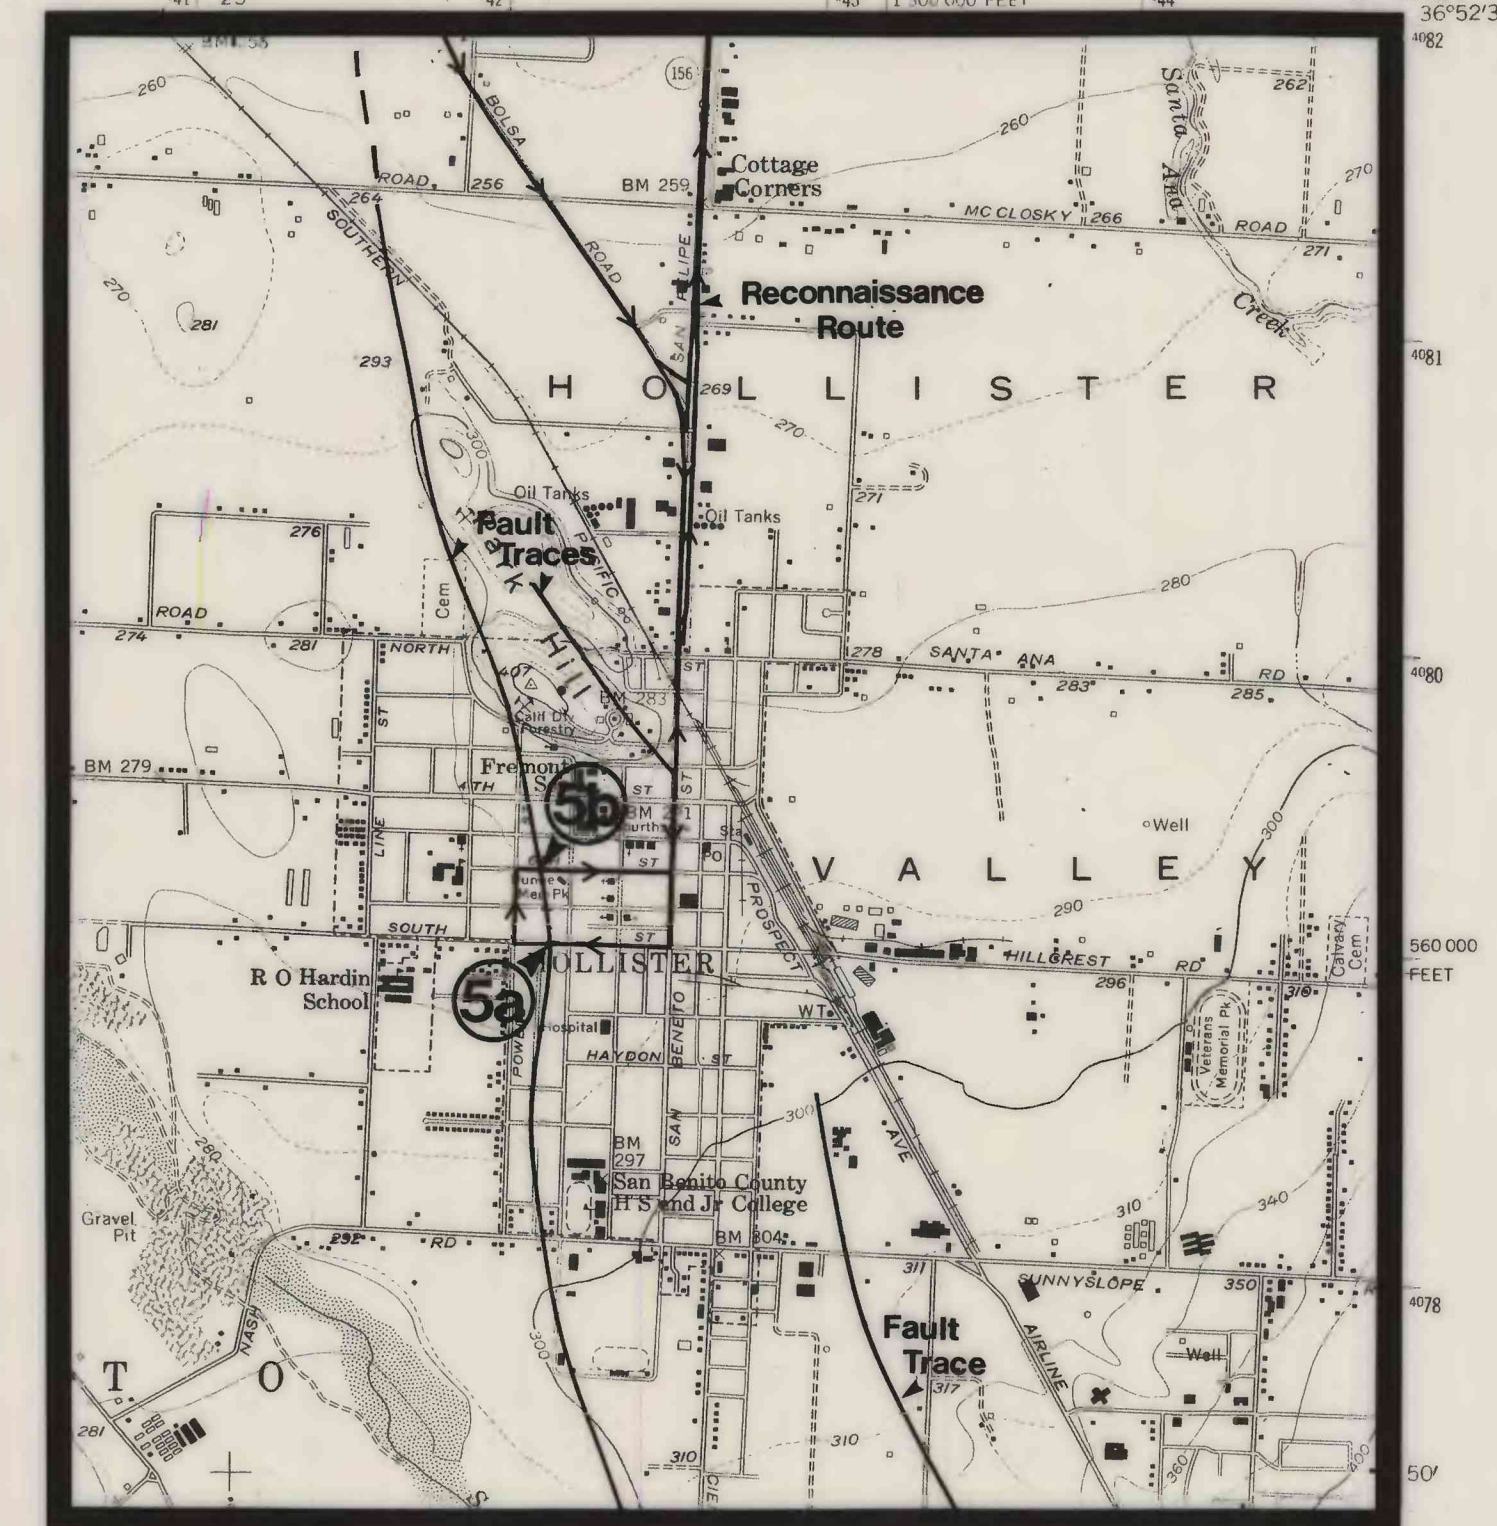
INSET

- Explanation
- ⑧ Site described in text
 - ▲ Rock fall
 - Rotational slump
 - ◆ Cracking of highway shoulder or turnout area
 - → Route of August 6 reconnaissance, arrows show direction of travel
 - ? Calaveras fault trace; dashed where location approximate, dotted where concealed
- Fault mapping by Herd (1979) and Herd and others (1979).
