Channel Erosion and Sediment Transport in Pheasant Branch Basin Near Middleton, Wisconsin— A Preliminary Report

R. S. Grant and Gerald Goddard

U. S. GEOLOGICAL SURVEY
Water-Resources Investigations
Open-File Report 80-161

February 1980

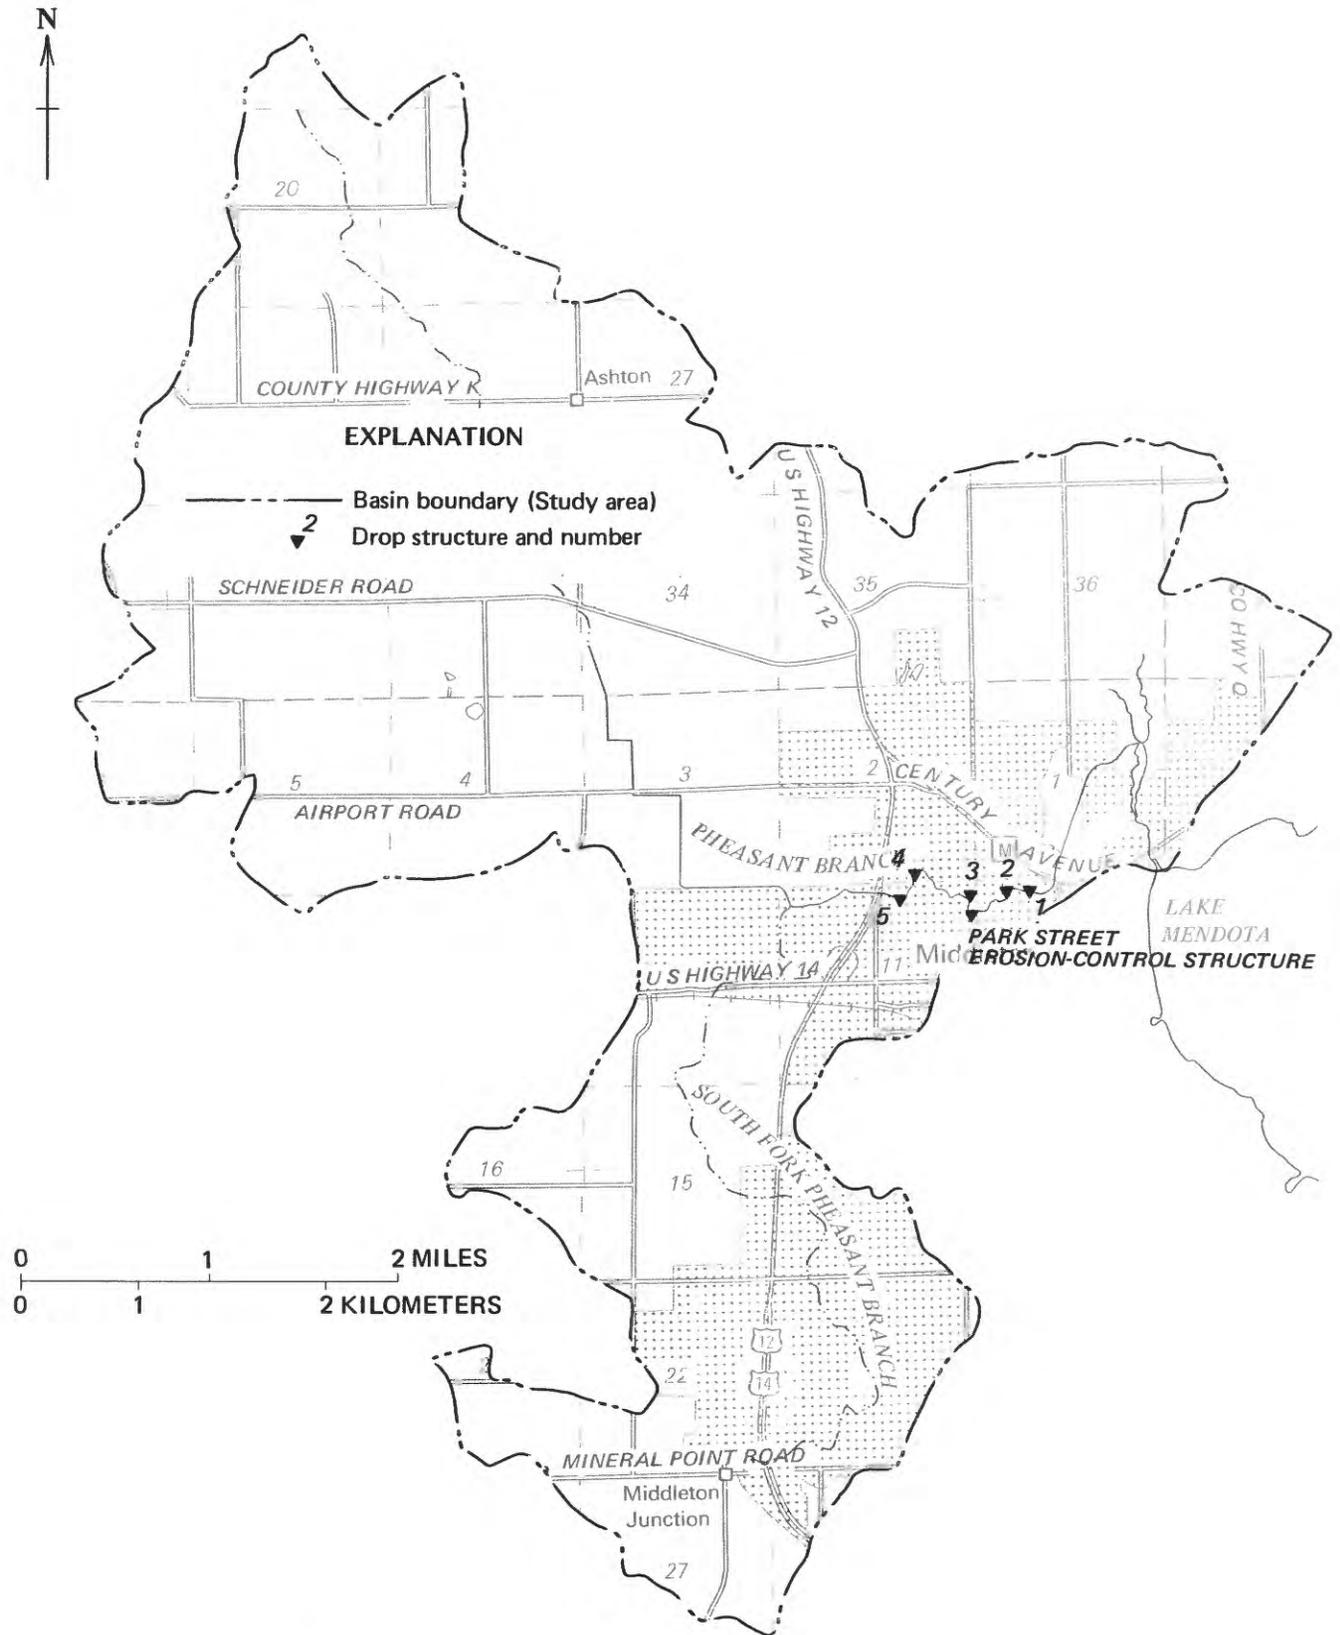
Figure 2. Location of drop structures between Century Avenue and U. S. Highway 12.

Because of severe channel-erosion problems between U.S. Highway 12 and Century Avenue, five drop structures were installed by the city of Middleton to decrease stream gradient (fig. 2). The structures also were designed as fords for a nature trail crossing the stream at these locations. An erosion-control structure also is located at the upstream end of the Park Street culvert. Photographs of typical structures are shown in figures 3 and 4.

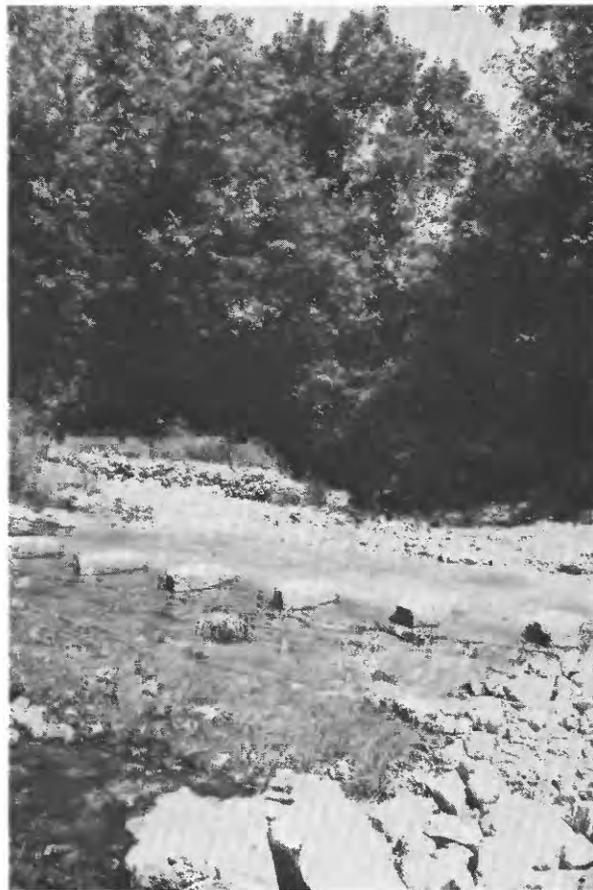
Figure 3. View upstream of drop structure 4.

The reach between U.S. Highway 12 and Century Avenue is so steep that six structures are not enough to decrease the overall effective stream gradient. Thus, high flow stream-velocity reductions probably occur only in a short reach upstream from each structure where velocities may drop below erosive levels. The structures, however, do inhibit downward cutting of the channel upstream from each structure.

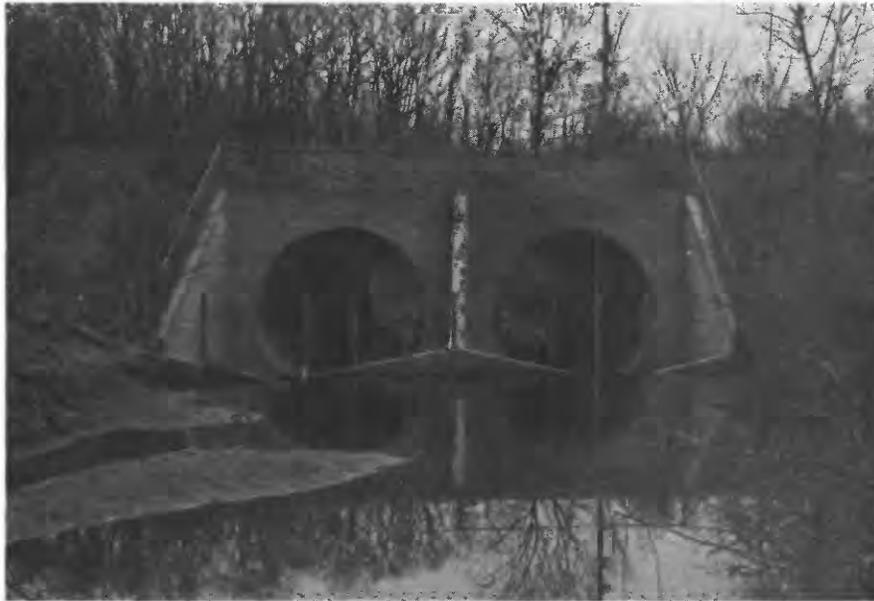
Figure 4. View downstream at Park Street erosion-control structure.

The decreases in suspended-sediment load for some storms may be caused by sediment trapping and deposition upstream from the drop structures and the erosion-control structure at Park Street. The channel upstream from this structure has been dredged several times, indicating that the structure does trap sediment. The small percentage of differences in suspended-sediment loads also may be subject to measurement accuracy. Further calibration of the automatic samplers may be needed.

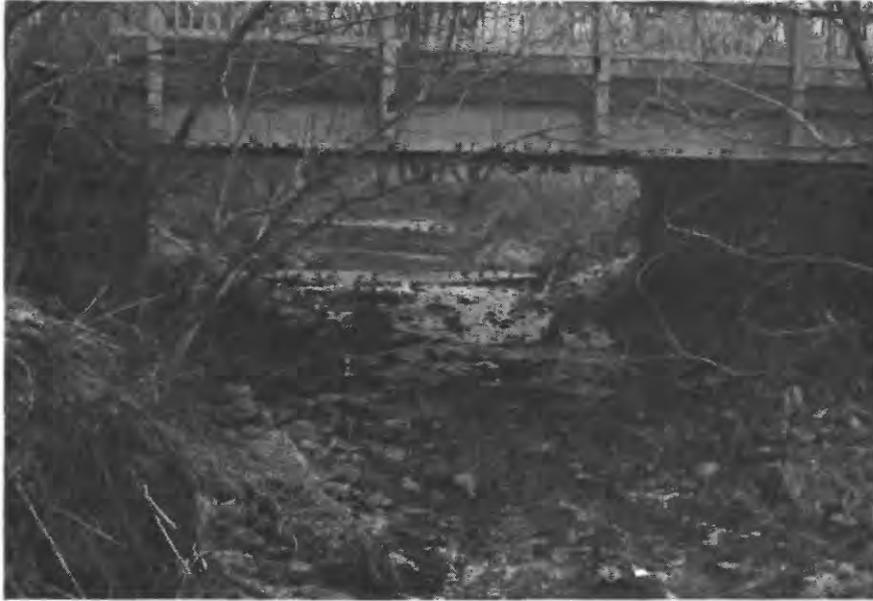
**Figure 5. View upstream under Century Avenue bridge in 1972
(Note concrete structure across stream at upstream side of bridge).**

The concrete structure housing sewer and water pipes at the upstream side of the Century Avenue bridge (figs. 5 and 6) inhibits downcutting also. Headward erosion from downstream uncovered the structure sometime before 1971. Severe headward erosion would have continued upstream if the structure had not been present.

Photographs of the channel at Century Avenue in 1972 and 1978 illustrate the magnitude of the channel-erosion problem (figs. 5 and 6). The concrete structure in the streambed containing sewer and water pipes was buried beneath the streambed during construction in 1959. About 4 vertical feet of the structure were exposed by 1978. The Century Avenue bridge was widened in about 1973 and the streambanks were riprapped, but this probably did not contribute much to the erosion problems downstream from the bridge.

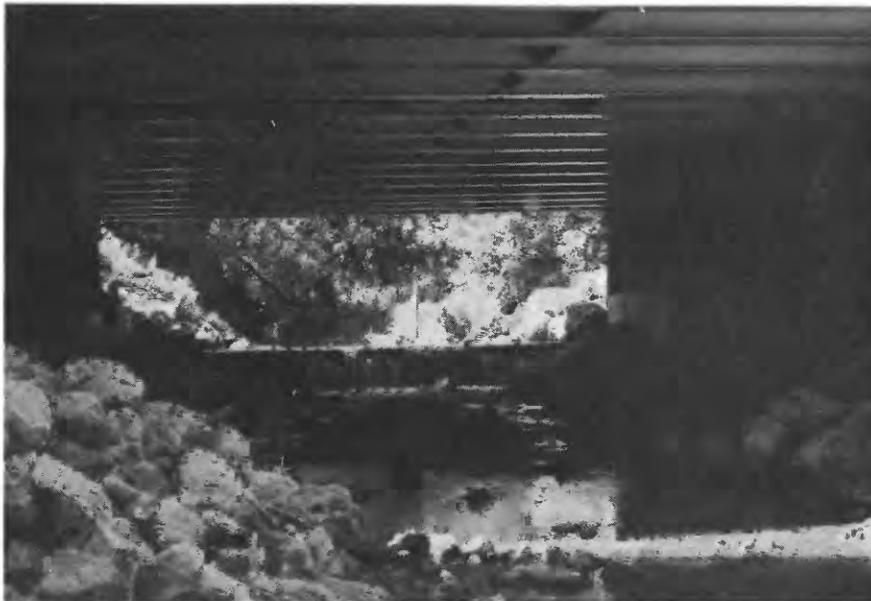
**Figure 6. View upstream under Century Avenue bridge in 1978
(Note concrete structure exposed 4 feet vertically).**

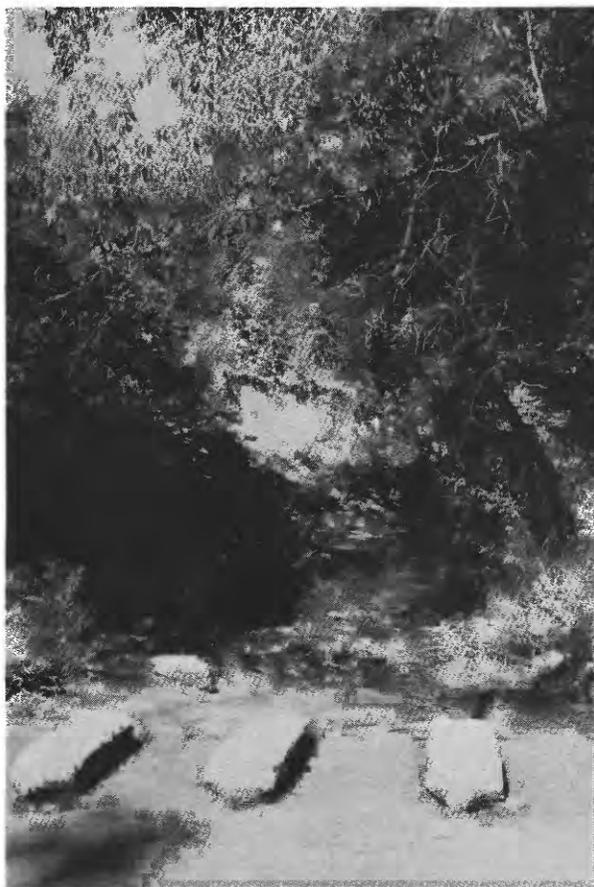
Figure 11. View of bank erosion downstream from drop structure 5.

A summary of channel changes between the marsh and County Highway K is presented in table 2. These data show that more than 90 percent of the channel erosion was associated with vertical cutting. The bank erosion that occurs generally is above the mean annual flood level. Bank erosion is caused by the erosion of the banks near the channel bed and the consequent slumping of the upper part of the banks into the channel. Soils along Pheasant Branch through the city consist mainly of Rodman sandy loam. This soil is excessively drained and is extremely susceptible to erosion. Also, a good level of plant cover to help prevent erosion (Glocker and Patzer, 1978) is difficult to maintain on this soil. Bank erosion at one site is shown in figure 11.
