REDDISH KNOB, VA.—W. VA.
NW/4 PARNASSUS 15 QUADRANGLE
N.3822.5—W.7907.5/7.5
1967

LANDSLIDES AND RELATED FEATURES
OF THE REDDISH KNOB, VA.—W. VA. QUADRANGLE
by Robert J. Hackman and Roger E. Thomas
1980
U.S. Geological Survey
OPEN FILE MAP 80-194 (D-7)

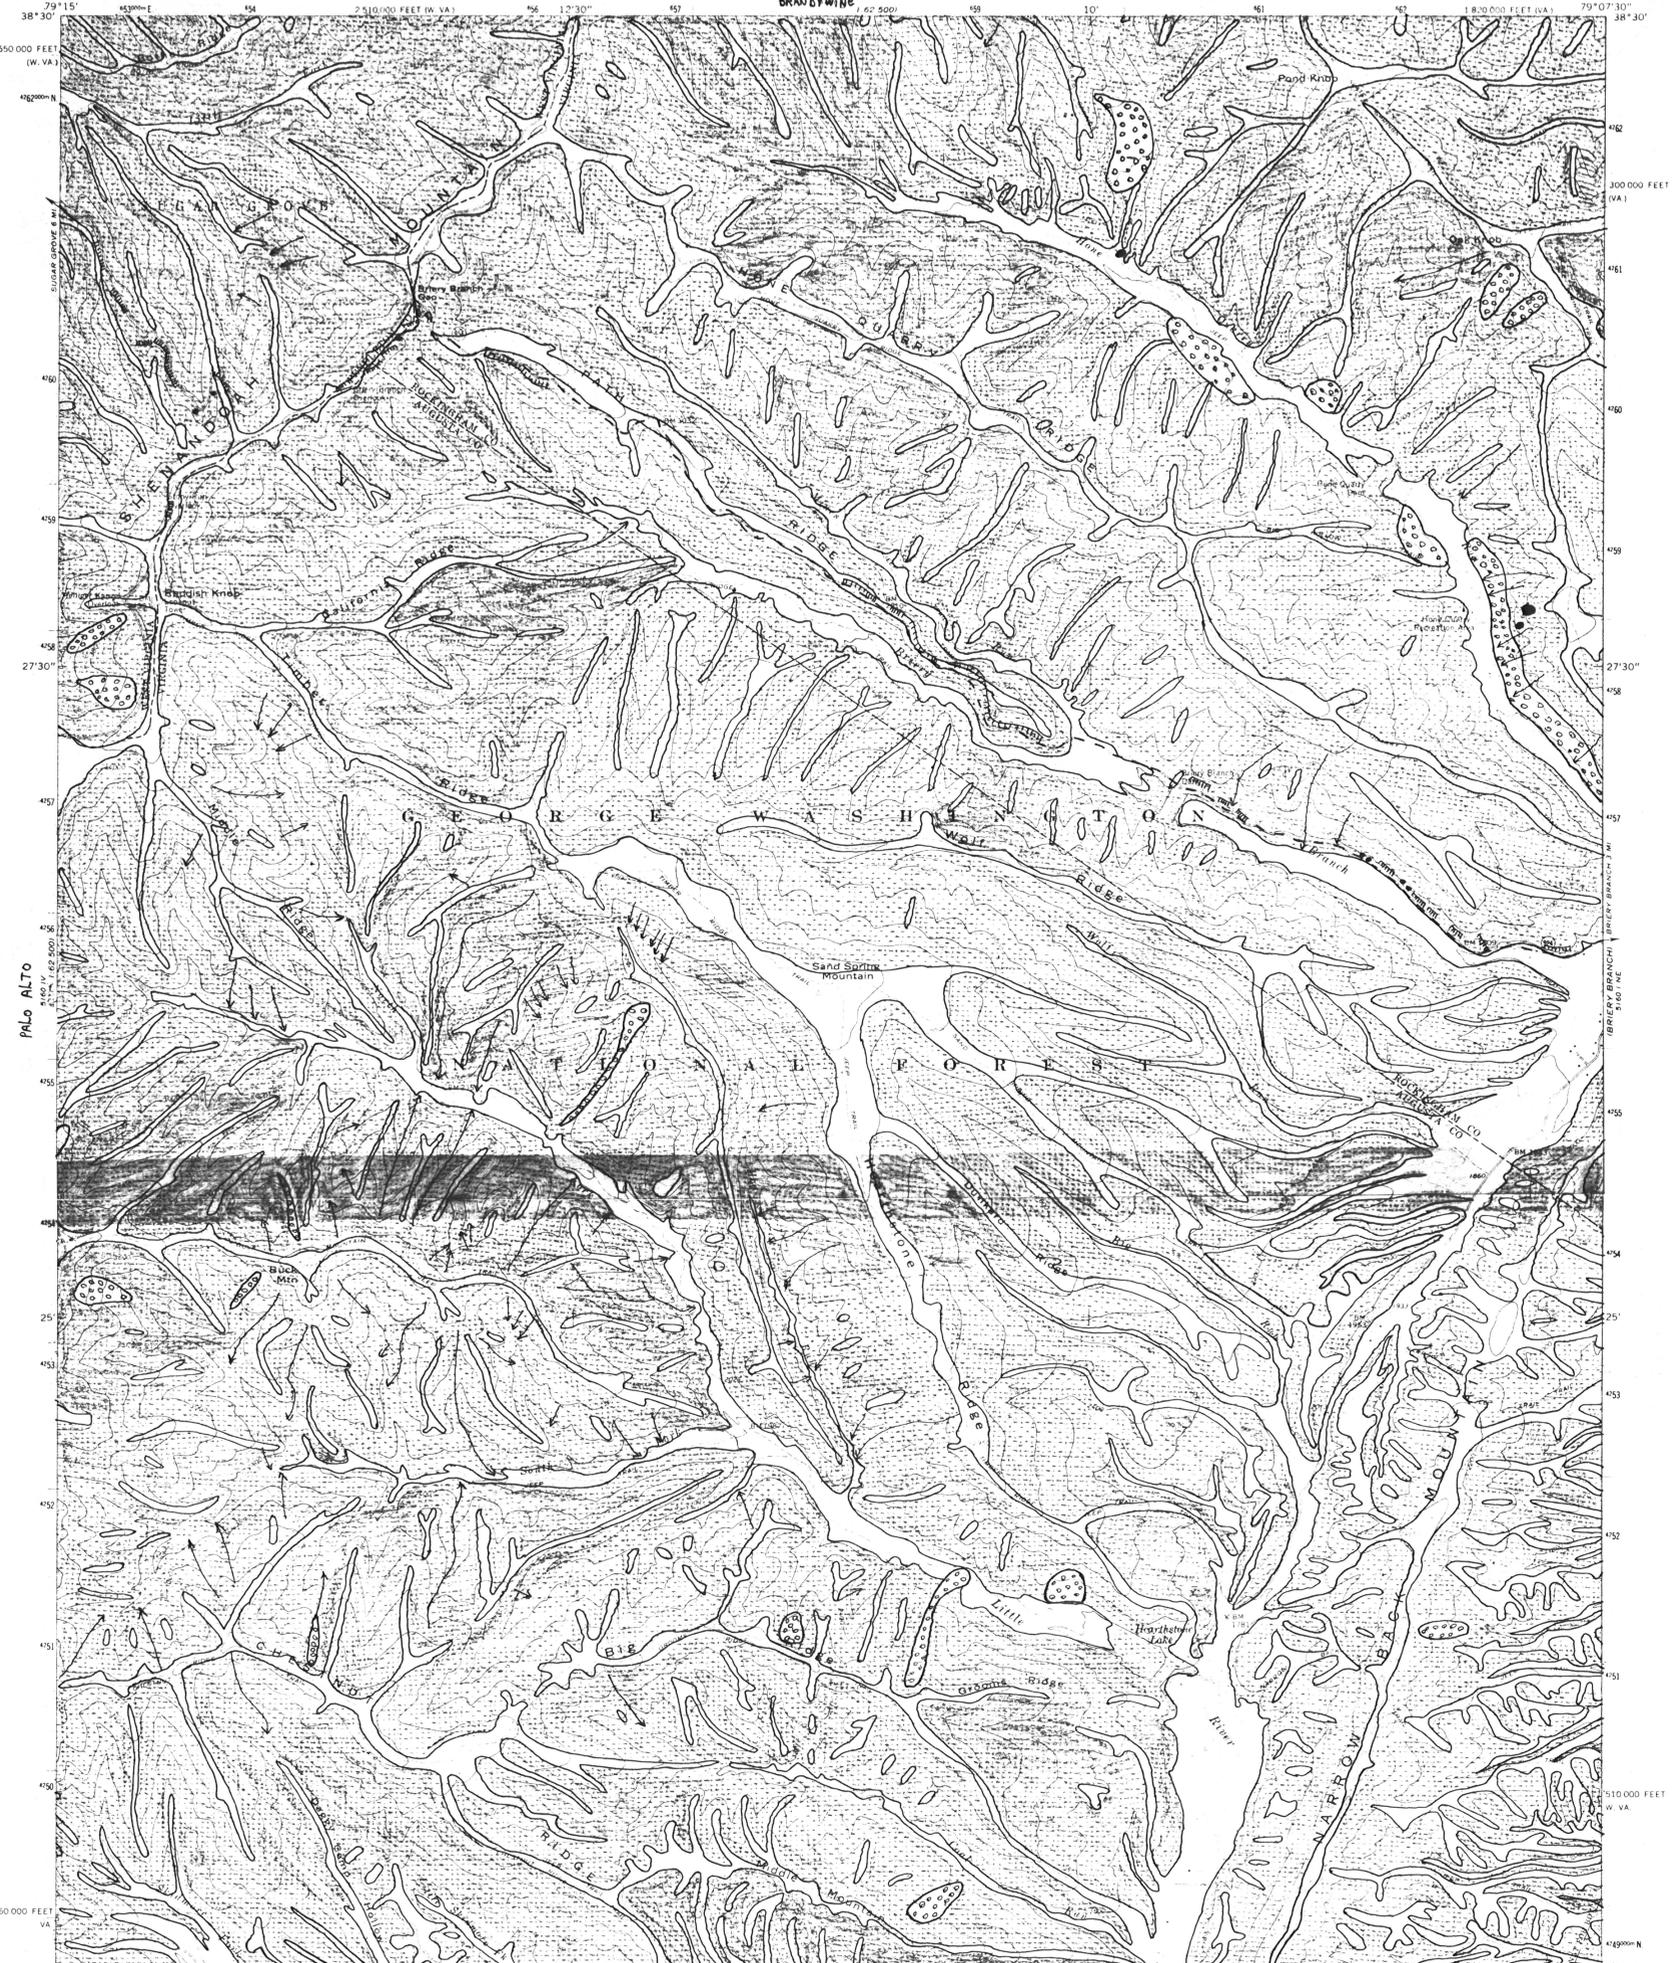
Landslides and related features interpreted from aerial photographs:
1:60,000 (black and white) 1959
1:79,000 (black and white) 1977

- ACTIVE OR RECENTLY ACTIVE LANDSLIDE**
Complex landslide composed of earthflow, debris slides, earth and rock slump. Identified from historical records, and from scars, debris and other field evidence. Ground extremely unstable; sliding accelerated by excavation, loading and changes in drainage conditions. May include areas with several active slides too small to be shown separately. Questioned where doubtful.

- OLD LANDSLIDE**
Area of extensive hummocky ground caused by earthflow and earth and rock slump. Lacks clear evidence of active sliding. Relatively stable in natural, undisturbed state, generally not affected by small structures properly sited in areas away from the edge of the toe; can be reactivated by extensive, rapid excavation, loading, and changes in ground water and surface water conditions. Area of old landslide probably includes recent ones not identified from field evidence or otherwise documented. Upslope boundary of landslide generally defined by modified scarp, but downslope (toe) may be gradational and not well defined. Questioned where doubtful.

- COMBINATION LANDSLIDE**
Area of recent and old slides in which individual slides are not identified.
- COLLUVIAL SLOPE**
Valley wall along major streams with slope as steep as 40° (85%); stony, clayey silt soil up to 50 ft. (15 m) thick; commonly buttressed by a terrace or bench at the toe of the slope; very susceptible to sliding by cutting of toe area, removal of terrace or bench, and overloading; slide commonly activated without apparent cause.

- COLLUVIAL SLOPES WITH LANDSLIDES**
Landslides too small or obscure to map individually.
- AREAS SUSCEPTIBLE TO DEBRIS FLOWS AND DEBRIS AVALANCHES**
Primarily shallow, narrow ravines and chutes with accumulation of stony colluvium generally 10 ft. (3 m) or less in thickness; susceptible to rapid movement during intense rainfall. Most ravines and chutes designated show evidence of former debris flows and avalanches. Symbol & designates historical debris flow or debris avalanche.

- AREAS SUSCEPTIBLE TO ROCKFALL**
Steep, locally vertical, natural and man-made slopes and cliffs, 15 ft. (4.5 m) or more high; formed dominantly of sandstone, limestone, sandy shale, mudstone and claystone. Interbedded mudstone, claystone and shale weather rapidly leaving sandstone and limestone rock faces unsupported.

- SOIL AND ROCK SUSCEPTIBLE TO LANDSLIDING**
Soil and rock similar to that involved in landslides elsewhere in map area; primarily areas underlain by claystone, mudstone and shale associated with other rock types. Rock weathers rapidly on exposure forming clayey soil highly susceptible to sliding. Includes coves (U-shaped, shallow valleys) containing thick layers of clayey soil that are very susceptible to sliding where excavation breaks continuity of slope and where overloaded by artificial fill.

AREAS LEAST PRONE TO LANDSLIDES
Map areas in which no patterns or symbols are shown; primarily valley floors, ridge tops and broad benches; modification by excavation and fill may lead to local landslides.

- MAN-MADE FEATURES**
- Strip mines (combination of letter symbols indicates complex formed of more than one type of strip mine)
 - sh — bench with high wall
 - sf — furrowed with high wall
 - sd — multiple furrows and multiple benches
 - ss — hilltop removed
 - srq — reclaimed by grading
 - sru — reclaimed by secondary use
 - sh/r — regraded in part, high wall remains
 - Coal refuse banks
 - r — identified on aerial photographs; not classified in field check
 - rb — not burnt nor on fire
 - rbb — burnt
 - rbd — burning
 - rbs — sludge
 - Quarries
 - q — quarry site
 - qub — spoil bank, quarry waste
 - Gravel pits
 - g — site of gravel pit
 - Slides in man-made features
 - af — earth flow in fill
 - a/s — earth flow in strip castings
 - a/r — earth flow in coal refuse

NOTE
Information shown is intended as a general guide to ground conditions as of the date of field check. Additional landslides and rockfalls should be anticipated in all map units. The map unit depicts the dominant condition in the area delineated and variations in slope stability may occur at any point in the unit. This map is suitable for general planning purposes and as a supplement to more detailed studies for site selection. The map cannot be used as a substitute for detailed geologic and engineering investigations to establish design and construction criteria of specific sites. Some symbols may not appear on this map because the description is applicable to a series of maps.

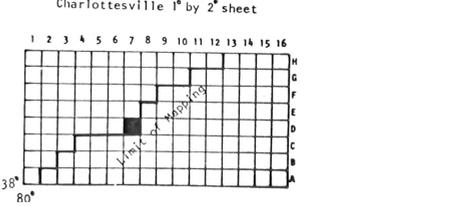
The first five digits of the open file number designate the specific 1:250,000 scale map sheet of which this quadrangle is a part. The last two digits designate the position of the quadrangle in a subdivision of the 1:250,000 scale map based on rows and tiers shown in the diagram to the right. The location of this quadrangle is shown by the black square.
