Winter Water--The Flooding at Boise, Idaho, January 11-12, 1979

By
R. W. Harper and E. F. Hubbard

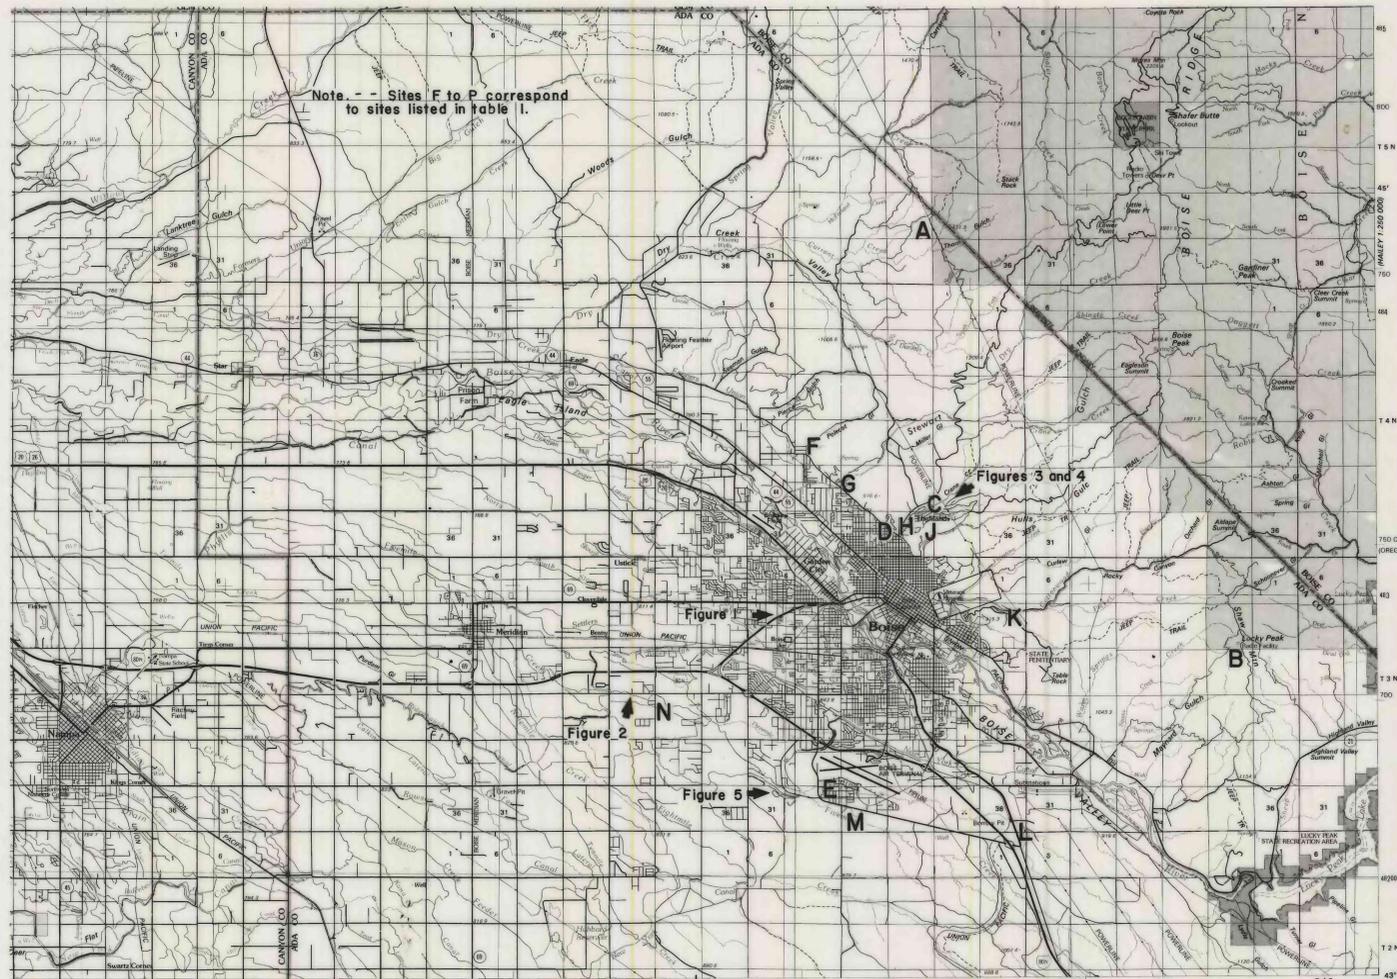
Letters that identify the site locations on the map correspond to those in table 1. The sites were selected on the basis of suitability for computing discharges, severity of the flooding, and availability of data for previous floods.

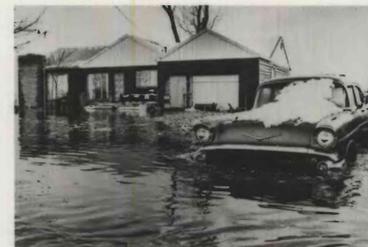
Figure 2.--Flooded depression near Fivemile Creek southwest of Boise. (Photograph by Idaho Statesman)

The snow melted rapidly under the steady rain. Runoff in streams draining the mountains increased, and water soon began to fill many surface depressions (fig. 2). Downward percolation of water was blocked by frozen ground. Along the Boise Front, observations made by the Northwest Watershed Research Center indicated little or no thawing of the frozen ground. Below about the 4,000-foot level, steep slopes rapidly shed their accumulation of snow. The stage for flooding was set.

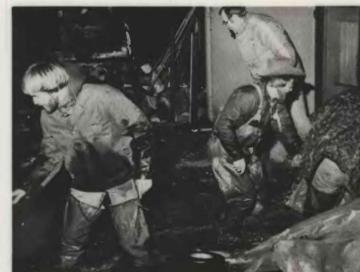
Figure 3.--Sandbagging a home near Crane Creek in the Highlands (Photograph by Idaho Statesman)

Flooding began in midafternoon on January 11, and by evening, was serious in many areas adjacent to the foothills. Hardest hit was the Highlands, a residential area along Crane Creek (map location C). Residents there worked frantically to protect their property (fig. 3). Sandbags were distributed by local agencies to anxious homeowners who filled and placed them. Teams of workers hastily constructed dikes of any material at hand, even plastic bags filled with snow (fig. 4). Many residents could only watch as ice-choked storm drains backed up to flood basements or lower levels of homes.

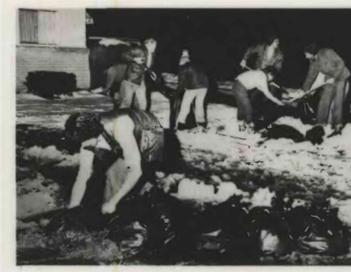
Figure 4.--Diking along Crane Creek using bags of snow. (Photograph by Idaho Statesman)
