DINKUM SANDS

Erk Reimnitz, Robin Ross, and P.W. Barnes

OPEN-FILE REPORT

80-360

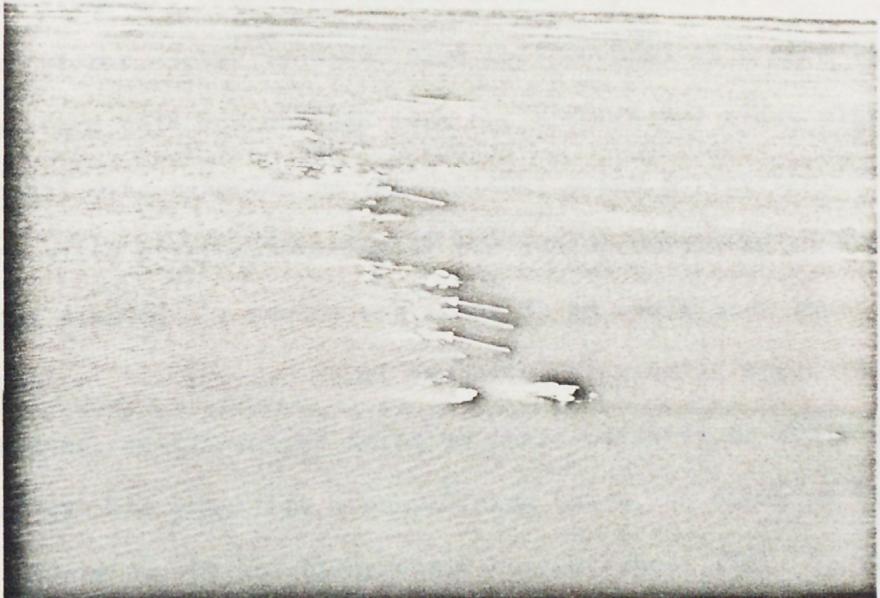
Figure 2. Aerial photograph of Dinkum Sands on July 15, 1979. The major gravel mounds above sea level are shown by white arrows. All other white objects are grounded ice.

Our first visit to Dinkum Sands on July 15, 1979 was prompted by reports that the State of Alaska had 'rediscovered the island.' The shoal, as seen from a helicopter on that date and photographed (Fig. 2) is studded by a series of isolated, small, irregular gravel mounds which break the sea surface. Many small grounded ice floes, remnants of ice piling on the shoal in the previous fall, form most of the light-colored, irregular surface features in the photograph. Submerged sea-ice kettles and ice gouges separate the line of gravel mounds.

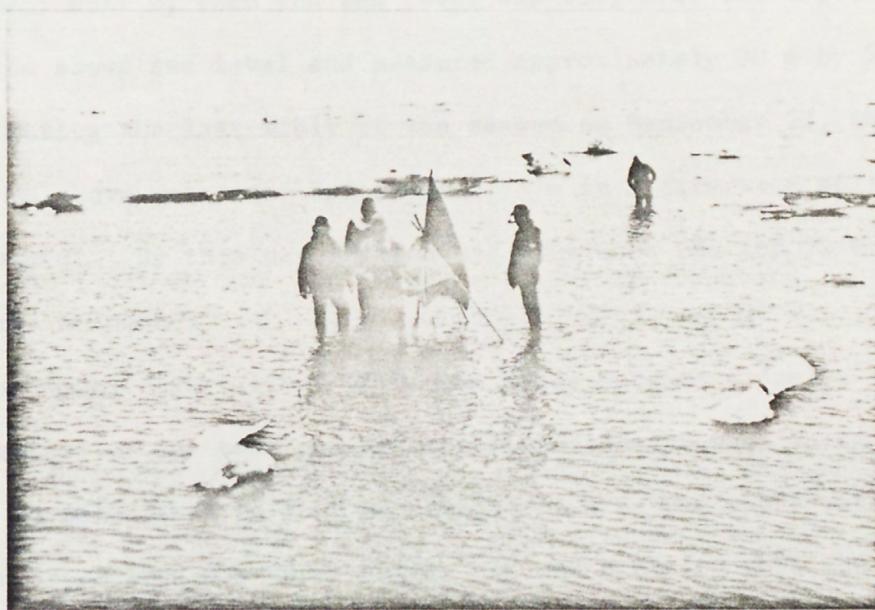
Figure 6. Dinkum Sands with the State of Alaska flag over the survey monument, during a visit by State and Federal officials on August 23, 1979. Minimum water depth was 20 cm.

On August 23 State and Federal Officials accompanied us on the R/V Karluk for a visit to Dinkum Sands where the State had placed a flag over a survey monument on the highest point (Fig. 6). The survey monument had been placed flush with the surface of the shoal on this spot. At the time of our visit the monument was beginning to protrude due to erosion of surface gravel. The shoal was submerged under 20 cm of water.
