(200)
R290
no 80-557

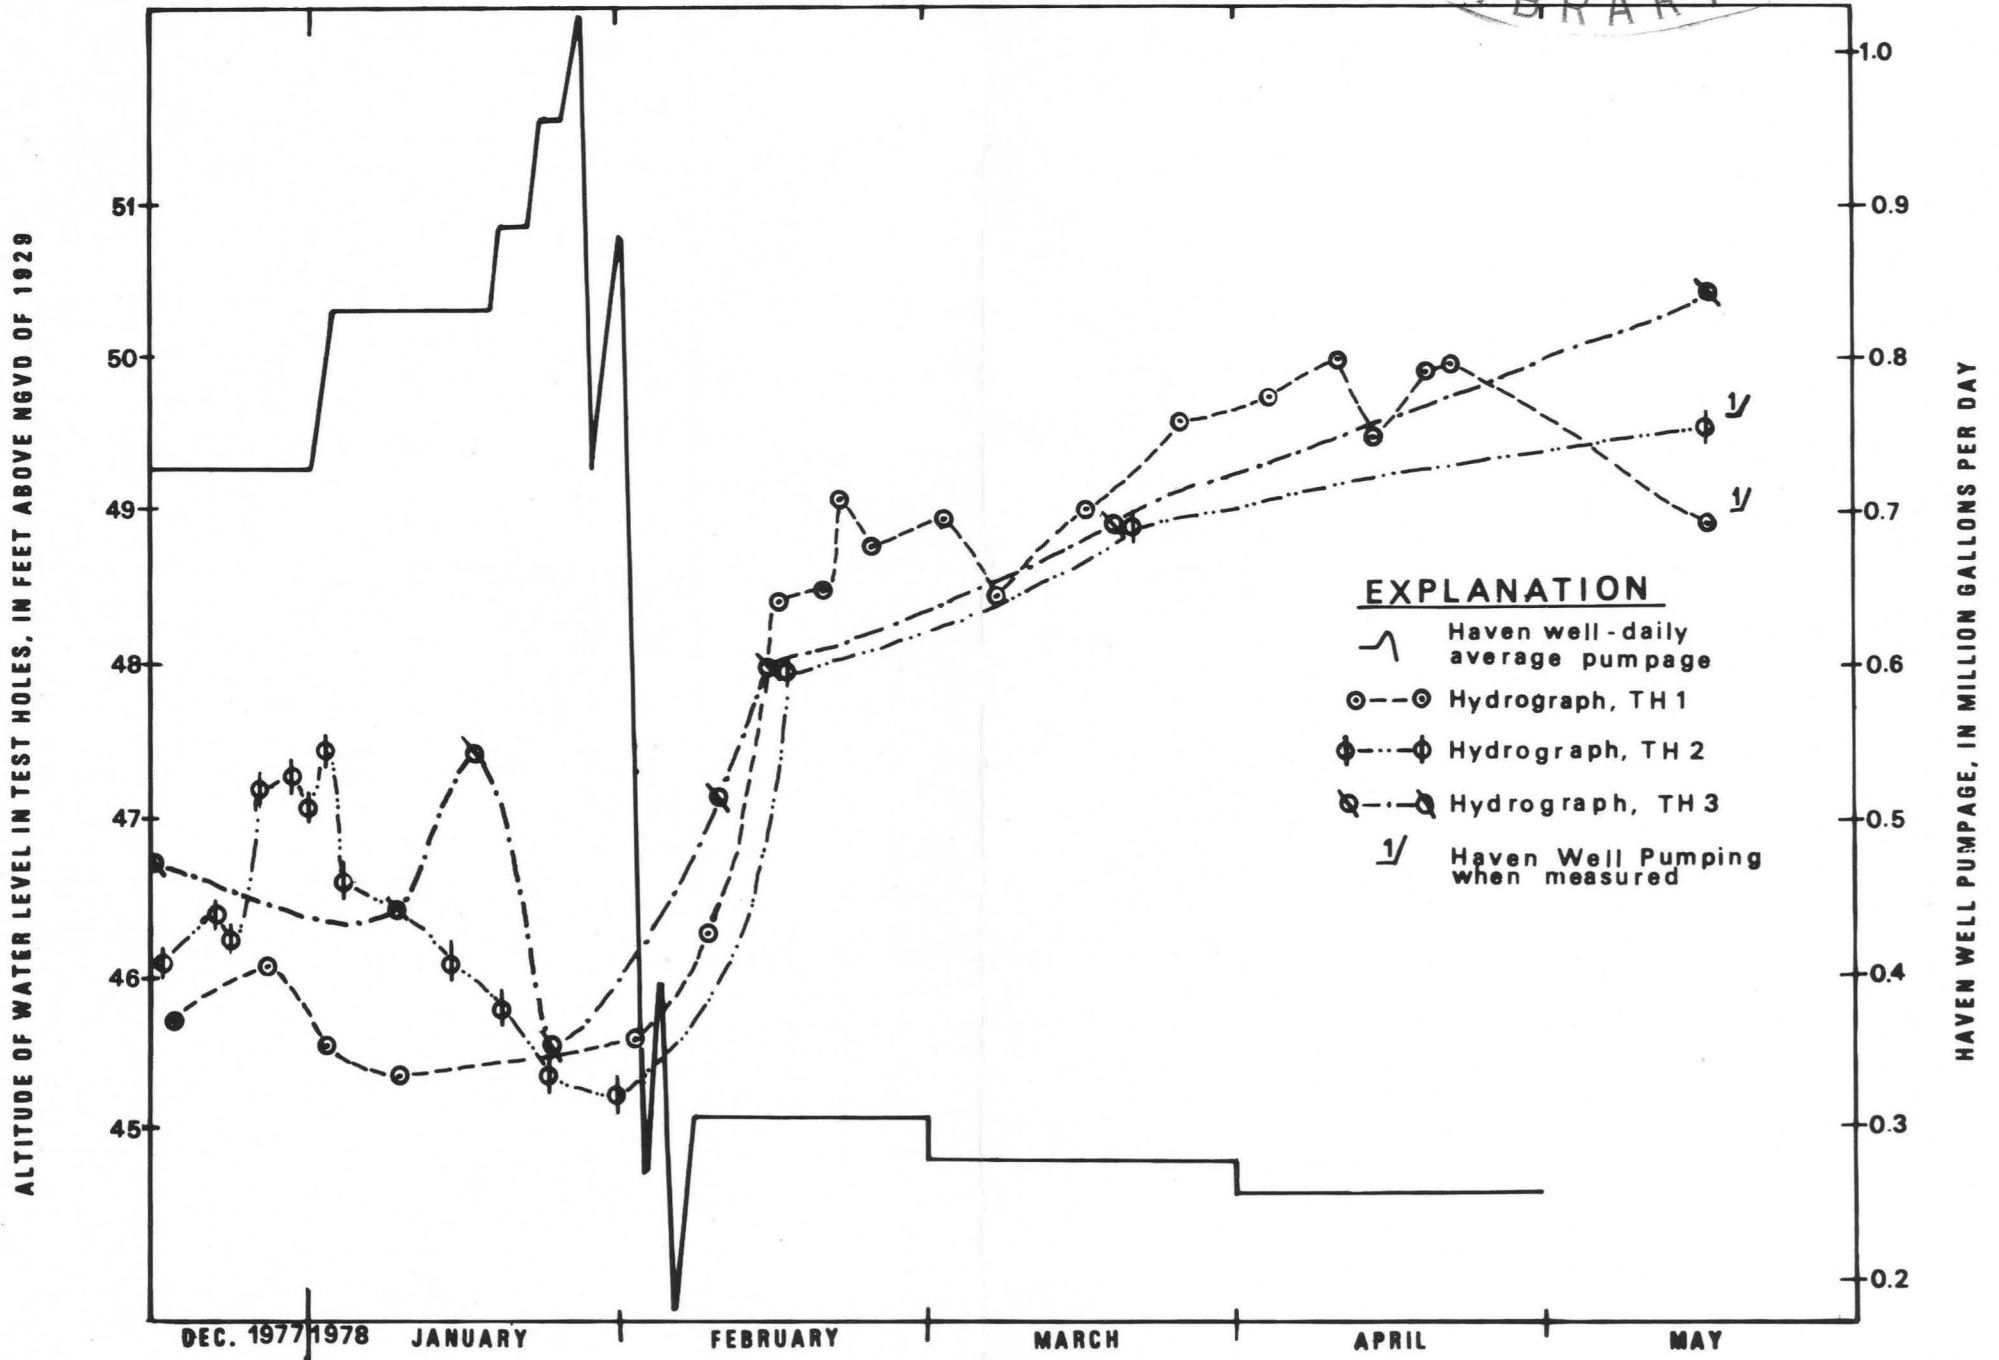
Figure 7.-- Comparison of pumpage at Haven well and water levels in nearby test holes
