UNITED STATES DEPARTMENT OF THE INTERIOR
GEOLOGICAL SURVEY

Investigation of a Natural Slope Failure
in Weathered Tertiary Deposits, Western
Powder River Basin, Wyoming

By Alan F. Chleborad

Open-File Report 80-673

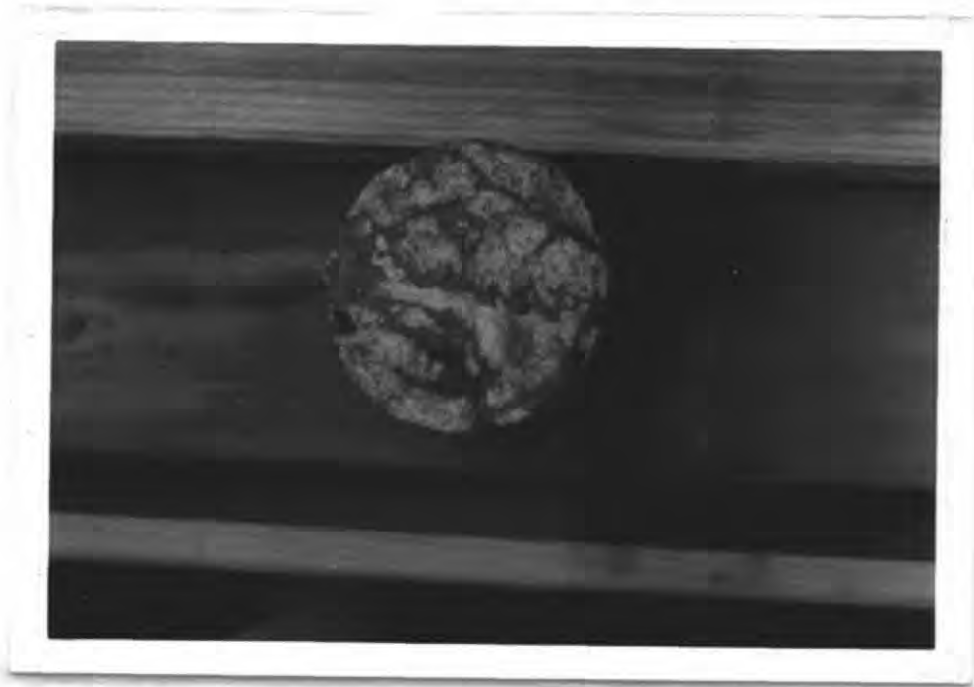
Figure 16. Photograph of Shelby tube core sample (7-cm diameter) from the lower zone of movement in inclinometer-hole NFI. The figure shows slickensided horizontal shear with gypsum crystals.

Detailed examination of the core sample in the laboratory revealed throughgoing slickensides at the points of maximum displacement in inclinometer-holes CHI (4.2 m) and NFI (4.2 m). In inclinometer-hole NFI the slickensides are horizontal and show faint striations indicating displacement (fig. 17). Orientation of the majority of the crystals parallel with the slickensided surface and the presence of sheared and ground crystals, often mixed with the clay, also indicate displacement and establish the presence of most of the crystals prior to some or all of the movement. Throughgoing slickensides were not found in samples from the middle of the slide (CMI). However, a few local slickensides were observed in silty clay from the lower zone of movement. These were small and slightly curved, and appeared randomly oriented.

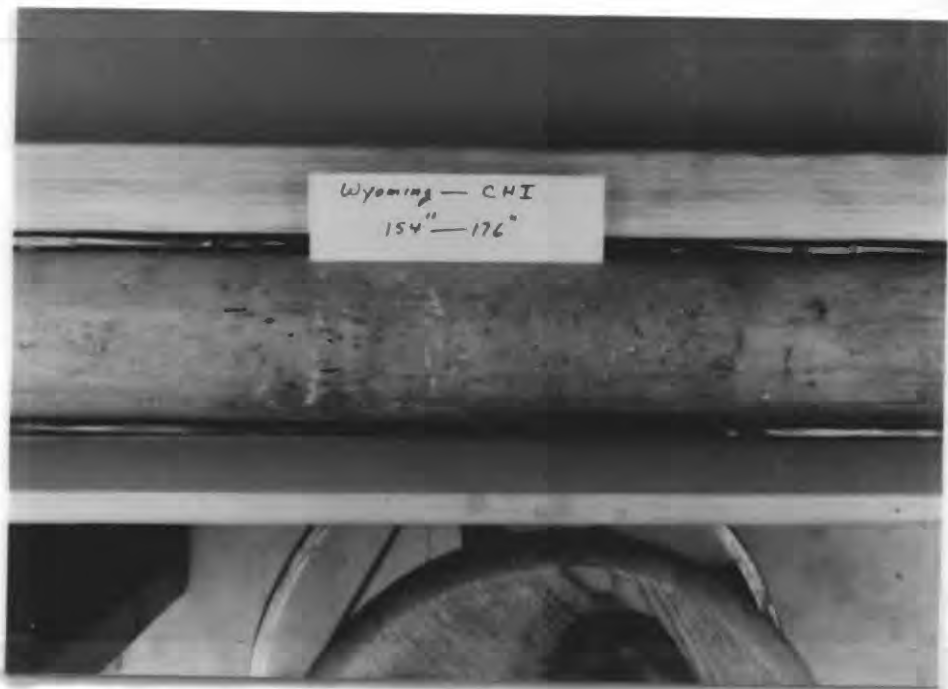
Figure 18. Photograph of Shelby tube core sample from the lower zone of movement in inclinometer hole CHI (3.9-4.5 m). Black specks in the core are carbonaceous particles in clay. White specks are gypsum crystals.

X-ray and chemical analyses were performed on samples from 3.6 to 6.2 m in inclinometer-hole CHI to determine clay types and abundance and to examine changes in mineralogy with depth across the zone of movement and into the immobile material below. Chemical analyses to measure total carbon and total sulfur content were performed on the same samples to determine the abundance of carbonaceous material and, in conjunction with the X-ray analyses, to estimate amounts of organic carbon and sulfur. Part of the tested core sample (that from the lower zone of movement) is shown in figure 18. Results of the analyses are presented in figure 19.
