MAP AND CROSS SECTIONS SHOWING FLOODFLOW CHARACTERISTICS AT COTTONWOOD COVE,
LAKE MEAD RECREATION AREA, CLARK COUNTY, NEVADA

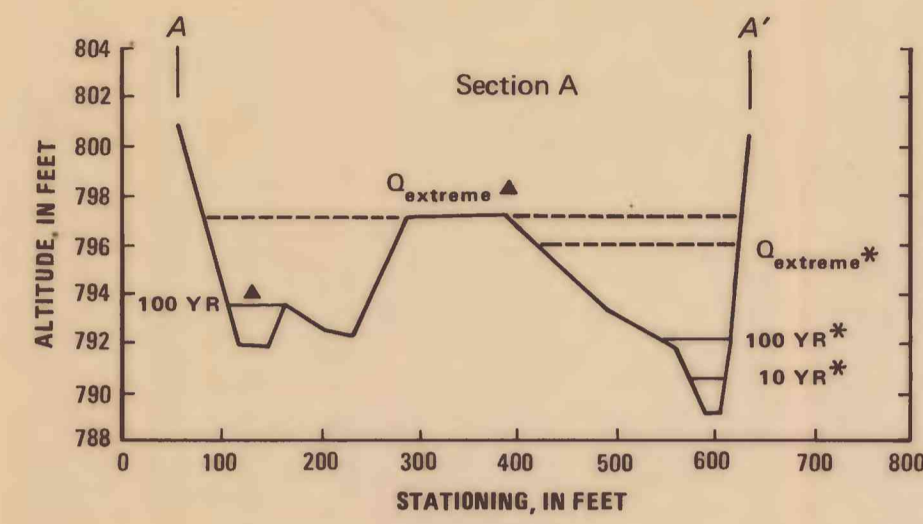
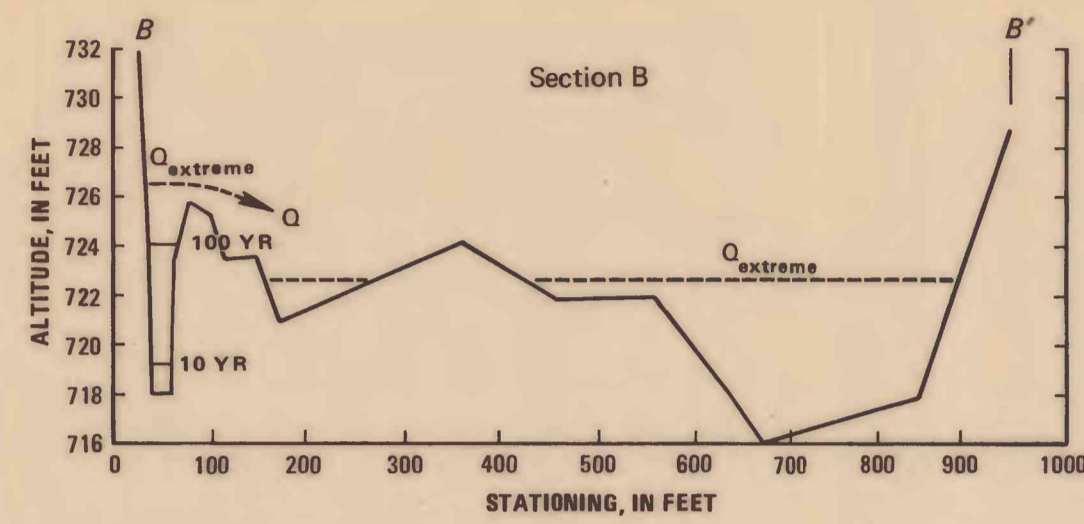
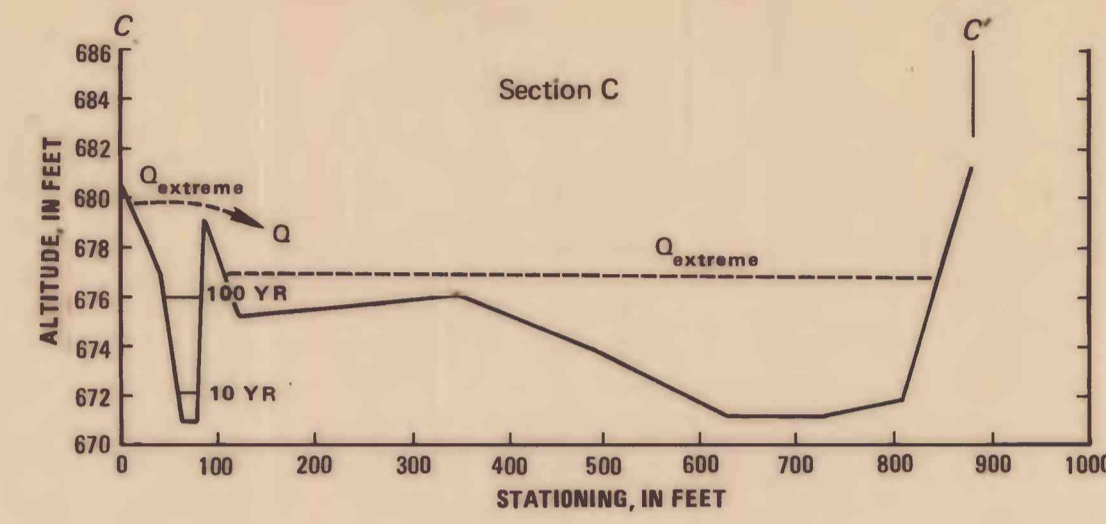
▲ Flooding from Ranger Residence Wash
* Flooding from Access Road Wash
