FLOOD OF SEPTEMBER 16, 1975 IN THE  
GUAYANILLA VALLEY, PUERTO RICOBy  
Karl G. JohnsonDEPARTMENT OF THE INTERIOR  
UNITED STATES GEOLOGICAL SURVEYWATER RESOURCES INVESTIGATIONS  
OPEN-FILE REPORT 80-1282

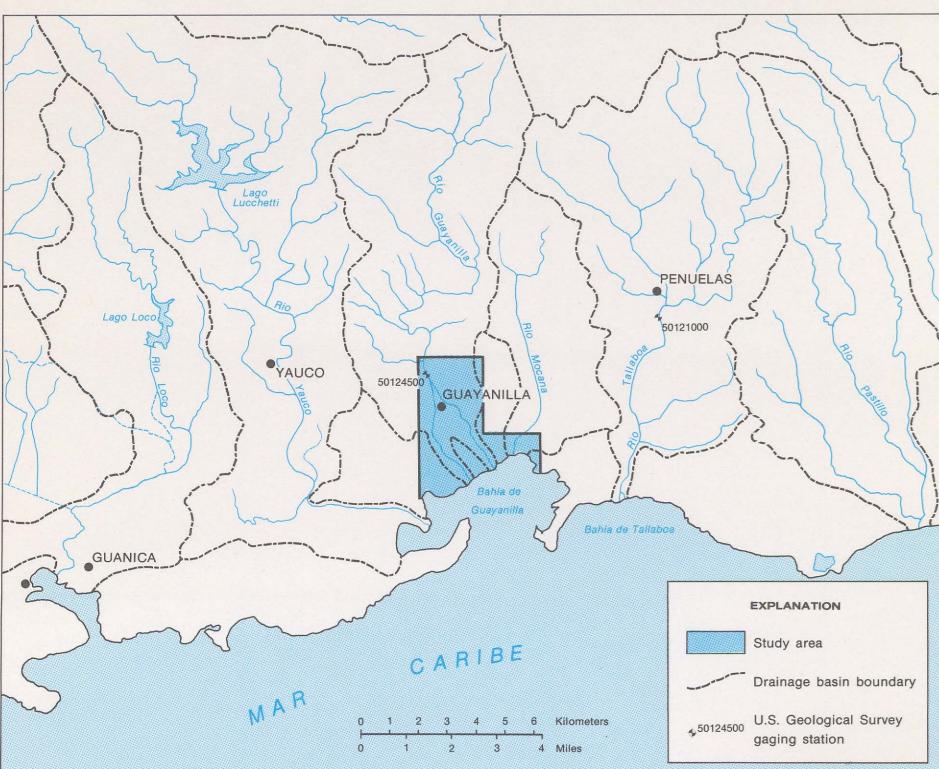
FIGURE 1. - Location of study area and the Rio Guayanilla drainage basin.

The Guayanilla Valley (fig. 1) lies on the southwestern coastal plain of Puerto Rico. It is 15.3 miles long and 3.5 miles wide, with an area of 52.5 square miles. It is in the upper part of the flood plain of the Rio Guayanilla. The climate on the coastal plain is semiarid with a mean annual precipitation of 1,140 mm, while in the mountainous area of the southern slopes of the Cordillera Central, the mean annual is 2,030 mm. The average daily temperature ranges from 27°C in the winter to 29°C in the summer.

The Rio Guayanilla basin is located on the southwestern slopes of the Cordillera Central (fig. 1). The Rio Guayanilla flows in a southerly direction from the rugged hills through steep slopes into a fan-shaped alluvial valley with milder slopes, and empties into Bahia de Guayanilla in the Caribbean Sea. The basin has a drainage area of 47.9 km<sup>2</sup> at the U.S. Geological Survey gaging station 50124500, and 53.9 km<sup>2</sup> at gaging station 50124000. The total drainage area of the basin is about 80 km<sup>2</sup>.

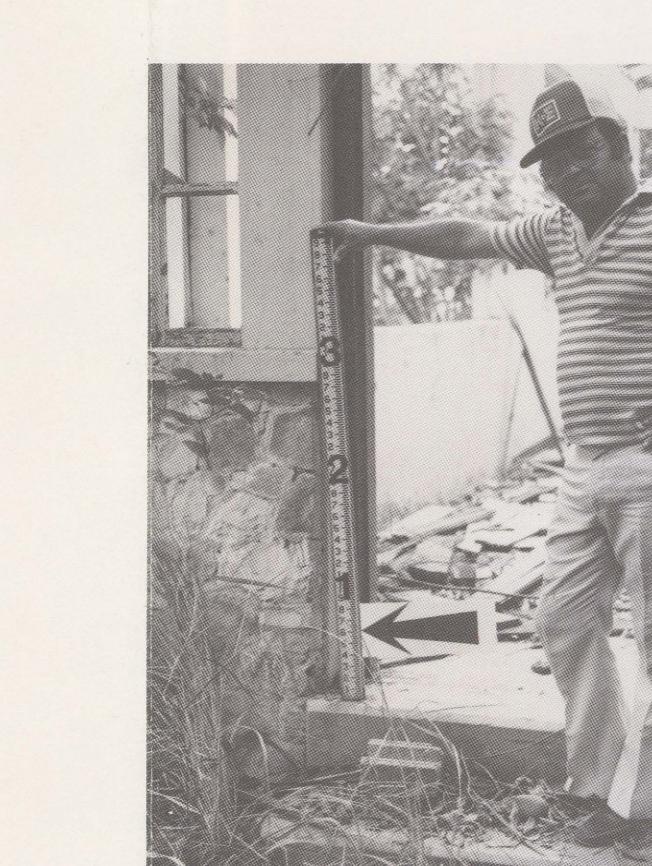
FIGURE 5. - Flood height (arrow) at Central Rufina on abandoned house (photograph C).

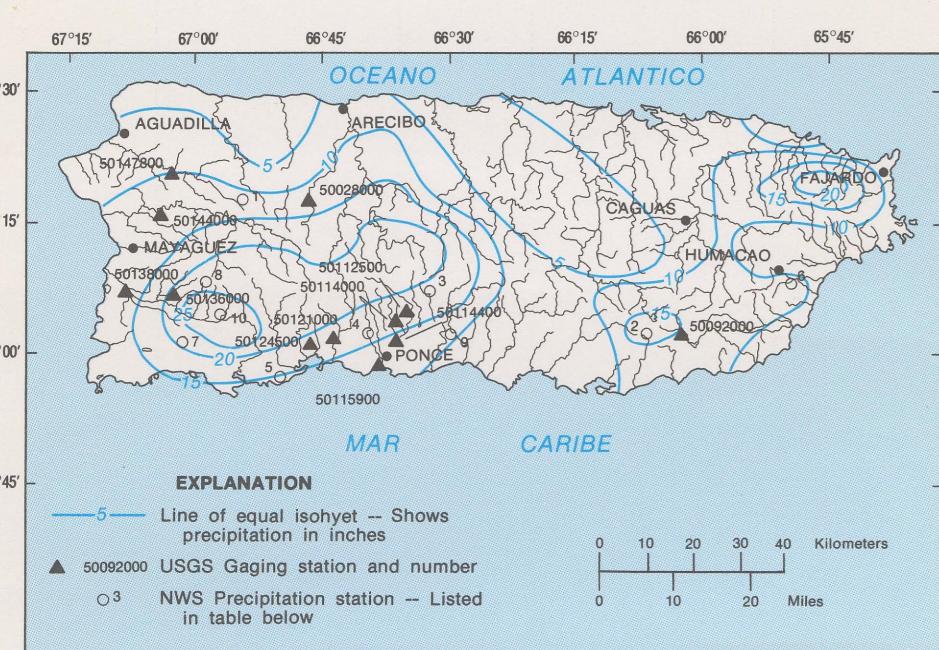
NUMBER ON MAP	LOCATION	PRECIPITATION, OF SEPTEMBER 15-17, 1975 IN INCHES			TOTAL
		15	16	17	
1	ADJUNTA SUBSTATION	0.15	11.99	4.87	17.01
2	CARITE PLANT NO. 1	0.05	10.05	6.85	16.95
3	CERRO MARAVILLA	0.46	2.37	18.83	
4	CORRAL VIEJO	0.10	7.58	8.26	15.94
5	ENSON	0.05	5.74	10.30	15.76
6	HUMACO	0.40	8.05	3.24	11.64
7	LAJAS SUBSTATION	0.29	3.10	12.26	15.65
8	MARICAO 2 SSW	2.32	6.05	14.10	22.47
9	MONTE 4E	0.00	2.90	7.78	10.68
10	SABANA GRANDE 2 ENE	1.20	14.00	11.50	26.70

FIGURE 2. - Map of Puerto Rico showing isobars for September 15-17, 1975. Locations of selected precipitation and stream-gaging stations, and table showing the precipitation for the selected stations.

**FLOOD OF SEPTEMBER 16, 1975**  
The passage of hurricane Eloise near the north coast of Puerto Rico caused torrential rains September 15, 16, and 17, 1975, producing destructive floods mainly in the southwestern part of Puerto Rico. Precipitation at 10 stations during September 15-17, 1975, and the distribution of precipitation throughout the island are shown in figure 2.

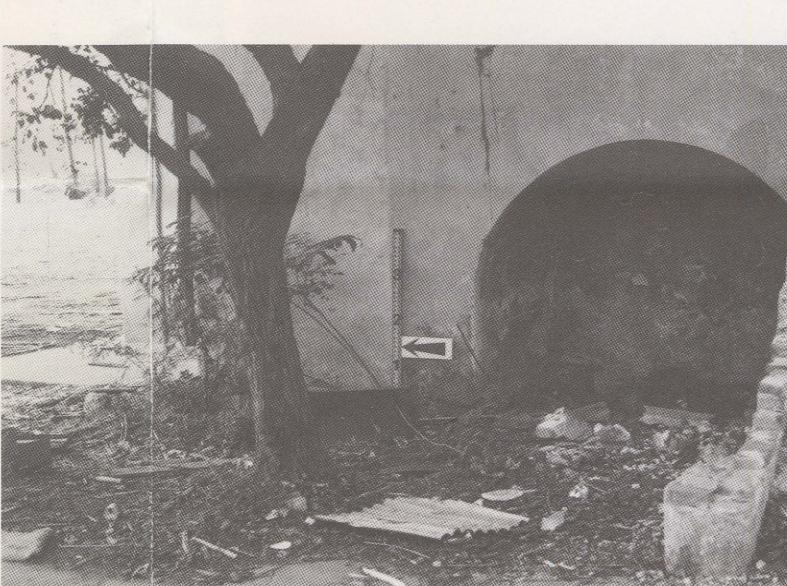
FIGURE 6. - Flood height (arrow) in front of Central Rufina office building (photograph D).

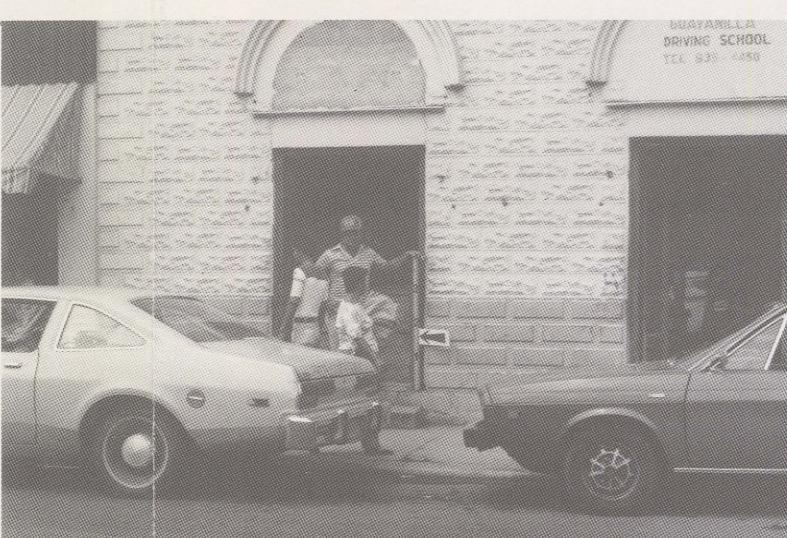
FIGURE 7. - Flood height (arrow) in front of Guayanilla Driving School (photograph E).

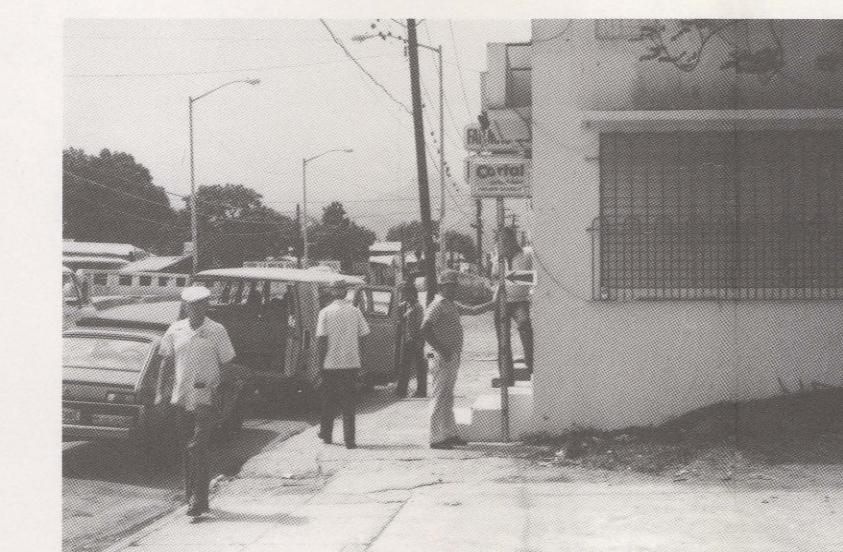
FIGURE 8. - Flood height (arrow) at Casa Yarma looking toward old Highway 2 bridge (photograph F).

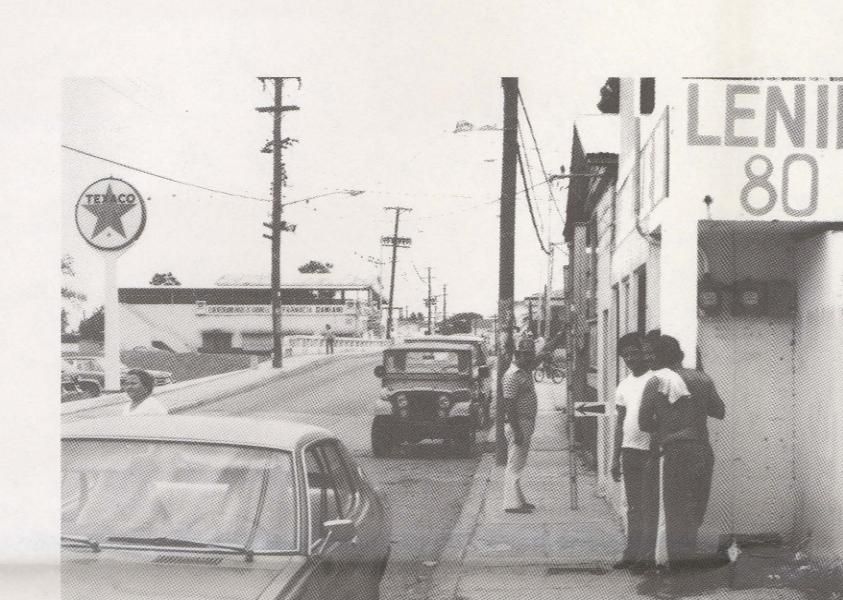
FIGURE 9. - Flood height (arrow) at barber shop La Moderna looking toward old Highway 2 bridge (photograph G).

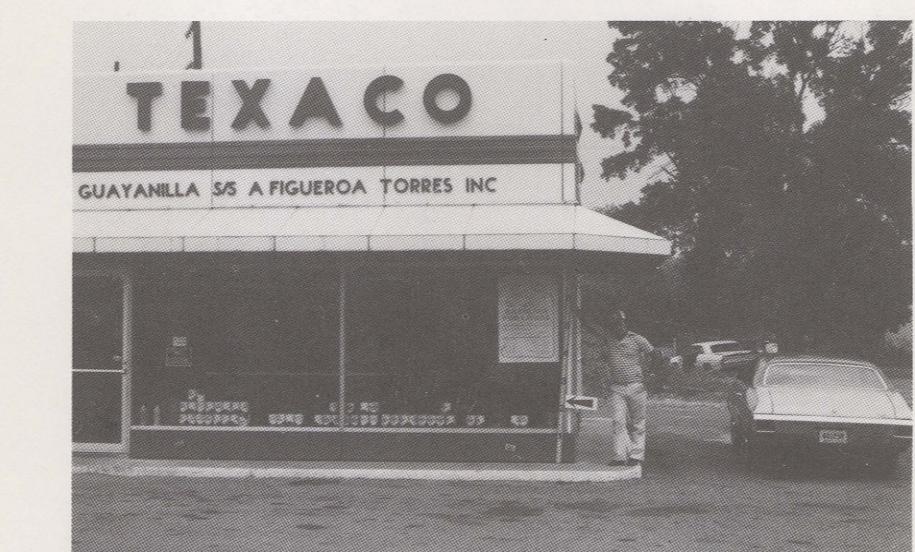
FIGURE 10. - Flood height (arrow) in front of Texaco garage A. Figueroa Torres, Inc., sector Los Sitos, Guayanilla (photograph H).

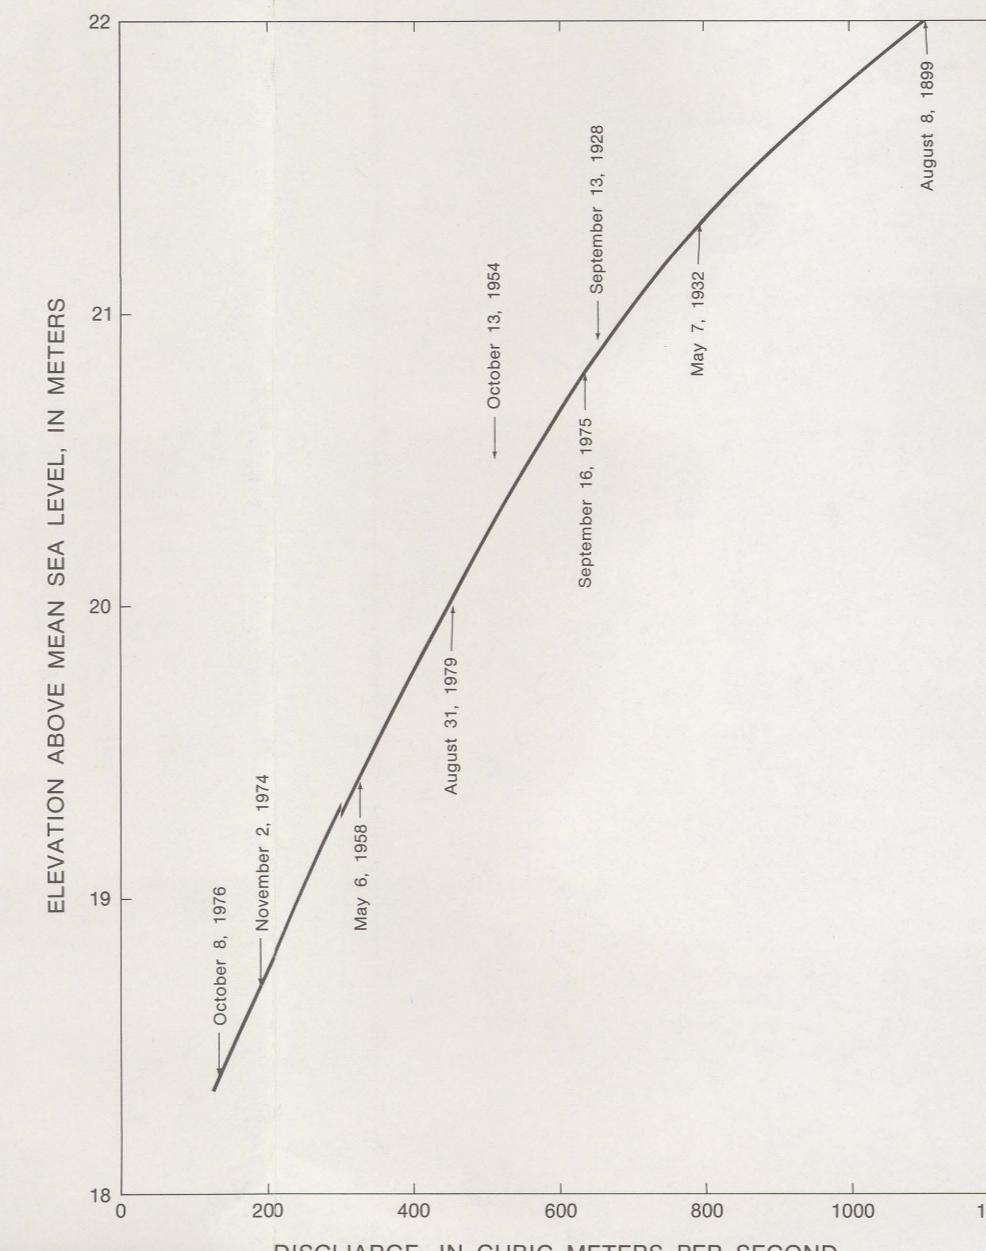
FIGURE 11. - Stage-discharge relation of gaging station 50124500 at Guayanilla, P.R.

A stage-discharge relation was developed at station 50124500 (fig. 11). The relation is based on historical data for the period 1899-1975, and current records at the site. The location of gaging stations 50124000 and 50124500, and the indirect-measurement site are shown in figure 12. The difference in drainage area between the indirect measurement site and the gaging stations is insignificant and no correction was applied to the measurement in this analysis.

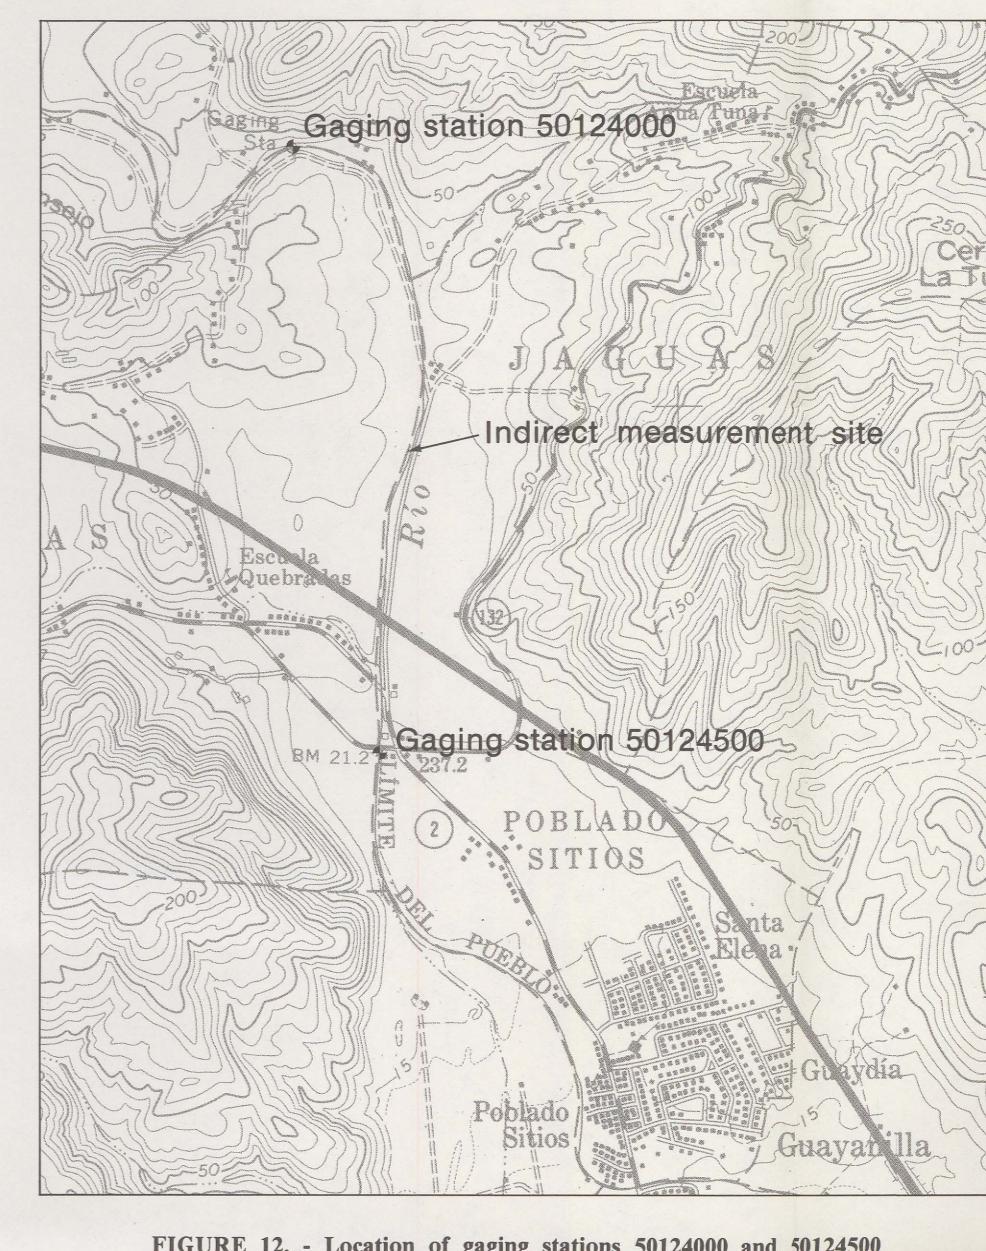
FIGURE 12. - Location of gaging stations 50124000 and 50124500 and indirect measurement site.

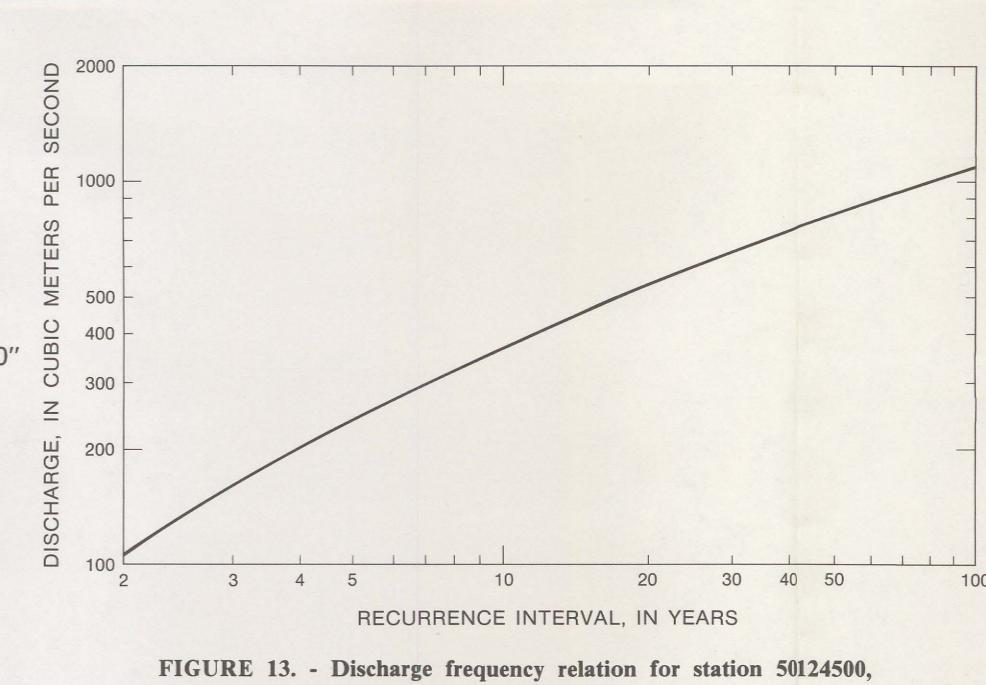
FIGURE 13. - Discharge frequency relation for station 50124500, Rio Guayanilla at Guayanilla, P.R.

Water Resources Council Bulletin 17A (appendix 8, 1977) recommends that the frequency relation at a gage site be defined by a curve of peak discharge for a selected frequency using the station data and data obtained from regional flood magnitude-frequency relation. This was done to relate the data obtained with the 18 years of station data and with results of a regional study accomplished by Lopez and others, 1979. The resulting frequency curve is shown in figure 13. The recurrence intervals shown in table 1 were derived from this figure.
